SUBJECT: LER 90-007-00:on 900517,reactor trip due to failure of
 feedwater regulating valve.

H. B. ROBINSON STEAM ELECTRIC PLANT, UNIT NO. 2
DOCKET NO. 50-261
LICENSE NO. DPR-23
LICENSEE EVENT REPORT 90-007

REACTOR TRIP DUE TO FAILURE OF FEEDWATER REGULATING VALVE

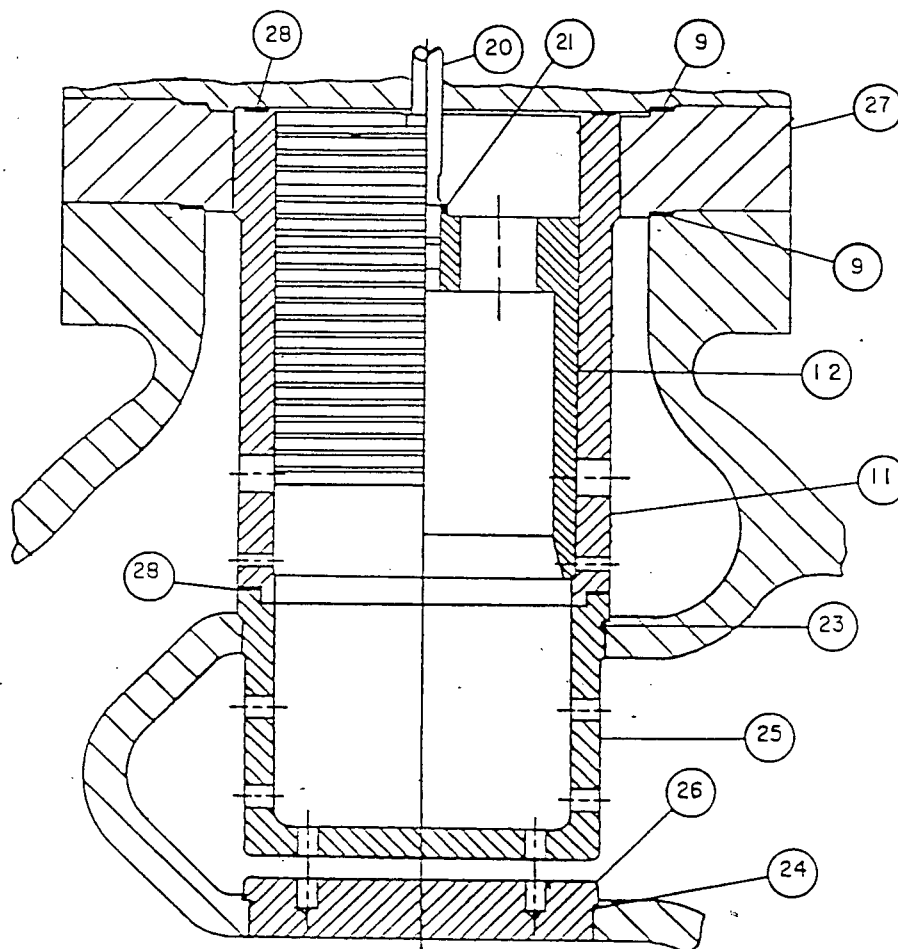
FIGURE 1

Subsequent disassembly of FCV-488 revealed that the valve spring pin had sheared, which allowed the valve plug to rotate and unthread from the valve stem (Reference Figure 1). This resulted in the steam flow-feedwater flow mismatch, with RPS actuation occurring when SG B level reached the low level setpoint. Since steam generator level control instrumentation sensed the reduced feedwater flow, a signal was generated to open the FRV, which resulted in the valve demand position indication reaching 100%. However, due to the degraded connection between the valve plug and stem, movement of the valve stem by its operator had no effect on actual feedwater flow to SG B.

The SG B feedwater regulating valve is a 12 inch cage and plug valve with special, cylinder-type, single stage trim.² Disassembly and inspection of this valve following the event revealed that the valve spring pin had sheared, which allowed the valve plug to rotate and unthread from the valve stem.³ Close inspection of the spring pin indicated that one end had been sheared, while the other end showed no signs of shearing. This indicated that the spring pin may not have been fully engaged through the valve stem and both sides of the plug boss. Some pitting corrosion was observed on the shaft of the spring pin, however, this is not believed to have contributed to its shearing. Based on this inspection activity, a contributing factor to this event was a lack of full engagement of the spring pin between the valve stem and plug which resulted in one end of the spring pin being excessively loaded.

Conversations with the valve vendor indicated that the recommended valve stem to valve plug torque is 100 ft-lbs. This information was found within existing plant documentation, but had not been incorporated into Corrective Maintenance procedure, CM-107, "Main Feedwater Regulating Valve Maintenance." Disassembly and inspection of SGs A and C FRVs, FCV-478 and FCV-498, found that FCV-478 had at least 100 ft-lbs. torque between the plug and stem, while FCV-498 had slightly less than the required torque. The exact torque value between the stem and plug for FCV-488 prior to disassembly and repair is not known. However, inadequate torque on the stem-to-plug assembly may have resulted in undue stresses on the spring pin, which may have contributed to the spring pin failure.

As stated above, SG B FRV, FCV-488, was disassembled, inspected, and repaired. This repair included installation of a new spring pin, however, the specified replacement part obtained from stock was found to be 3/16 inch diameter and 1 1/4 inches long. To ensure full engagement of both ends of the spring pin, an acceptable replacement pin was installed which was 3/16 inch diameter and 1 1/2 inches long. Also, due to damage found on the valve stem threads, a new valve stem was obtained and installed. The valve plug was installed and properly torqued to 100 ft-lbs.

Finally, CM-107 has been revised to incorporate the proper stem-to-plug torque value of 100 ft-lbs. This procedure revision was completed and implemented on June 15, 1990.
