SUBJECT: LER 91-003-00:on 910214,containment vessel fire during  
 refueling.Caused by overheating of electrical cable.Number  
 of corrective actions developed & Licensee fire protection &  
 health physics personnel conducted tour.W/910325 ltr.

H. B. ROBINSON STEAM ELECTRIC PLANT, UNIT NO. 2  
DOCKET NO. 50-261  
LICENSE NO. DPR-23  
LICENSEE EVENT REPORT NO. 91-003-00

TITLE (4) CONTAINMENT VESSEL FIRE DURING REFUELING DUE TO NON-APPROVED EQUIPMENT HEATING PROCESS
---

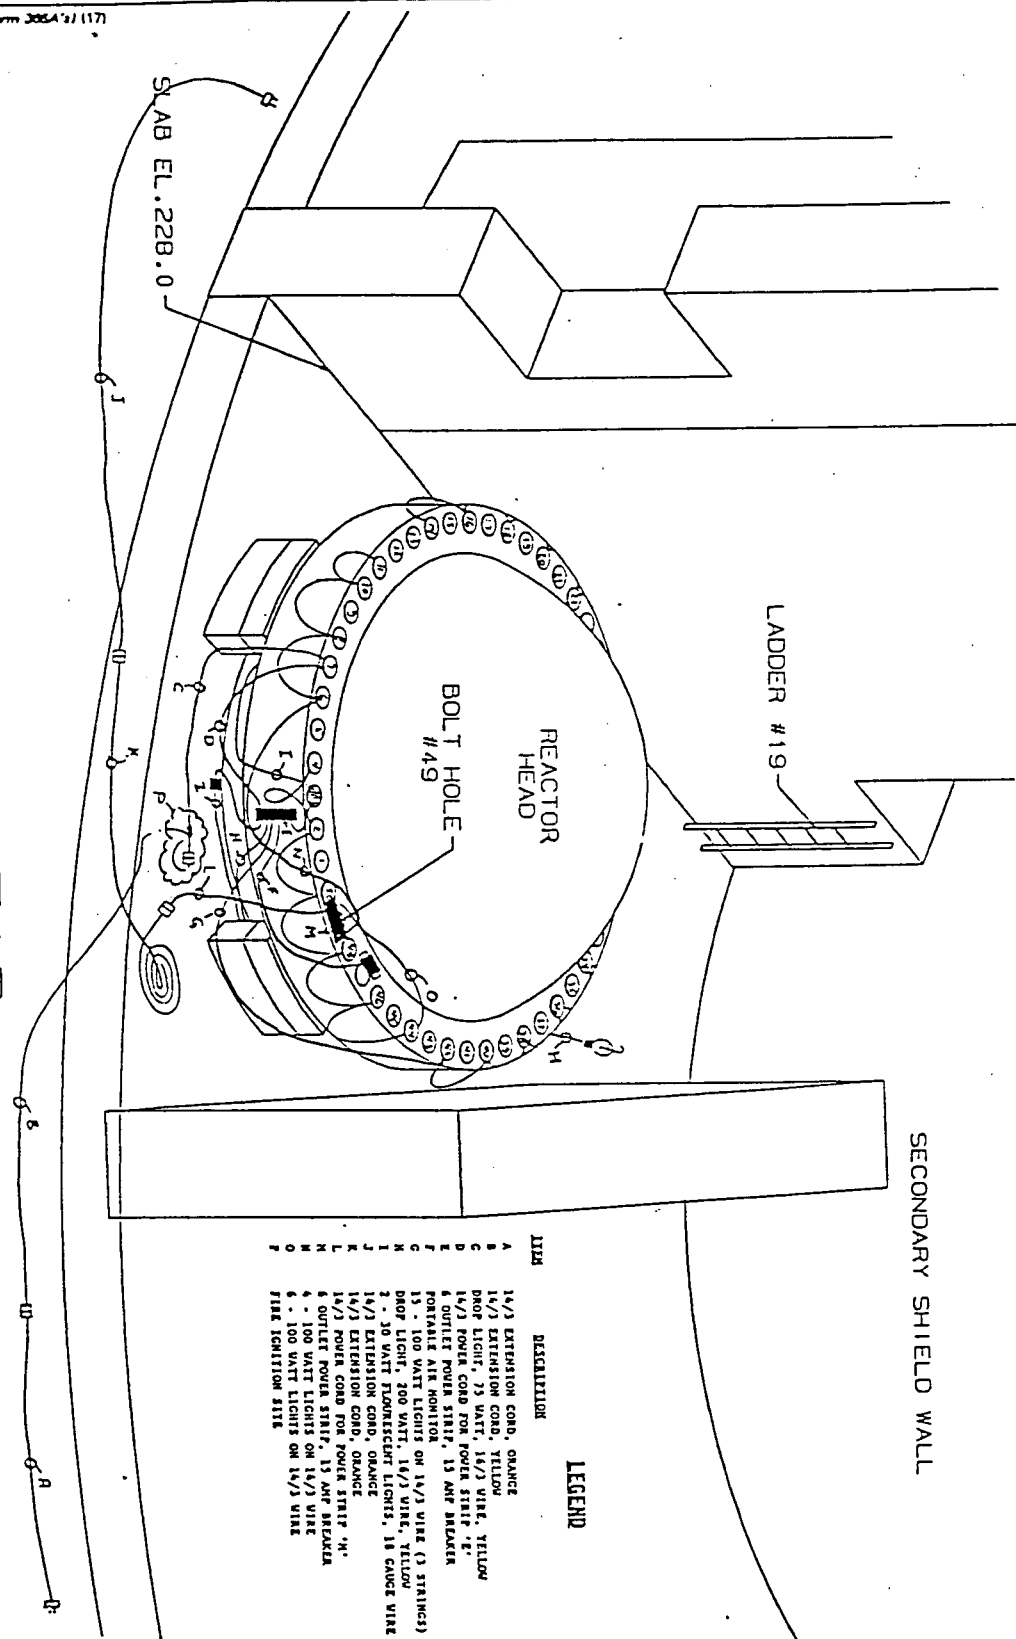
"FIGURE 1"

REACTOR HEAD  
STORAGE AREA  
LOOKING N 45 E DOWN

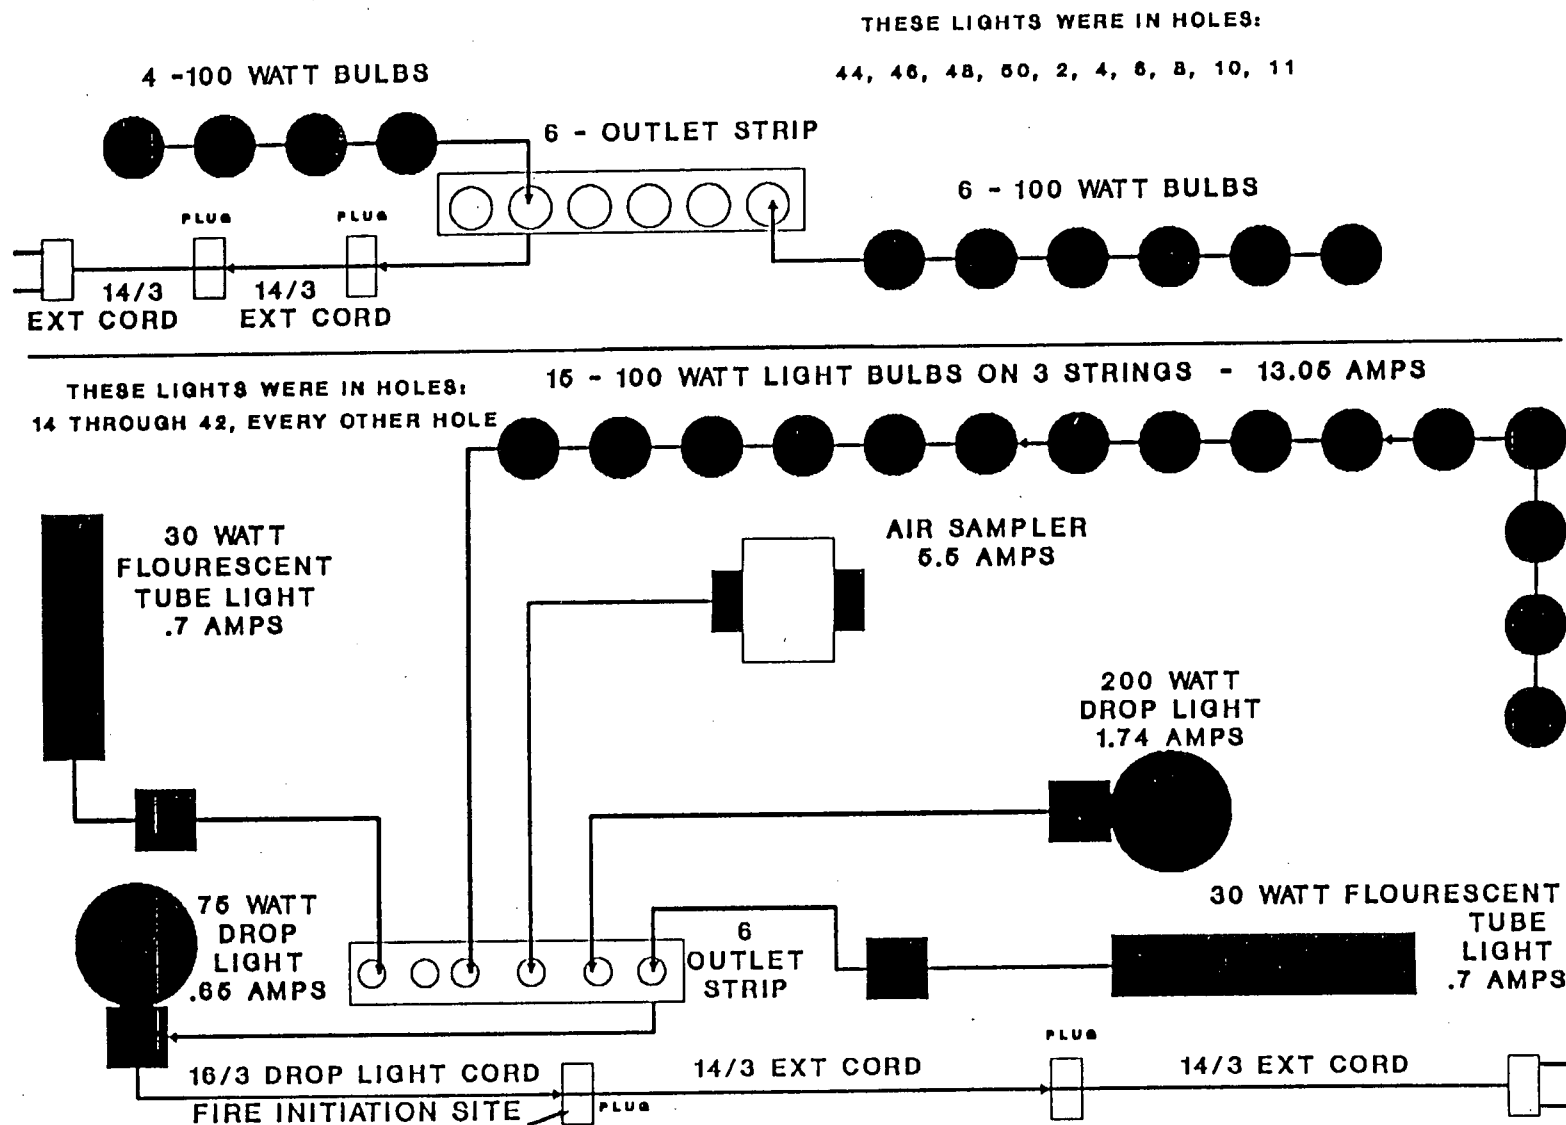
"FIGURE 2"

The root cause investigation, conducted in accordance with the Plant Corrective Action Program, determined that the fire resulted from localized overheating of electrical cable insulation at a knotted plug connection between a drop light and an extension cord. The drop light and cord were in a circuit feeding temporary lights being used to warm the reactor vessel head. Reconstruction and analysis of the electrical configuration revealed an overloaded condition for the cables in use (Figure 2). Two cables had been knotted together within six inches of the end plugs, which may not have been tightly connected. This provided a high resistance connection which created an increased potential ignition source. The overloaded electrical cords, combined with the high resistance knotted connection, resulted in sufficient heat to ignite the electrical cord insulation. An adjacent fire retardant tarpaulin, utilized to facilitate the head warming activities, ignited and the fire spread to combustible materials in the area, such as cotton towels which had been used to protect the head "O" rings.

This event is attributed to heating the head without adequate control of a temporary power configuration, resulting in an electrically overloaded condition, combined with utilization of excessive combustible materials in the head storage area.

**RV HEAD HEATING WIRING DIAGRAM**

Due to the scope and depth of the investigation performed to determine the root cause of the fire and to develop recommendations to preclude recurrence of this event, a number of corrective action recommendations were developed. Items under consideration include development of controls for temporary power installations, controls for portable heater applications, and improved controls over transient combustibles. These recommendations are being addressed via the Plants' Corrective Action Program.
