SUBJECT: LER 92-017-00:on 920822,loss of offsite power occurred due
 to trip of Startup Transformer.Repairs to start-up
 transformer completed & normal power restored.W/920921 ltr.

H. B. ROBINSON STEAM ELECTRIC PLANT, UNIT NO. 2
DOCKET NO. 50-261
LICENSE NO. DPR-23
LICENSEE EVENT REPORT NO. 92-017-00

UNUSUAL EVENT DUE TO LOSS OF OFF-SITE POWER AND REACTOR TRIP

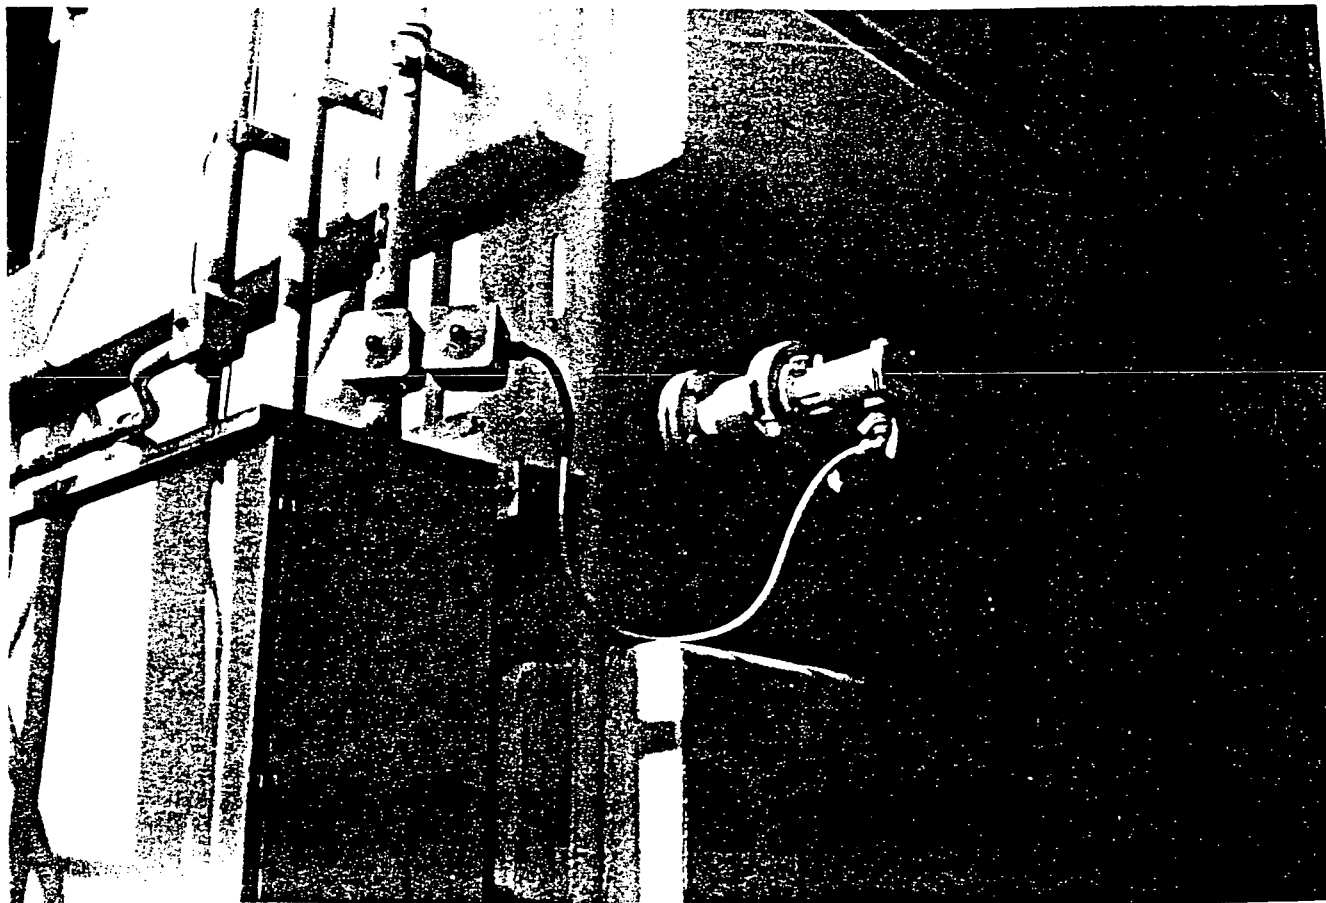
SUDDEN PRESSURE FAULT PROTECTIVE RELAY CIRCUITRY

The start-up transformer trip was caused by a short circuit in the sudden pressure fault protective relay sensing circuitry. This short circuit was the result of water collecting in the base of the cable connector at the relay (see attached photograph). A cable connects the relay to a junction box approximately two and one half feet away, and about six inches above the relay. The cable houses three conductors which connect the relay to the transformer protective circuitry. This cable is hollow with the conductors loose inside. The junction box, which is designed with a drain hole for removal of moisture, had been inadvertently rotated to the point where the drain hole allowed water to collect inside. The water subsequently entered the hollow cable and traveled to the base of the relay/cable connector, where it shorted across two soldered connections.

(CORRECT POSITION)

Repairs to the start-up transformer were completed and normal power was restored to the emergency busses at 0050 hours on Sunday, August 23, 1992. The Unusual Event was terminated at 0124 hours.
