SUBJECT: LER 92-020-00: on 920930, during surveillance test on fire protection sys, 525 pounds of carbon dioxide released in vital area. Caused by debris in disk surface & pilot valve. Fire protection/surveillance test revised. W/921021 ltr.

H. B. ROBINSON STEAM ELECTRIC PLANT, UNIT NO. 2
DOCKET NO. 50-261
LICENSE NO. DPR-23
LICENSEE EVENT REPORT NO. 92-020-00

ALERT DECLARATION DUE TO UNPLANNED RELEASE OF TOXIC GAS IN VITAL AREA

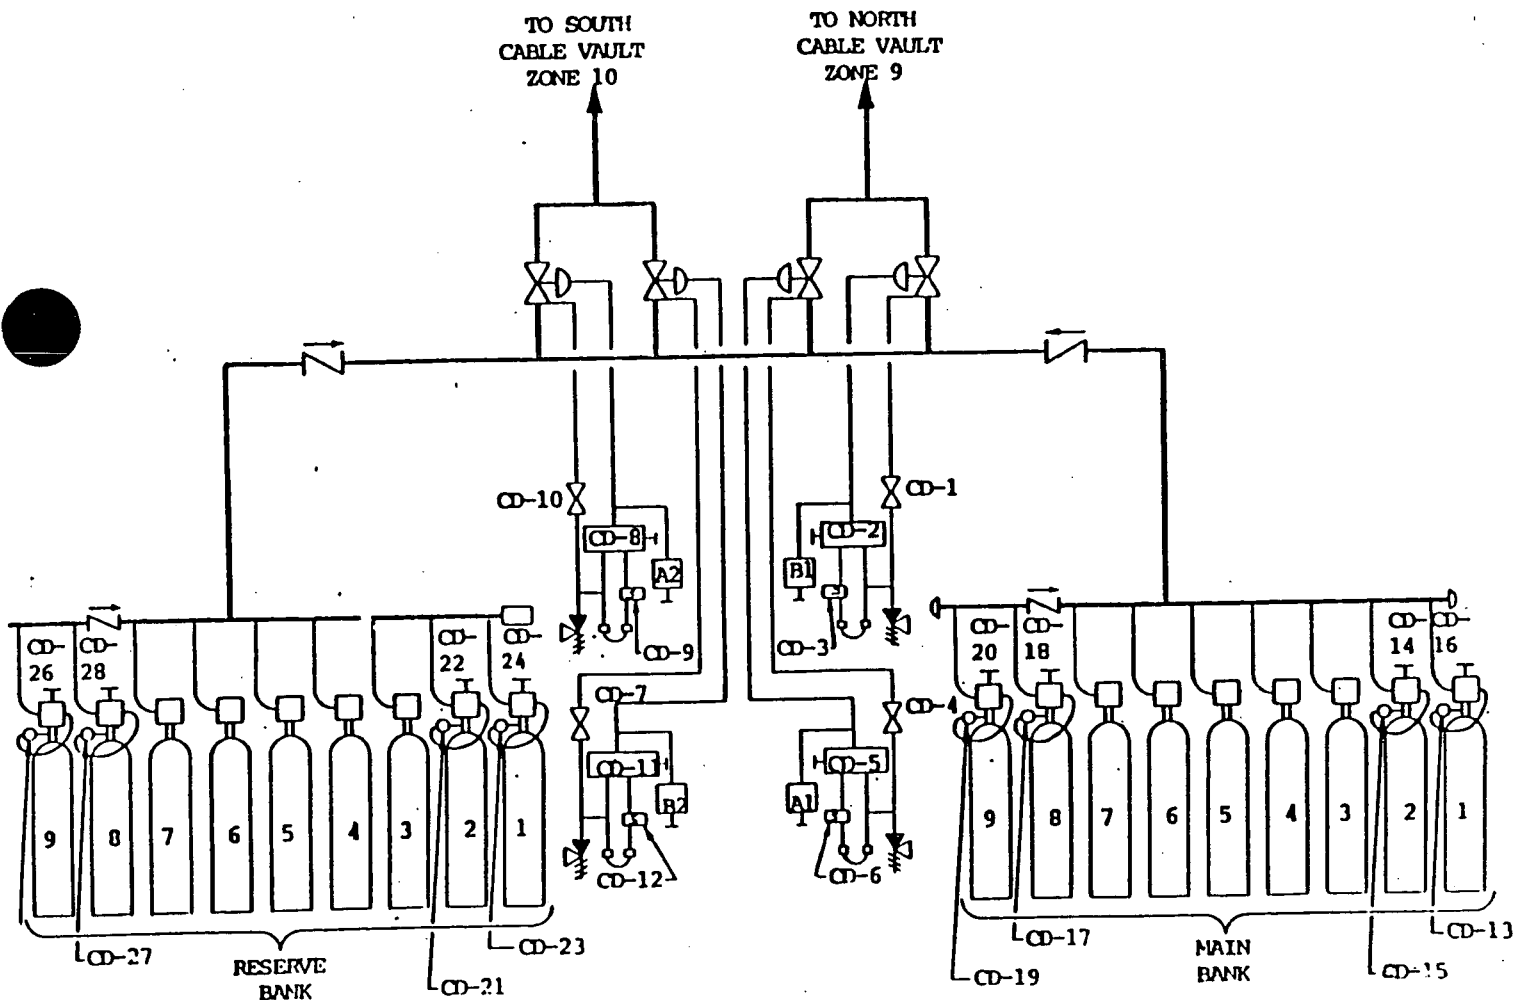
DIAGRAM 1

At approximately 0315 hours step 7.1.14 of the procedure was being performed which reconnects the solenoid pilot valve CD-13 to the cylinder in MCD Bank Slot 1 (refer to diagram 1). The solenoid valve is normally closed and de-energized, and when it is connected to the cylinder it becomes pressurized. By design, when connecting the solenoid valve to the cylinder, slight CO₂ leakage occurs at the valve connection until the connection is tightened to provide a seal. When solenoid pilot valve CD-13 was connected this normal leakage was noted. The connection was being tightened when the Fire Protection Technician performing the work realized that the pressure passed through the solenoid valve.

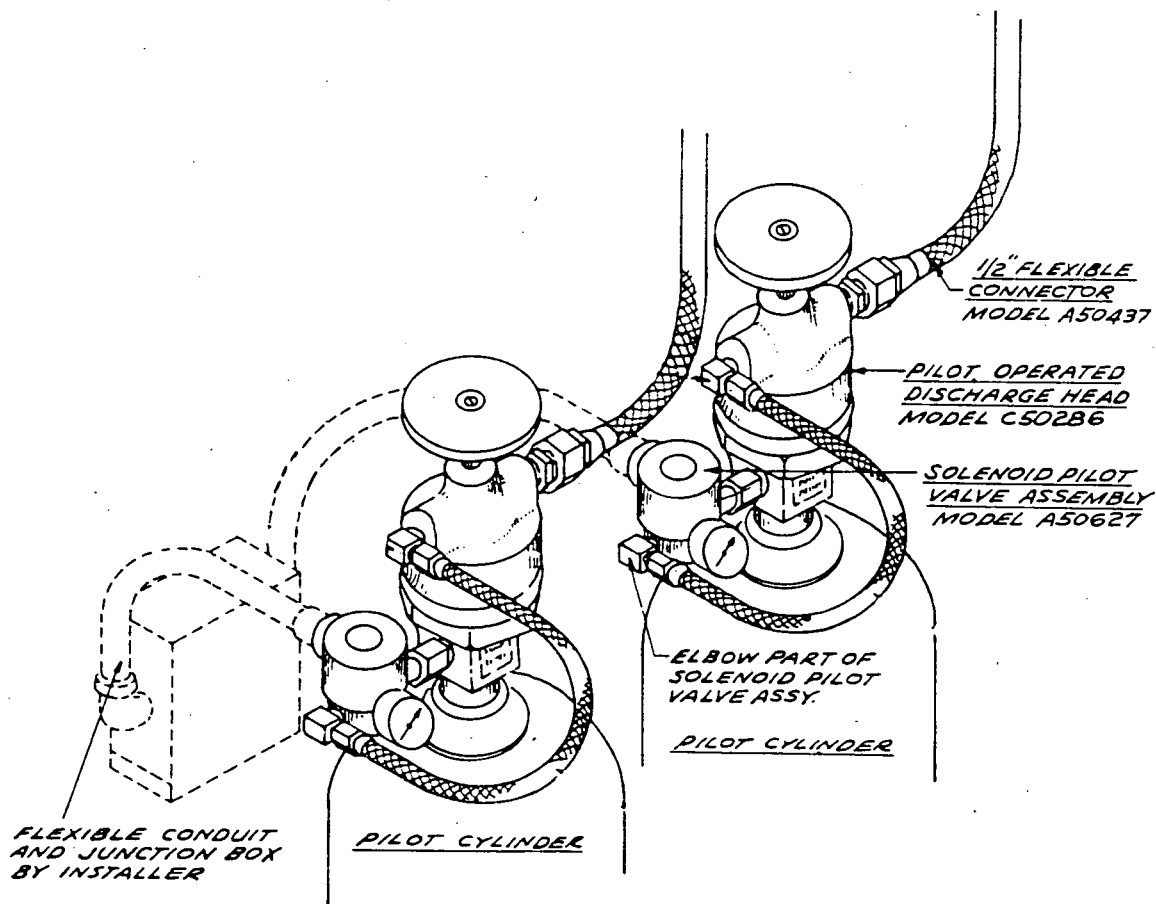
DIAGRAM 2

CO₂ flowed through the solenoid valve to the Pilot Operated Discharge Head, pressurizing and actuating the first cylinder (refer to diagram 2). This in turn pressurized the manifold and, as designed, actuated the remaining six cylinders, releasing CO₂ into Pipe Alley. A total of seven cylinders actuated and released 525 pounds of CO₂ over a five hour period. However, because no electrical signal actuated the system, the solenoid valves that control opening of the selector valves that route CO₂ to the cable vaults were not actuated. Therefore the flow path was closed and no CO₂ was discharged to the North and South Cable Vault.

The cause of this event is attributed to debris on the solenoid pilot valve disk surface. The Solenoid Pilot Valve was open allowing CO₂ to flow through and pressurize the Pilot Operated Discharge Head, actuating the Main Bank of cylinders for the North and South Cable Vault Room. An indentation was found on the Solenoid Pilot Valve Body Disc that appeared to cover between ten and fifteen percent of the disc surface. In addition, a surface scratch was found on the valve body seat. This gave the appearance that a piece of debris had lodged between the Solenoid Pilot Valve Disc and the Valve Body Seat, creating a flow path that actuated the Pilot Operated Discharge Head. This in turn actuated the remaining six cylinders.

Adverse Condition Report ACR 92-358 was initiated to document this event, and to conduct a root cause investigation. This investigation has been completed, and corrective actions identified. These actions include revising Fire Protection Surveillance Test procedures to require disconnecting the 3/16 inch flexible hose from the Solenoid Pilot Valves prior to connecting to cylinder. In addition, a review of procedures for Cleanliness and Flushing Requirements will be performed to determine applicably to Operations procedures, which will be revised accordingly.
