H. B. ROBINSON UNIT NO. 2
ROUTINE OPERATING REPORT NO. 4
FOR PERIOD

APRIL 1, 1972 THROUGH SEPTEMBER 30, 1972

CAROLINA POWER & LIGHT COMPANY
H. B. ROBINSON STEAM ELECTRIC PLANT

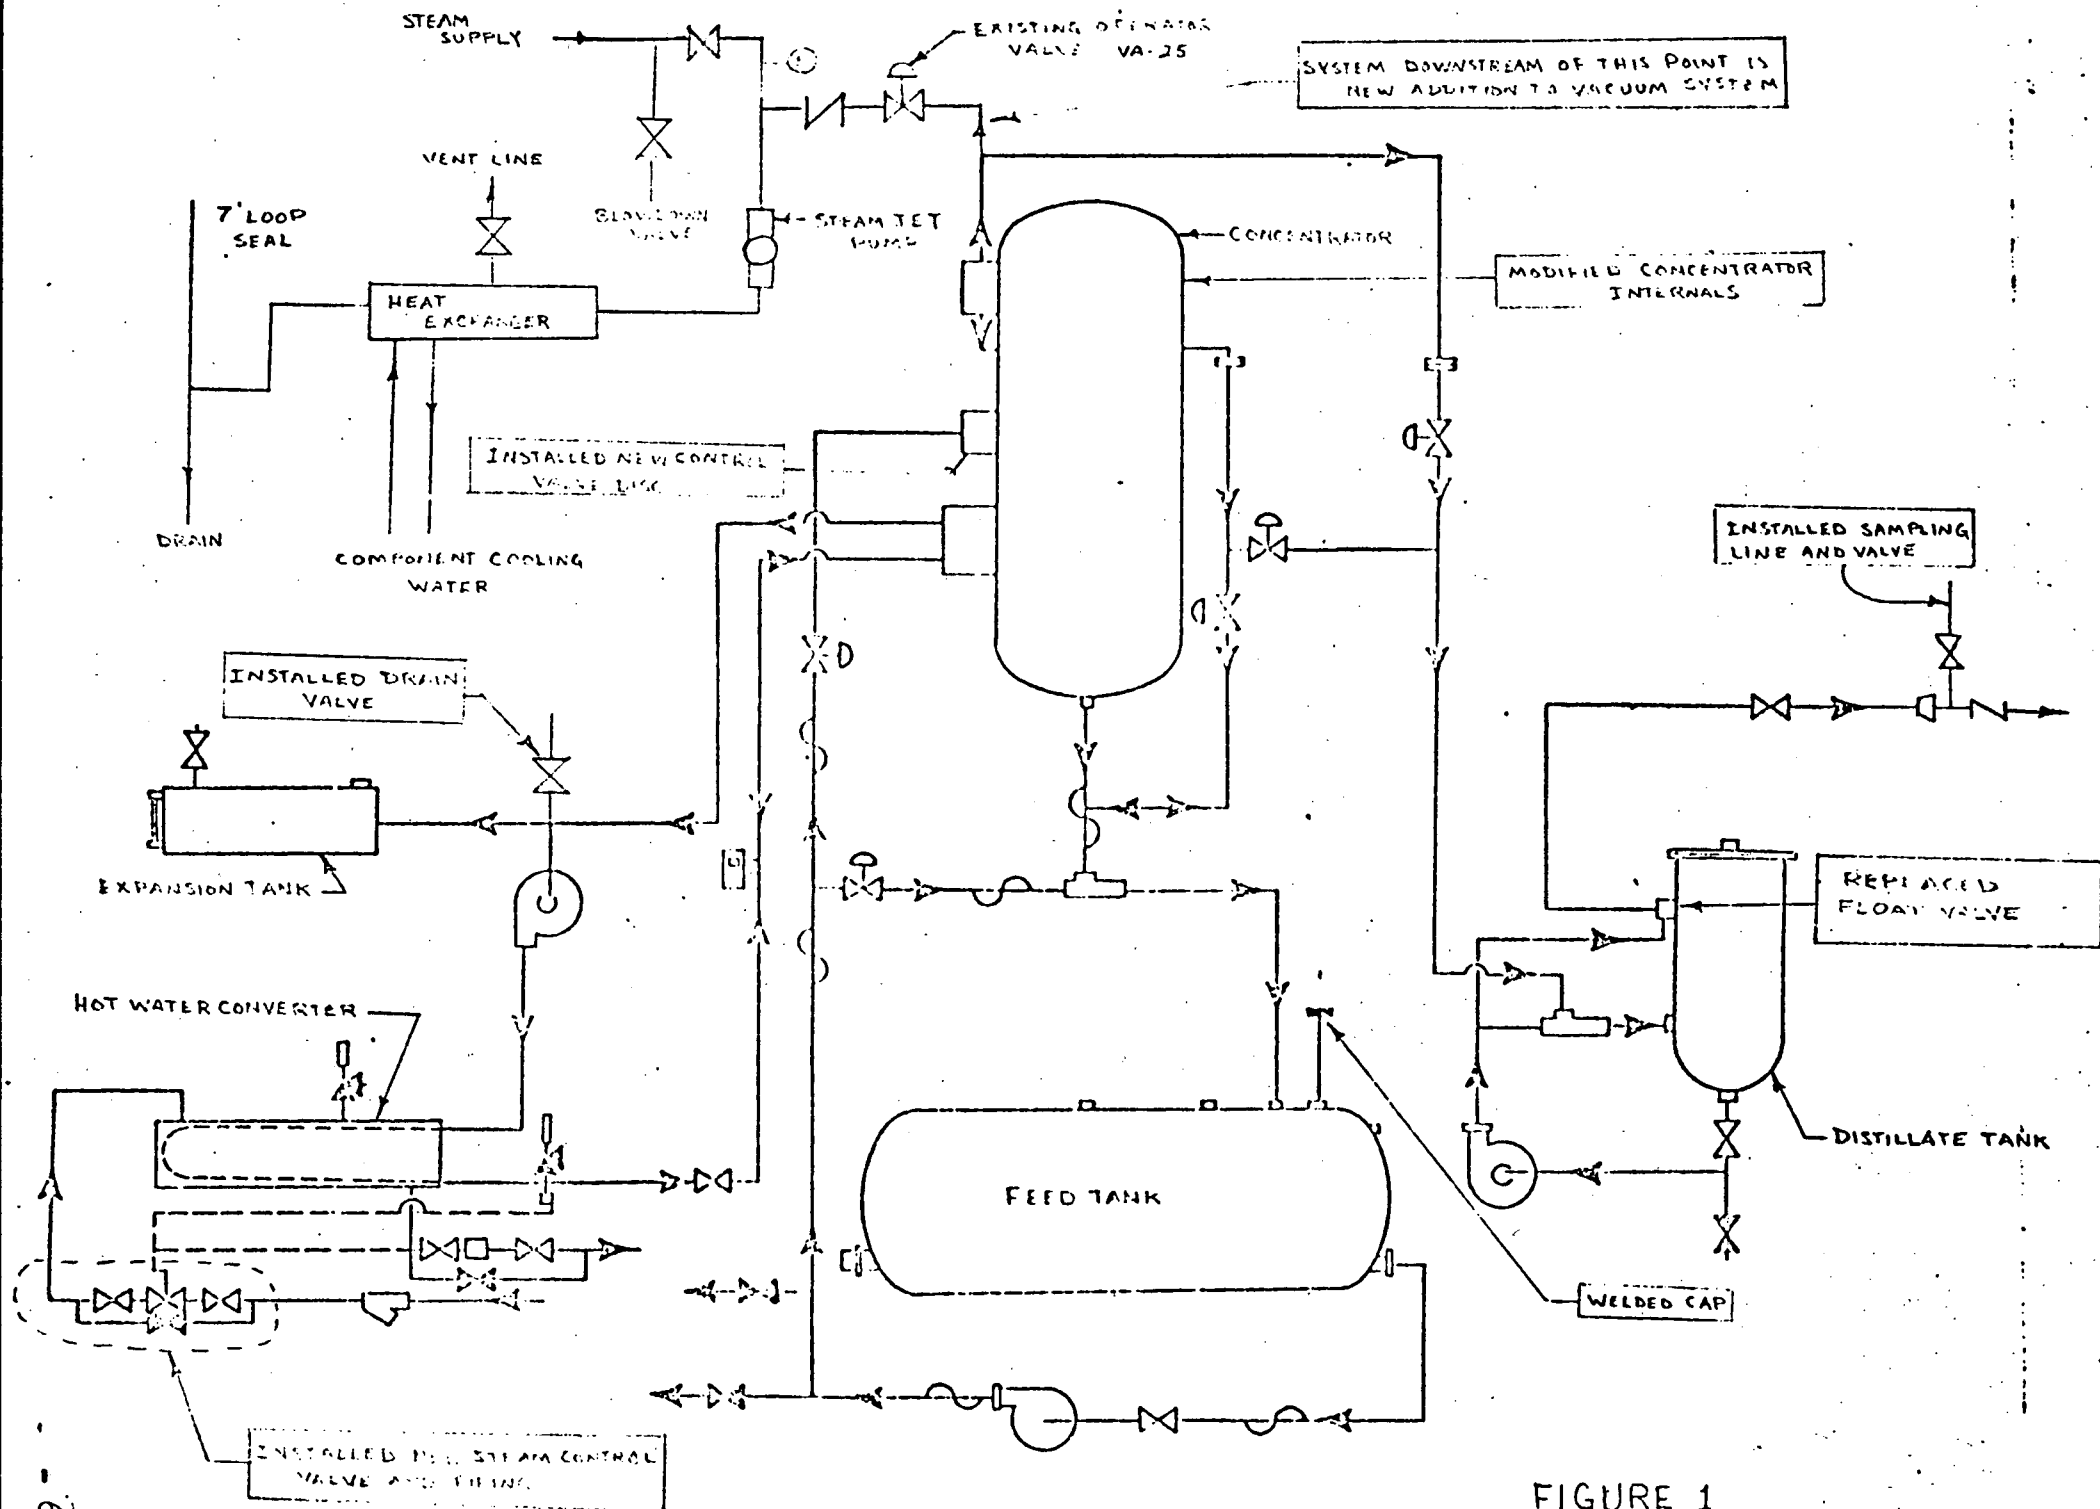
FIGURE 1

WASTE EVAPORATOR MODIFICATION

EQUIPMENT	NATURE OF MAINTENANCE	EFFECT ON SAFE OPERATION	MALFUNCTION		CORRECTIVE/PREVENTIVE ACTION	TIME OUT OF SERVICE
			CAUSE	RESULT		
Boric Acid and Waste Evaporators	Design Change (Mod. and Setpoint Rev. Approval No. 59)	None	The units had not met design parameters of output or decontamination factor; vacuum systems lacked reliability. AMF provided modification plans.	-----	Added new steam jet ejectors to vacuum systems. Modified internals of waste concentrator. Installed new steam supply piping and regulator on waste evaporator hot water-converter system.	-----

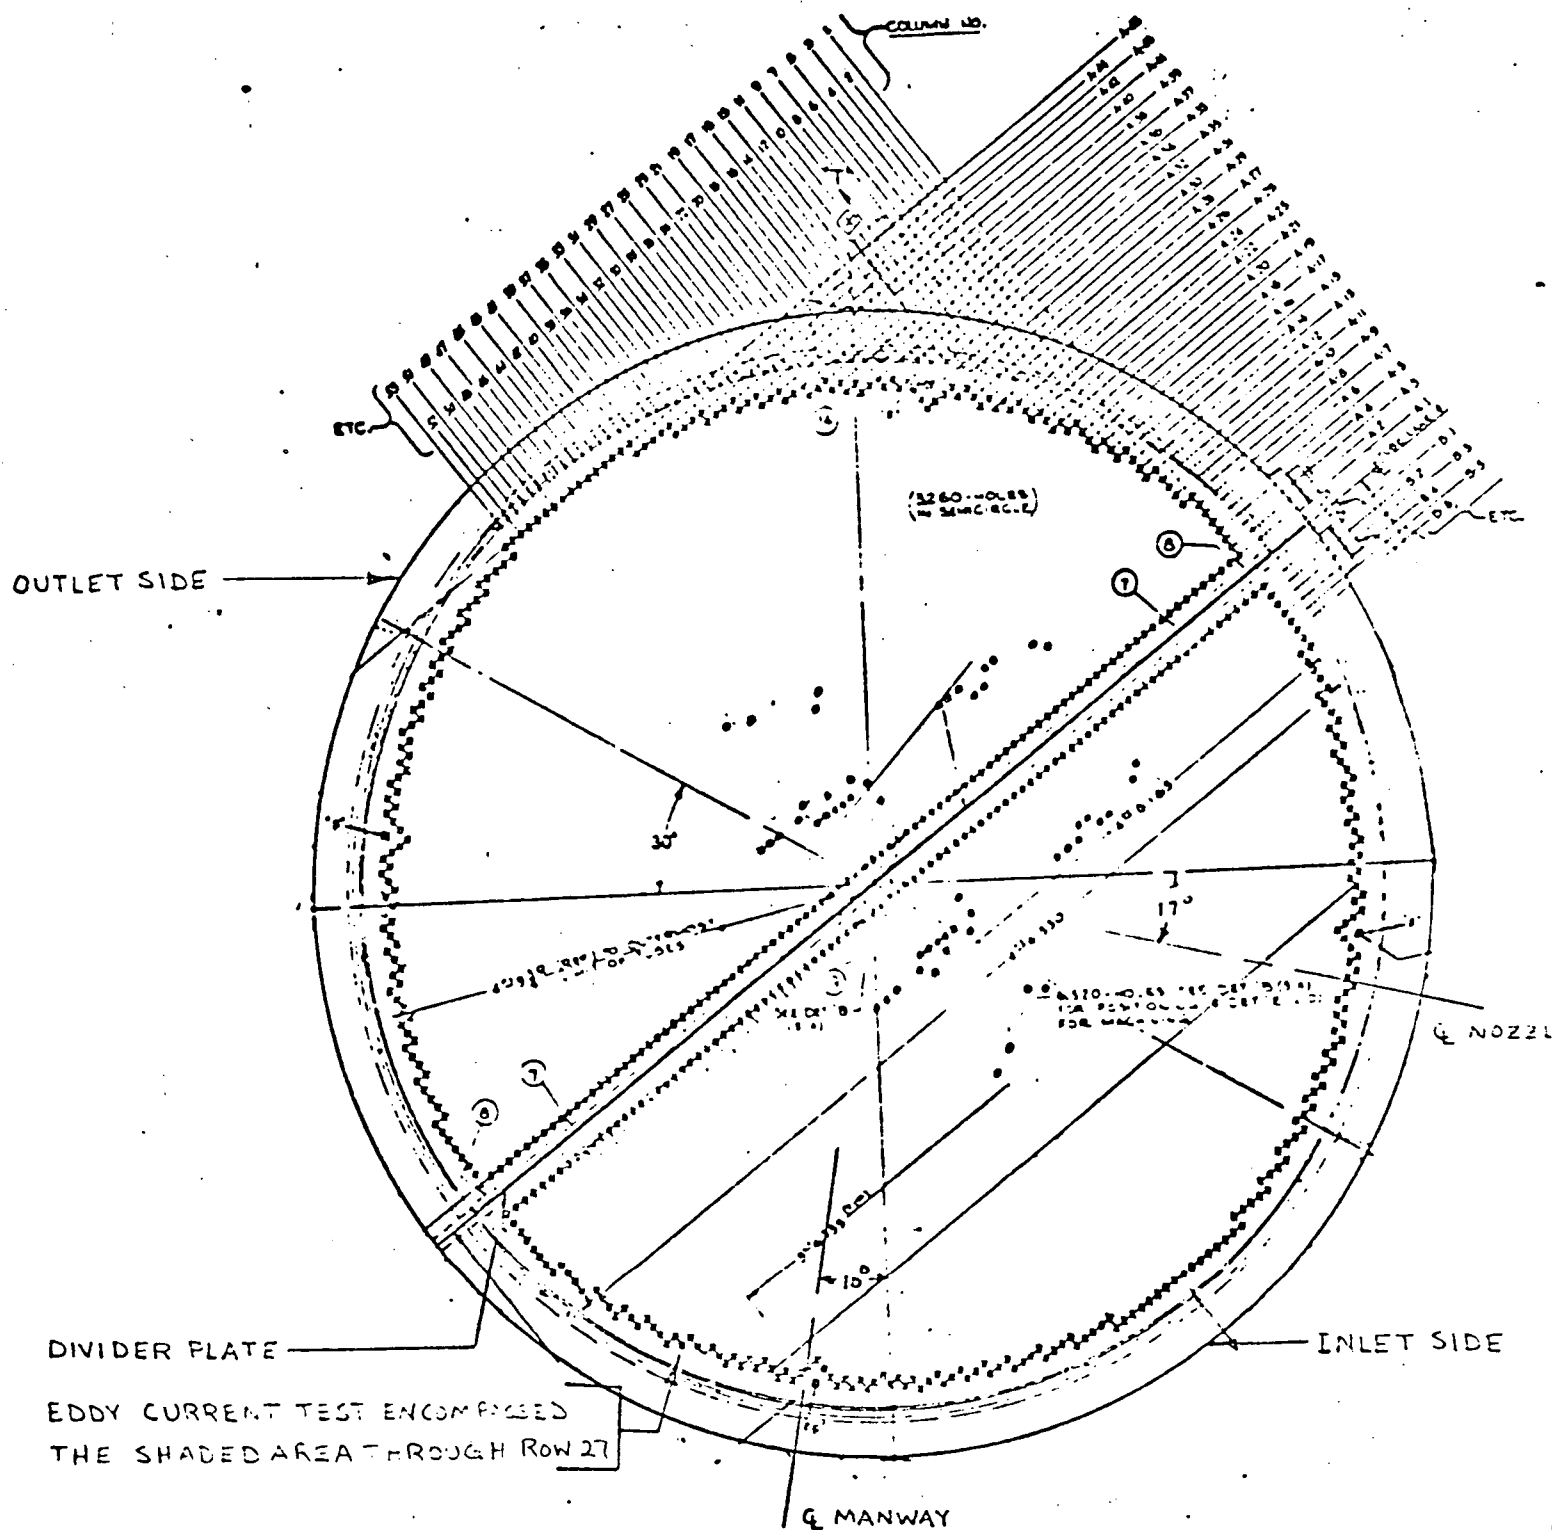
LOCATION OF PLUGGED TUBES IN SG "A"

ROW	COLUMN	PENETRATION(%)	REMARKS
5	41	50	
6	20	90	
7	21	90	
7	27	90	
7	28	--	Inadvertently Plugged
7	41	60	
7	43	100	Leaking Tube
7	44	--	Pulled this Tube
7	45	85	Attempted to Pull These Tubes
7	46	50	
7	47	90	
8	25	80	
8	26	--	Inadvertently Plugged
8	29	85	
8	30	85	
8	31	--	Inadvertently Plugged
8	42	75	
8	45	85	
8	48	75	
8	50	75	
8	51	90	
8	52	60	
9	47	80	
15	41	50	
16	40	75	
18	46	90	
19	48	50

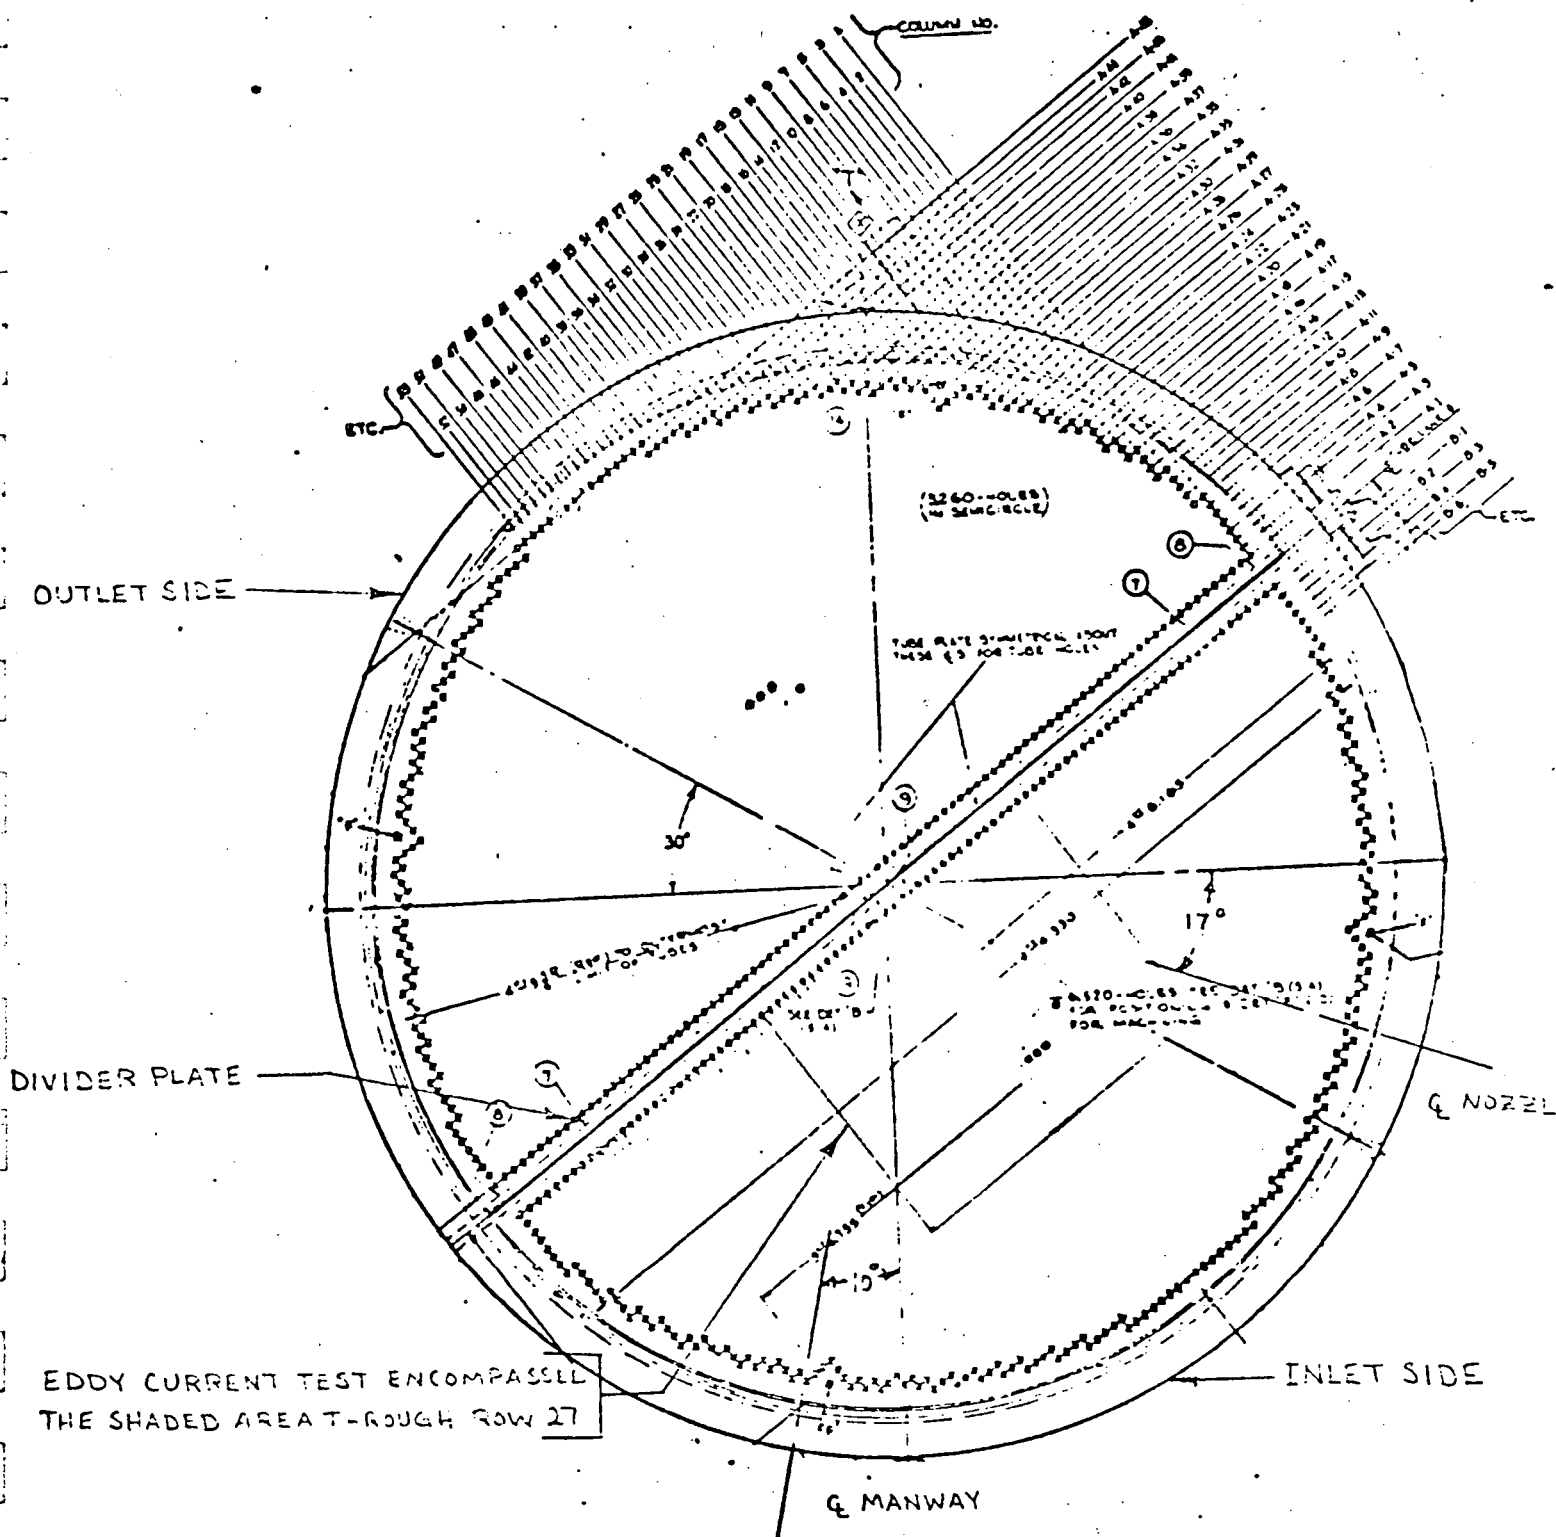
LOCATION OF PLUGGED TUBES IN SG "B"

ROW	COLUMN	PENETRATION (%)	REMARKS
18	41	75	All These Tubes were Plugged using explosive welding plug
20	44	60	
20	45	85	
20	46	75
