DOMINION NUCLEAR CONNECTICUT, INC.
MILLSTONE POWER STATION UNITS 2 AND 3
LICENSEE EVENT REPORT 2014-006-00
MILLSTONE POWER STATION DUAL UNIT
REACTOR TRIP ON LOSS OF OFFSITE POWER

LICENSEE EVENT REPORT 2014-006-00
MILLSTONE POWER STATION DUAL UNIT
REACTOR TRIP ON LOSS OF OFFSITE POWER

4. TITLE
Millstone Power Station Dual Unit Reactor Trip on Loss of Offsite Power

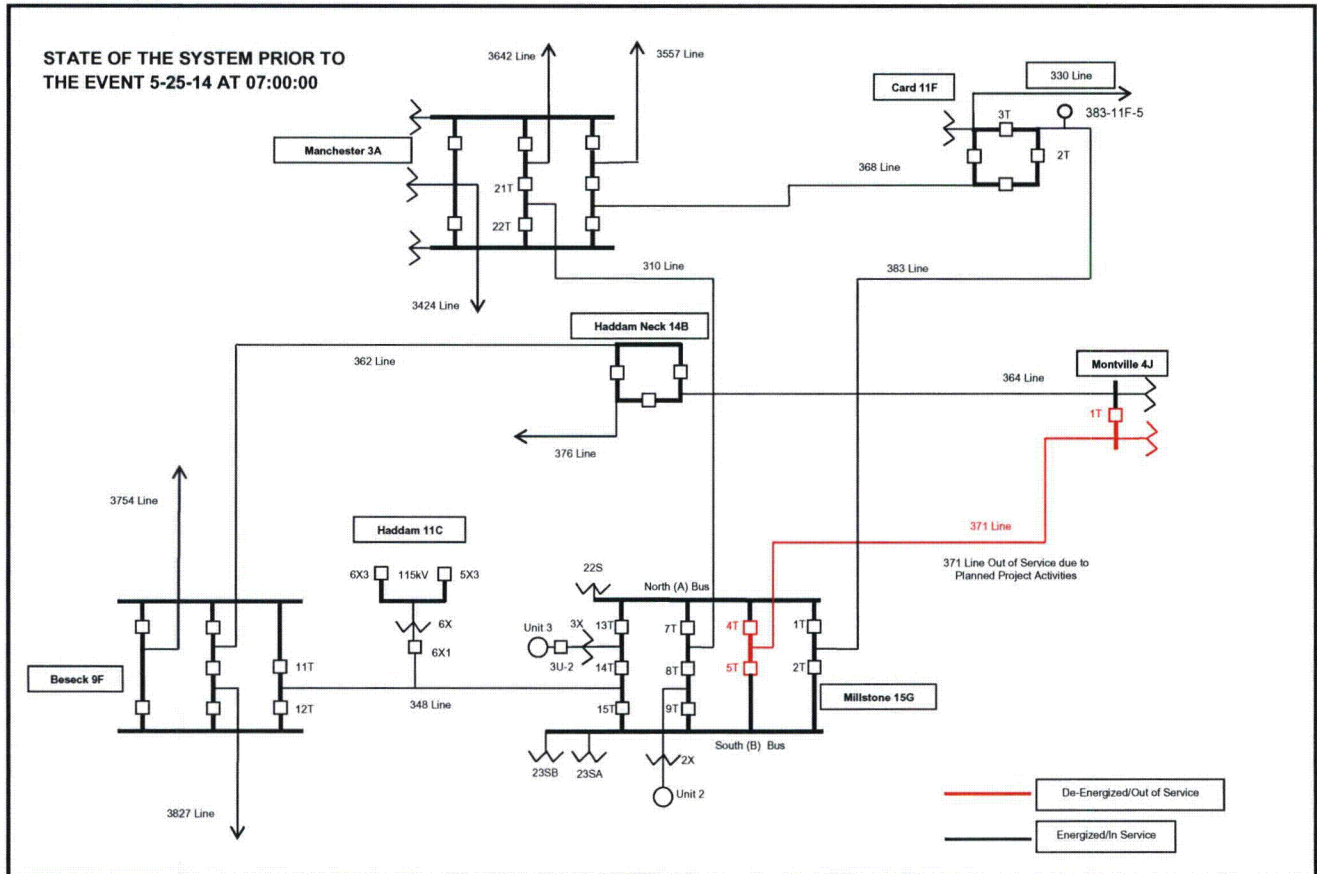
The switchyard, which is configured in a breaker and a half arrangement, buses together four 345 kV transmission line circuits, two generator circuits and two station service circuits.

The four transmission line circuits terminated at the switchyard are:

- a. TO Millstone to Beseck Line Number 348
- b. TO Millstone to Card Line Number 383
- c. TO Millstone to Montville Line Number 371
- d. TO Millstone to Manchester Line Number 310

These circuits connect the station to the 345 kV system transmission grid and constitute the MPS offsite AC power source.
