H. B. ROBINSON UNIT NO. 2
LICENSE NO. DPR-23
BULGED AREAS IN THE CONTAINMENT LINER

H. B. ROBINSON UNIT 2
BULGED AREAS IN THE CONTAINMENT LINER

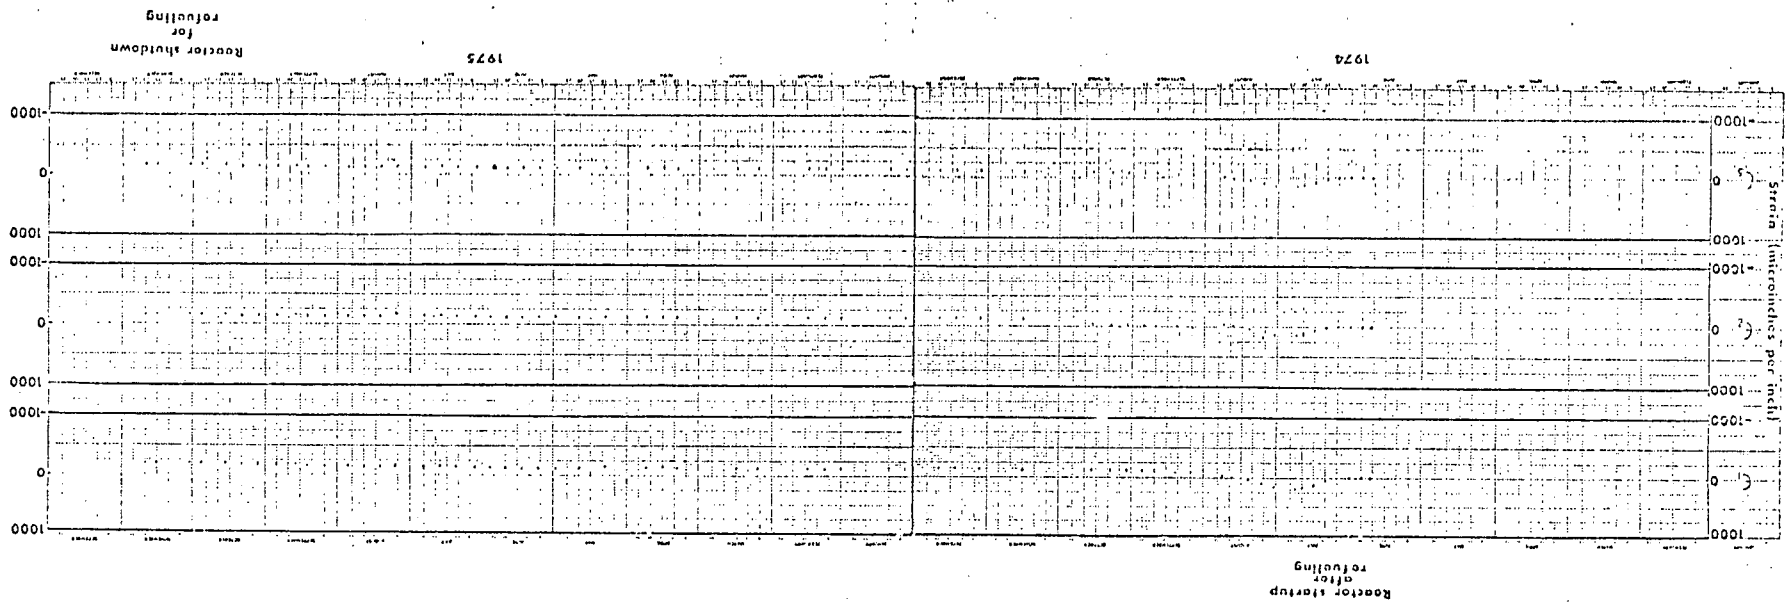
A typical strain gage plot is attached for illustration. The graph shows strains from each of three strain elements of a rectangular rosette gage plotted with time. In general, the gages all showed movement from the period July through September, 1974 following the return to full power operation after the refueling. This movement appeared to be caused by the temperature change or temperature gradient across the liner due to the reactor heat inside containment. No subsequent similar movements were observed in response to temperature effects, so the initial movement may have been due to a curing of the gage epoxy bond or some other initial instability. During this initial three-month period all but five of the gages went into tension and reached a peak strain of several hundred micro inches/inch, although some were higher. The five gages that went into compression peaked in the range of 250 to 750 micro inches/inch. The gage which reached the maximum strain was located in a solid unbulged area. By the end of September, 1974, the gages had stabilized out and most had come back to or below the point of zero strain indicating that the strains were within the elastic region of the liner material. The few strain channels that did not return to zero remained in the zero to 200 micro inches/inch range.

For the 14-month period from October, 1974 to the present time, there has been virtually no movement in the majority of the gages. In some of the gages a slight movement of 50 to 200 micro inches/inch into compression can be seen as a gradual downward drift over the 14-month period.
