Ltr re their rpt 50-261/73-70, furnishing addl info regarding the incident involving primary to secondary leakage in steam generator "C"... w/atchmt.....

PLANT NAME: H. B. Robinson Unit #2

H. B. ROBINSON UNIT NO. 2  
LICENSE DPR-23  
NOVEMBER 22, 1973 STEAM GENERATOR OUTAGE

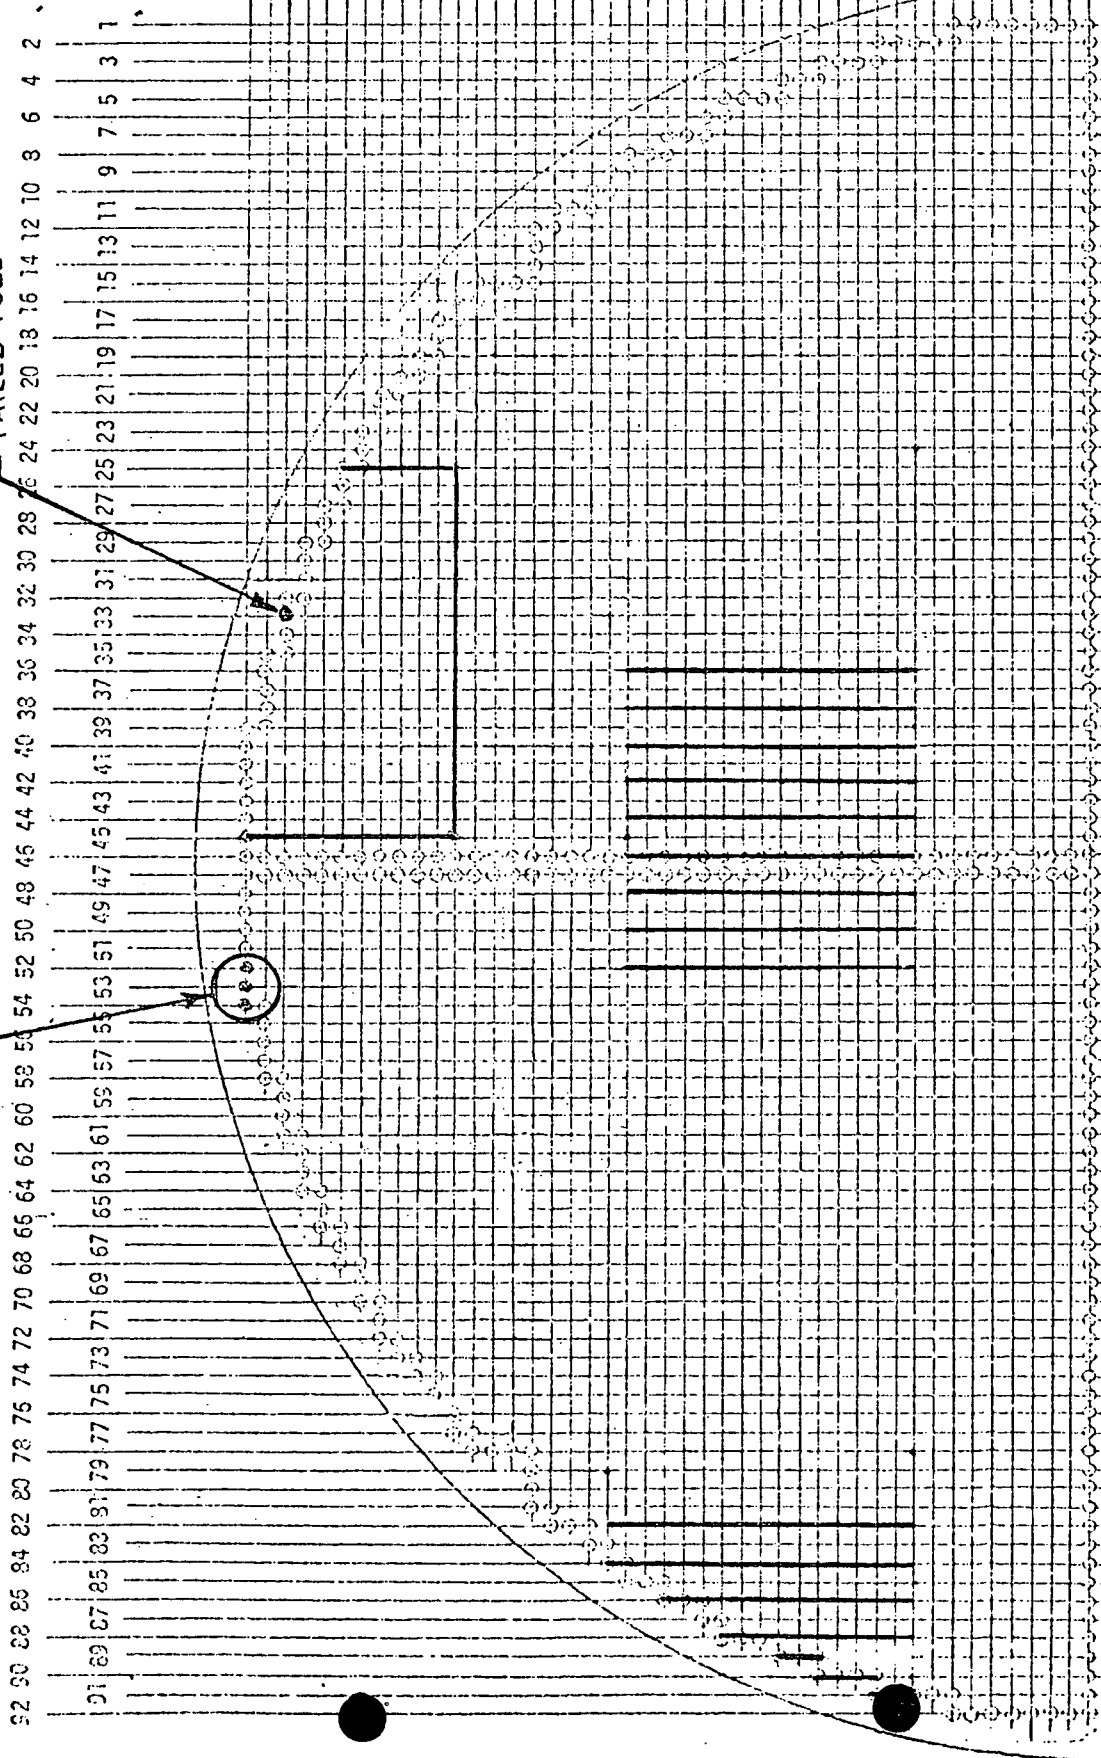
SG-C

Eddy current manual hand probing of the leaking tube and some 14 tubes adjacent to it was initiated on the afternoon of November 24. The leak was verified to be in the tube located at row 43, column 33. The failure was determined to exist approximately six inches above the uppermost tube support in the U-bend area. No other tubes inspected in the area showed signs of significant wall thinning.

Equipment to facilitate automatic remote eddy current testing was placed in operation November 26. With this equipment in use some 200 tubes adjacent to the failed tube, 140 tubes in the center of tube bundle, and 70 tubes in a peripheral region above the manway were inspected. All the tubes were examined completely around the U-bend. No other tube problems were identified. See enclosed sketch for areas inspected.

During initial plant construction three tubes on the periphery of steam generator "C" tube bundle were found to have received arc strikes during fabrication. These tubes were accordingly plugged at that time. It is surmised that this recent failure may be the result of an arc strike on the subject tube which went undetected during construction. Such an arc strike would have caused an area of thin wall and high stress which could have developed into a tube failure. See enclosed sketch for location of tubes that were plugged during construction.

TUBES WITH ARC STRIKES + WERE  
PLUGGED DURING CONSTRUCTION

FAILED TUBE

TUBES INSPECTED NOV. 1973

The leaking tube was explosively plugged on November 29 at approximately 1800. Manway and access plate cover replacement was begun later that evening and completed early on the morning of November 30. At approximately 0930 on November 30 a secondary side hydrostatic test of 800 psig was performed and a visual inspection on the primary side of steam generator "C" was made. No leakage around the plug or in any of the other tubes was detected. Plant heatup then proceeded and a 1710 psid differential pressure was imposed across the steam generator tubes. No leakage was observed. The unit was accordingly placed back in service on December 3.
