Carolina Power & Light Company

February 9, 1973

H. B. ROBINSON UNIT NO. 2
LICENSE DPR-23
LEAK IN FEEDWATER SYSTEM

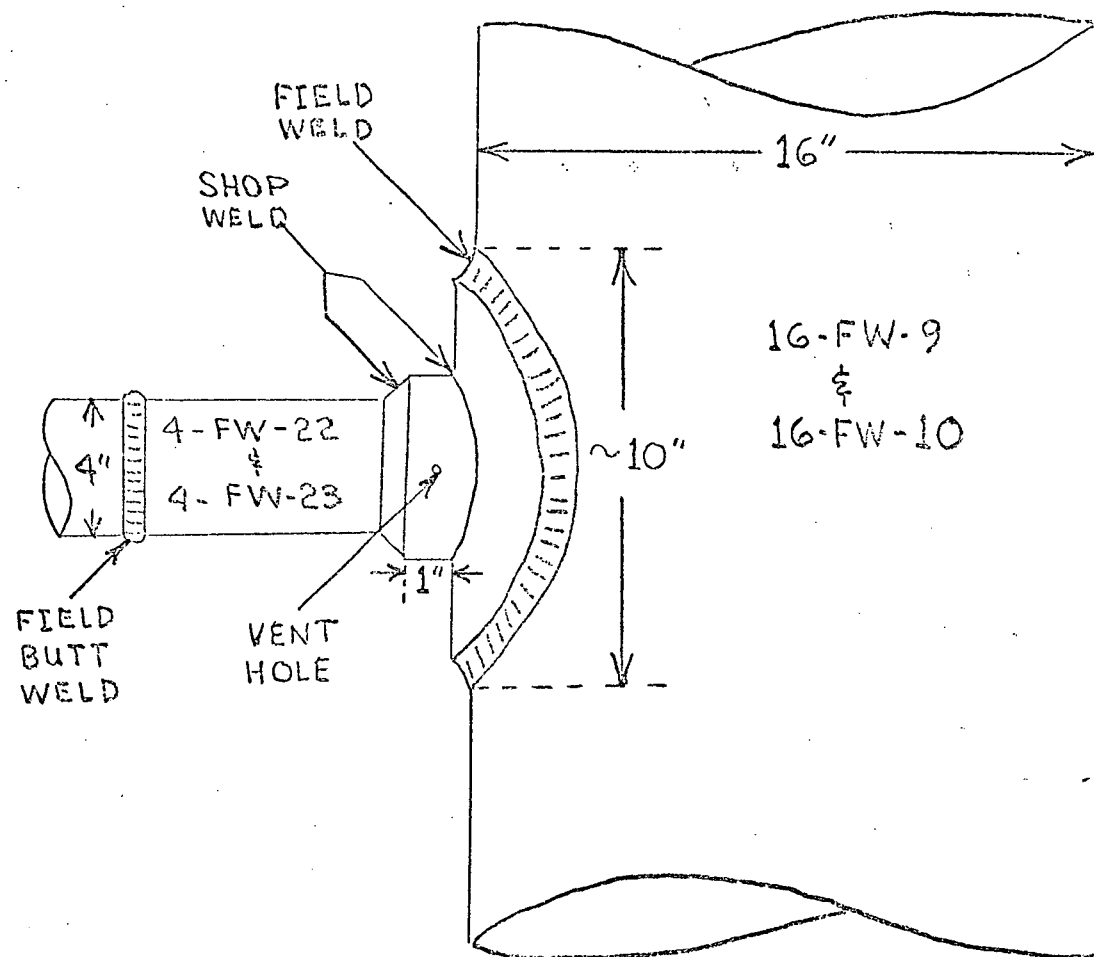
FIGURE 1

On December 20, 1972, a leak of approximately one-half gallon per minute was detected inside the containment vessel. The leak was in the joint where the "B" auxiliary feedwater pipe (4-FW-23) joins the "B" main feedwater pipe (16-FW-10) (Figure 1). The unit was shut down on December 21, 1972, a repair effected on December 22, 1972 and the unit returned to service on December 23, 1972.

The repair made on December 22, 1972 consisted of plug welding a drilled hole in the weld saddle. At the time, it was thought that the hole was a construction error that had not been properly repaired. Further investigation into the cause of the leak raised questions concerning the correctness of the repairs. It was determined that the drilled hole was a telltale vent hole in the weld saddles and that a leak through the vent hole indicated that the pressure boundary weld was leaking. Furthermore, welding up the vent hole had resulted in the saddle welds becoming the pressure boundary. Ebasco, the architect engineer during construction, and B. F. Shaw Co., the fabricator of the feedwater pipe sections, were consulted and agreed that the saddle welds were not designed as a pressure boundary. Both recommended that a repair to the pressure boundary weld, under the saddle, be made. It was also determined that approximately one year ago an identical improper weld repair had been made on the "A" feedwater piping.

The leaks in the pressure boundary welds were caused by small cracks in the welds. These cracks could have been caused by a combination of vibration, thermal shock, or small defects in the original welds. It is the opinion of the Plant Nuclear Safety Committee, Ebasco engineers, and B. J. Shaw engineers that the weld repair has improved the strength of the joint above the original weld. Ebasco is conducting a thorough engineering study of the weld failure to determine the cause of the original failure and to determine if additional steps are required to prevent recurrence. Should this study indicate that additional changes are prudent, they will be accomplished during the refueling outage beginning in mid-March, 1973.

AUXILIARY TO MAIN FEEDWATER CONNECTION
(ORIGINAL)

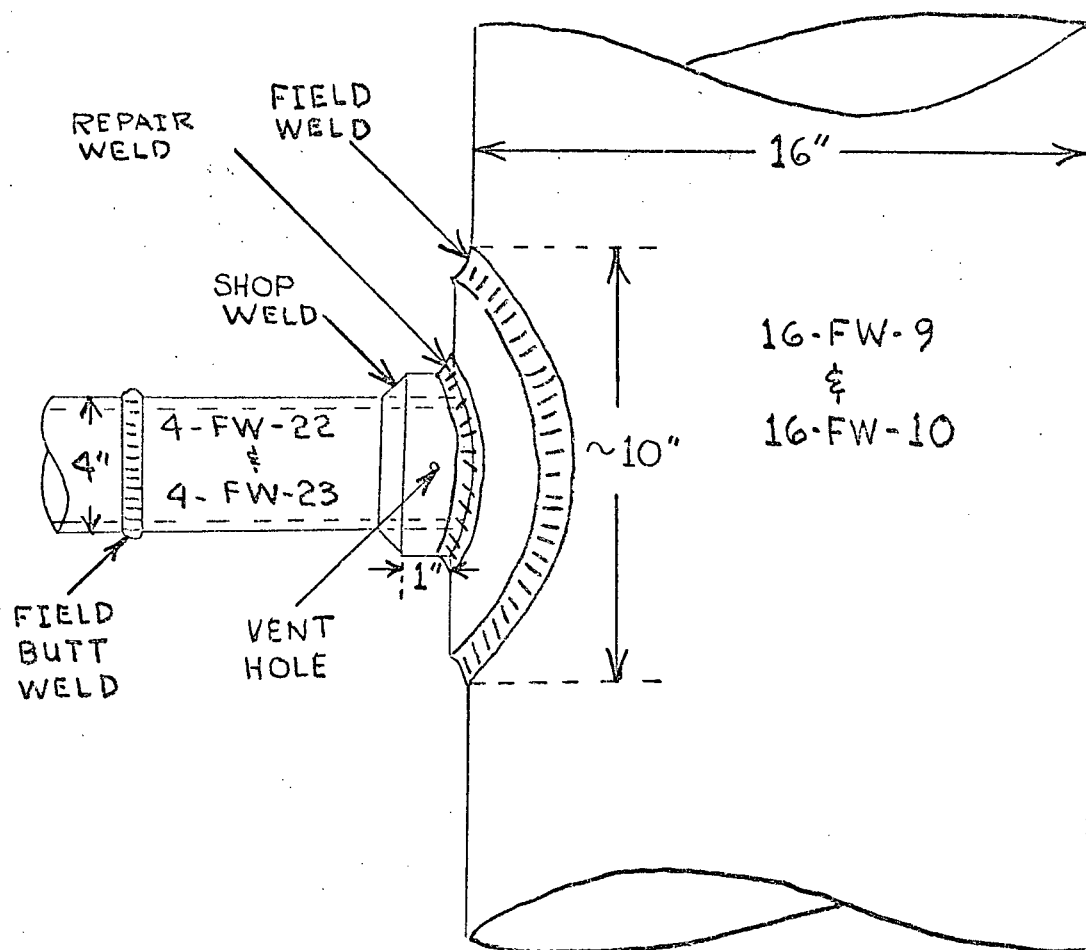
FIGURE 2

AUXILIARY TO MAIN FEEDWATER CONNECTION
(REPAIRED)

The plant was shut down on January 4, 1973 to make repairs to the pressure boundary welds on A and B feedwater piping. The Plant Nuclear Safety Committee had met to discuss the situation in detail and had recommended that appropriate repairs be made to the pressure boundary welds. It was also determined that the joint design on "C" feedwater piping was not similar to "A" and "B".

The repair consisted of grinding out the original shop welds and rewelding the pressure boundary (Figure 2). A B. F. Shaw Co., engineer was engaged to provide technical direction to the welding, inspection and heat treating of the affected piping. The plant was returned to power on January 9, 1973 after the repairs had been reviewed by the Plant Nuclear Safety Committee.
