H. B. ROBINSON UNIT NO. 2
LICENSE NO. DPR-23
FAILURE OF VALVE V2-16C TO OPEN

ABNORMAL OCCURRENCE REPORT

1. Report No. 50-261/74-24
- 2a. Date November 19, 1974
- 2b. Occurrence Date November 13, 1974
3. Facility H. B. Robinson Unit No. 2
Hartsville, South Carolina 29550

Valve V2-16C, Auxiliary Feedwater Pump discharge valve to "C" Steam Generator, failed to open.

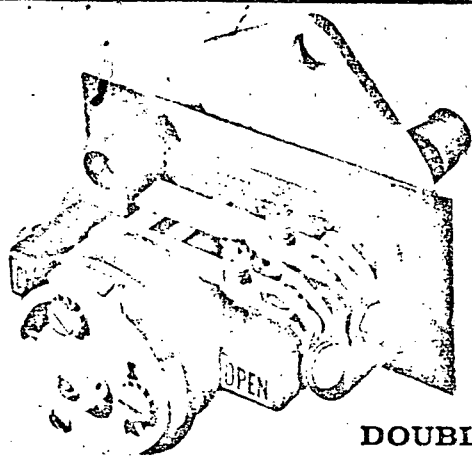
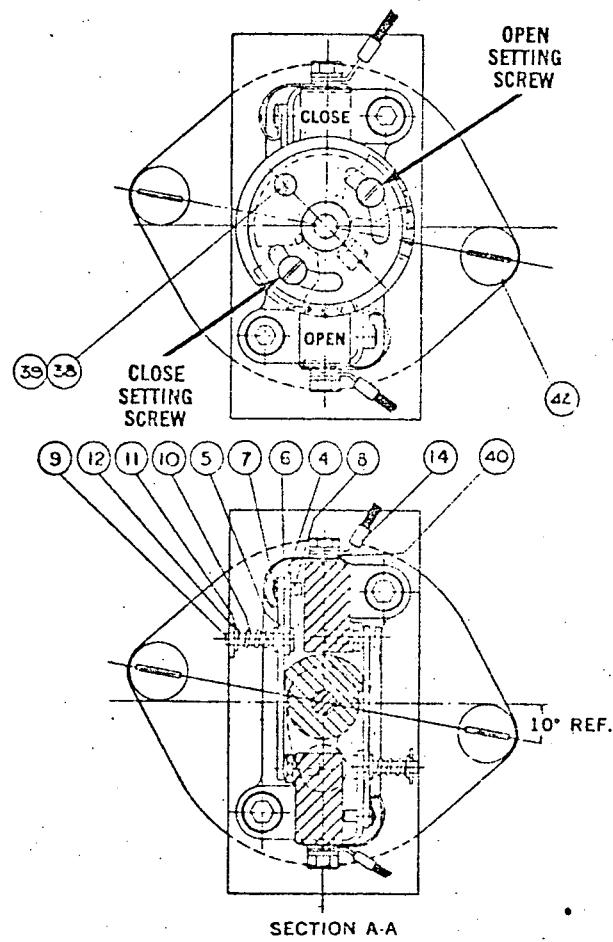
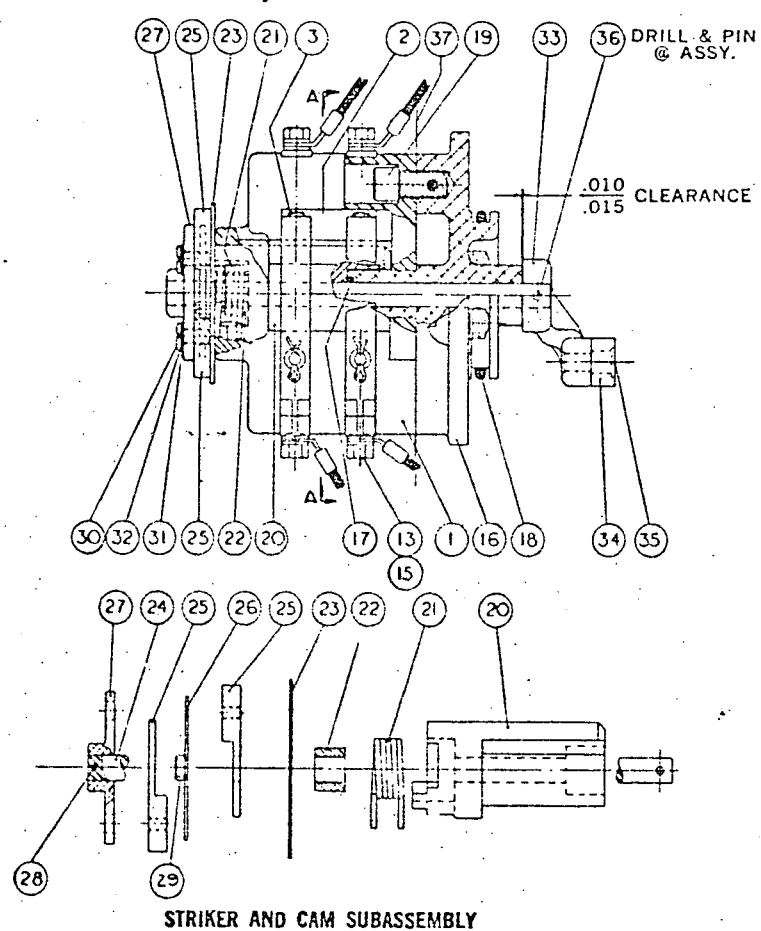
FIGURE 1 PROCEDURE FOR SETTING TORQUE SWITCH FC SMB-00/SMB-000

Inspection of the torque switch revealed that the roller on the torque switch arm (see attached drawing) had an excessive amount of play in it. This caused the torque switch to delay shutting off the drive motor when the valve was being closed. The delay resulted in excessive torque being applied to seat the valve. Therefore, the valve plug was jammed against the seat rings so tightly that the drive motor could not develop enough torque to pull the valve plug free.

The torque switch on the operator from V2-16C was replaced. However, because of the high failure rate of this particular valve it was decided to swap this operator with an identical Limitorque operator on V2-20B, cross-connect between AFW pumps discharge lines "B" and "C." V2-16C and V2-20B were reassembled and test operated several times without failure.
