ABNORMAL OCCURRENCE REPORT TO THE AEC

Cracked Weld on Feedwater Pump Warmup Line Orifice

1. Report Number: AO 263/74-19
- 2A. Report Date: June 24, 1974
- 2B. Occurrence Date: June 14, 1974
3. Facility: Monticello Nuclear Generating Plant (DPR-22)
Monticello, Minnesota 55362
4. Identification of Occurrence:

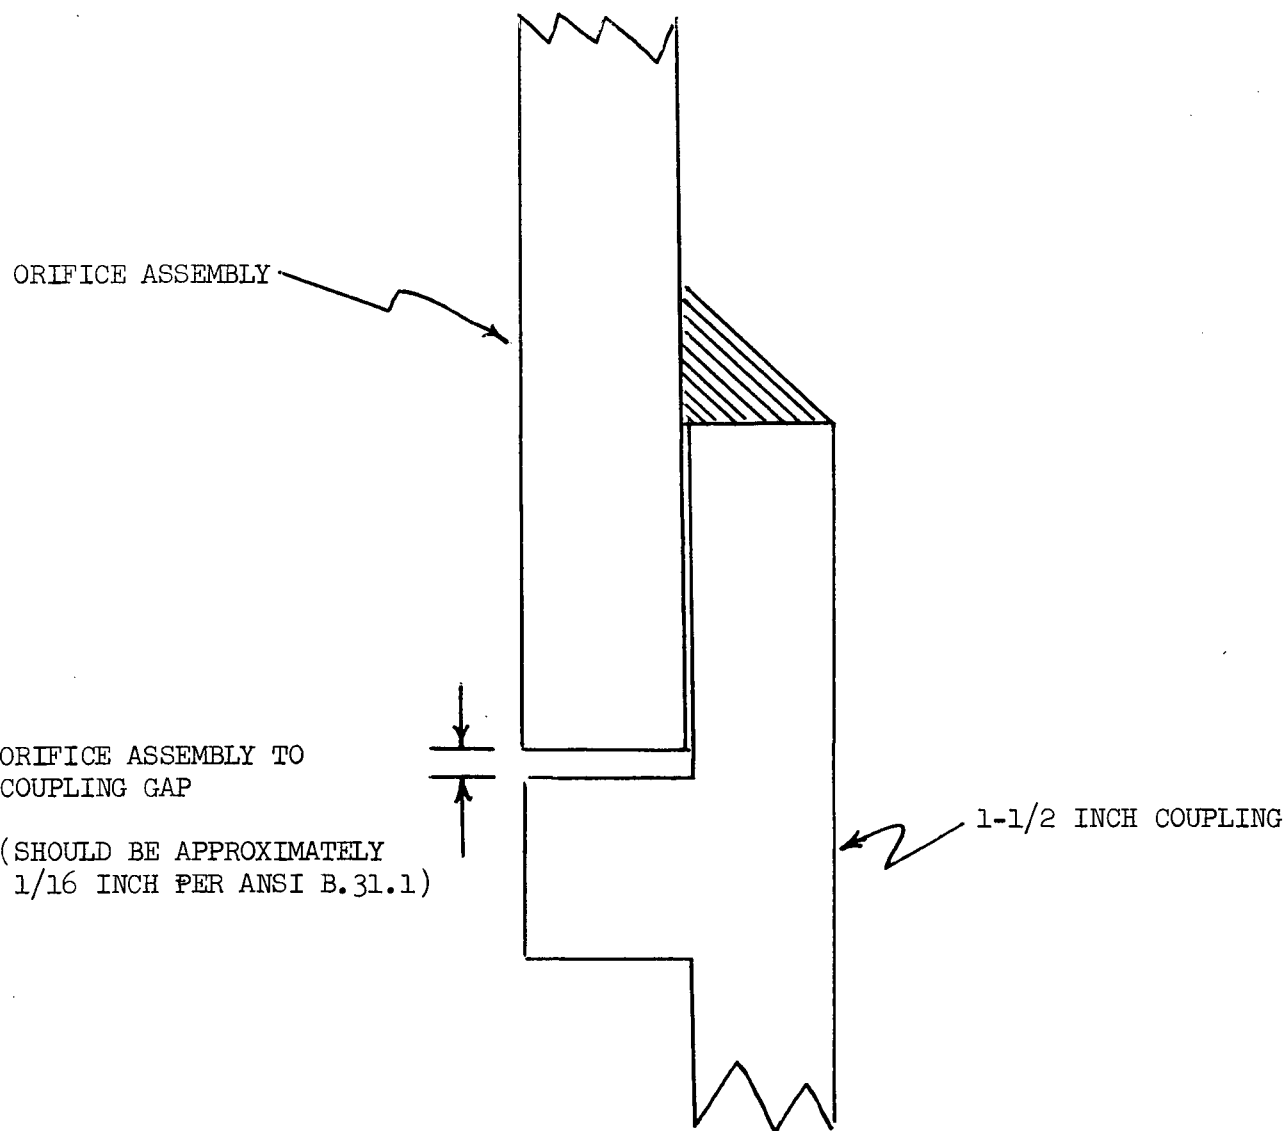
FIGURE 1

On June 14, 1974, water was discovered leaking from the #11 reactor feed-pump warmup line. The line was inspected following removal of the insulation and the leak was found to be coming from a 3/16" circumferential crack in one of the warmup line restricting orifice-to-coupling welds (on the high pressure side of the orifice). A plant shutdown was begun immediately and the reactor was placed in a hot standby condition to allow isolation of the feedwater lines and repair of the crack.

Installation/Construction: Inspection revealed that the orifice assembly-to coupling gap (see Figure 1) was less than that specified by the ANSI B.31.1 code. Based on the measurements taken, it is felt that stresses induced due to thermal expansion of the orifice assembly caused the weld to crack.

ORIFICE ASSEMBLY TO
COUPLING GAP

(SHOULD BE APPROXIMATELY
1/16 INCH PER ANSI B.31.1)

The orifice assembly-to-coupling weld was ground out. The orifice assembly was rewelded to the coupling leaving a 1/16" gap as outlined in ANSI B.31.1. The repair weld was dye penetrant tested and found to be acceptable. All other orifice assembly-to-coupling welds on both reactor feedpump warmup lines were visually inspected and found to be acceptable.
