Letter furnishing additional information to A/O #50-261/75-9, Concerning Corrective Actions and Inspections Subsequent To "C" Reactor Coolant Pump Seal Failure. With Attached Appendix A.....

PLANT NAME: H.B. Robinson # 2

H. B. ROBINSON UNIT NO. 2
LICENSE NO. DPR-23
CORRECTIVE ACTIONS AND INSPECTIONS SUBSEQUENT
TO "C" REACTOR COOLANT PUMP SEAL FAILURE

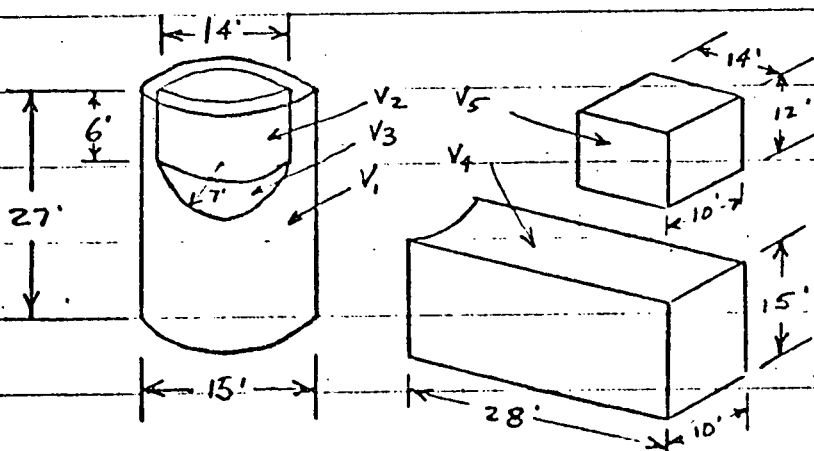
V_s can be approximated as the volume of a cylinder, V_1 , minus the volumes of a cylinder, V_2 and a hemisphere (the reactor vessel), V_3 plus the volumes of two rectangular prisms, $V_4 \neq V_5$.

$$\begin{aligned} V_s &= 4771 - (924 + 718) + 4200 + 1680 \\ &= 9009 \text{ ft}^3 \end{aligned}$$

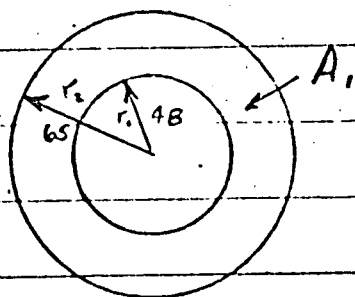
A_1 can be approximated by subtracting the area included in the polar crane wall from the cross sectional area of the containment vessel

$$\begin{aligned} A_1 &= \pi r_2^2 - \pi r_1^2 \\ &= 3.14 (65)^2 - 3.14 (48)^2 \\ &= 6034 \text{ ft}^2 \end{aligned}$$

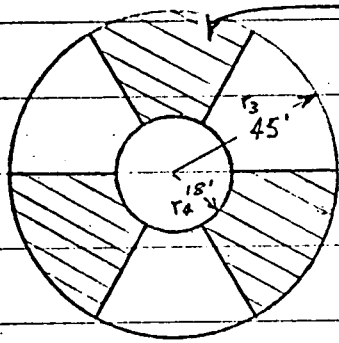
A_2 (area at 228' level)

A_2 can be approximated as half of the area between the missile shield and the inside of the polar crane wall

$$\begin{aligned} A_2 &= \frac{1}{2} (\pi r_3^2 - \pi r_4^2) \\ &= \frac{1}{2} [3.14(45)^2 - 3.14(18)^2] \\ &= 2671 \text{ ft}^2 \end{aligned}$$
