H. B. ROBINSON UNIT NO. 2
LICENSE DPR-23

SECOND REFUELING OUTAGE - SUMMARY OF EVENTS OF INTEREST

H. B. ROBINSON UNIT NO. 2
SECOND REFUELING OUTAGE
SUMMARY OF EVENTS OF INTEREST

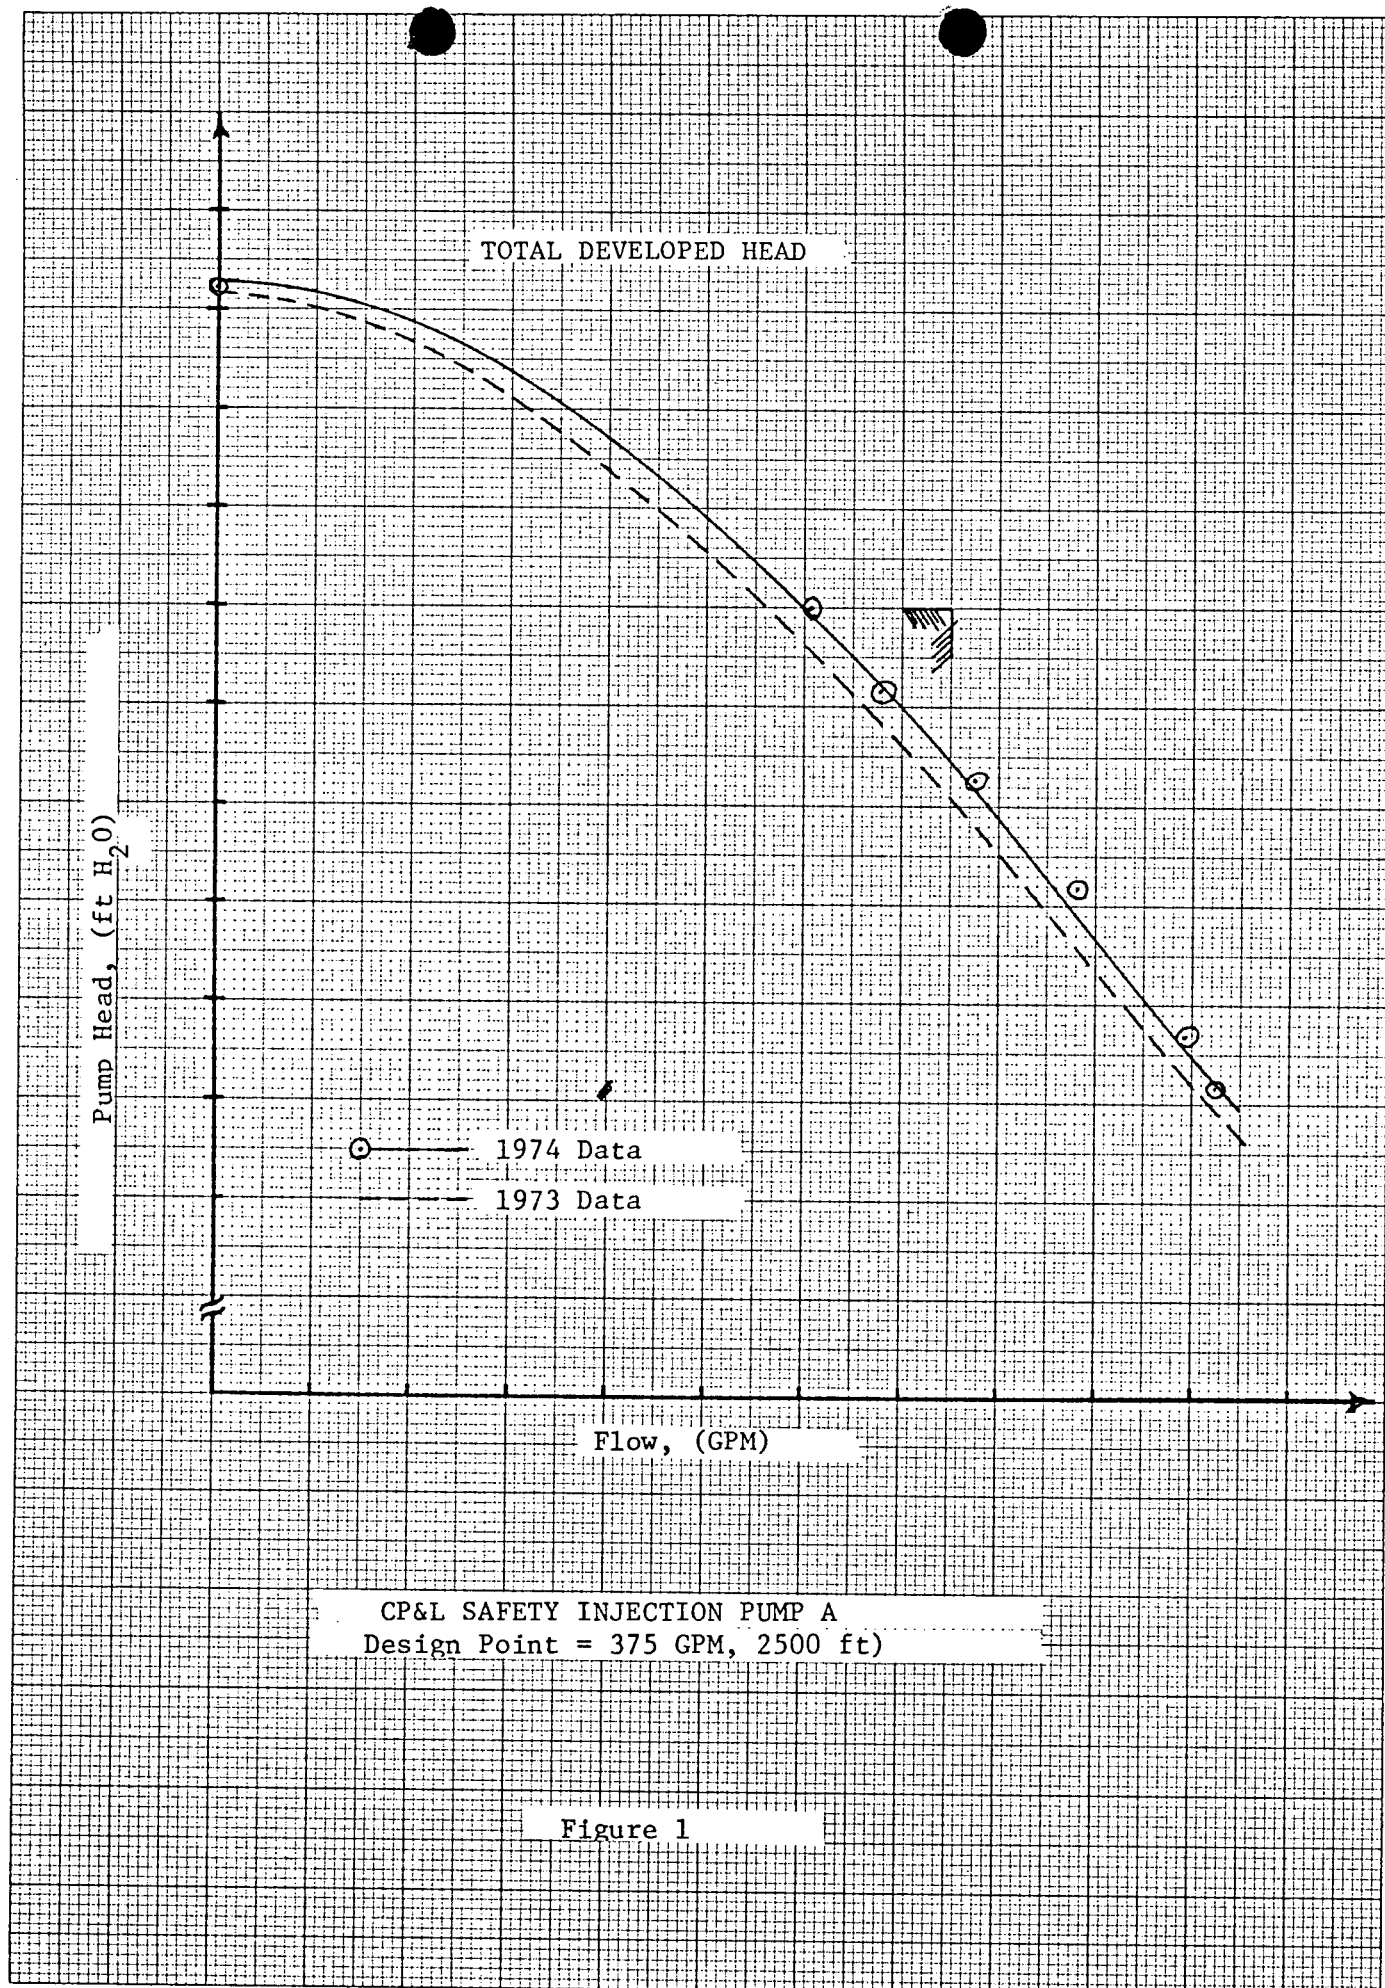
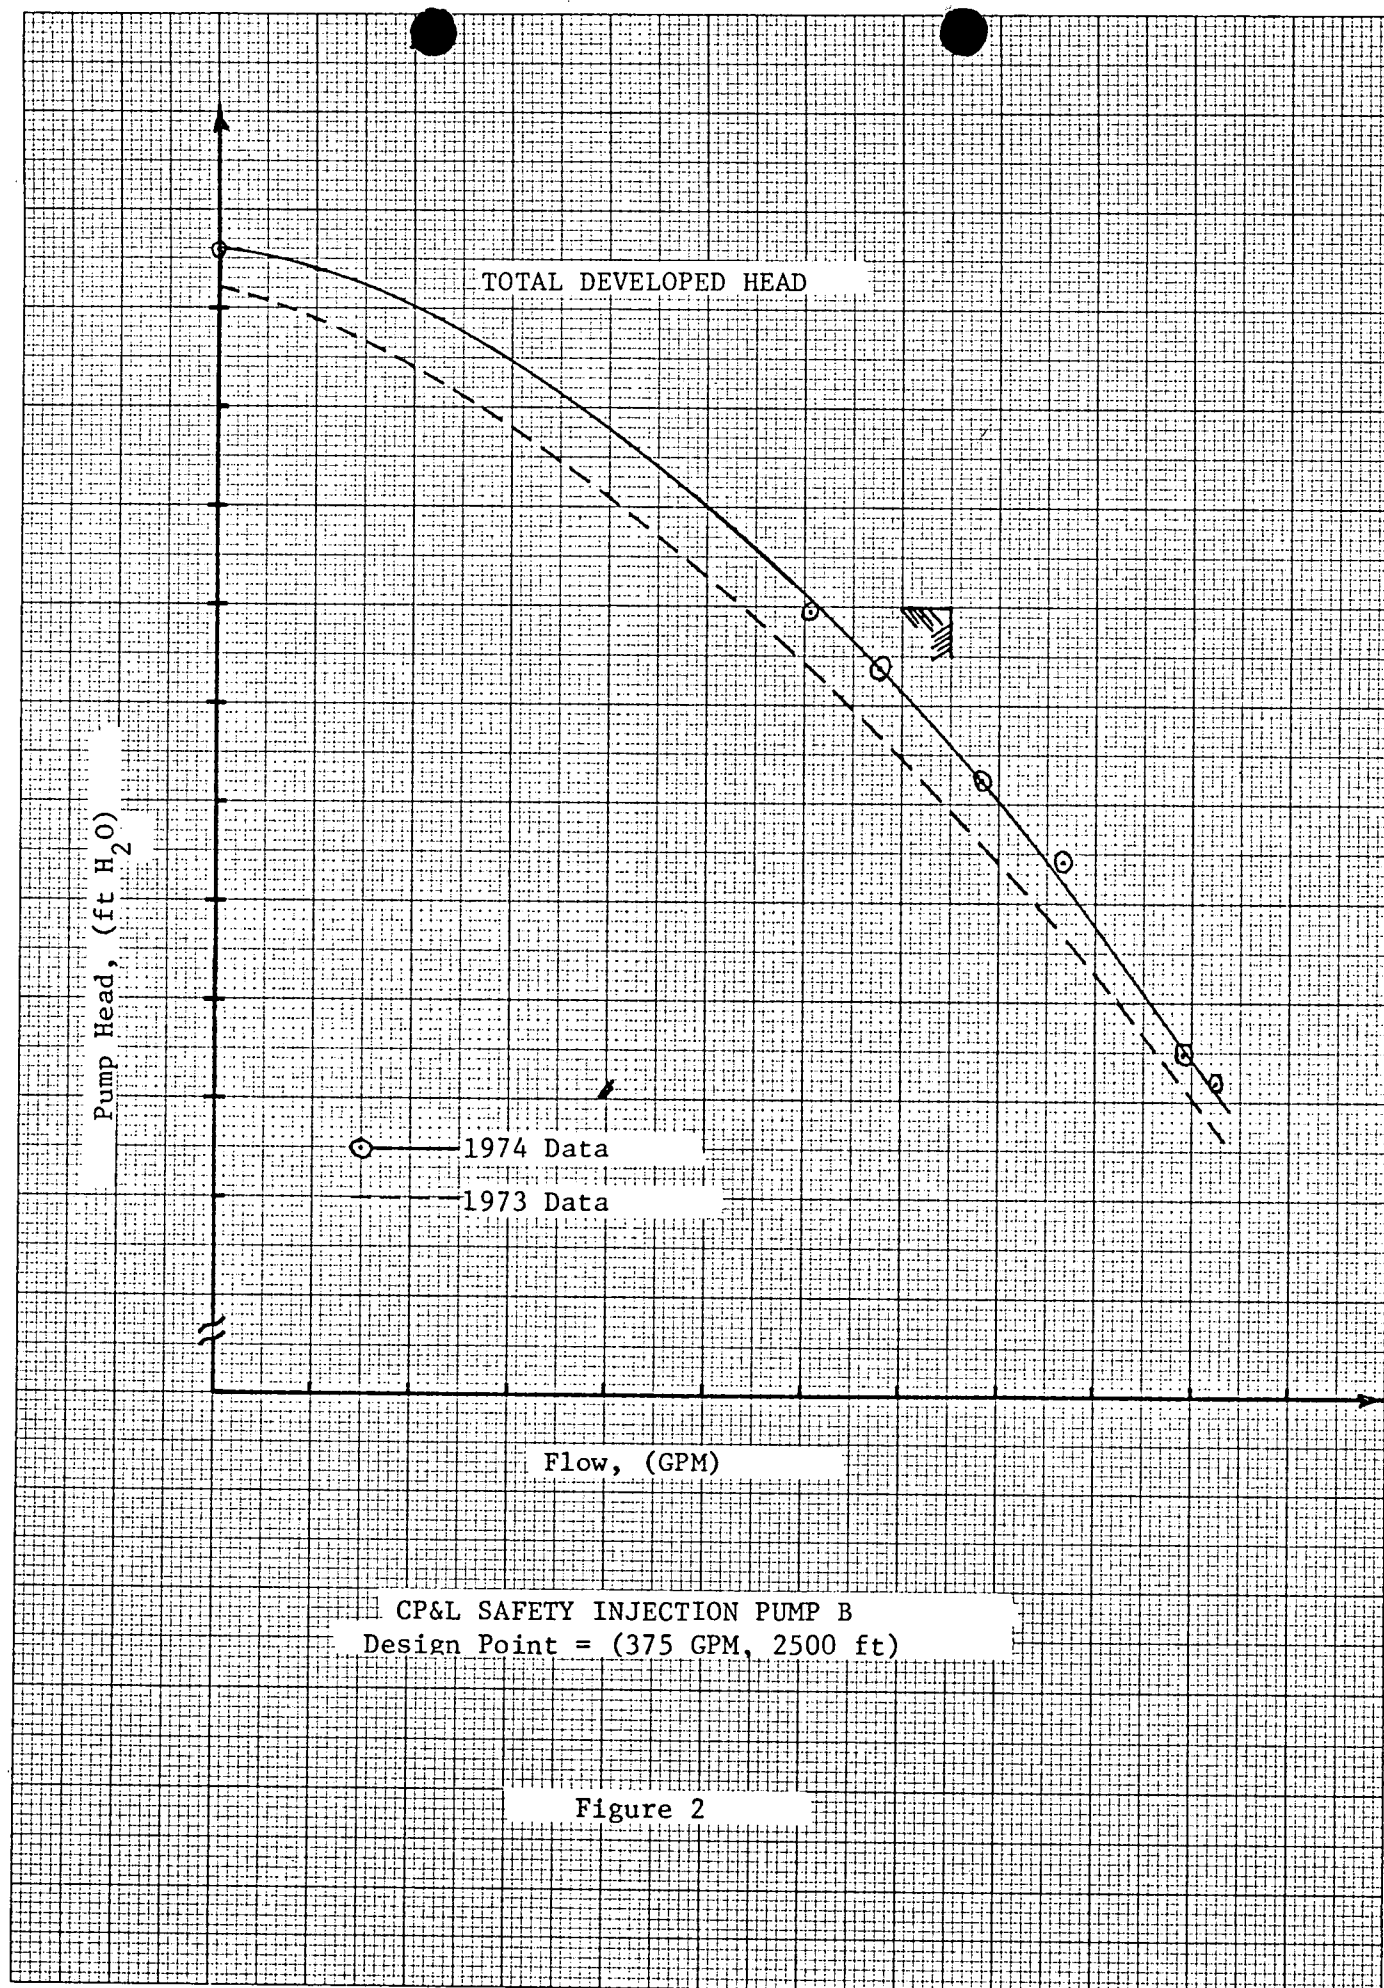
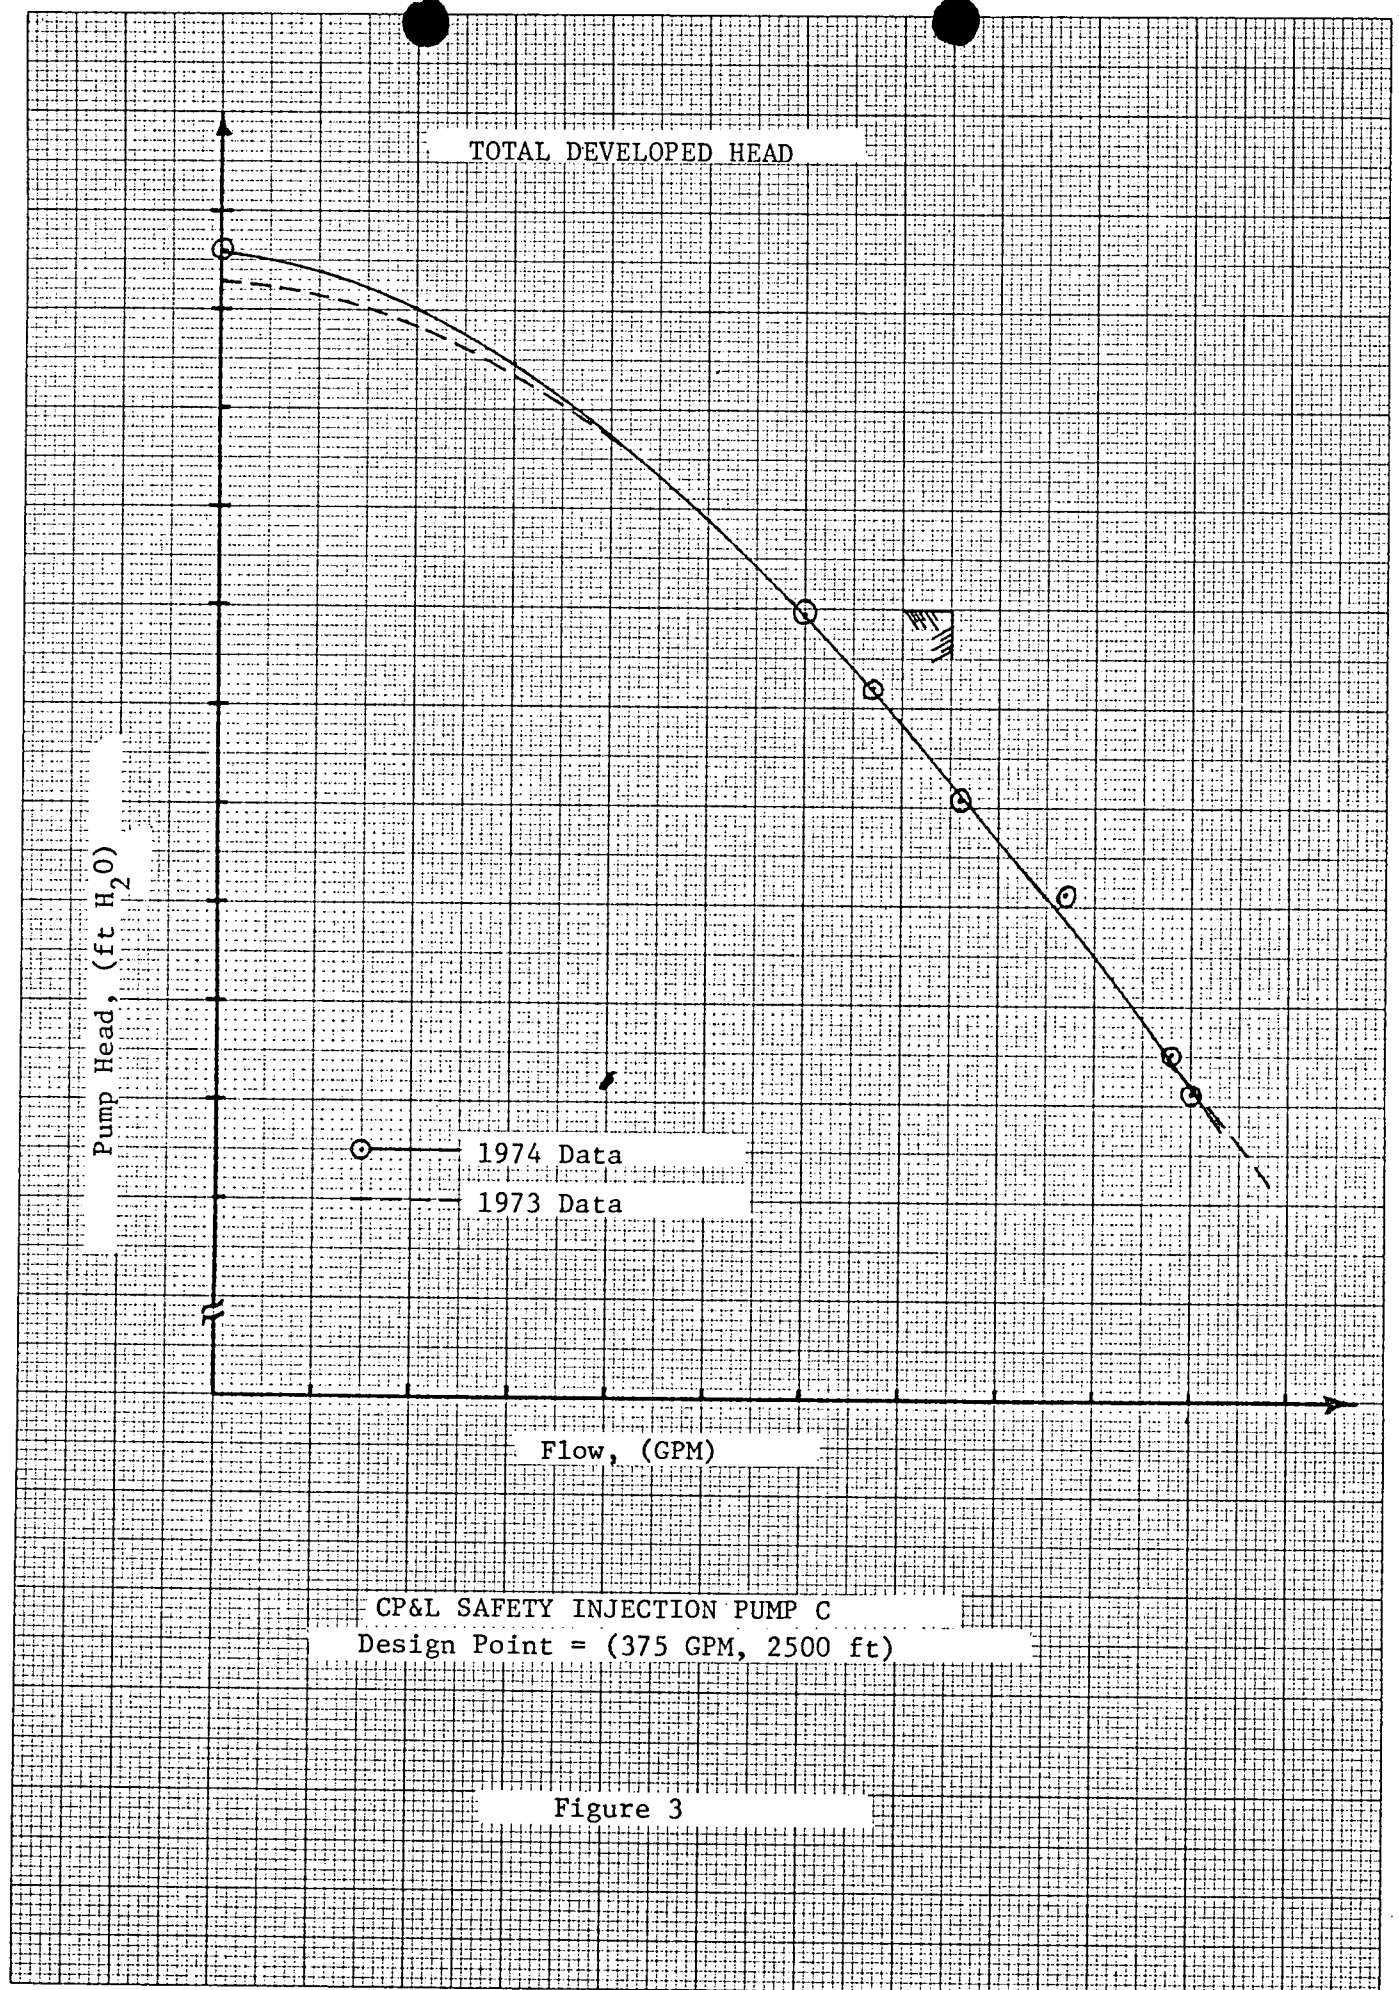
The test results indicated that the total developed head for each of the three safety injection pumps, while running on miniflow, was above the minimum acceptance value of 1425 psig and therefore in accordance with the Technical Specification requirements. For all three pumps, the measured TDH was found to be somewhat higher than had been measured during a similar test in 1973 and before the pumps were refurbished. Refer to attached Figures 1, 2, and 3.

As a part of the outage maintenance all three safety injection pumps were disassembled and inspected. Pump shaft seals were replaced at that time. A crack in the "B" pump eight stage impeller was also weld repaired and "B" pump impeller shaft was replaced. Previous repairs in November of 1973 consisted of replacement of the "A" pump impeller shaft.

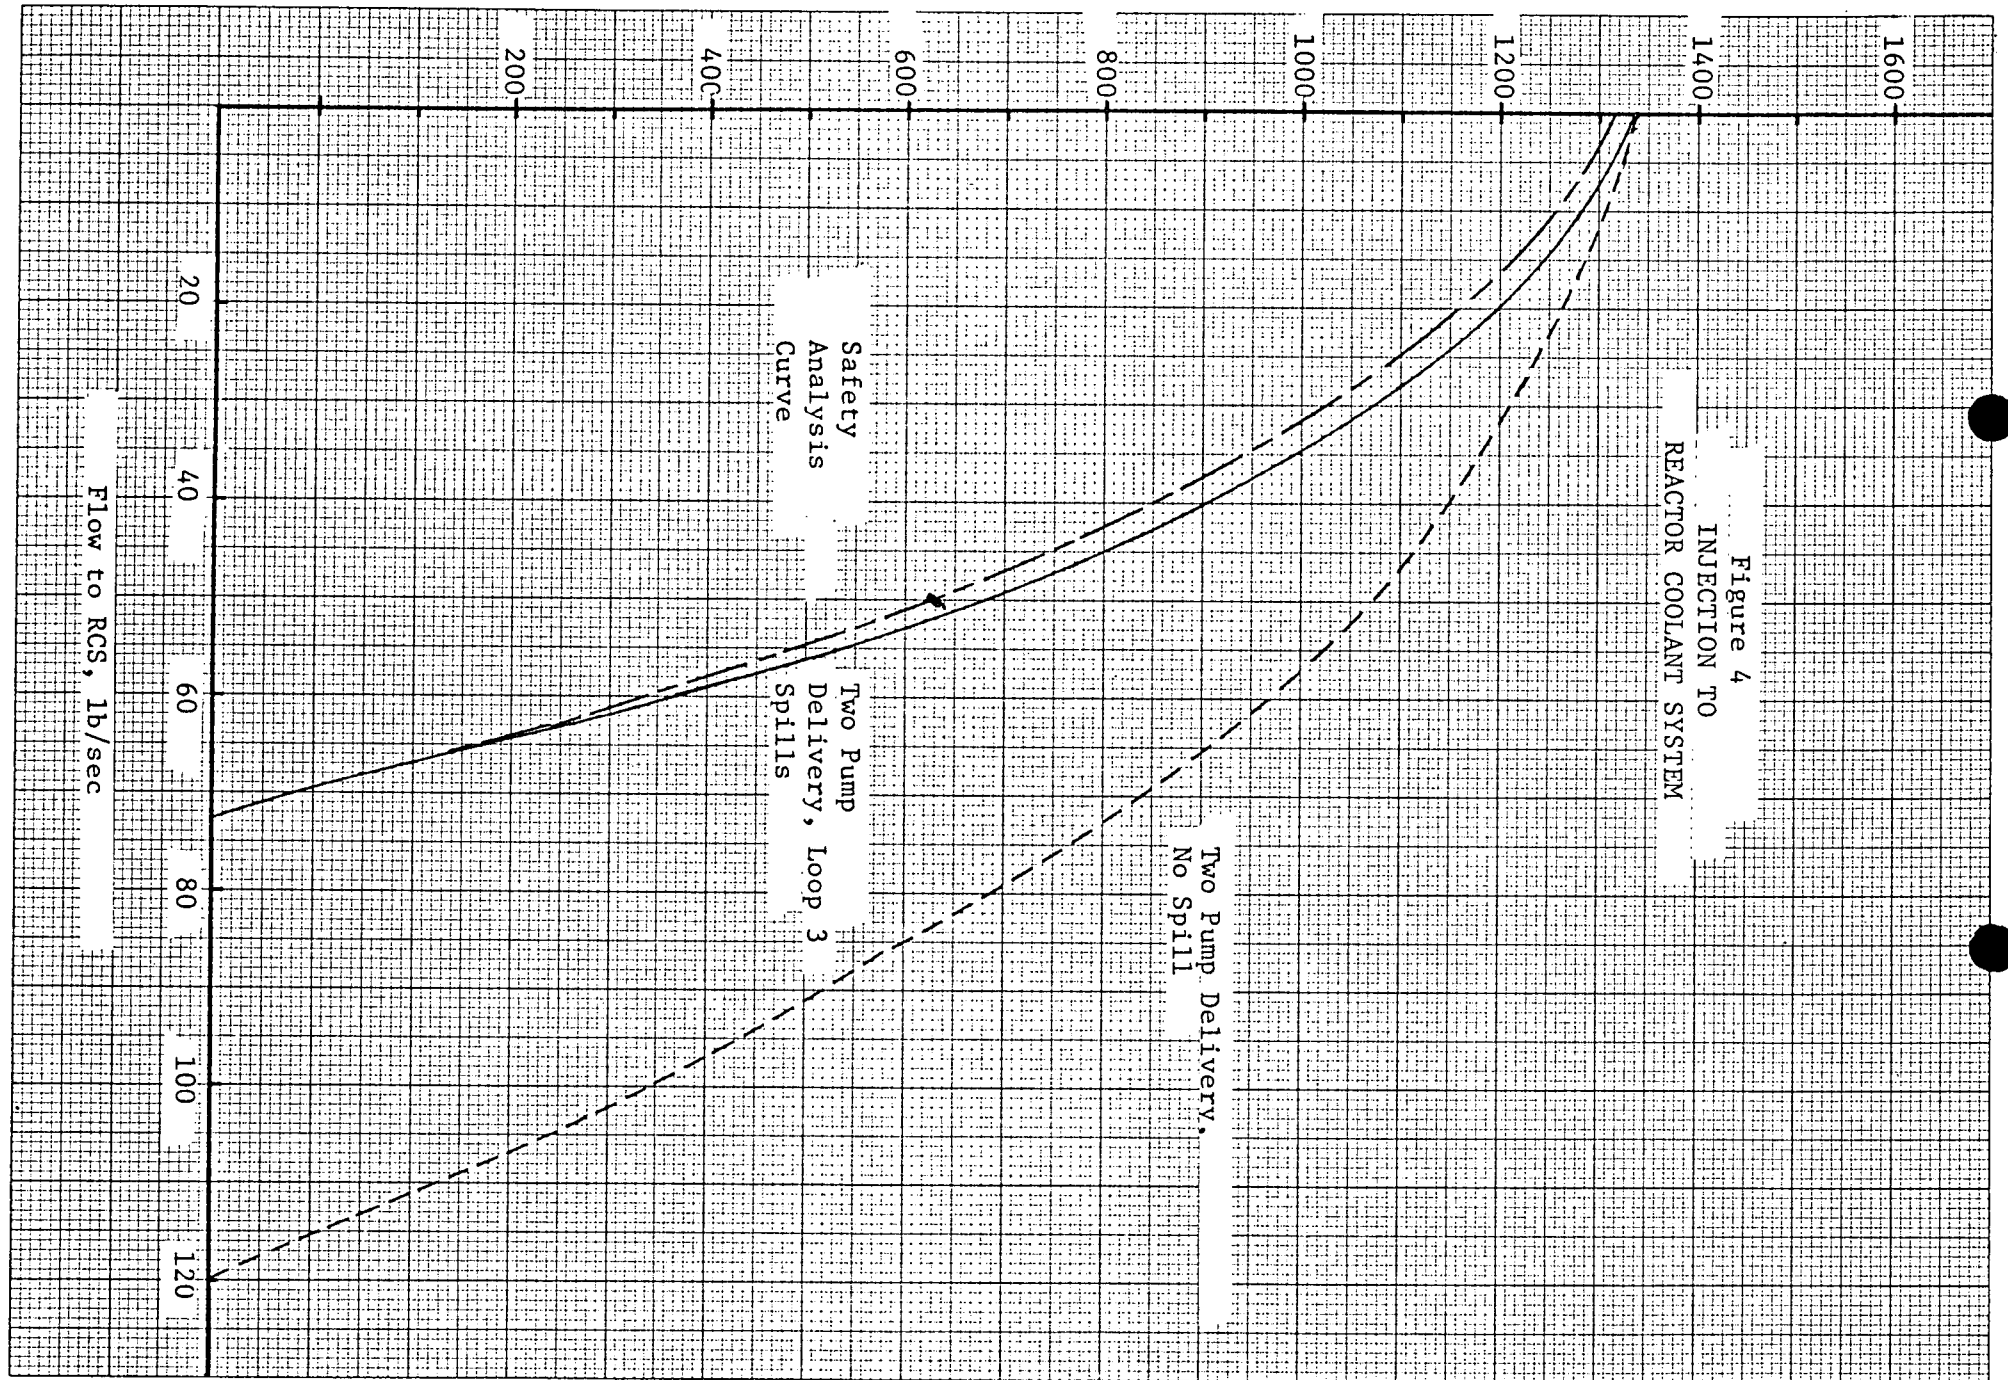
The results plotted on Figure 4 indicate that the system performance for the minimum safeguards case used in the safety analyses again was verified by the test. The system delivery calculated from the test data was slightly greater at the higher reactor backpressure which represents a small improvement in the speed at which the boron injection tank contents would be swept into the reactor during a steam break accident.

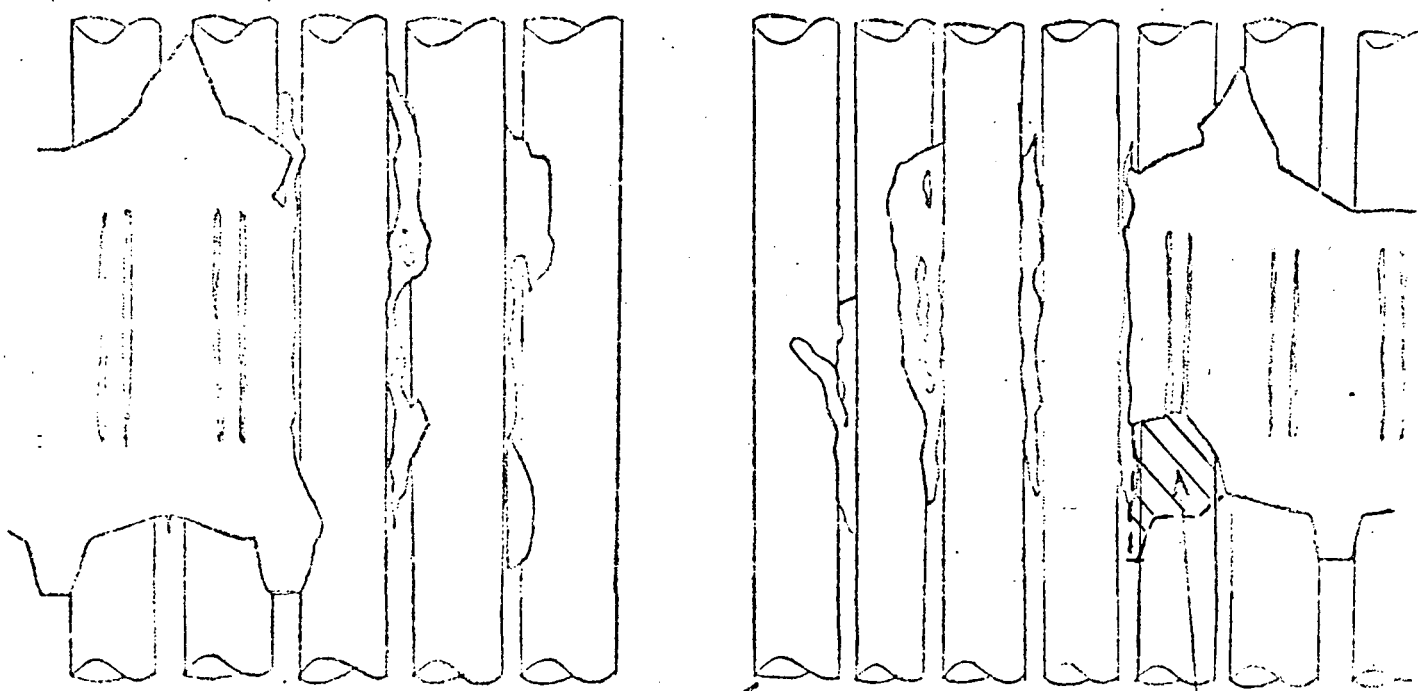
FIGURE 5

Via television inspection it was verified that the fragments were dislodged from the sixth grid, faces 1 and 2 of fuel assembly C-08. Refer to Figures 5 and 6 for the location of the displaced straps. One section of the strap on face 1 was not accounted for. The section was approximately $\frac{1}{4}$ inch by $\frac{3}{4}$ inch. Adjacent fuel assemblies, B-06, C-43 and B-52, were inspected, and no damage to these assemblies was detected.

GRID FRAGMENTS
LOCATED 11-29-73

FUEL ASSY C-08

GRID #6
