Carolina Power &amp; Light Company

May 25, 1973

50 - 261

H. B. ROBINSON UNIT NO. 2  
LICENSE DPR-23  
REFUELING OUTAGE

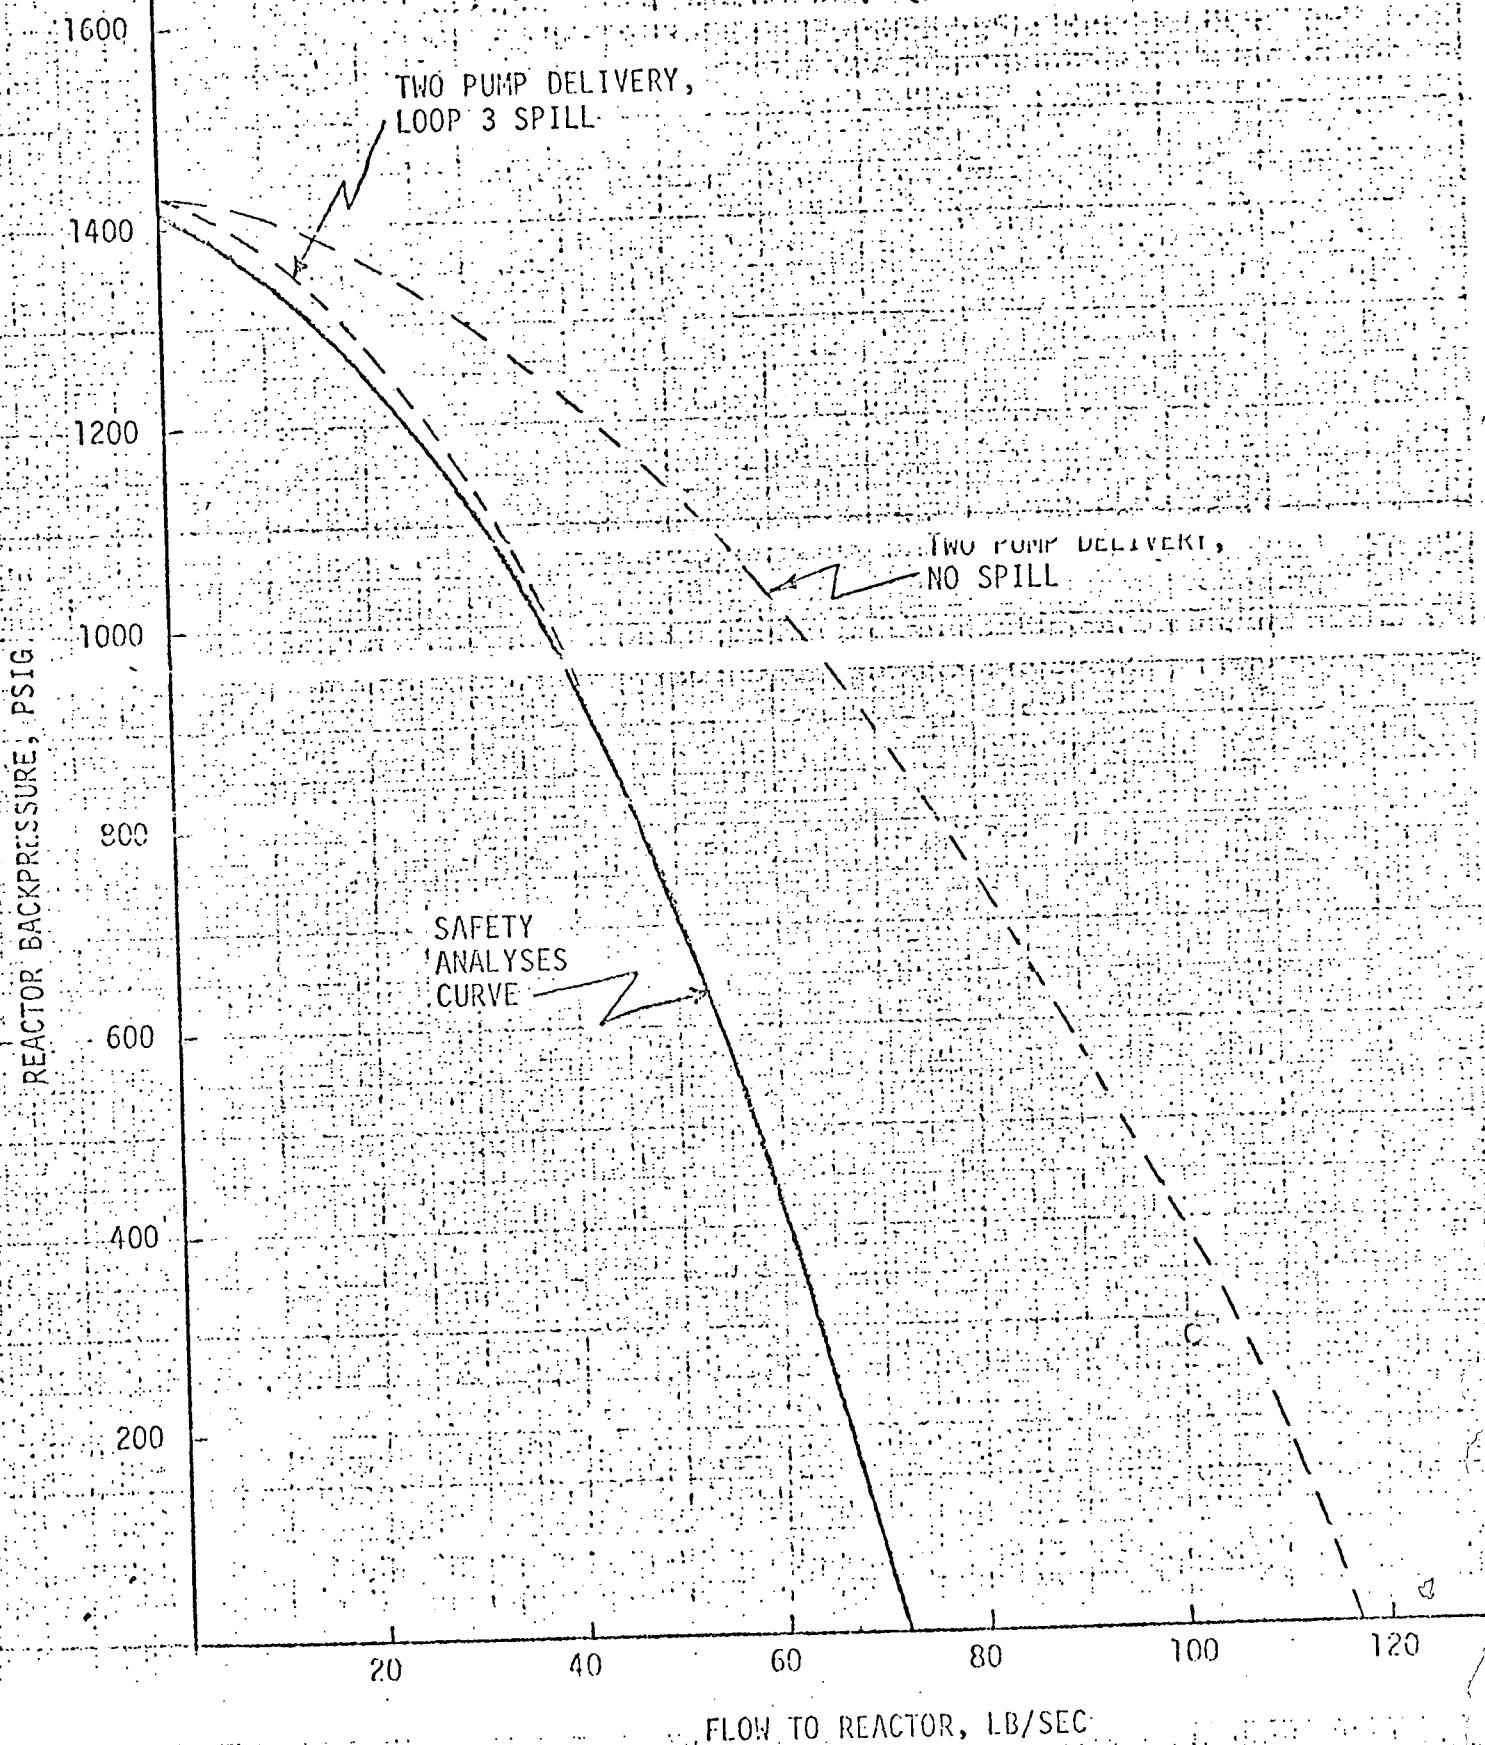
FIGURE 1

1. The system performance for the minimum safeguards case used in the safety analyses was verified by the test. System delivery at the high reactor back pressures as determined by the test was slightly greater than that assumed in the safety analysis (see figure 1). This represents a slight conservatism, when compared to the safety analysis, in the speed at which boron injection tank contents would be swept into the reactor during a steam break accident.
2. The required flow to the reactor through the three cold leg injection lines from two operating pumps was demonstrated by the test for each pair of pumps.

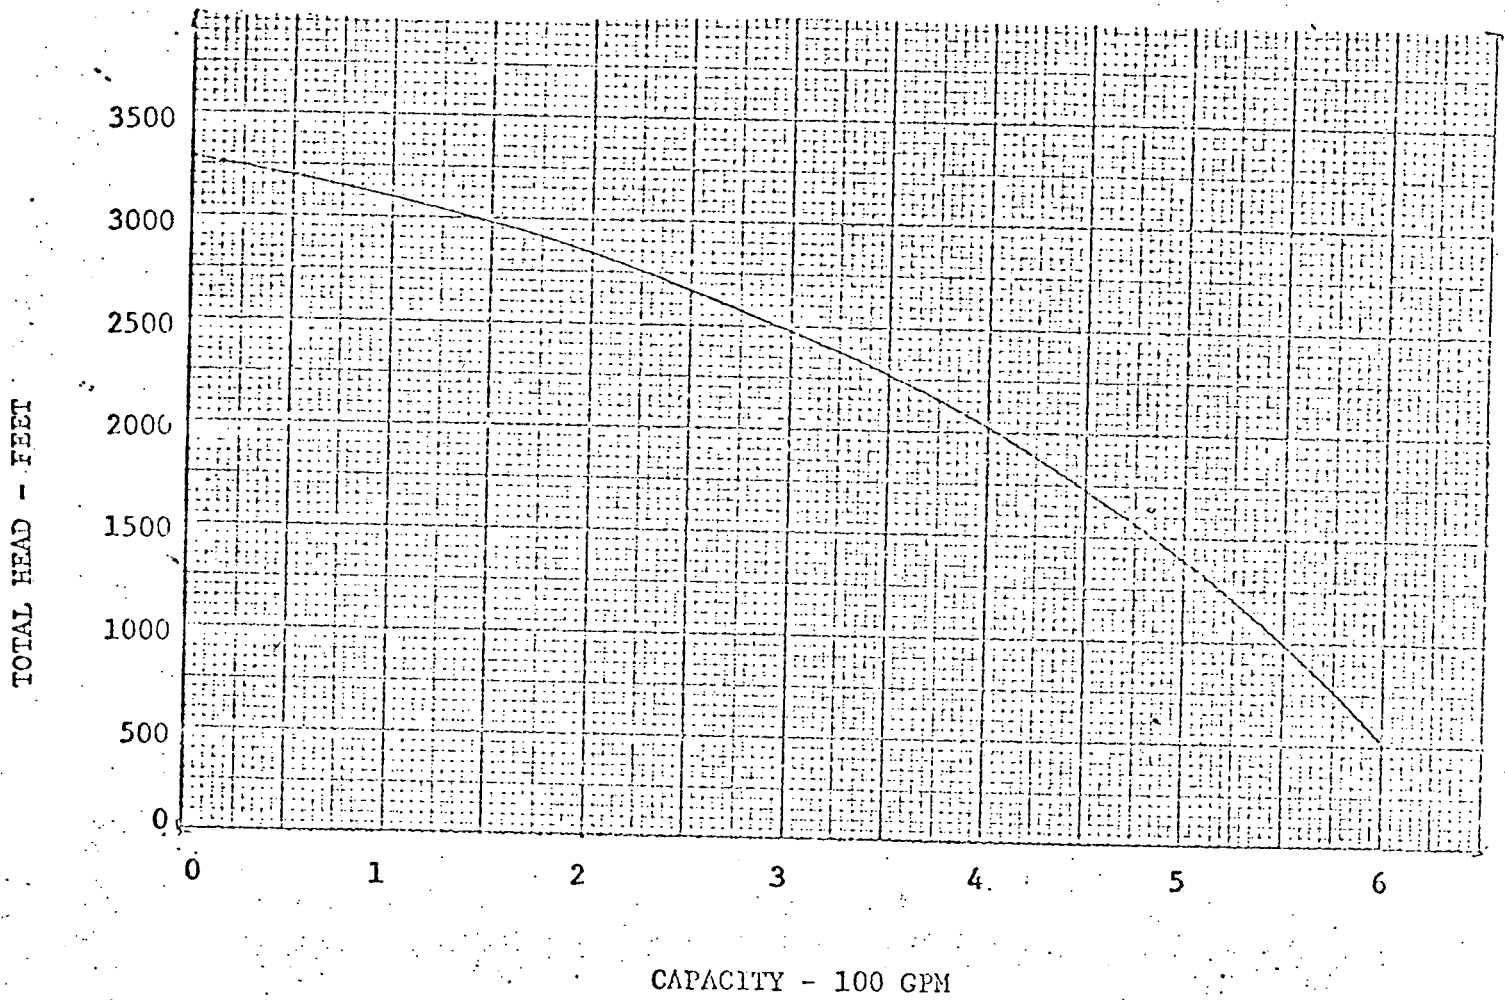
FIGURE 2

The test results also indicated that several data points for each pump fell slightly below the pump characteristic submitted to the AEC Division of Reactor Licensing in Carolina Power & Light Company's letter, Docket No. 50-261, dated August 12, 1970, (see figures 2 through 5). For this reason, we are reporting this information to the Division of Reactor Licensing.

Since the overall system performance for the minimum safeguards case used in the safety analyses was verified by the test, there are no unreviewed safety problems associated with the apparent change in pump characteristics. Therefore, Carolina Power & Light Company will continue to operate H. B. Robinson Unit No. 2 in accordance with the approved Technical Specifications. Normal Periodic Tests of the safety injection pumps will be continued in order to verify satisfactory operability and performance. It is our intention to conduct further system tests and to inspect at least one safety injection pump during the next refueling shutdown.

Westinghouse has requested Worthington, the pump vendor, to review the results of the H. B. Robinson tests. We will forward additional comments and recommendations for resolution of this matter as soon as available.

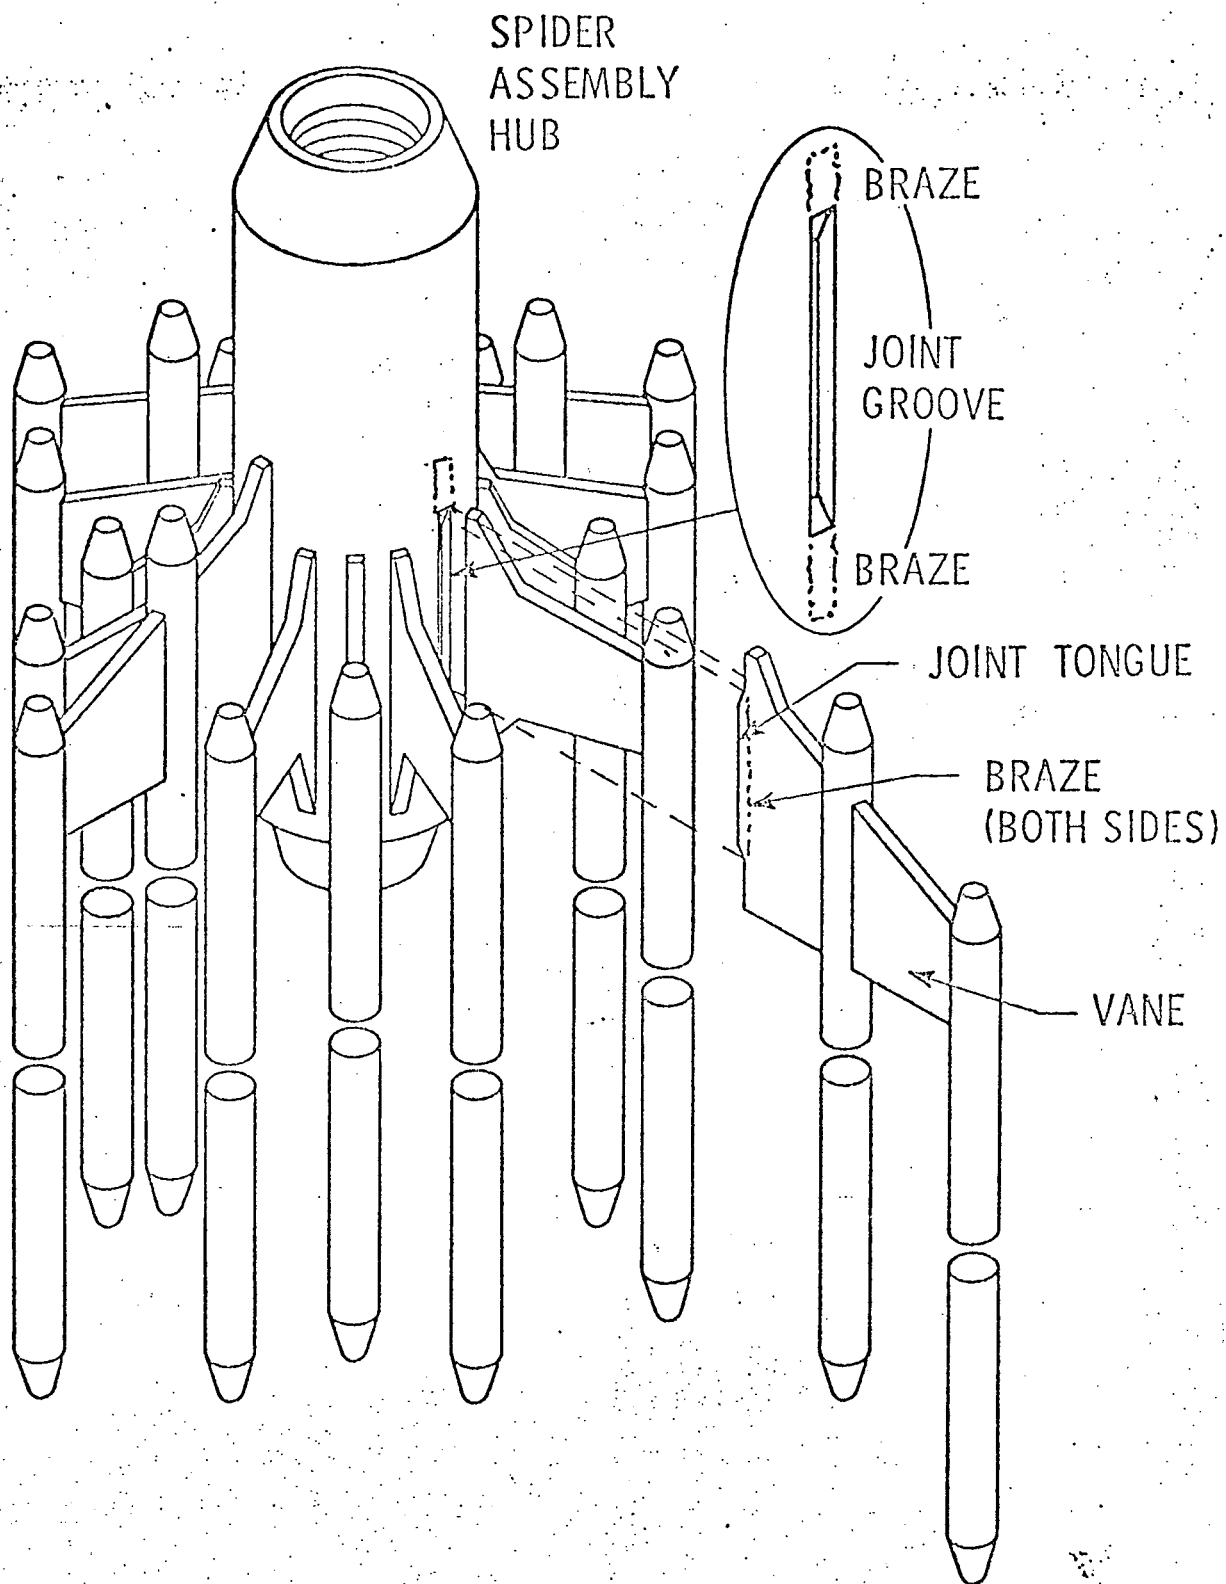
Figure 6. Control Rod Braze Joint Configuration

On April 4, 1973, during core unloading, a vane from the RCC in fuel assembly A-19 was discovered separated from the spider hub during operations in the RCC change fixture (see figure 6). The following special inspection and evaluation was conducted immediately upon discovery of the problem:

- 1) Only one RCC Assembly was involved. No anomalies were observed in the inspection of remaining RCC Assemblies.
- 2) Radiation measurements revealed the rodlets on the separated vane three feet from the top were at a level of  $1.1 \times 10^5$  R/hr compared with 600 mr/hr for the rodlets on the main control rod assembly. This result indicates the separated vane with the two rodlets was in the full scram position in core for a significant period of time while the remaining rodlets with spider assembly were in the normal low flux position, withdrawn from the core. Calculations indicate the period of time was about 8000 full power hours of plant operation.

- 4) No event in plant operating history could be related to the failure incident.
- 5) No anomalies were visible in the braze joint.

- 1) less than full strength on the braze joint on the RCC Assembly and
- 2) abnormal loading on the RCC Assembly due to the presence of debris.

There were no positive indications as to the cause of failure. Since no markings indicating interference or impact were present on the failed vane, it appears that the joint was not overstressed because of jamming from debris. On the other hand, visual examination of the braze joint showed no indication of insufficient braze.

Although there was no evidence of the presence of debris, this does not exclude the possibility that debris existed earlier in cycle I operations. Radiation levels on the failed vane indicate that the failure occurred early in the first cycle. However, extensive operating time has been accumulated with the other control rods, and the probability is good that if other rods were similarly affected, they would have exhibited problems.

In any event this failure did not cause damage to the control rod guide tube. The RCC was replaced with a spare assembly from on-site spares, and the new RCC was test dropped five times at hot shutdown conditions with satisfactory results. This incident is considered an isolated one, and no further action is deemed necessary.
