PLANT NAME: H. B. ROBINSON UNIT #2

H. B. ROBINSON UNIT NO. 2
LICENSE DPR-23
STEAM GENERATOR TUBE INSPECTIONS

SUMMARY OF STEAM GENERATOR TUBE DEGRADATION FOUND IN 1974 OUTAGE

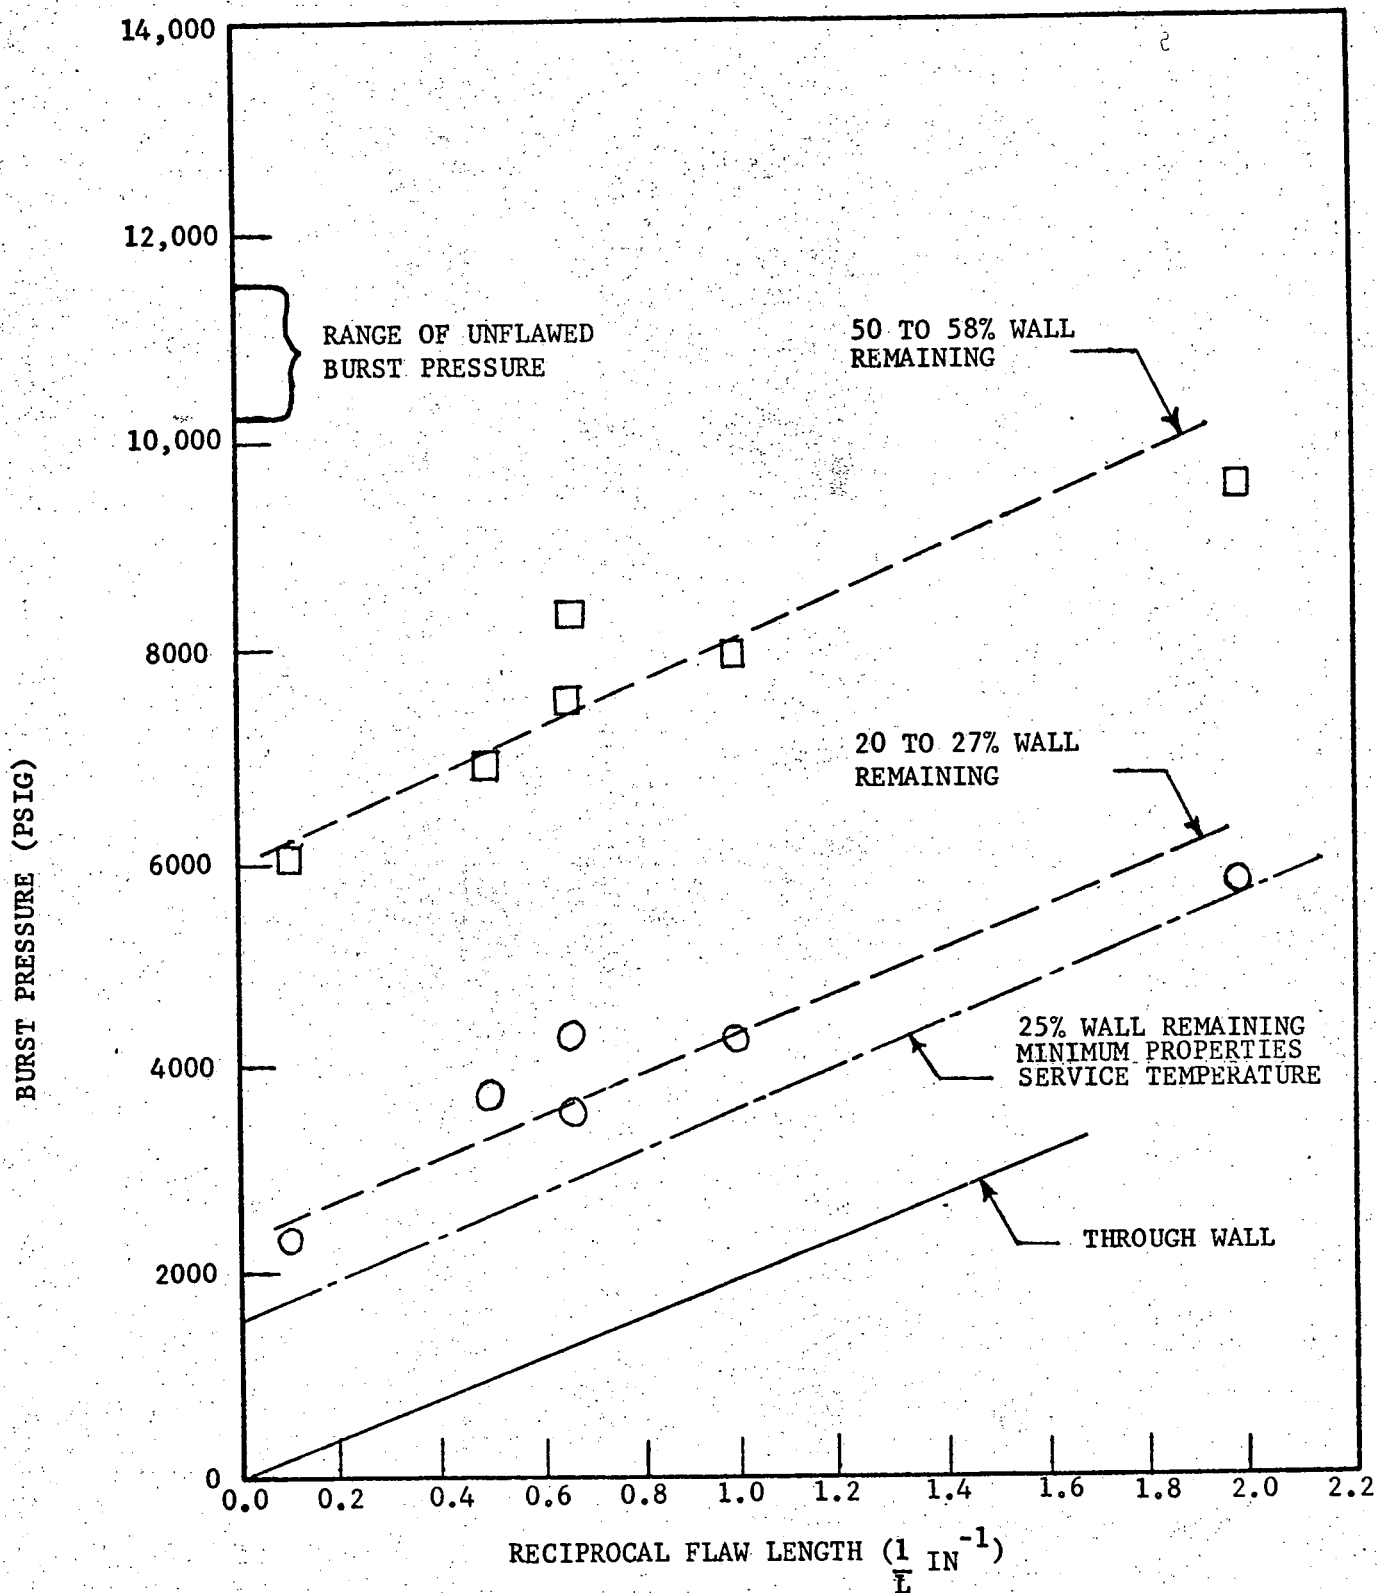
Figure 1. Room Temperature Burst Pressure of 7/8" Tubes with Machined Flats

The results of this series of tests are presented in Figure 1 as burst pressure versus reciprocal flaw length. The slope of these curves is essentially the same as those obtained from a similar program where partial through-wall slots were machined in the tubing. The results of this series of tests on 7/8 inch tubing were as expected and they tend to confirm the results of the previous tests.

It will be noted from this data that the burst pressures at room temperature are in the range of 3700 to 4200 psi for tubing with 1 to 2 inch long flaws and with approximately 25% of the original wall remaining. The burst pressure increases to about 6000 psi when the flaws are in the 1/2 inch long range. For comparison the burst pressure for normal tubing is approximately 11,000 psi.

The effect of service temperatures and minimum code allowable properties are also indicated on Figure 1 for 25% wall remaining. It will be noted that the strength of the tube to withstand internal pressure is substantial even with as little as 25% of the tube wall remaining.

Referring to Figure 1, the curve indicated as minimum tube properties at service temperature with 25% wall, it will be noted that with a 2-inch long flaw the tubing will withstand 2500 psi internal pressure. Shorter defect lengths and nominal material properties would increase the allowable pressure loading on the tube.

For this limiting condition it is concluded that the minimum acceptable wall would be equivalent to 25% of the original tube wall based on a two-inch long broad-area defect, considering that the tubing has minimum mechanical properties. A review of material test reports for steam generator tubing has indicated that the tubing is consistently produced with nominal properties providing additional margin for this analysis.
