Carolina Power & Light Company

July 23, 1975

H. B. ROBINSON UNIT NO. 2
LICENSE NO. DPR-23

RESPONSE TO NRC REQUEST FOR ANALYSIS TO DETERMINE
POTENTIAL OCCURRENCE OF SECONDARY SYSTEM FLUID FLOW INSTABILITY

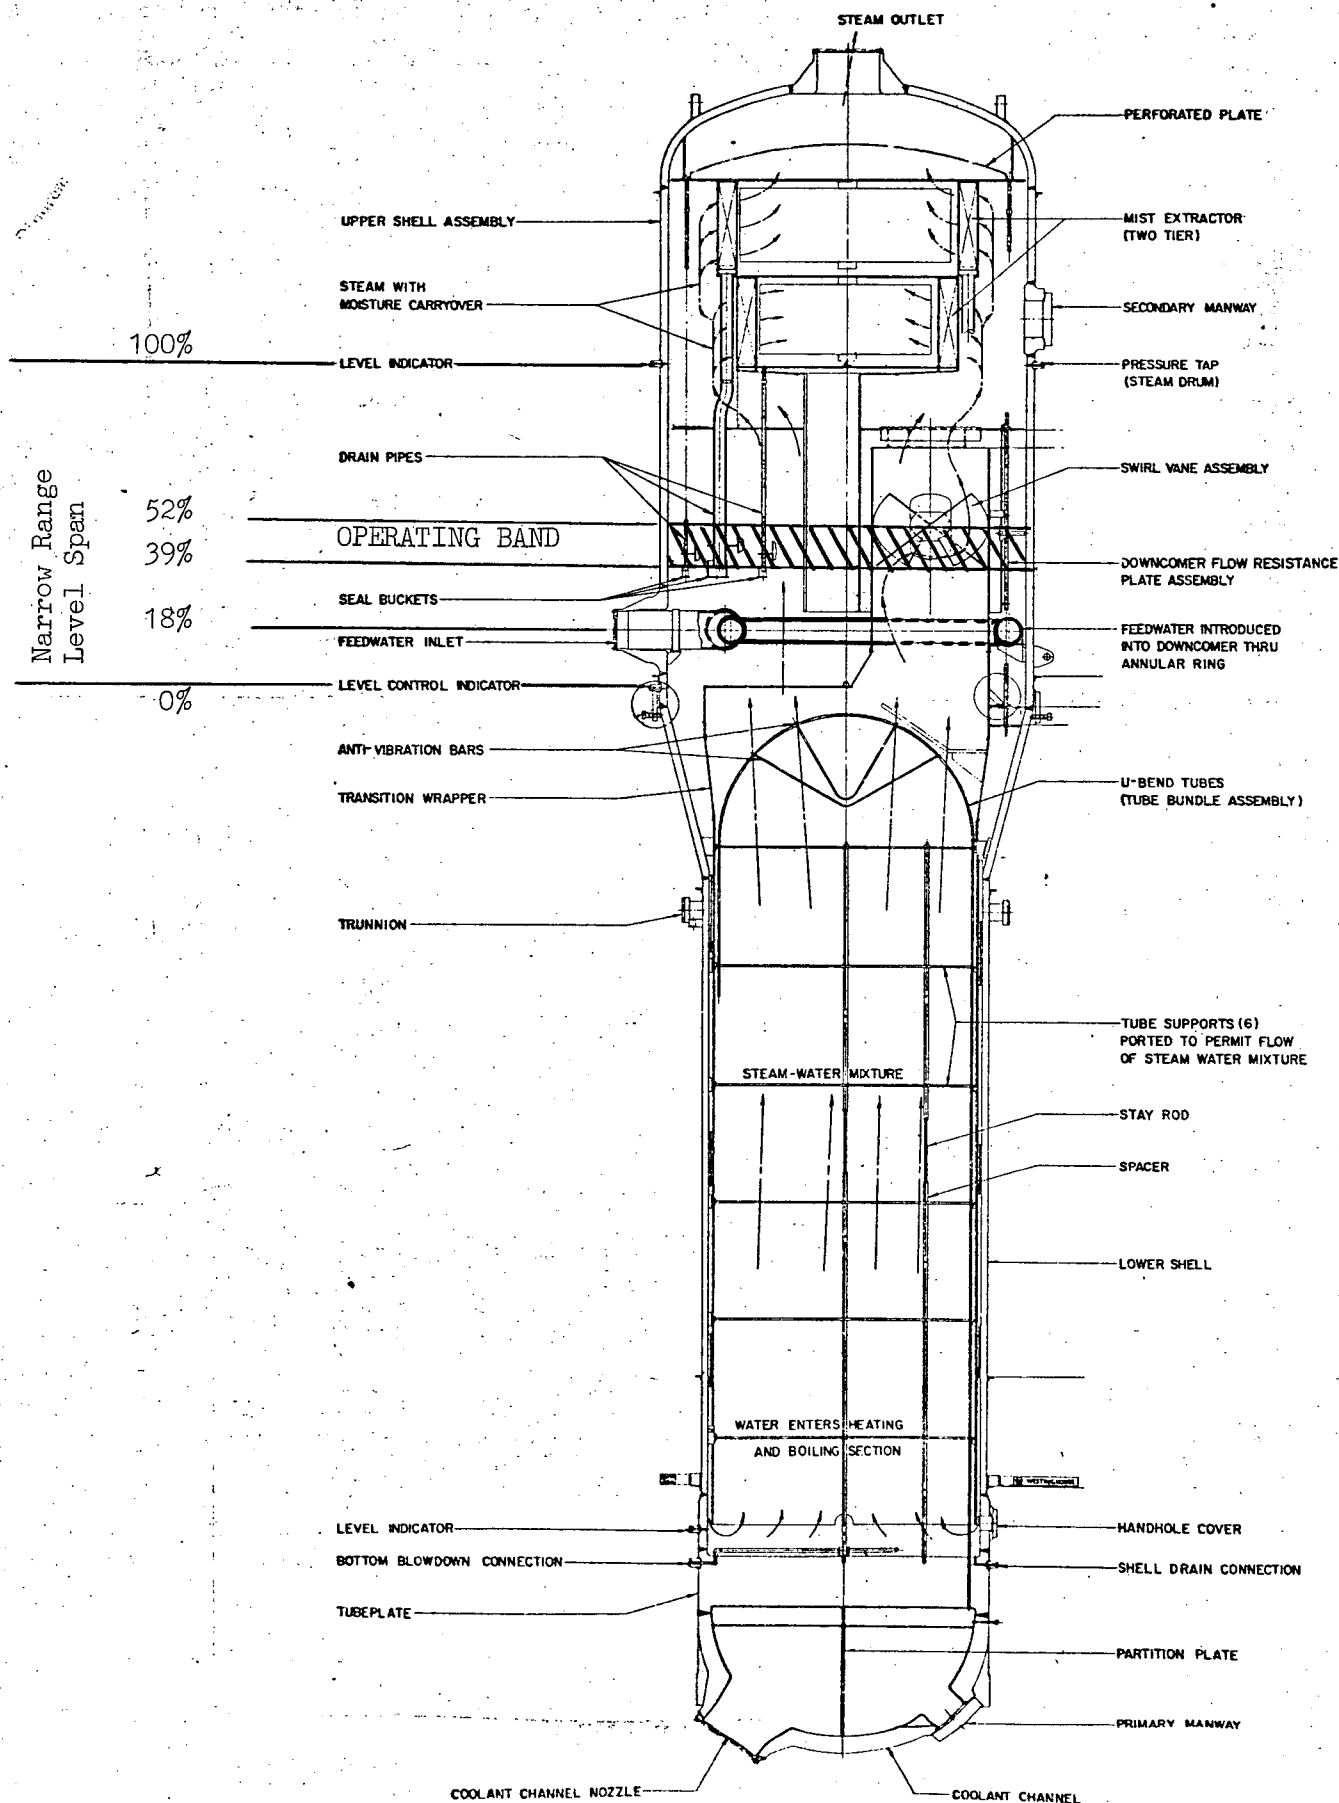
The steam generators installed in H. B. Robinson Unit No. 2 are illustrated in Figure I. The figure indicates the relative position of the feedwater ring within the span of the narrow range level indicator. During normal operation the steam generator level is programmed to operate at 52% of narrow range span from 20% to 100% reactor power. Below 20% of rated power, the level is programmed to drop linearly to 39% of narrow range span at zero power. Figure I also illustrates these programmed levels and their relation to feedwater ring position. Table I below summarizes the various setpoints associated with the narrow range steam generator instrument.

As indicated in Figure I, the lowest level reached during operation before action is initiated (15%) is below the center line position of the feedwater ring (18%). However, this is of no apparent consequence as discussed below.

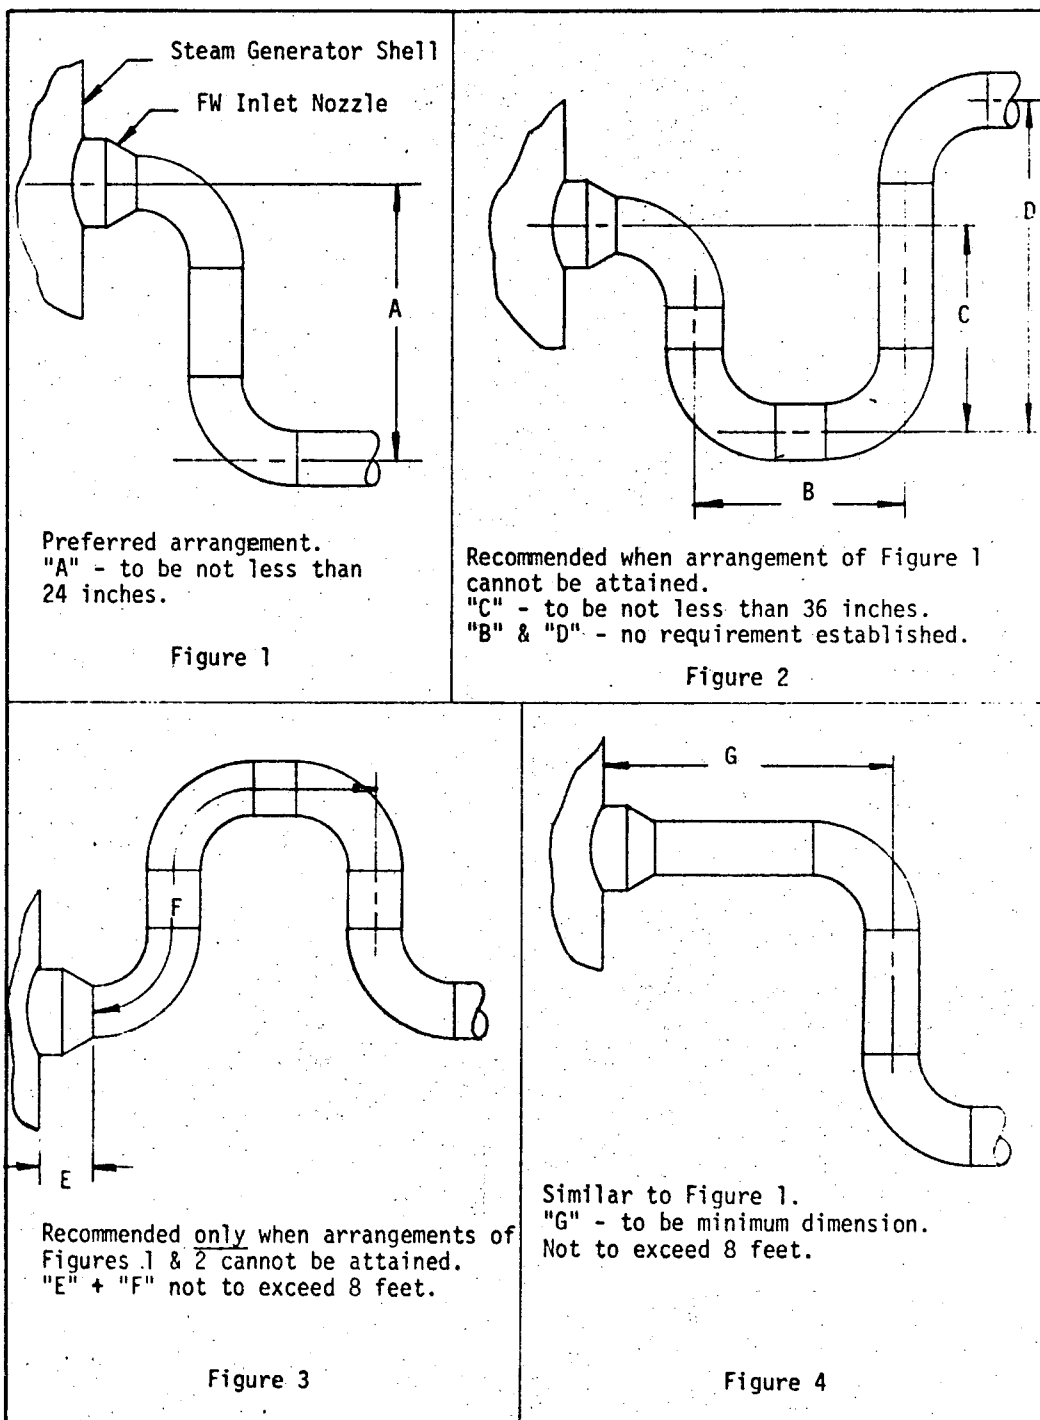
Attachment to NSD-TB-75-7

This lack of occurrence of water hammer under the above mentioned conditions is attributed to the piping arrangement in the feedwater system. A recent technical bulletin from the steam generator vendor (Westinghouse NSD-TB-75-7) describes the water hammer phenomenon and discusses the probable causes, effects and methods of minimizing occurrence. As a result of a test program conducted by the vendor, observations indicate that the probability of damage from water hammer can be kept to a minimum by the elimination of long horizontal pipe runs at the feedwater inlet nozzle. This minimizes the length of pipe which can drain into the steam generator when the level drops below the feedwater inlet and reduces the magnitude of a water hammer slug, thereby reducing the amplitude of the resulting pressure wave. Figure II was taken from the technical bulletin and illustrates various acceptable piping arrangements as recommended by the vendor. The arrangement at

H. B. Robinson can be best described as a combination of arrangements 1 and 4 of Figure II where dimension "A" is no less than 20 feet and "G" is approximately $3\frac{1}{4}$ feet. Therefore, based upon this technical bulletin, the as-built piping in the feedwater system is in a preferred configuration for the purpose of reducing the effects of water hammer, and no changes to system design are planned.
