PLANT NAME: H B ROBINSON -- UNIT 2

H. B. ROBINSON STEAM ELECTRIC PLANT, UNIT NO. 2
DOCKET NO. 50-261
LICENSE NO. DPR-23

ADDITIONAL INFORMATION - CONTAINMENT TENDON SURVEILLANCE PROGRAM

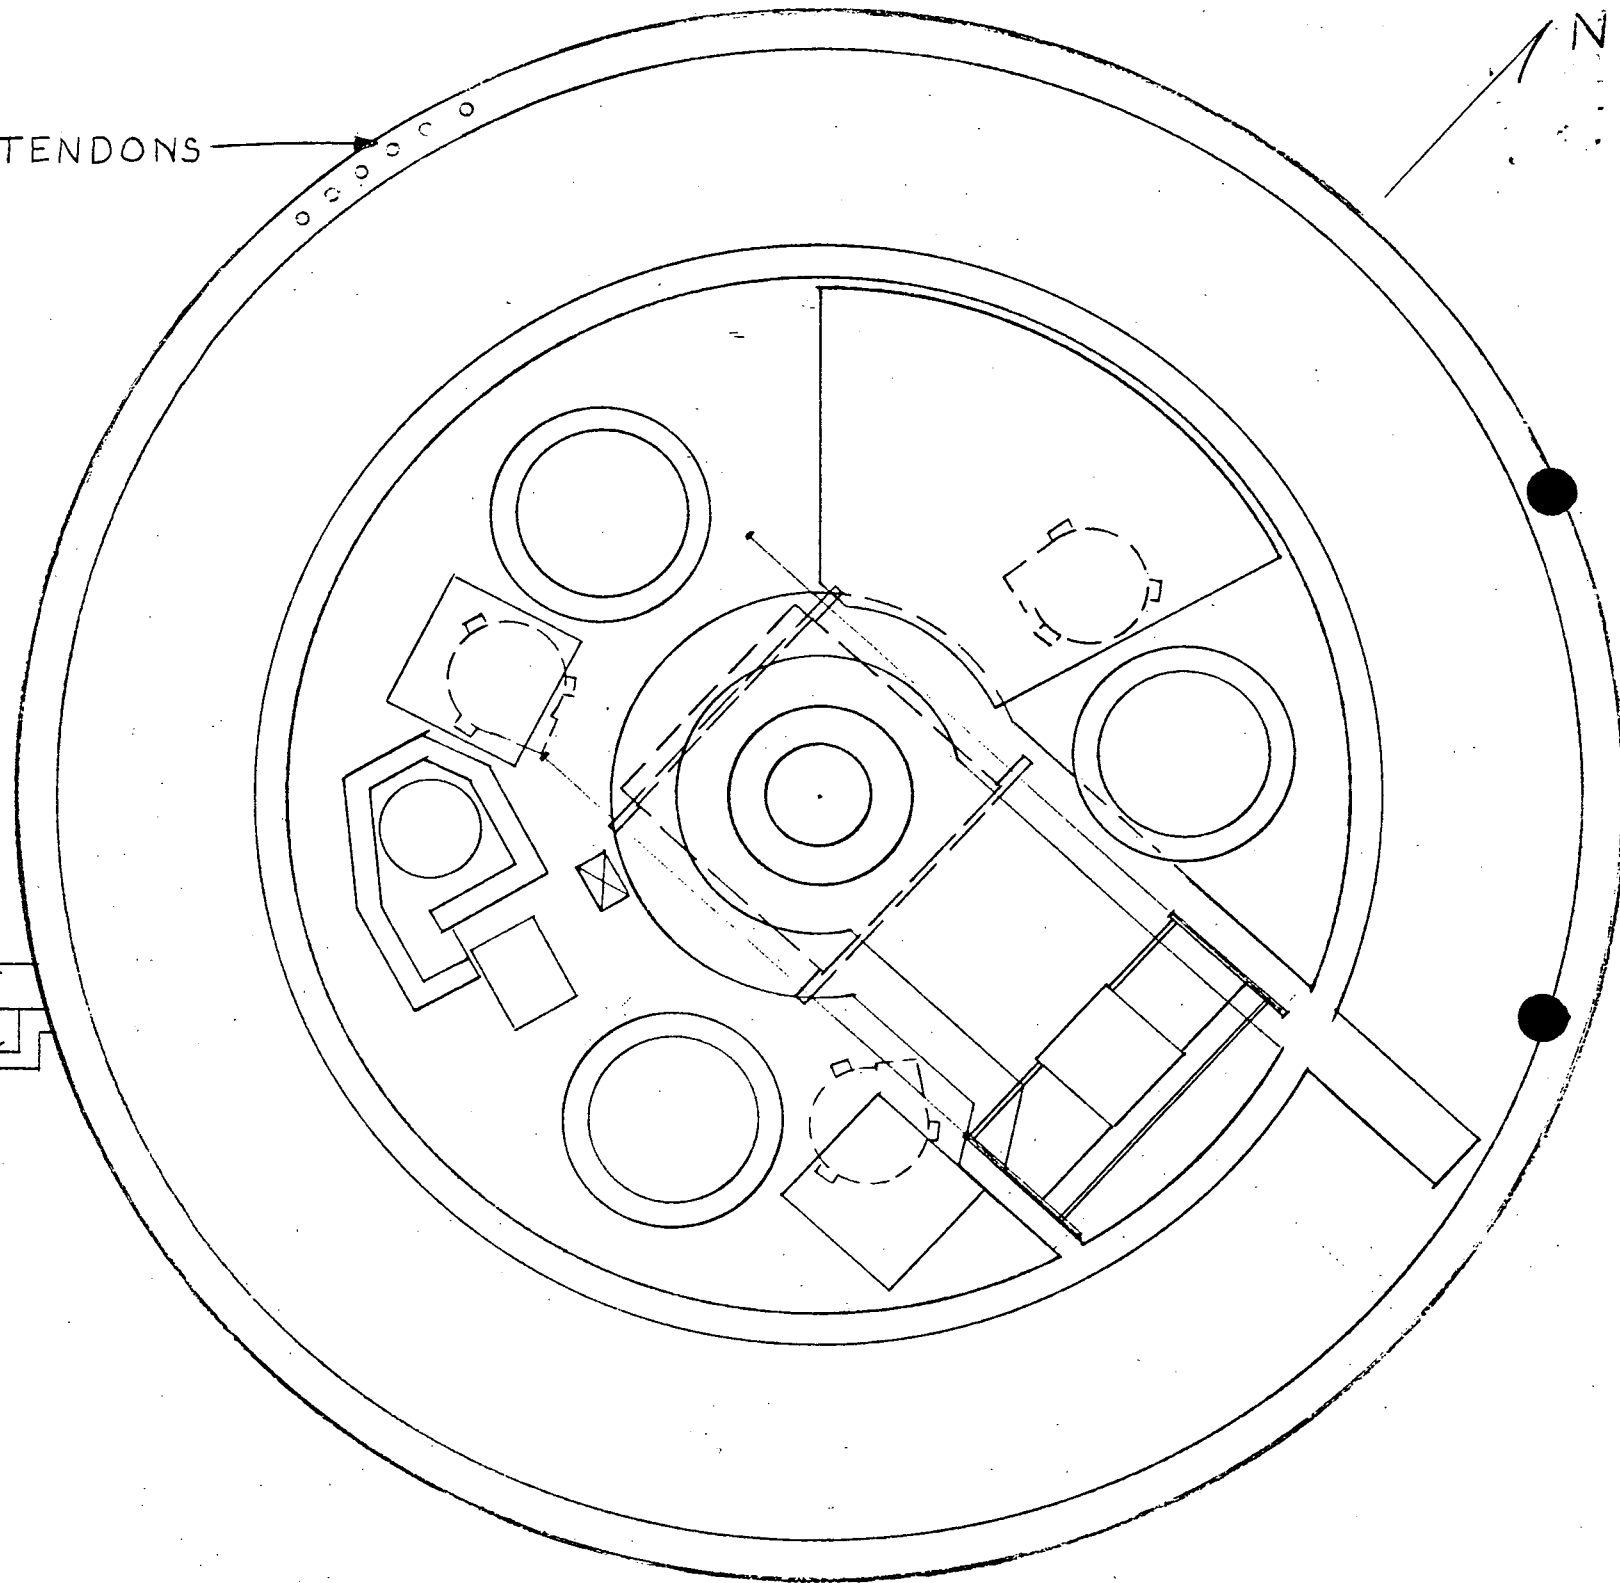
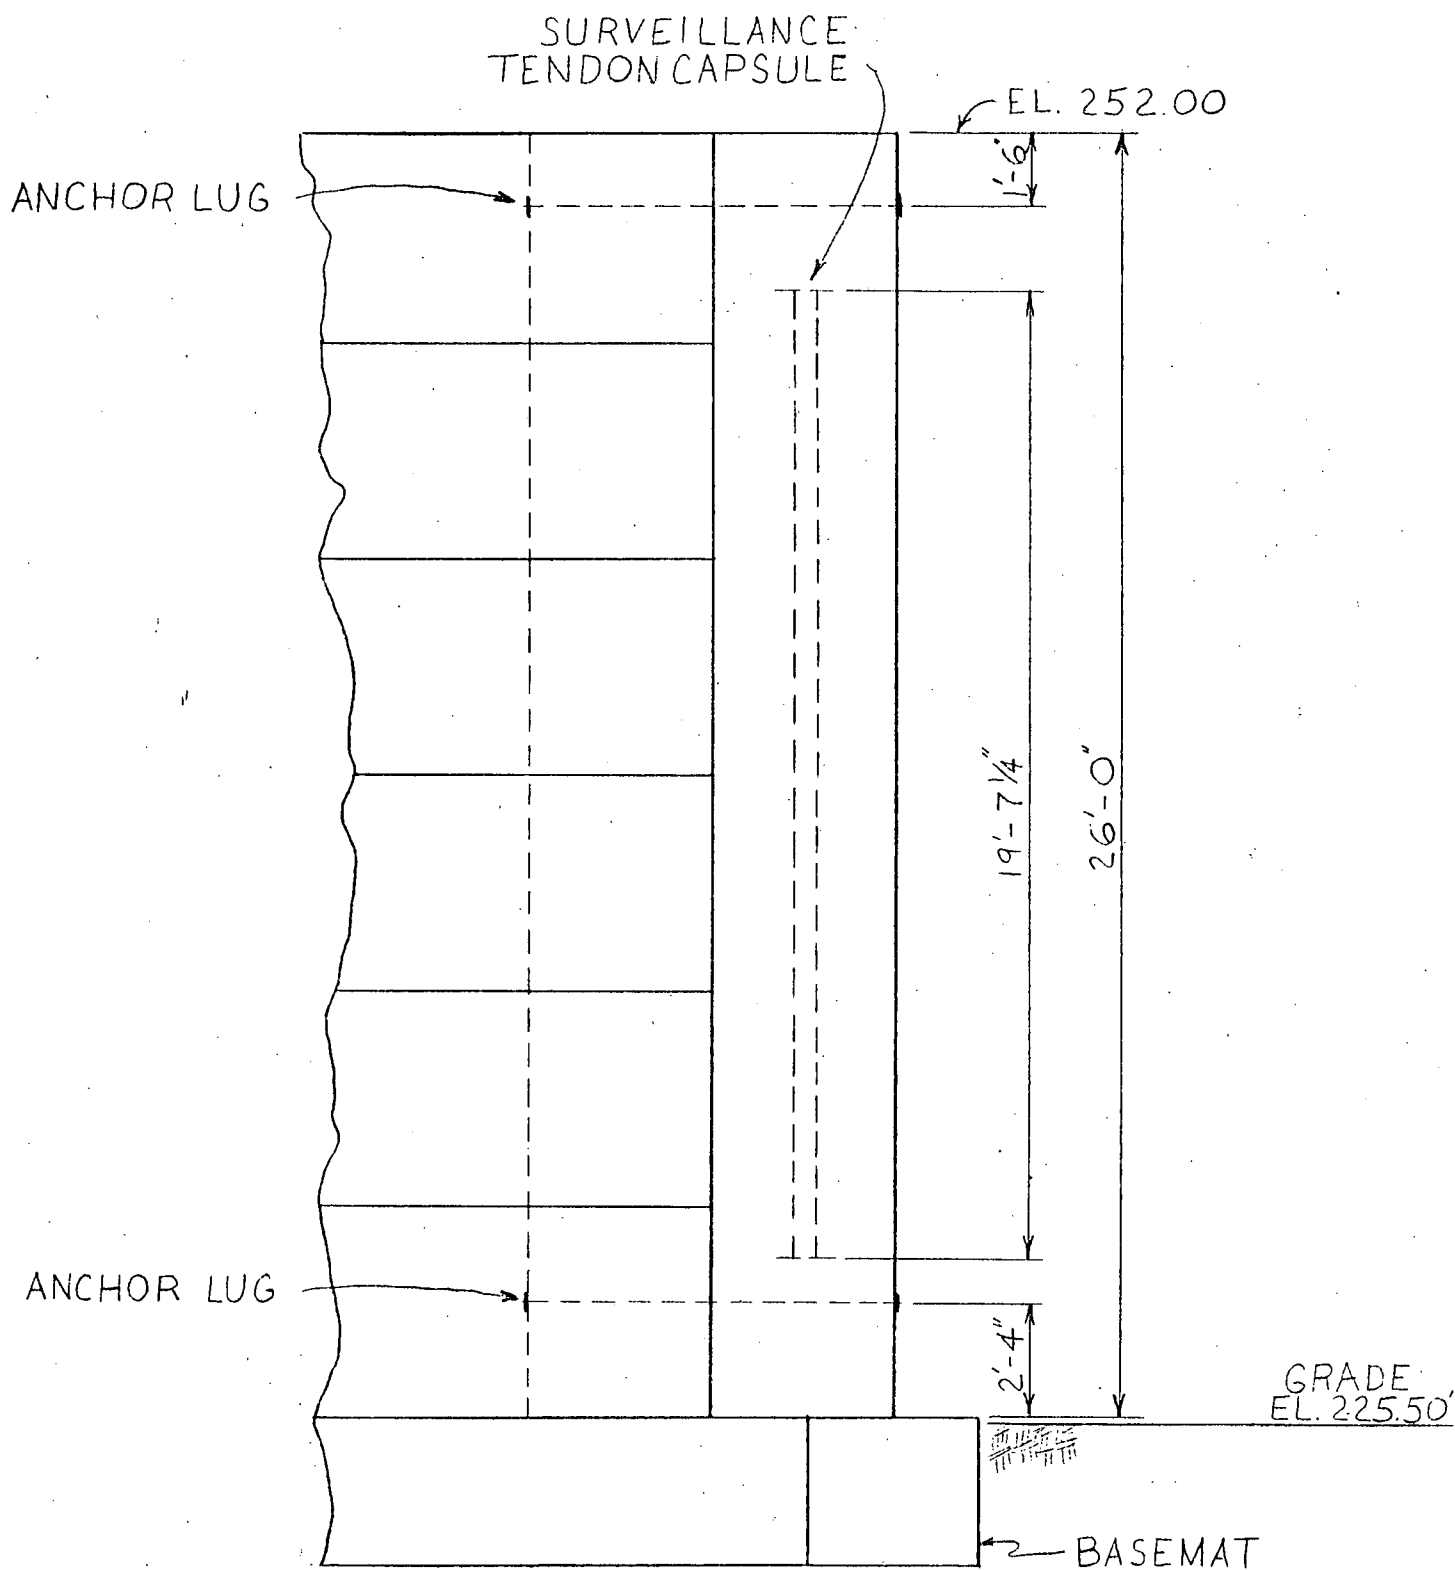
SURVEILLANCE
TENDON CAPSULE

Response: The attached sketches show the relative location of the surveillance tendons to the containment as well as the dimensions of the capsule.
