Generic Letter 95-05 Tube Intersection Burst Test, Leakage Test, and Morphology  
Conclusions  
(87 Pages Follow)

# **Interim Report: Examination of Steam Generator Tubes Removed from Beaver Valley Unit 2**

Prepared for the  
FirstEnergy Nuclear Operating Company

**SG-CCOE-14-1**  
**Revision 0**

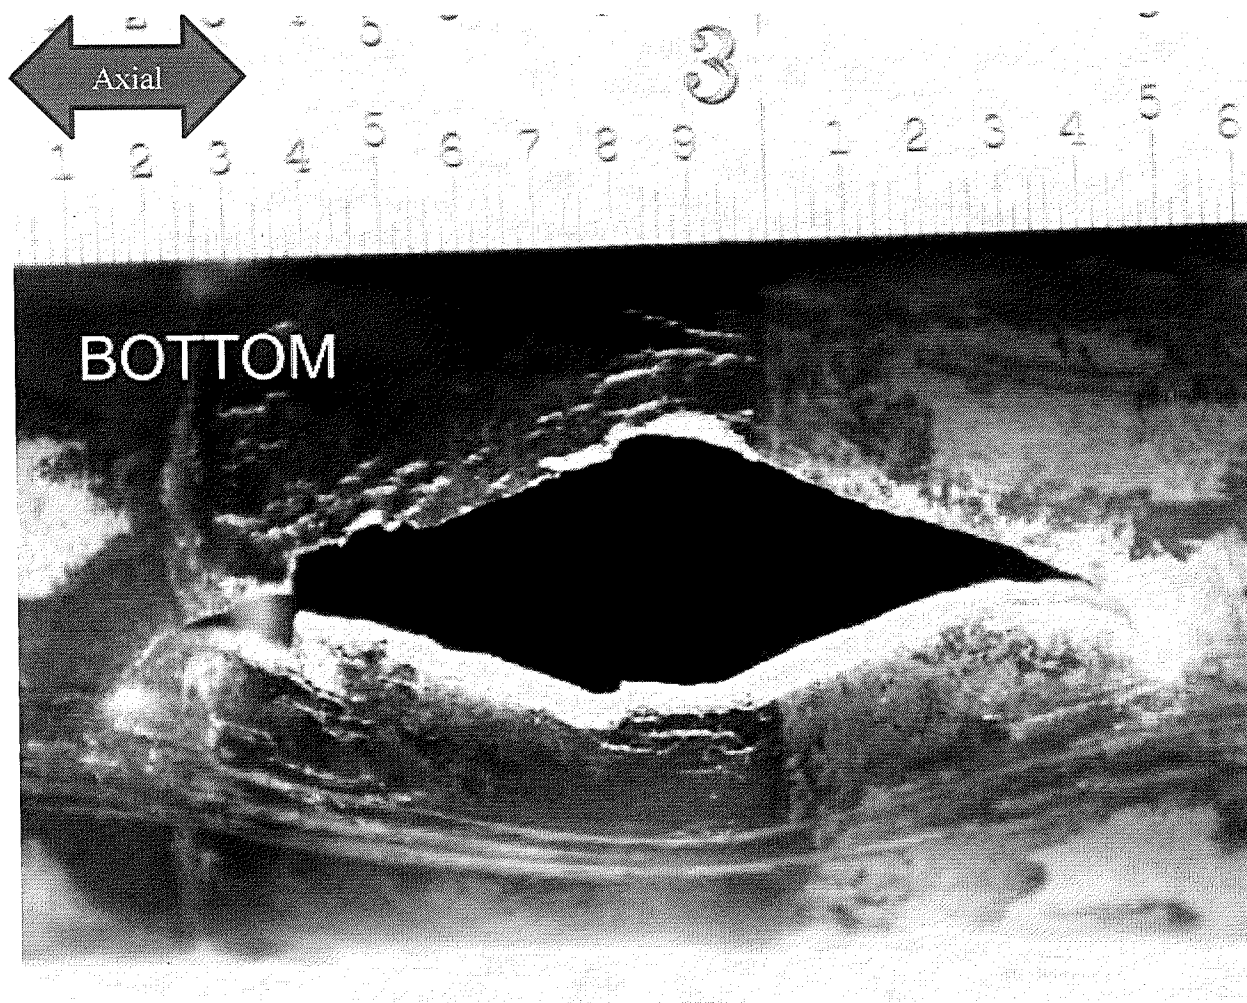
The 02H TSP region of tube R19C38 burst in the TSP region. The center of the burst was skewed about 0.2 inches above the TSP centerline and the burst opening extended above and below the TSP region. The burst occurred at the 350° orientation. There were several regions of short (<0.15 inch) axial cracks around the circumference, most of which were located near the burst opening. These are shown in the Figure 4-14 diagram. Some of these short cracks can be seen near the burst opening as shown in Figure 4-8; others are shown in Figure 4-15, Figure 4-16 and Figure 4-17.

Figure 4-8: Burst Opening at R19C38-3B (02H)

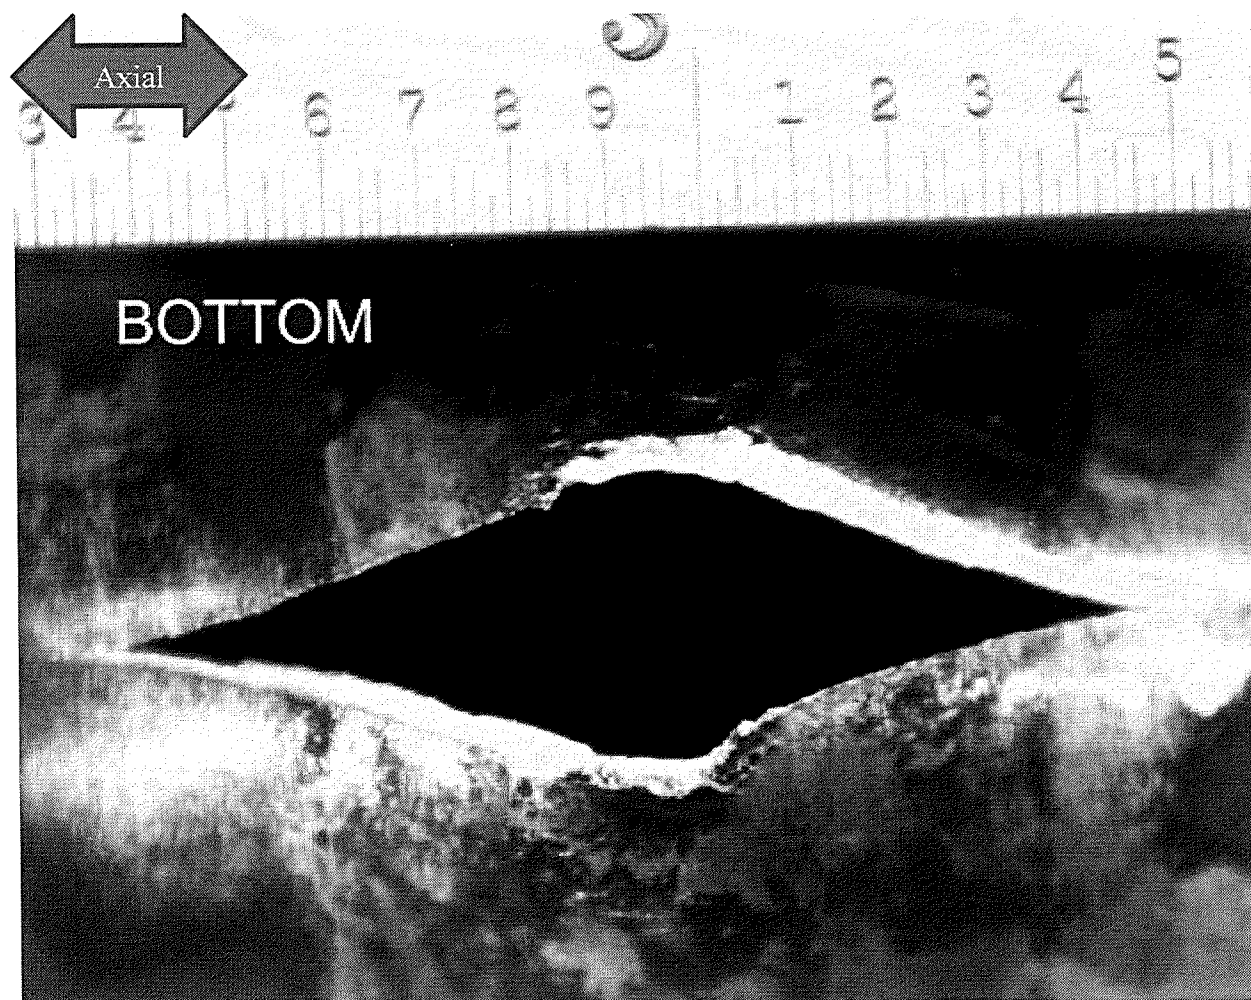
The 04H TSP region of tube R24C41 burst in the TSP region. The center of the burst was aligned with the TSP centerline and the burst opening extended above and below the TSP region. The burst occurred at the 90° orientation. There were several regions of small axial cracks around the circumference, most of which were located near the centerline of the TSP region. There was another region of larger axial cracks, located between 315° and 360°, all within the center third (0.25-inch long) portion of the TSP length. These are shown in the Figure 4-23 diagram. Figure 4-24 and Figure 4-25 show the region of the larger cracks. These cracks are significantly oriented in the axial direction. Figure 4-12 shows some cracking adjacent to the burst opening; Figure 4-26 shows a closer view of these cracks.

Figure 4-12: Burst Opening at R24C41-6B (04H)

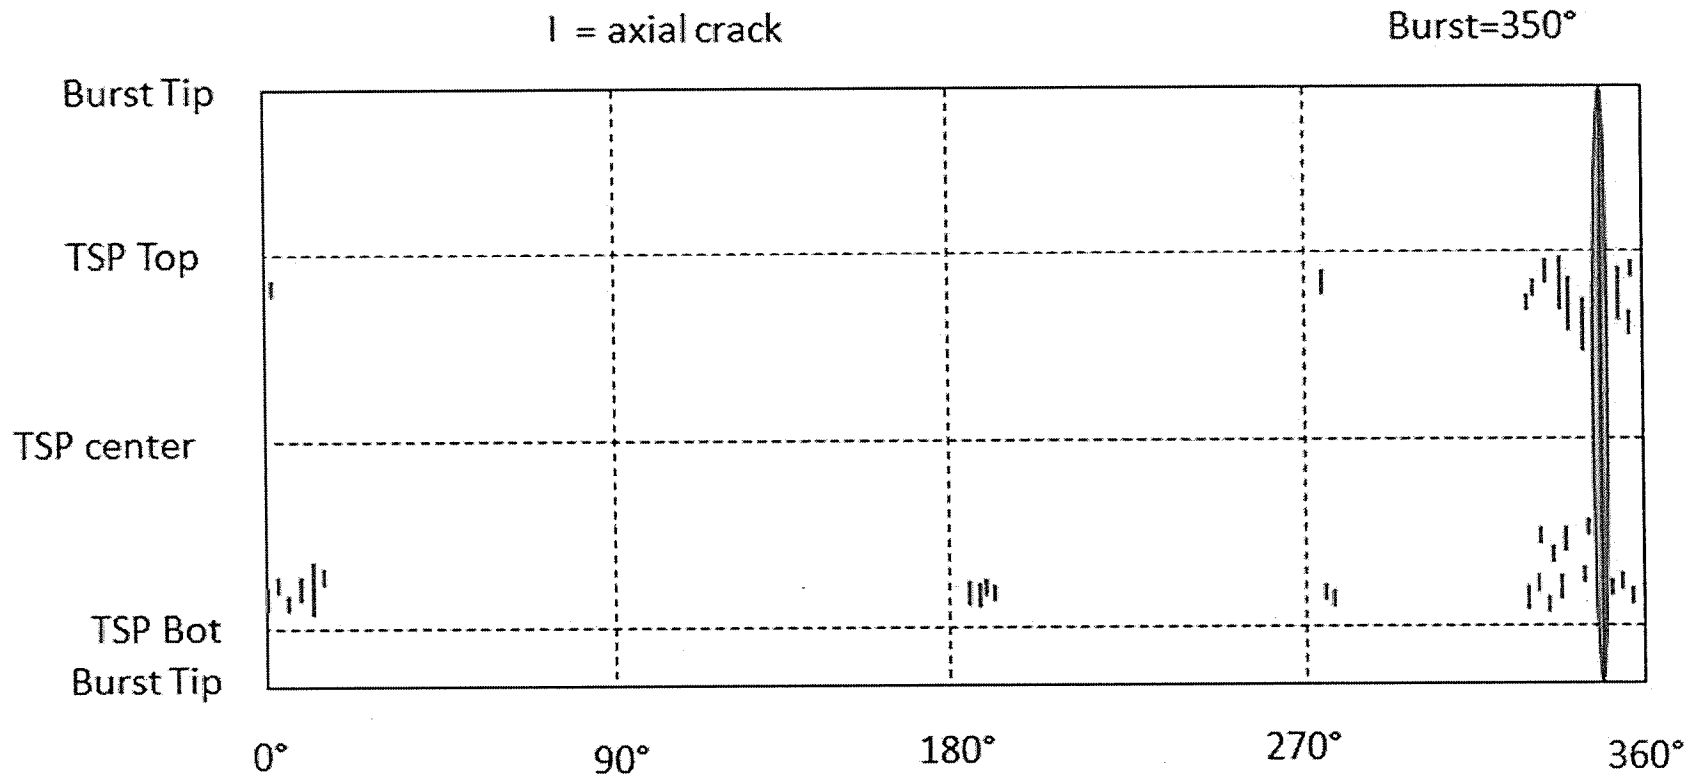
Figure 4-14: Post-Burst Observations on R19C38-3B (02H Region)

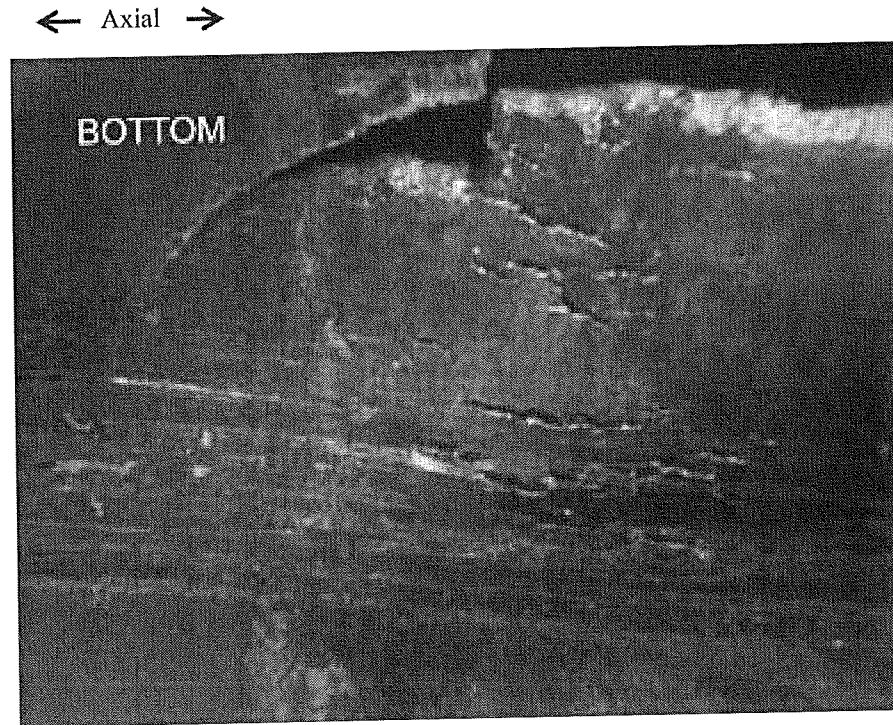
Figure 4-15: Short Cracks Near the Bottom of the 02H TSP of R19C38 (0° Orientation)

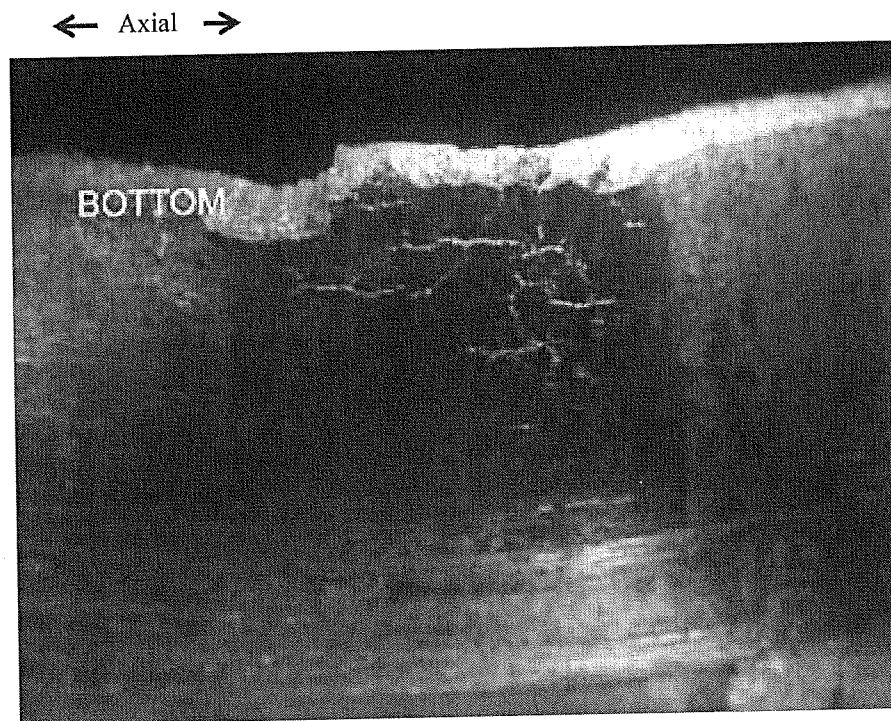
Figure 4-16: Short Cracks Near the Top of the 02H TSP of R19C38 (0° Orientation)

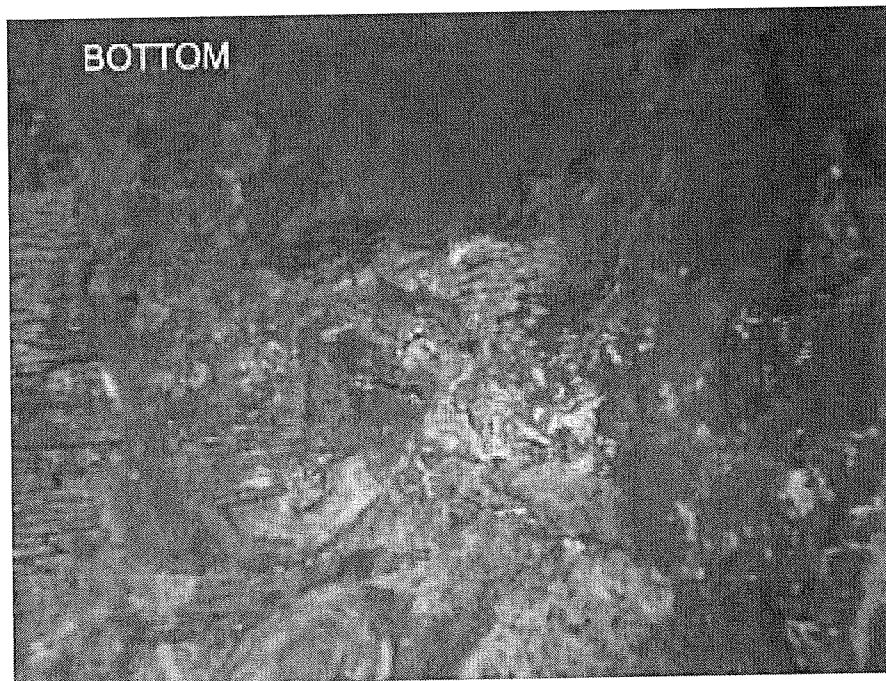
Figure 4-17: Short Cracks Near the Bottom of the 02H TSP of R19C38 (200° Orientation)

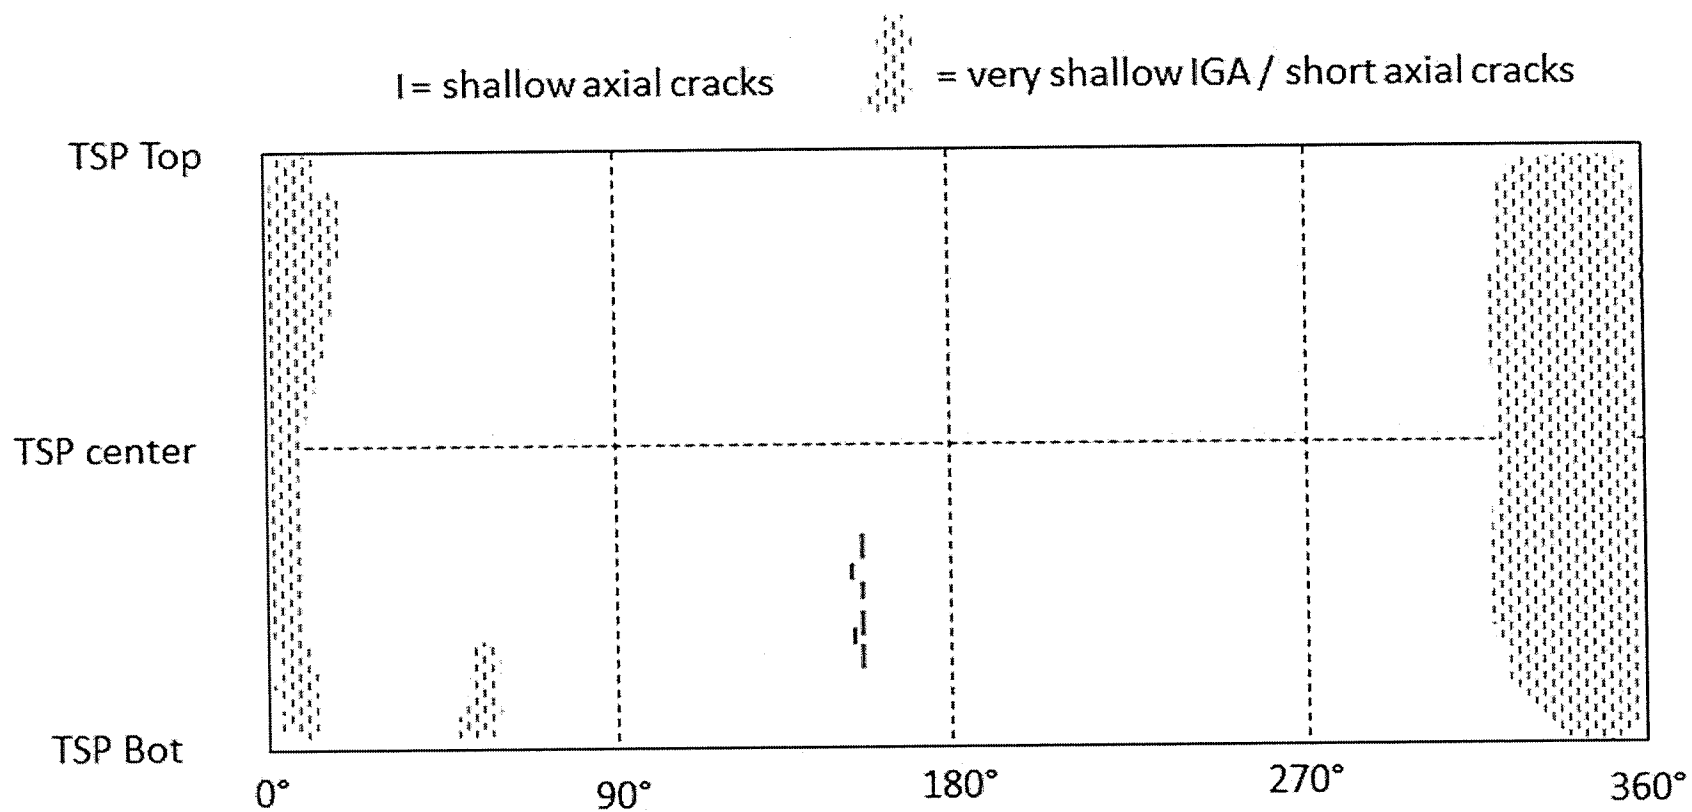
The 02H TSP region of tube R24C41 did not have a burst. There was a region of marginally-discernable (shallow) corrosion that was partially obscured by surface deposits, and was either a patch of short axial cracks or IGA. It also had another region with shallow corrosion that was discernable as axial cracks. These are shown in the Figure 4-18 diagram and in the Figure 4-19 photo.

Figure 4-18: Post-Burst Observations on R24C41-3B (02H Region)

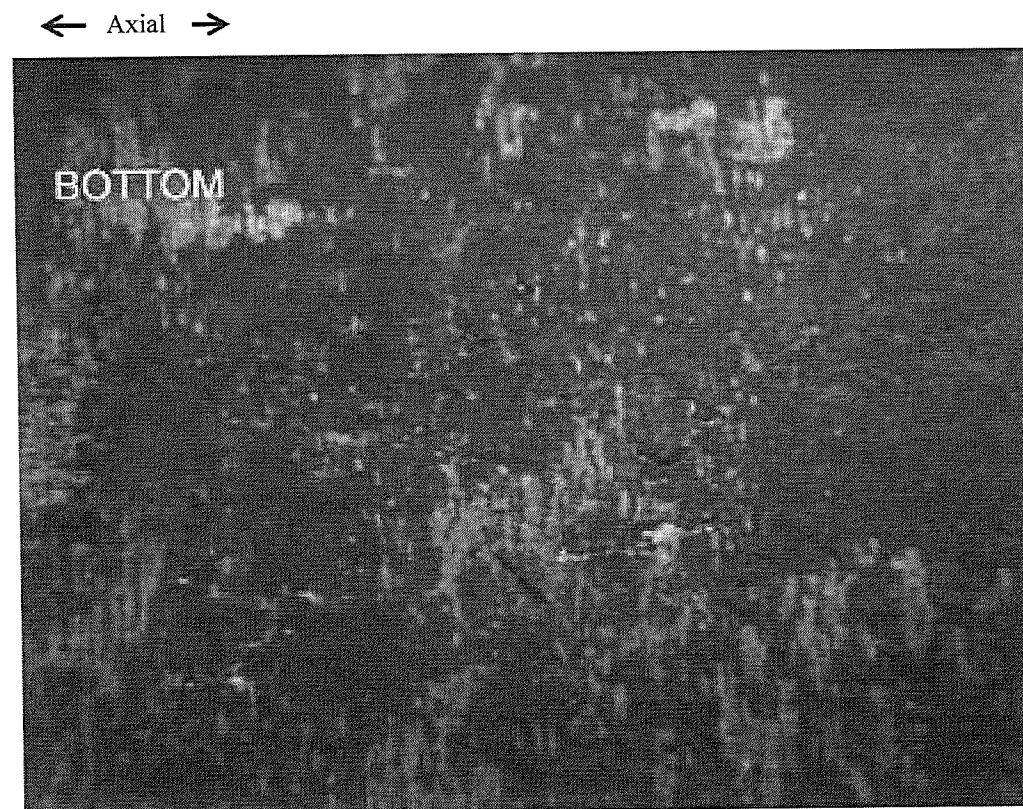
Figure 4-19: Shallow Corrosion Partially Obscured by Surface Deposits, Near the 0° Orientation of R24C41 02H

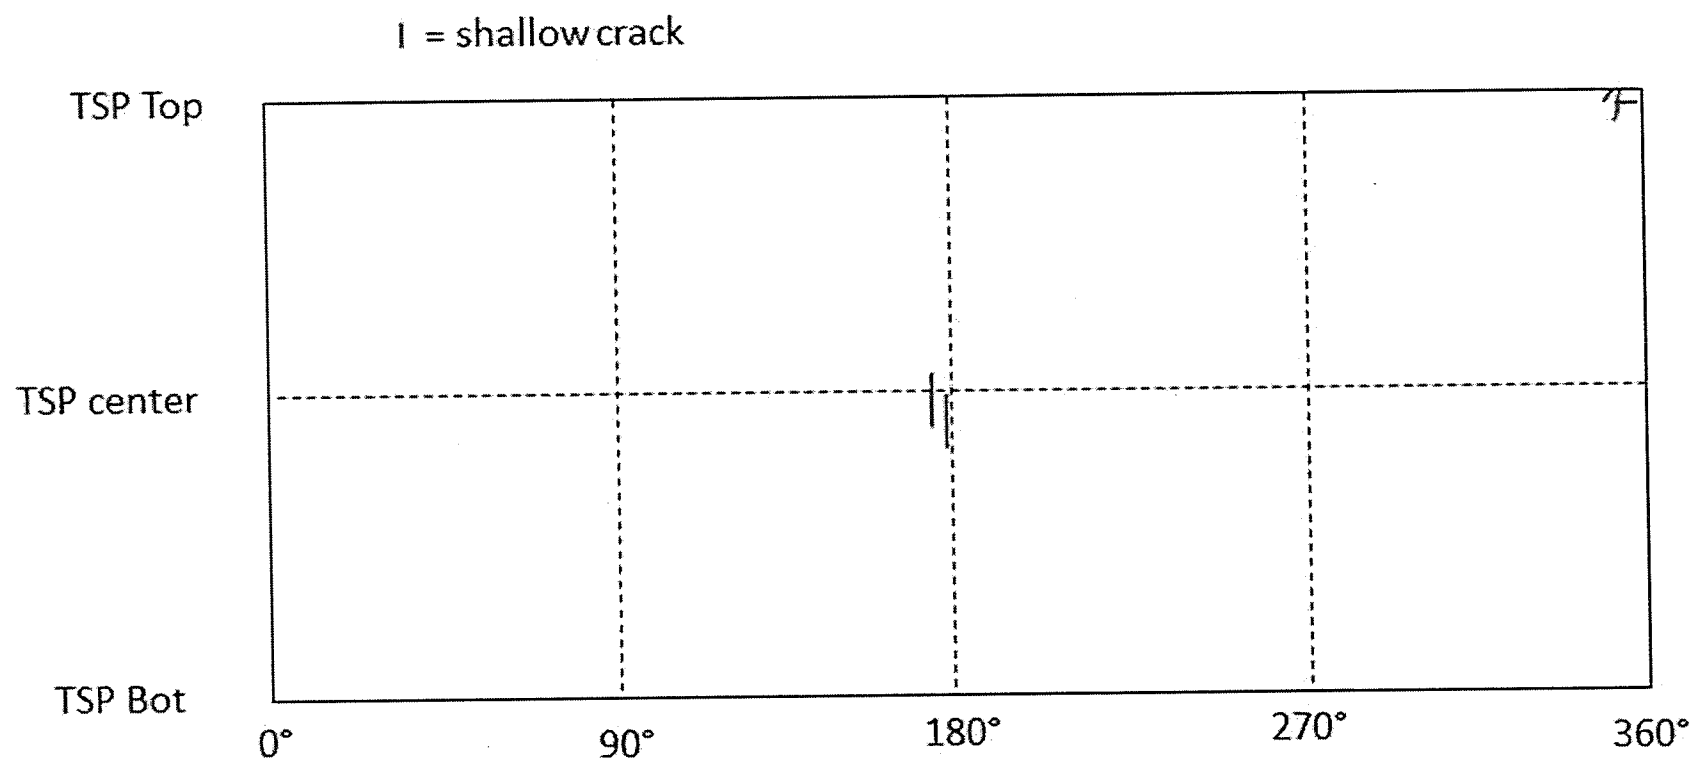
The 03H TSP region of tube R24C41 did not have a burst. There were two regions with shallow cracks. These are shown in the Figure 4-20 diagram. The photo in Figure 4-21 shows the shallow axial cracks located near the 180° orientation, as indicated by the two arrows. Figure 4-22 shows the shallow cracks at the top of the TSP region near the 0° orientation. These cracks are neither axial nor circumferential, which may be attributable to their short length and shallow depth.

Figure 4-20: Post-Burst Observations on R24C41-5B (03H Region)

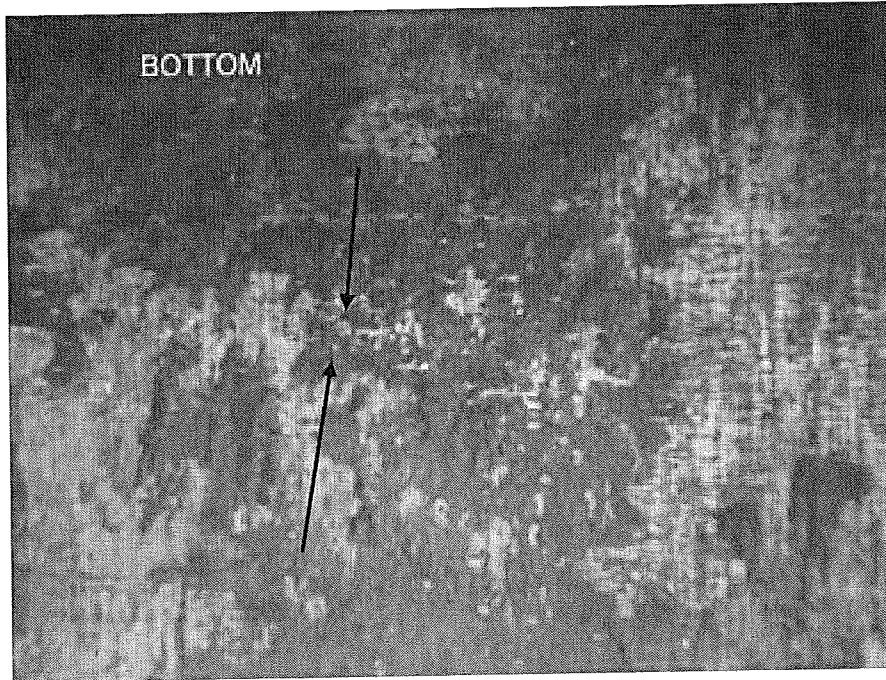
Figure 4-21: Shallow Axial Cracks (Marked with Arrows) Near Center of R24C41 03H TSP Region (180° Orientation)

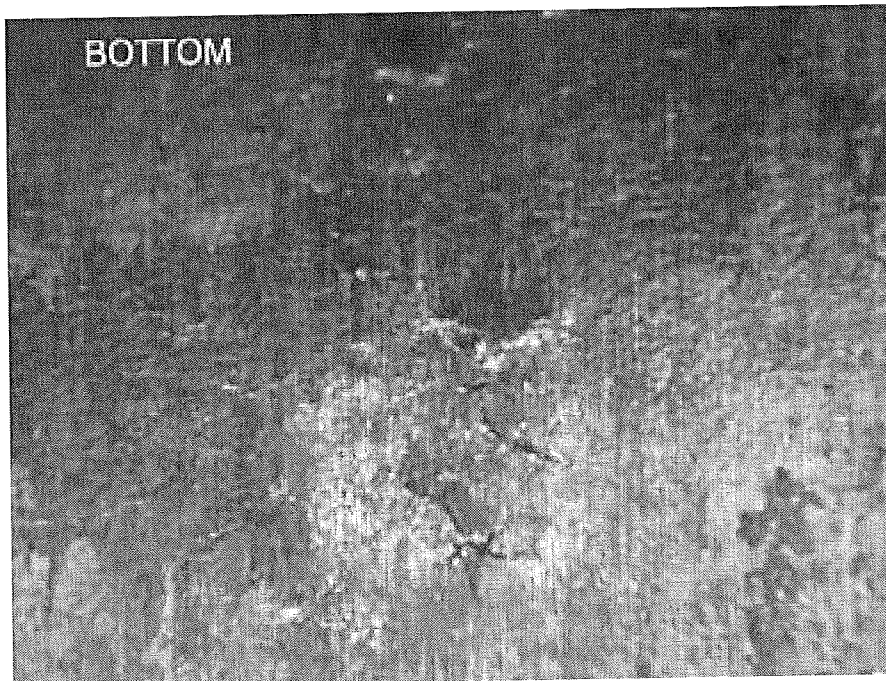
Figure 4-22: Shallow Non-axial Cracks at Top of R24C41 03H TSP Region (0° Orientation)

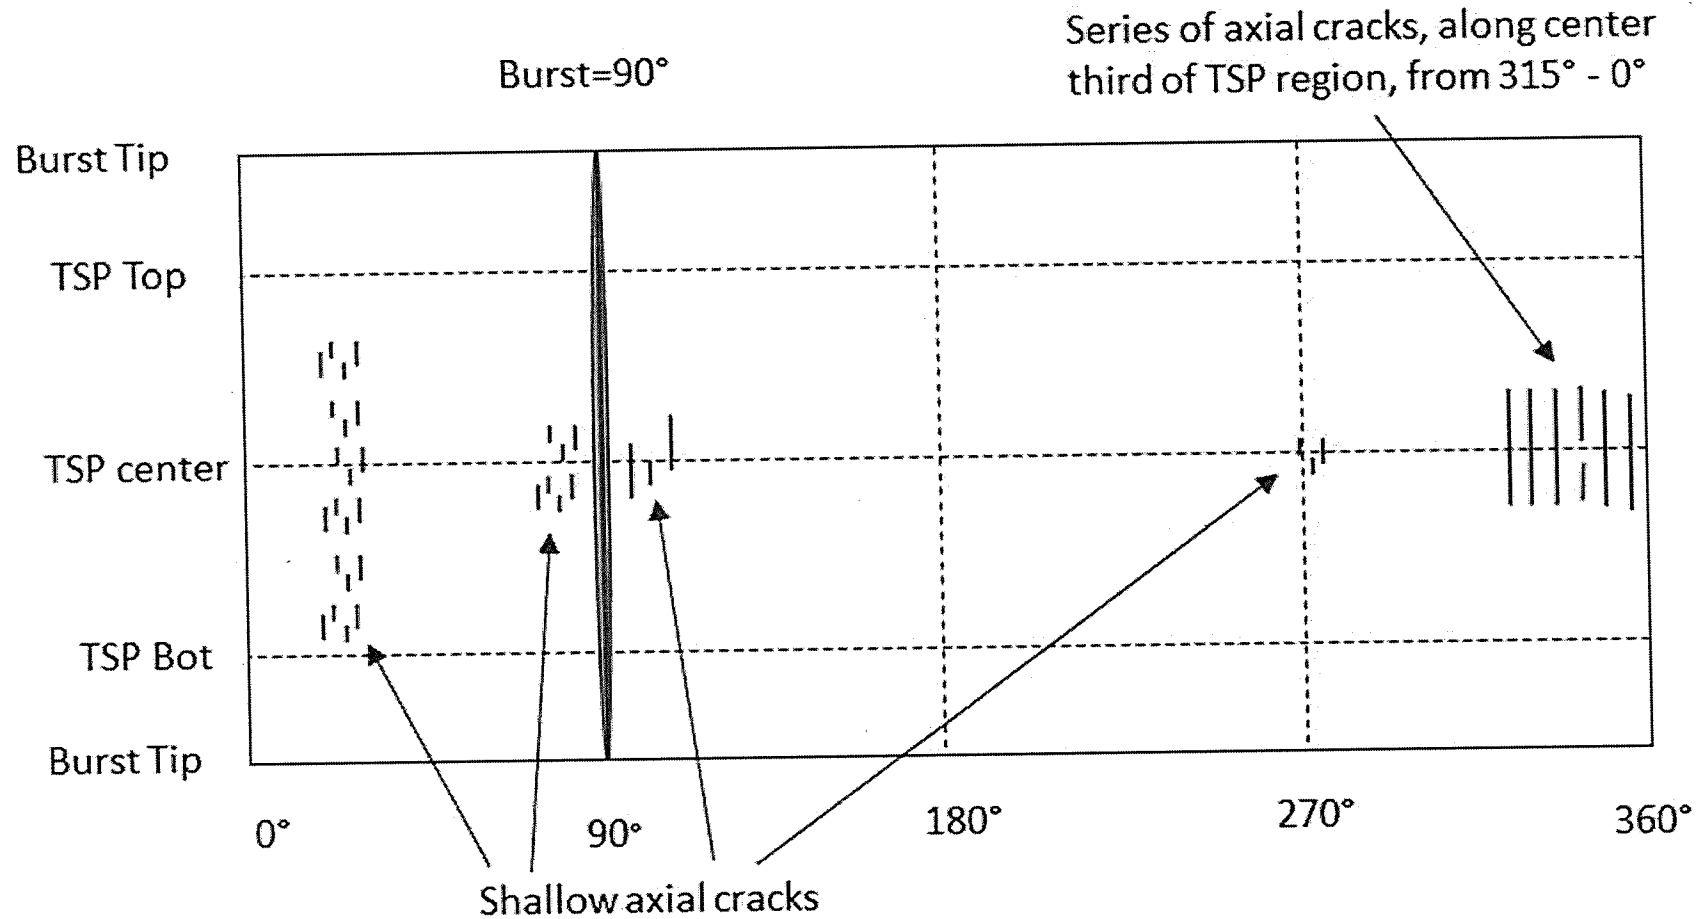
Figure 4-23: Post-Burst Observations on R24C41-6B (04H Region)

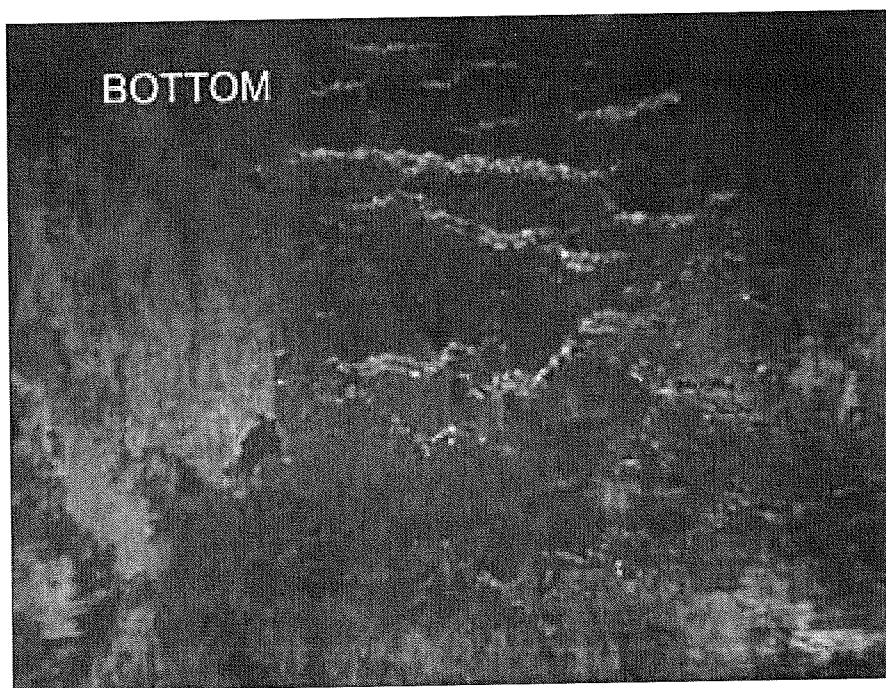
Figure 4-24: Larger Axial Cracks Near the Centerline of R24C41 04H TSP Region, Between 335°-360°

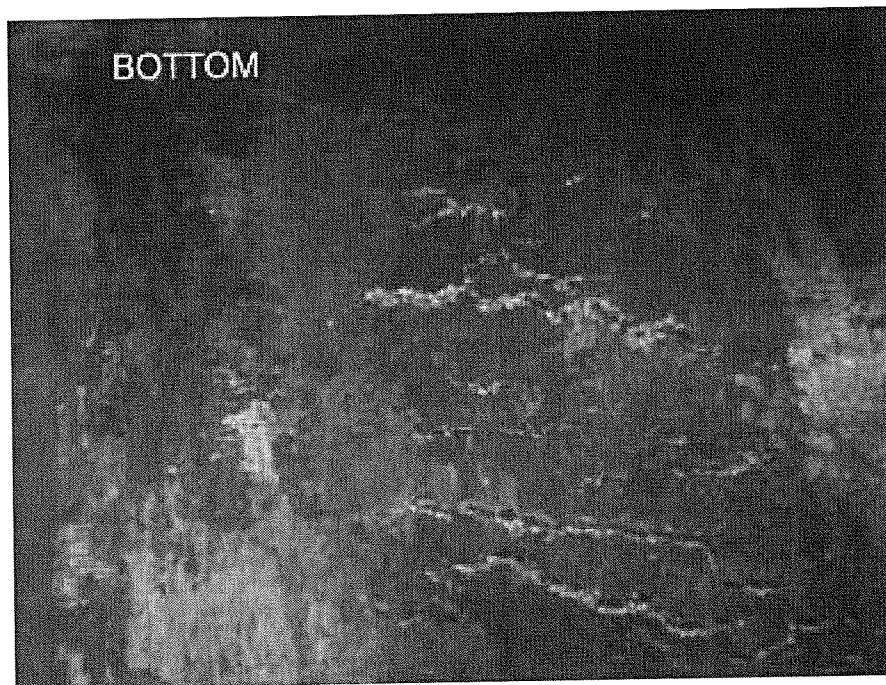
Figure 4-25: Larger Axial Cracks Near the Centerline of R24C41 04H TSP Region, Between 315°-340°

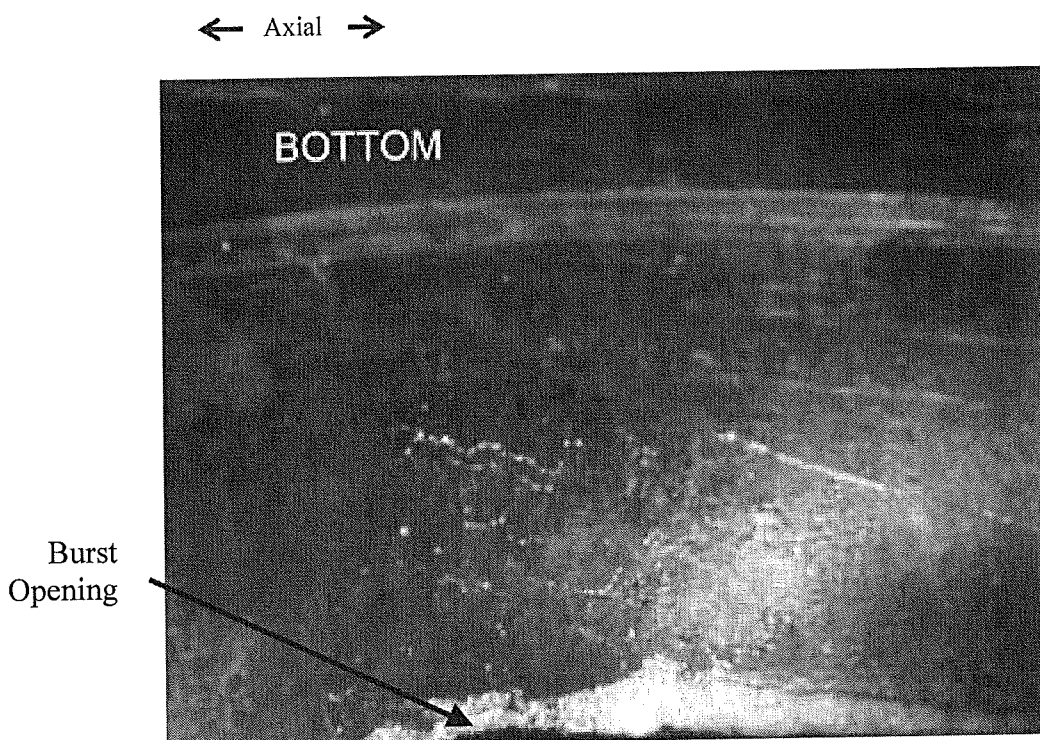
Figure 4-26: Example of Shallow Cracks Located Adjacent to the Burst Opening Of R24C41-6B (04H) at the 90° Orientation

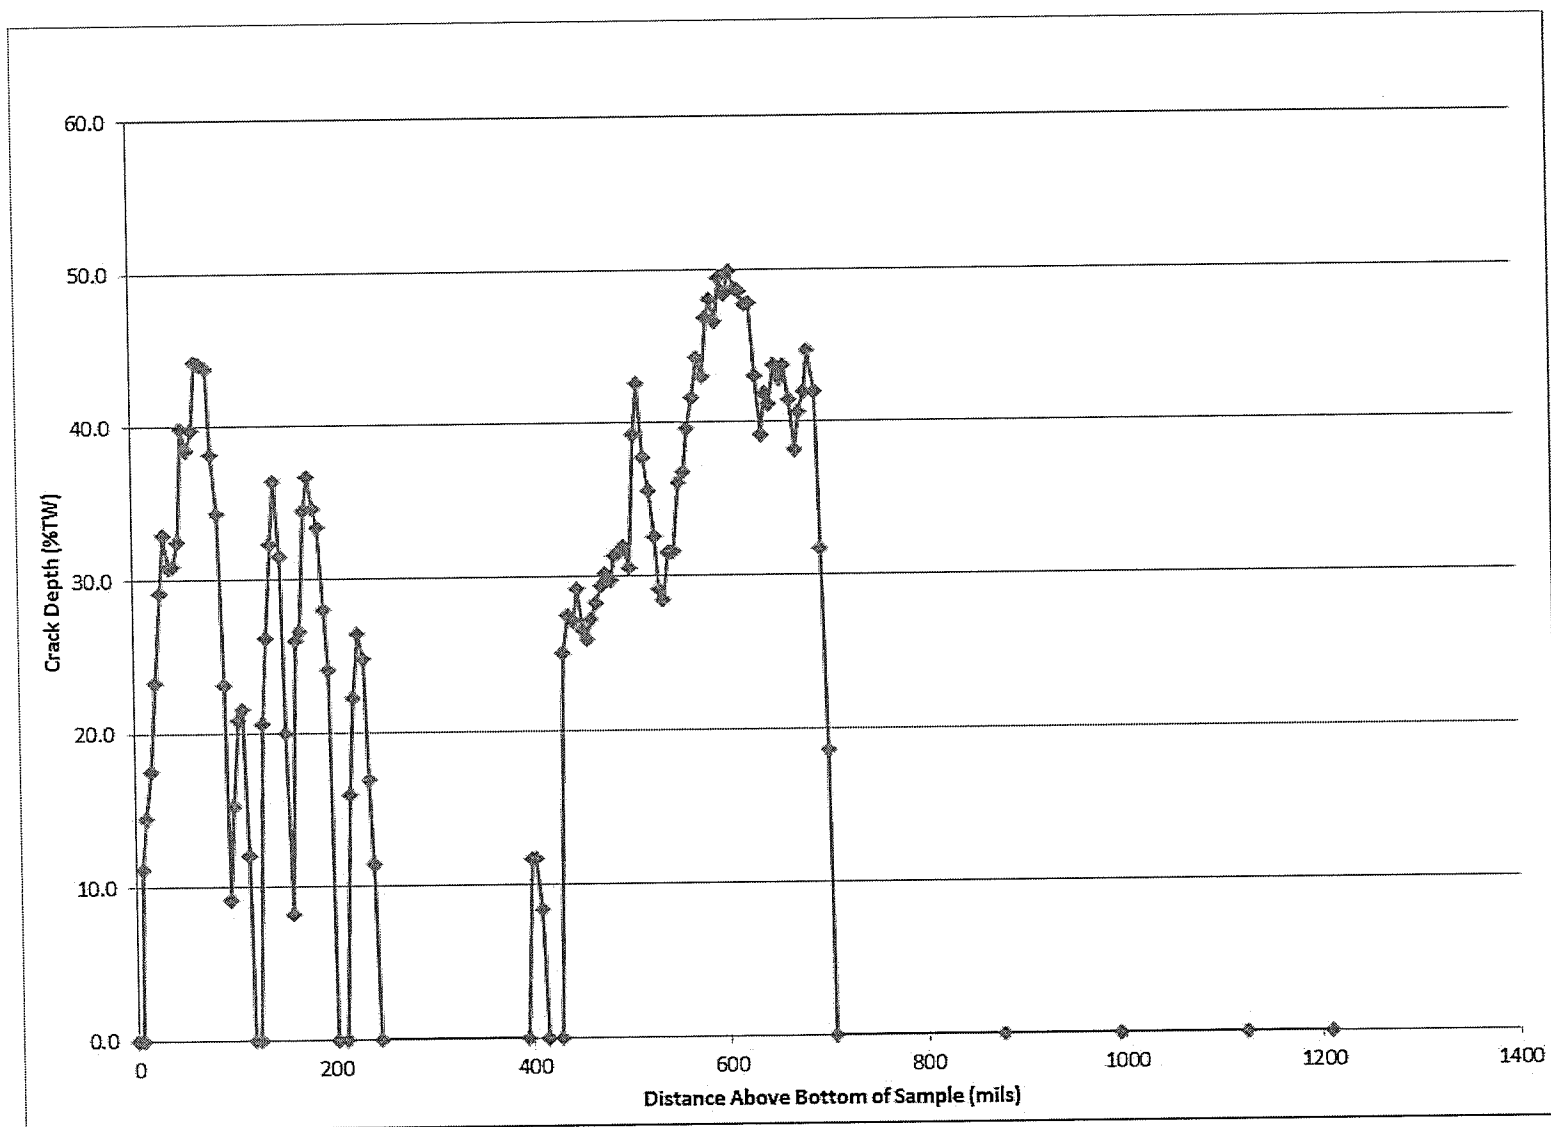
Table 6-1 provides a summary of the depth profiles for the burst openings. R19C38-3B (02H) had the deepest corrosion, at 49.9%TW. The burst opening of R24C41-6B (04H) had a maximum depth of corrosion of 48.6%TW.

Figure 6-3: R19C38-3B (02H) Burst Opening Depth Profile

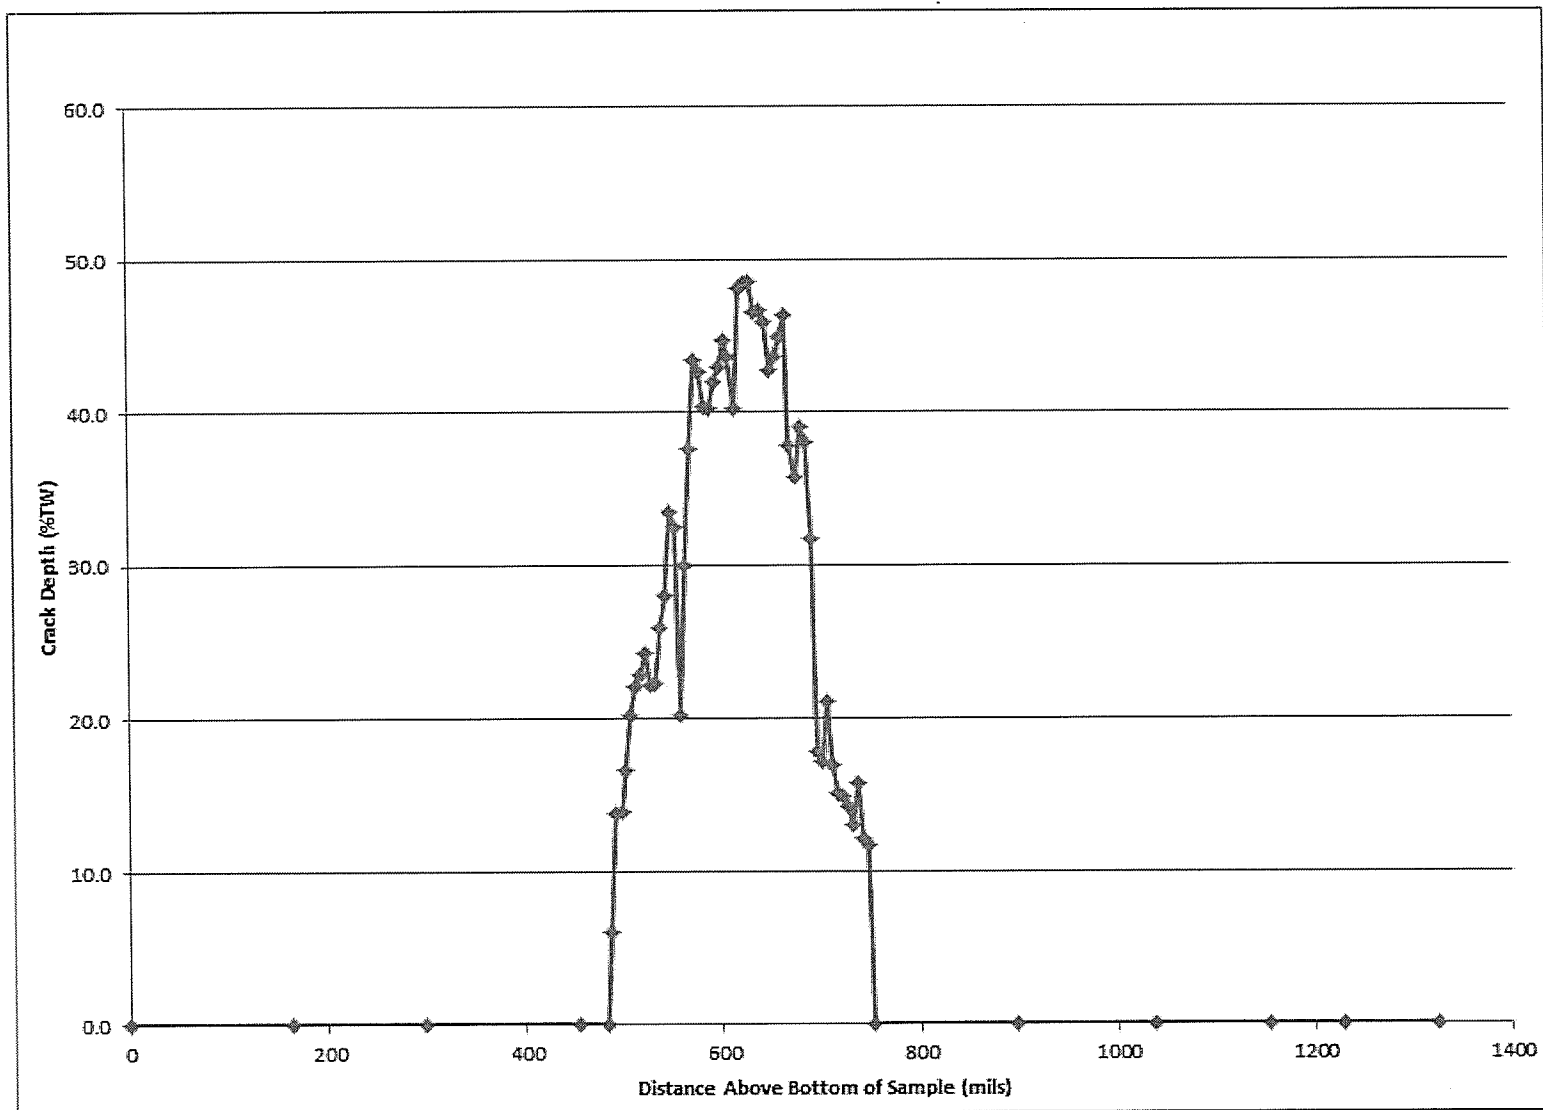
Figure 6-4: R24C41-6B (04H) Burst Opening Depth Profile

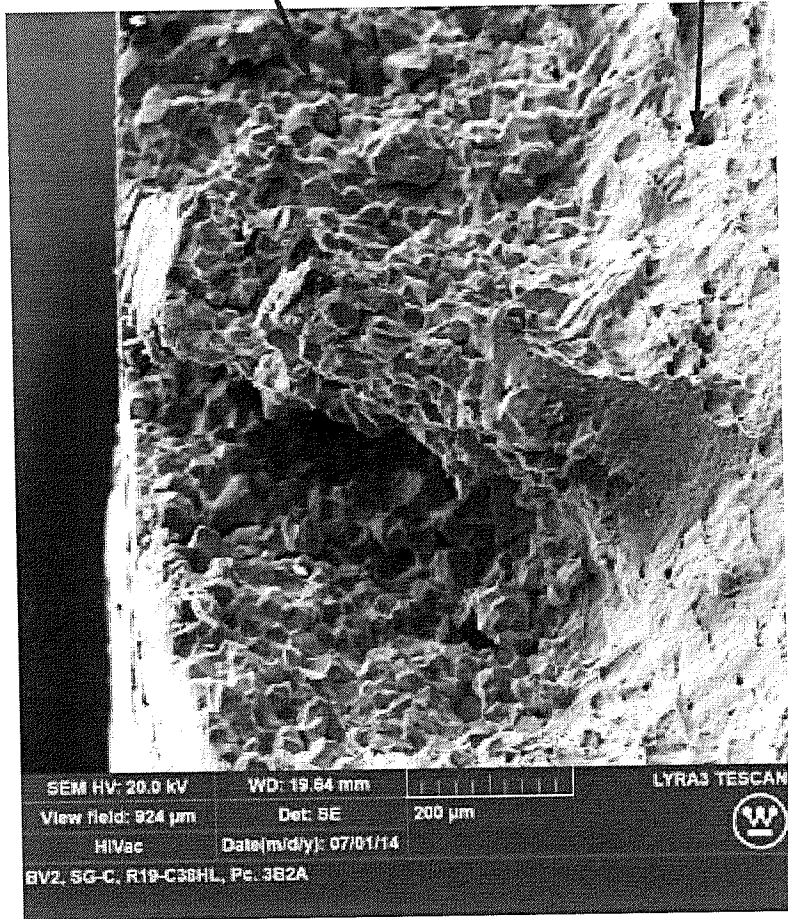
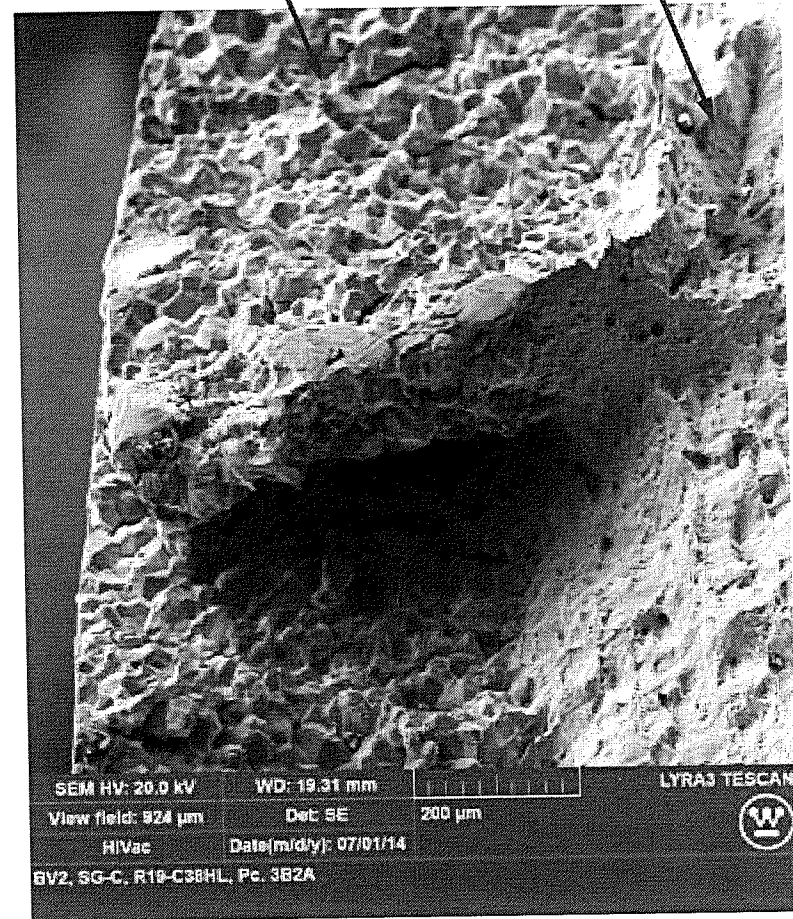
Figure 6-5 presents an example of the crack surface of the R19C38-3B burst opening. The surfaces having the rock candy appearance is intergranular cracking - the part of the tube wall that occurred during in-service operation. The dimpled surface is ductile tearing - the part of the tube wall that failed during the burst test. Figure 6-6 presents another region of the fracture surface with intergranular cracking. These surfaces are typical of the burst opening.

Figure 6-5: Example of R19C38-3B Burst Opening Fracture Surface (Near Top End of Crack)

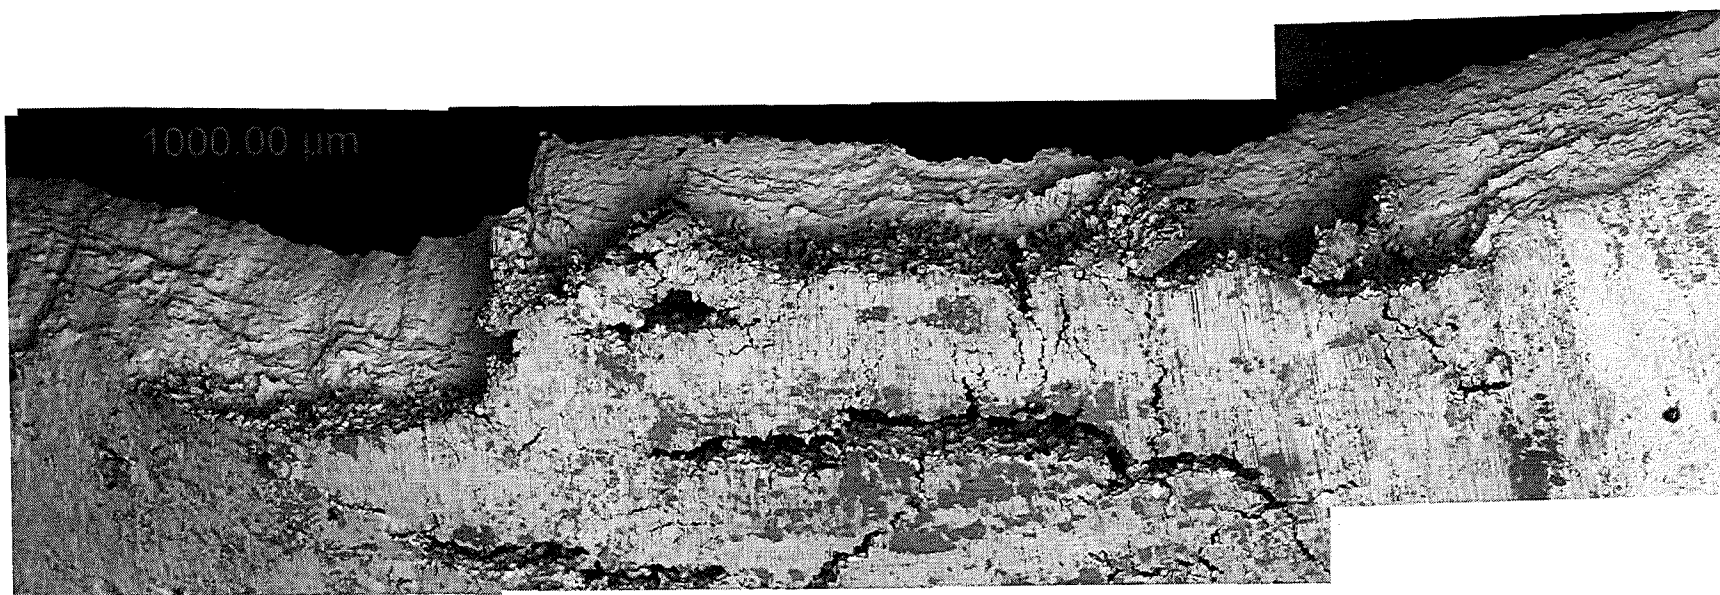
Figure 6-7 shows the OD surface of R19C38 02H near the burst opening. In this view, the axial direction is horizontal. This fractograph montage shows several secondary axial cracks with some minor branching and a small patch of intergranular attack (IGA). All of the secondary cracks are intergranular. This surface is typical of axial OD initiated stress corrosion cracking (ODSCC).

Figure 6-7: OD Surface of R19C38 02H, Adjacent to Burst Opening (Axial Direction is Horizontal)

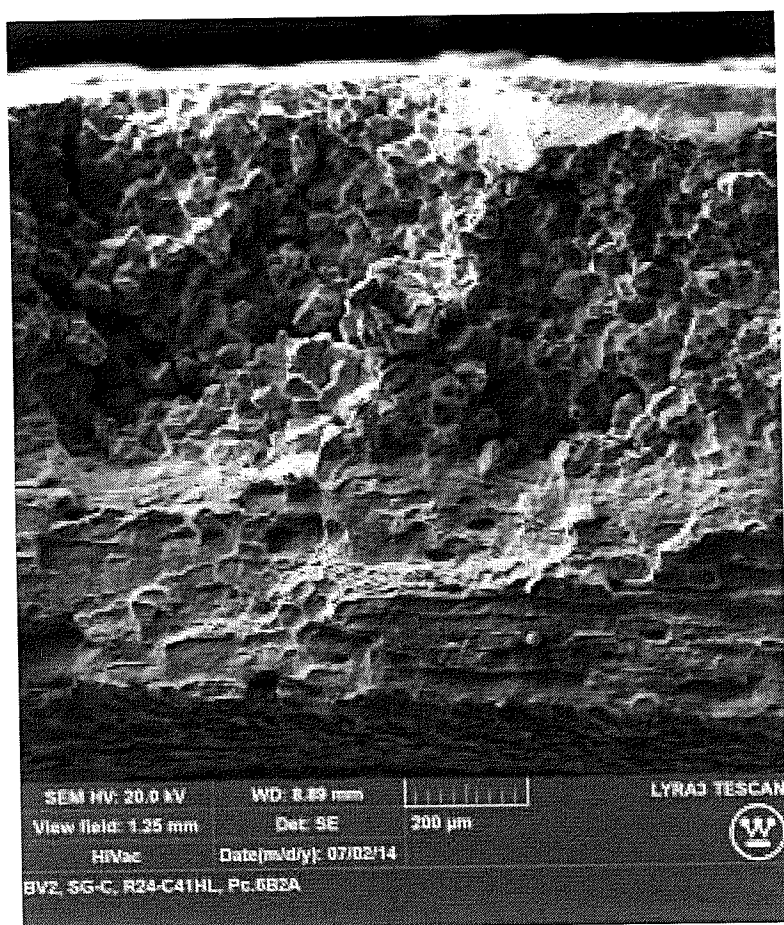
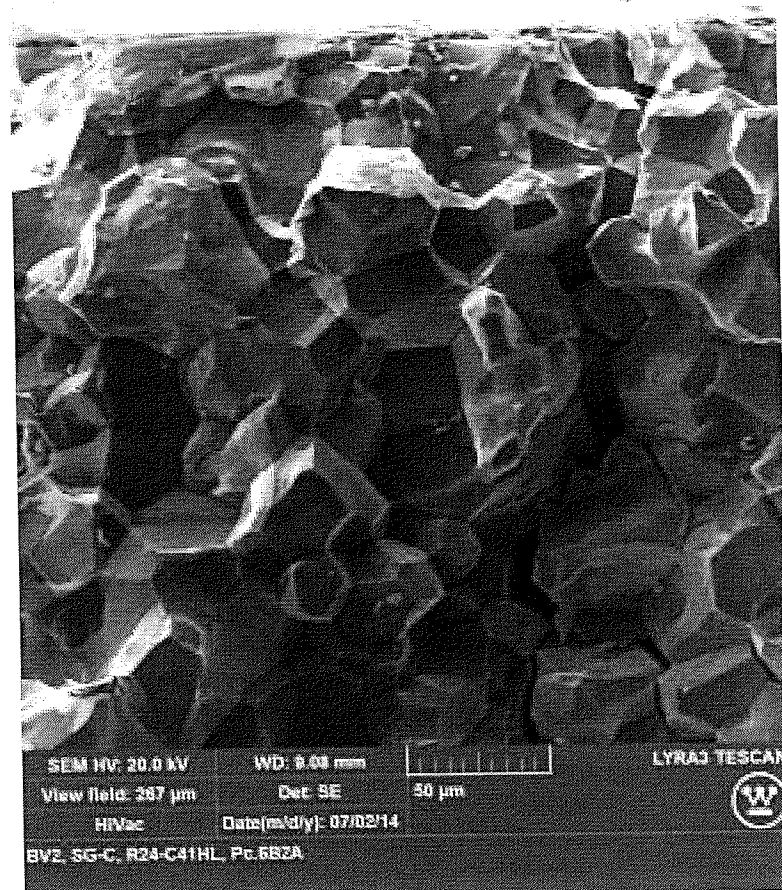
Figure 6-8 shows an area on the crack surface of the R24C41-6B burst opening. The fracture surface consists of intergranular cracking (the rock candy topography) and ductile tearing. The figure shows a higher magnification view of the intergranular fracture surface. This example is typical of the burst opening fracture surface.

Figure 6-8: Example of R24C41-6B Burst Opening Fracture Surface
