Generic Letter 95-05 Tube Intersection Burst Test, Leakage Test, and Morphology  
Conclusions  
(87 Pages Follow)

# **Interim Report: Examination of Steam Generator Tubes Removed from Beaver Valley Unit 2**

Prepared for the  
FirstEnergy Nuclear Operating Company

**SG-CCOE-14-1**  
**Revision 0**

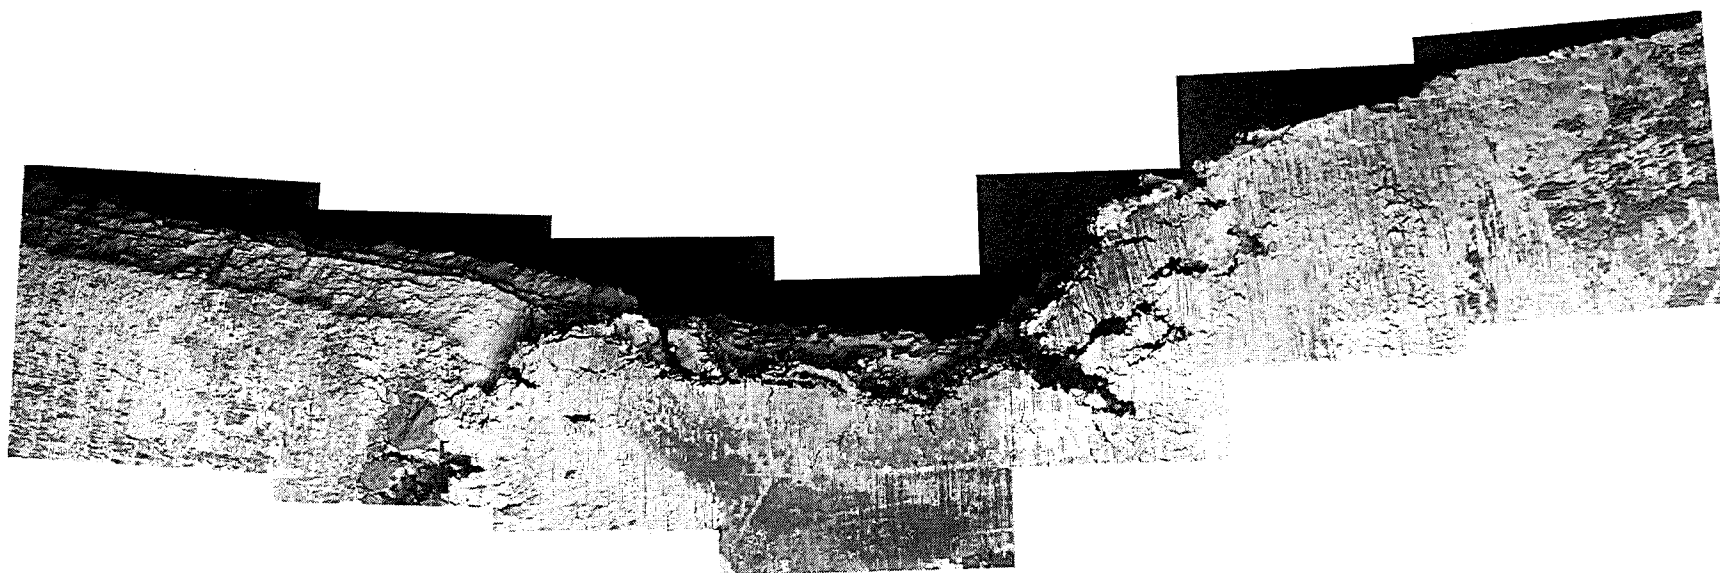
Figure 6-9 shows the OD surface of R24C41 04H near the burst opening. In this view, the axial direction is horizontal. This fractograph montage shows several secondary axial cracks and some patches of shallow intergranular attack (IGA). This surface is typical of axial ODSCC.

Figure 6-9: OD Surface of R24C41 04H, Adjacent to Burst Opening (Axial Direction is Horizontal)

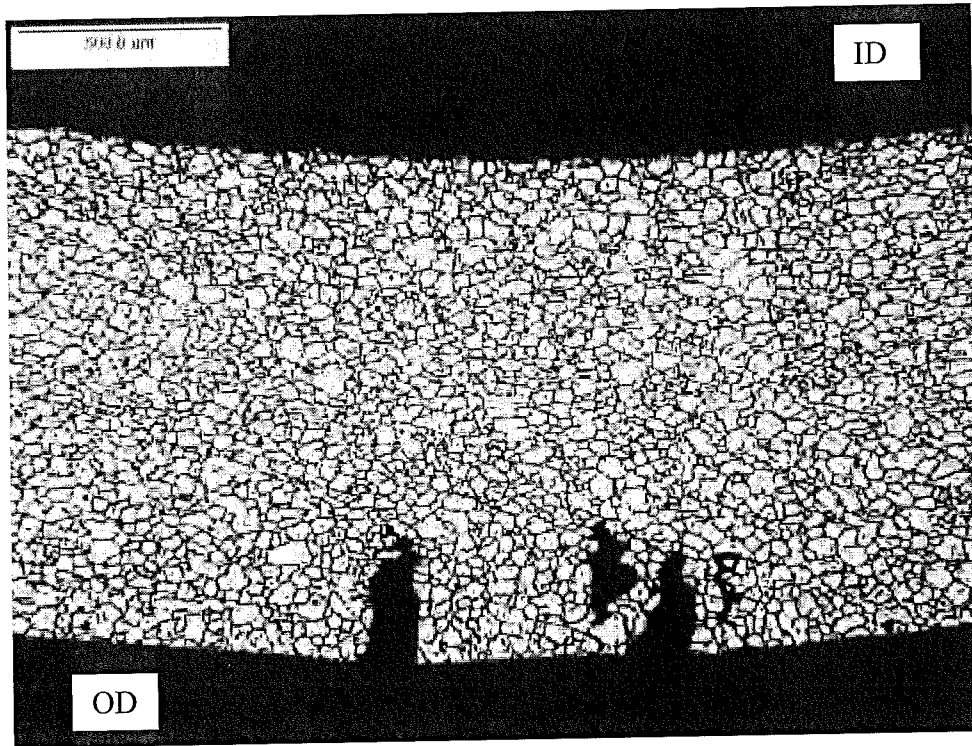
Figure 7-2: R19C38 02H Cracks at 200°

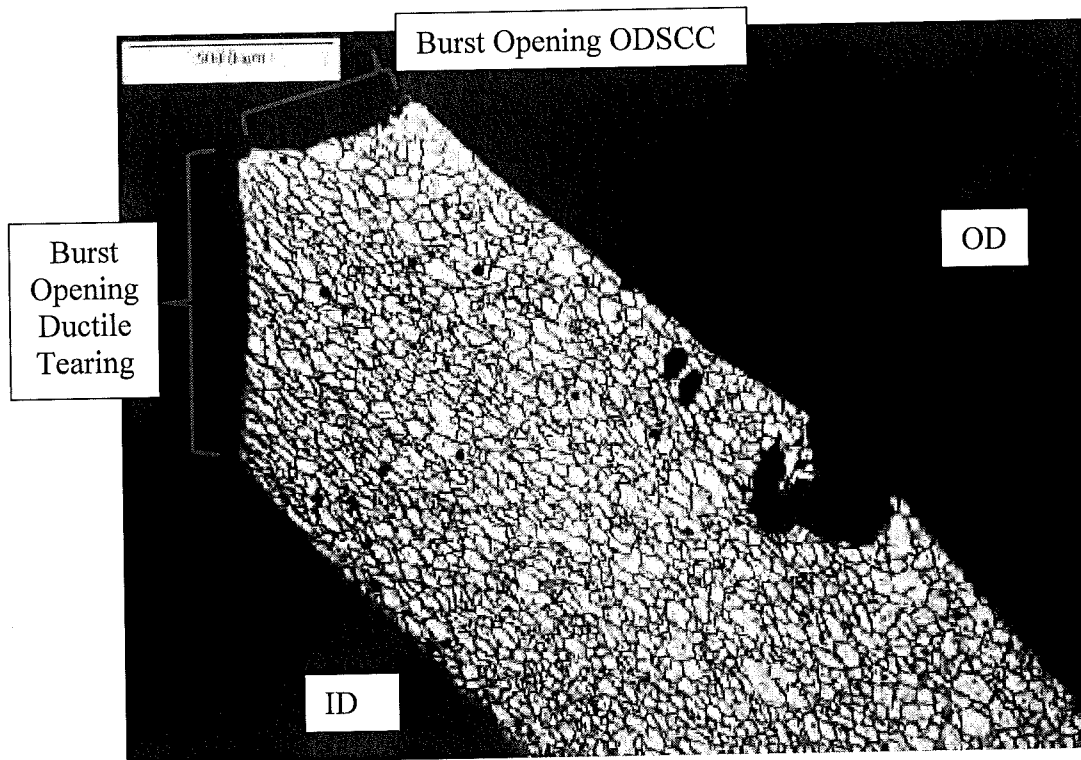
Figure 7-3: R19C38 02H Crack at 340°

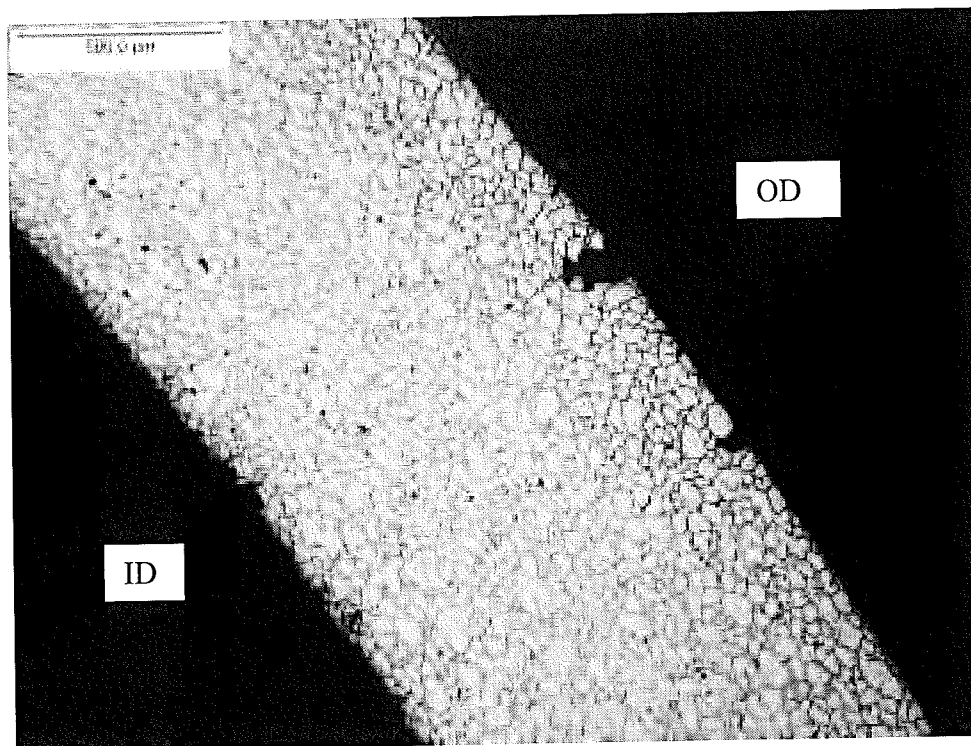
Figure 7-5: R24C41 02H Cracks at 20°

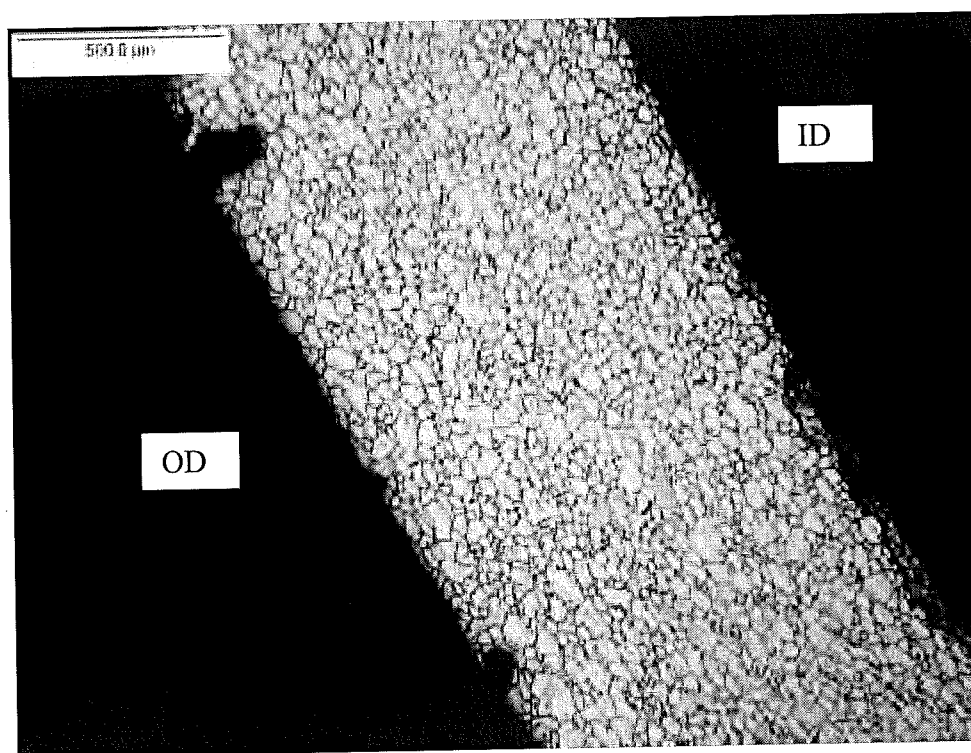
Figure 7-6: R24C41 02H Cracks at 160°

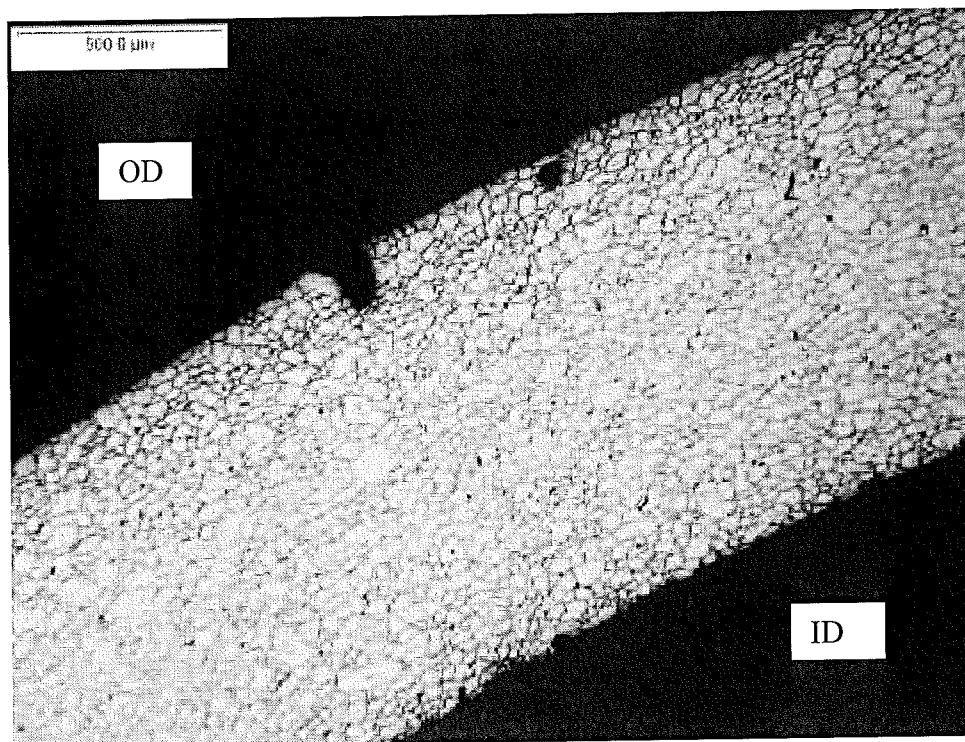
Figure 7-7: R24C41 02H Cracks at 340°

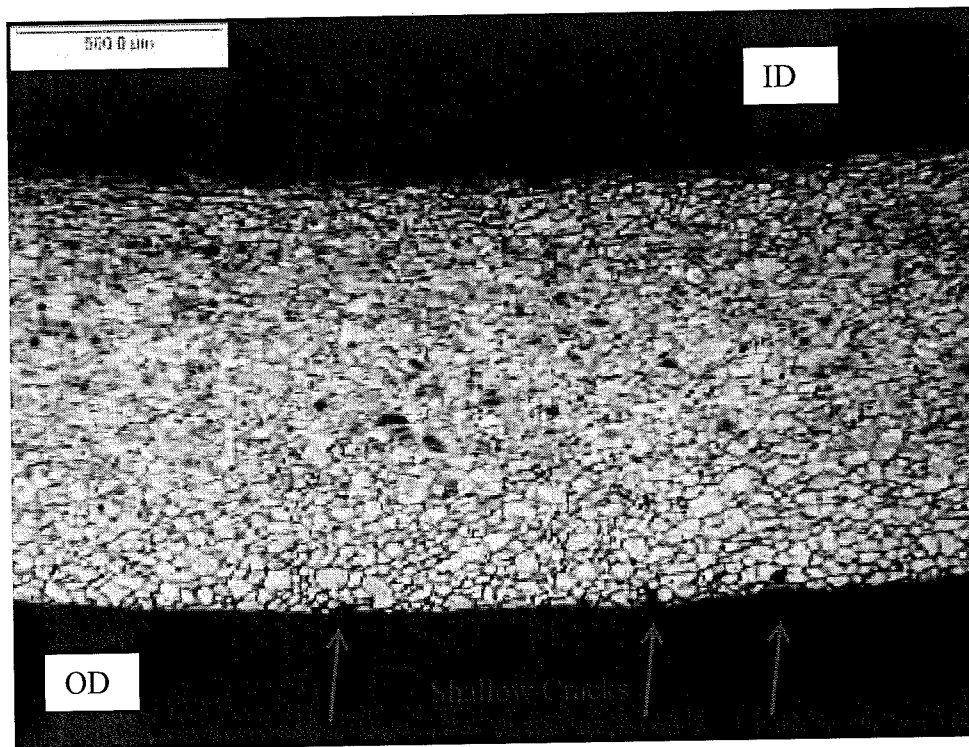
Figure 7-9: R24C41 03H Cracks at 180°

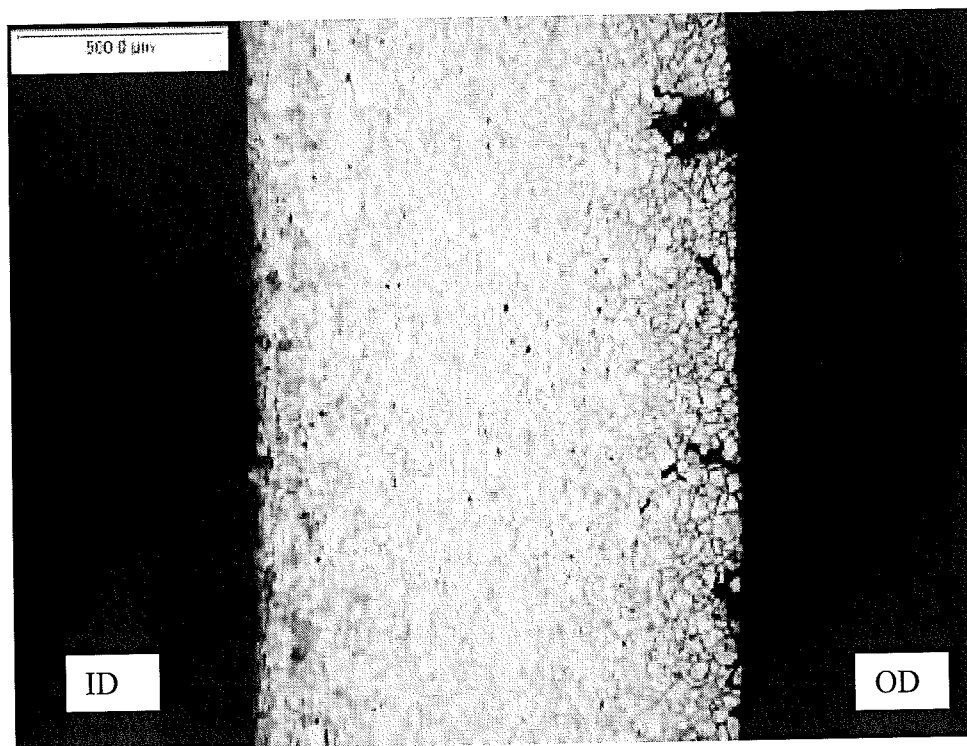
Figure 7-11: R24C41 04H Cracks at 80°

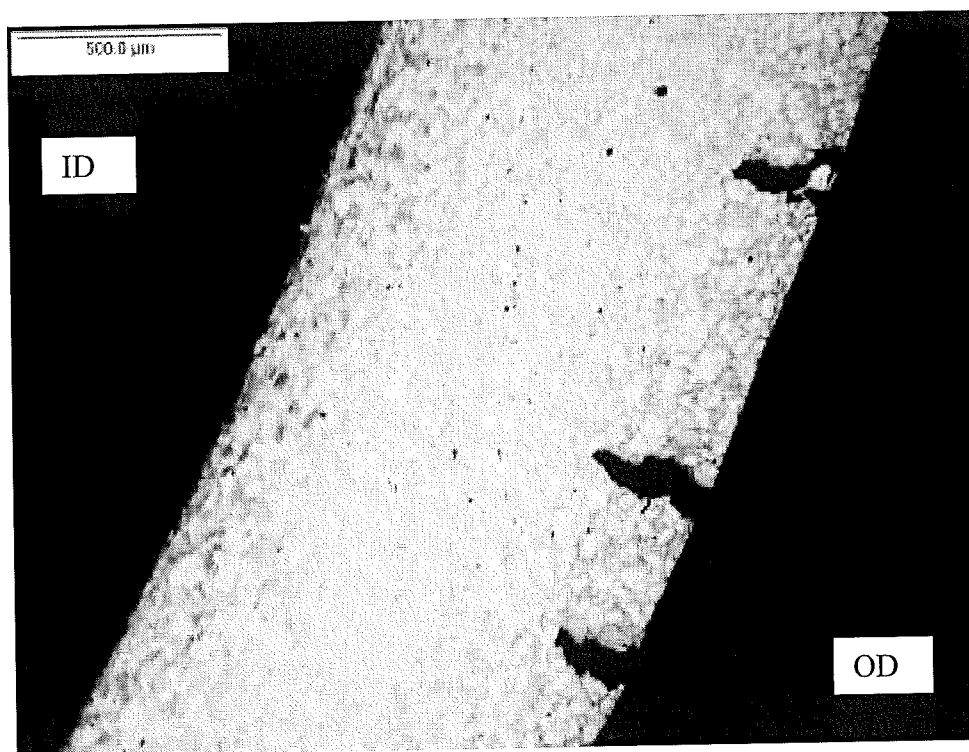
Figure 7-12: R24C41 04H Cracks at 40°

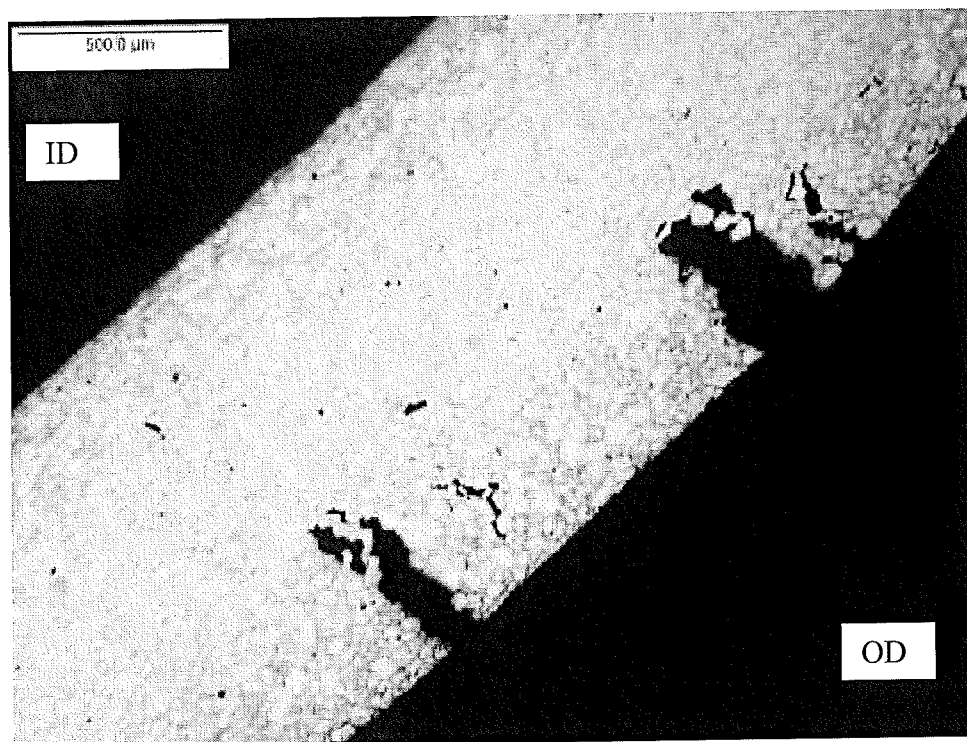
Figure 7-13: R24C41 04H Cracks at 350°

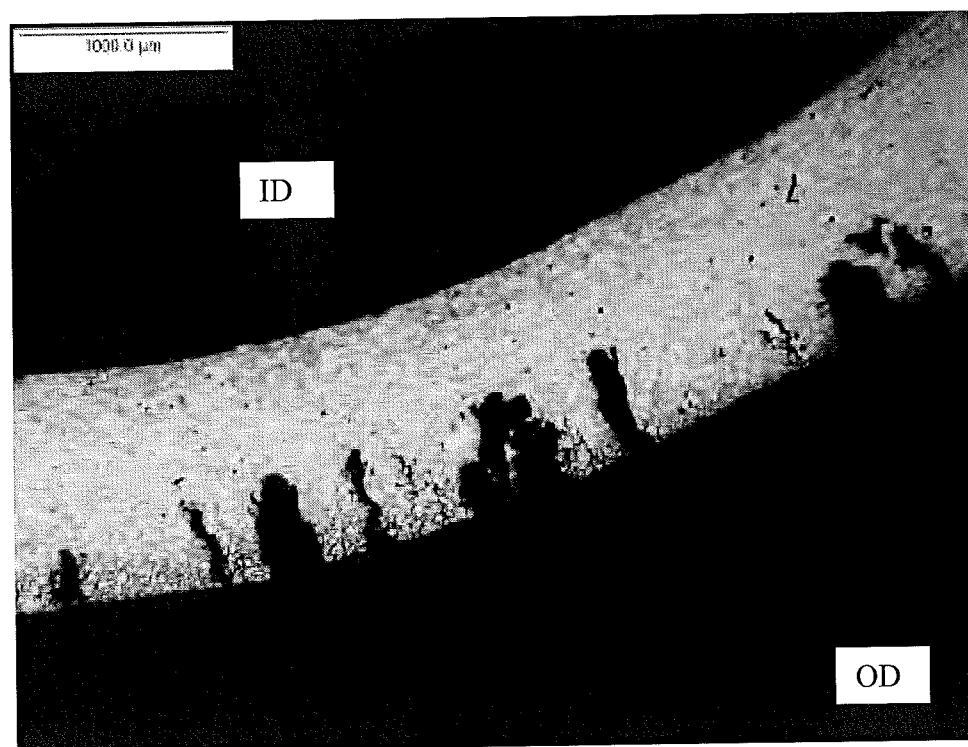
Figure 7-14: R24C41 04H Cracks at 335°

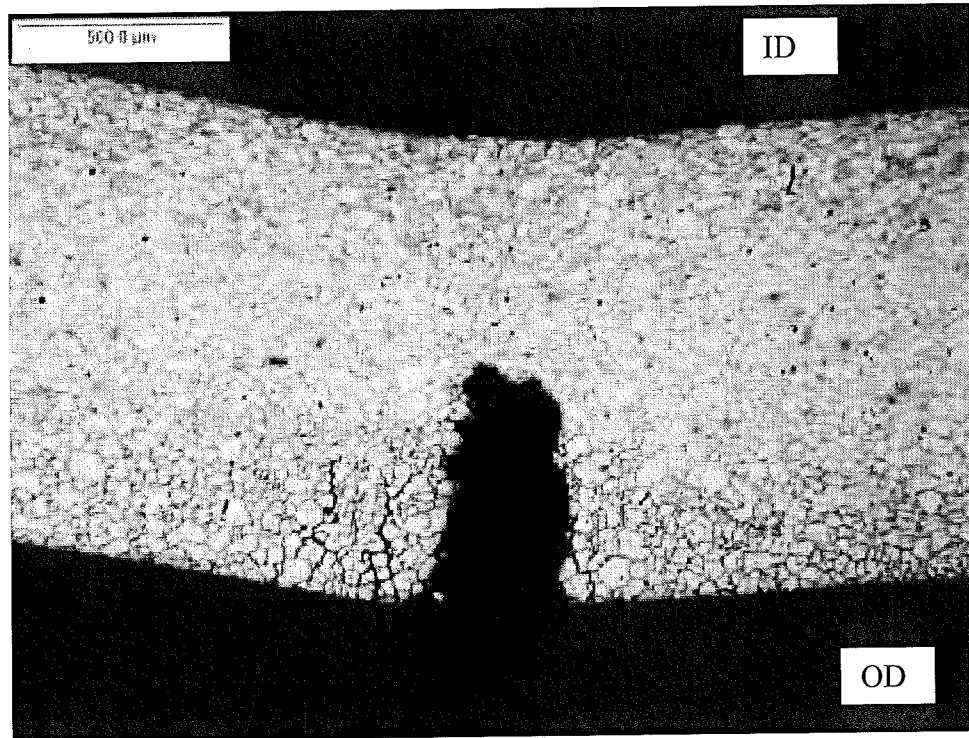
Figure 7-15: R24C41 04H Cracks at 315°

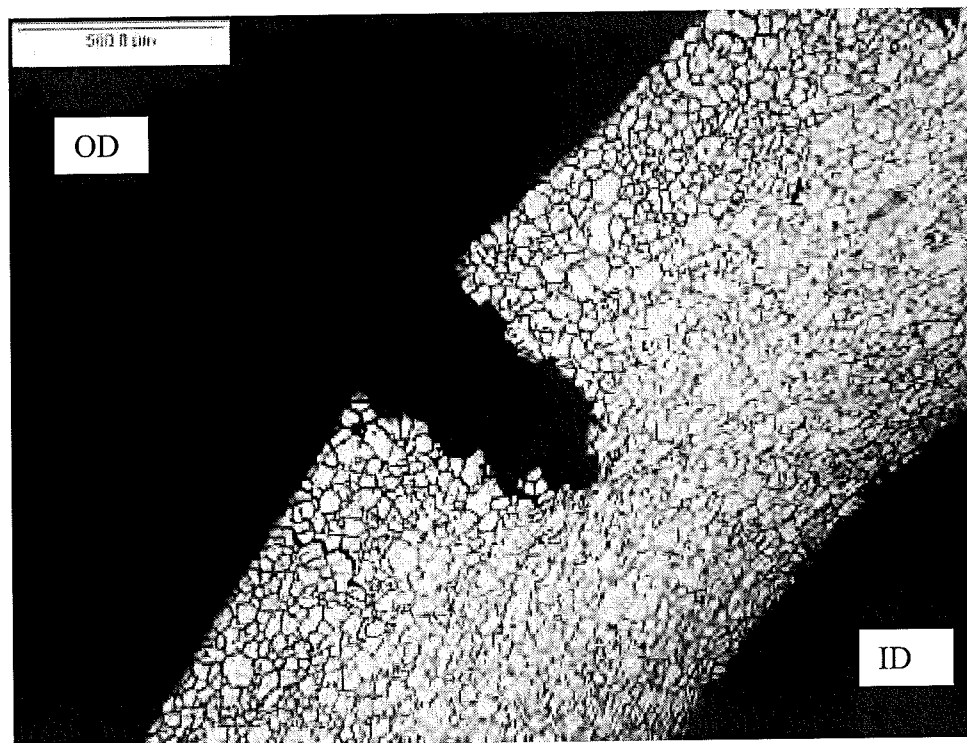
Figure 7-16: R24C41 04H Cracks at 350°, 20 mils Further Down the TSP from Figure 7-13
