AEROTEST OPERATIONS, INC.
(Aerotest Radiography and Research Reactor)

August 15, 2013

As per my telephone conversation with you earlier today, we are reporting that during our annual fuel inspection from July 24-26, 2013, we discovered two more aluminum fuel elements with non-displaced cracks, S/N 612E and 630E. The cracks are both longitudinal cracks at about 22" from the bottom of the element, in the non-fuel area near the fuel boundary.

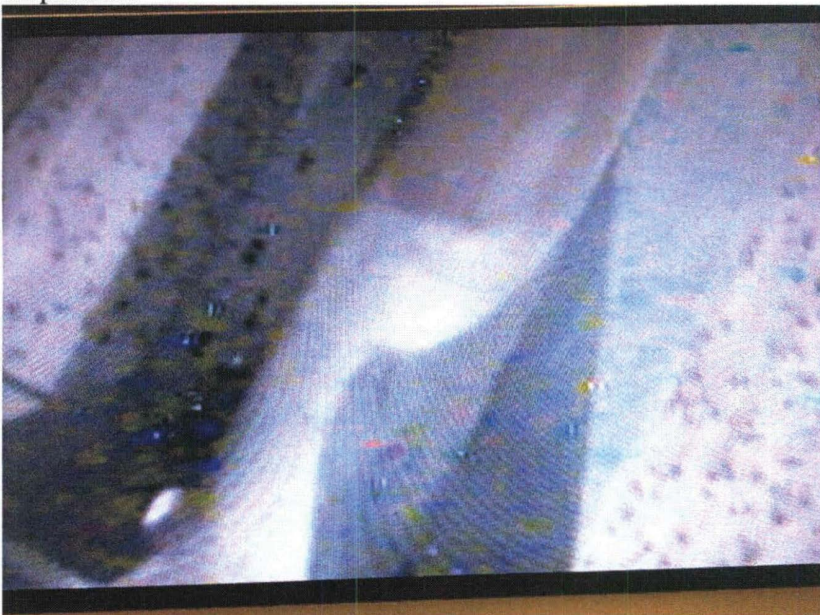
S/N 612E: This element had been removed from the core in 2005 and had been stored in the wall storage rack since then. The visible separation was not apparent in the 2012 inspection:

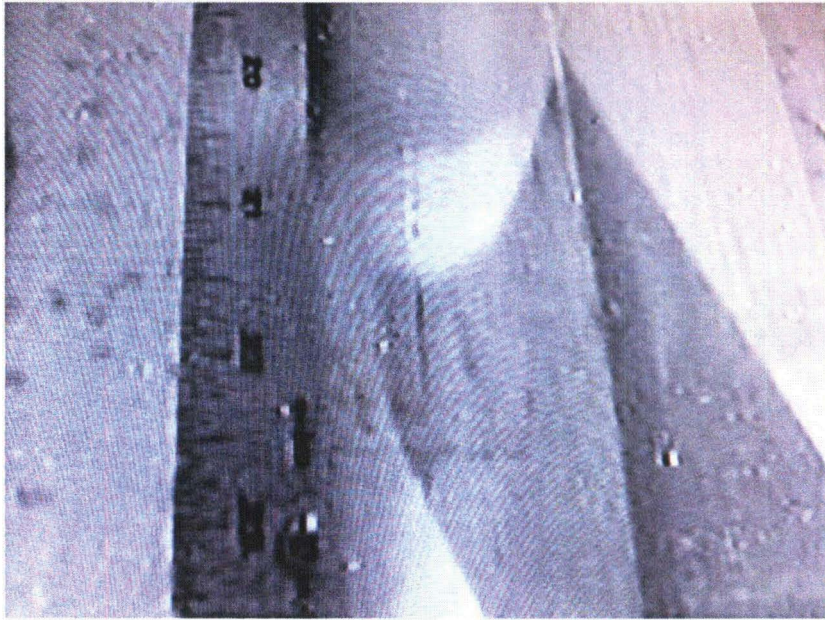
It is clearly visible now in 2013 in the same position:

Please note that the elements are mounted in our inspection fixture which we have been using since 2012. The two different inspections have the camera (which is on a pole that we move up and down) in a somewhat different angle position for each inspection effort, so the view is not precisely the same for the four still shots taken off of the video. We attempted to get the best still shot we could to show the worst view of the crack for each year. On the full video, the crack can appear longer in 2013 when the light hits it right.

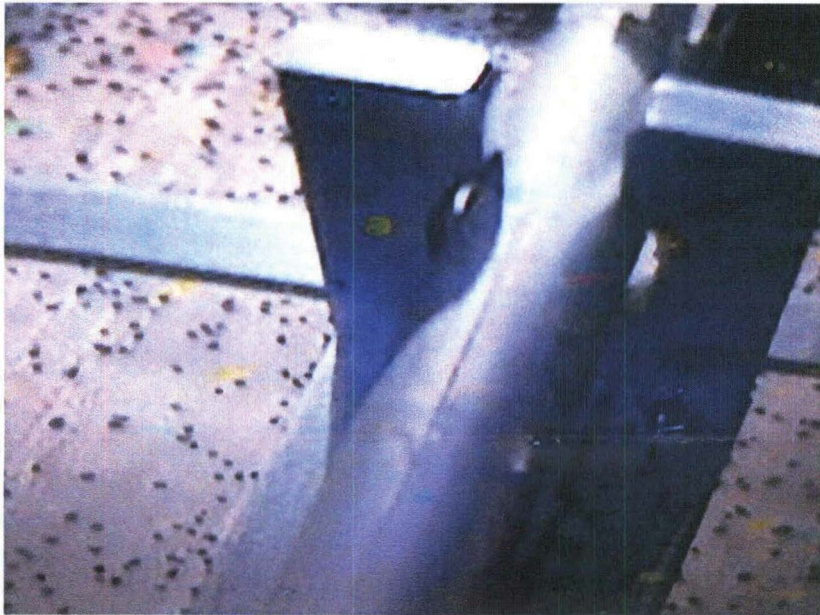
S/N 630E: This element was previously one of the elements that would not fit through the upper grid plate prior to the fuel removal work done in 2012. There was a vertical line on the elements in 2012 which evidently caused much discussion among the fuel inspection crew at the time. Also present poolside was Craig Bassett of the NRC. The 2012 video (which has no audio discussion since the camera is underwater) lingers for a long time on the area in question. After shining the light around in different areas, it was decided that there was no depth for light to go into, and therefore because of the straightness of the line, it was probably just a vertical scrape caused by rubbing the element against the storage rack or grid plate while lifting it upward. All of our previous cracks were more jagged than this:

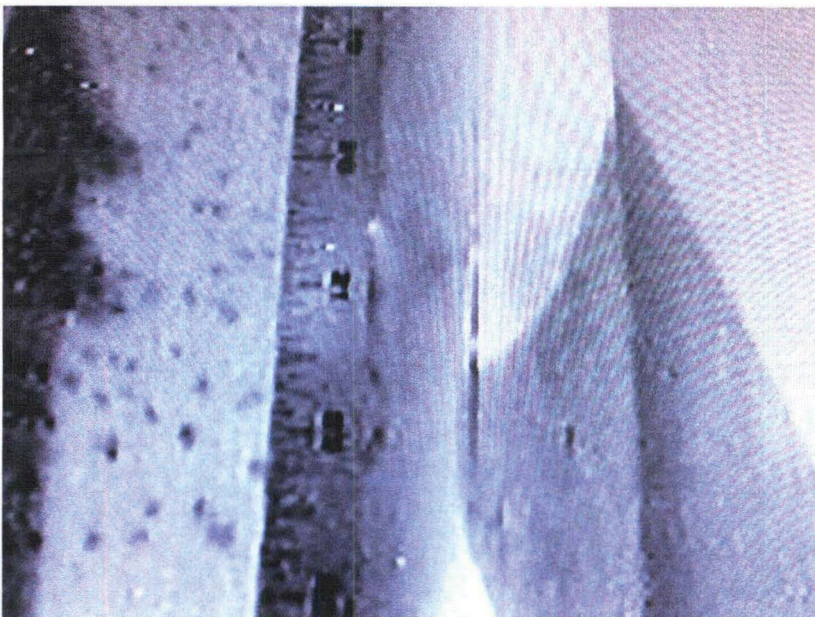
In 2013, the vertical line appears wider, and there is now some depth similar to a groove. Please note that the last picture is upside down from the others; we paused the video shot and took the pictures with an iPhone. For some reason, the computer flipped the image when I converted it from an iPhone to a jpeg image, but you can see the mark right down the middle. It is obvious there has been a change that has developed over the year. There is also a little pea of material in the center of the crack in two places, perhaps just an area where the clad did not open up:

Both of these elements still appear to have very good structural integrity. There is no obvious evidence that either of these cracks has gone all the way through the clad. Moving the lighting around does not appear to show a deep area where light penetrates only when directly in front of the crack, therefore it seems to us that the crack is not as deep yet as some others we have seen. Since July of 2012, these elements have been stored in subcritical assembly storage racks. Therefore, these elements have not received any kilowatt hours or even been in close proximity to other elements or a neutron source while these changes have been occurring. The pool water chemistry is still extremely good, less than 2 micromhos of conductivity.

As you know, in December of 2012, we canned all of our elements that had any cracks in them, for a total of 22 canned elements so far. We do have 2 additional cans available right now, but unless the NRC would like us to consider otherwise, we would prefer not to can these elements at this time. If we can these elements, we will not be able to inspect them again without removing them from the conditioned cans. Putting them in the cans where they are in a dry environment will change the conditions for these elements. We would like to observe these elements over the next year in the same environment to see how the areas might change. This is a good opportunity to get information about cracking in aluminum elements while the elements are clearly still structurally sound. Our pool water counts remain low as they have since we canned up the other elements, so we don't believe that they are leaking any significant isotopes.
