**RE: Uranium One, Willow Creek ISR Operations, Mine Unit 5, Header House 5-5 Spill, Follow-up Inspection Report, Permit No. 478**

# IN SITU MINE INSPECTION REPORT

<b>Permit Number:</b>	PT0478	<b>Permittee:</b>	URANIUM ONE USA INC
<b>Inspection Date:</b>	6/4/2014	<b>Inspector(s):</b>	Luke McMahan
<b>Report Date:</b>	8/5/2014	<b>Participant(s):</b>	Kevin Filbert (Uranium One)
<b>Last Inspection:</b>	1/21/2014	<b>Current Bond:</b>	\$21,075,000
<b>Inspection Reason(s):</b>	Follow-up	<b>Field Conditions:</b>	Clear, calm, ~80° F
		<b>Approval Date:</b>	4/18/1978
<b>Status:</b>	Active	<b>Approved Acreage:</b>	14986.38
<b>County:</b>	Johnson	<b>Mineral:</b>	Uranium

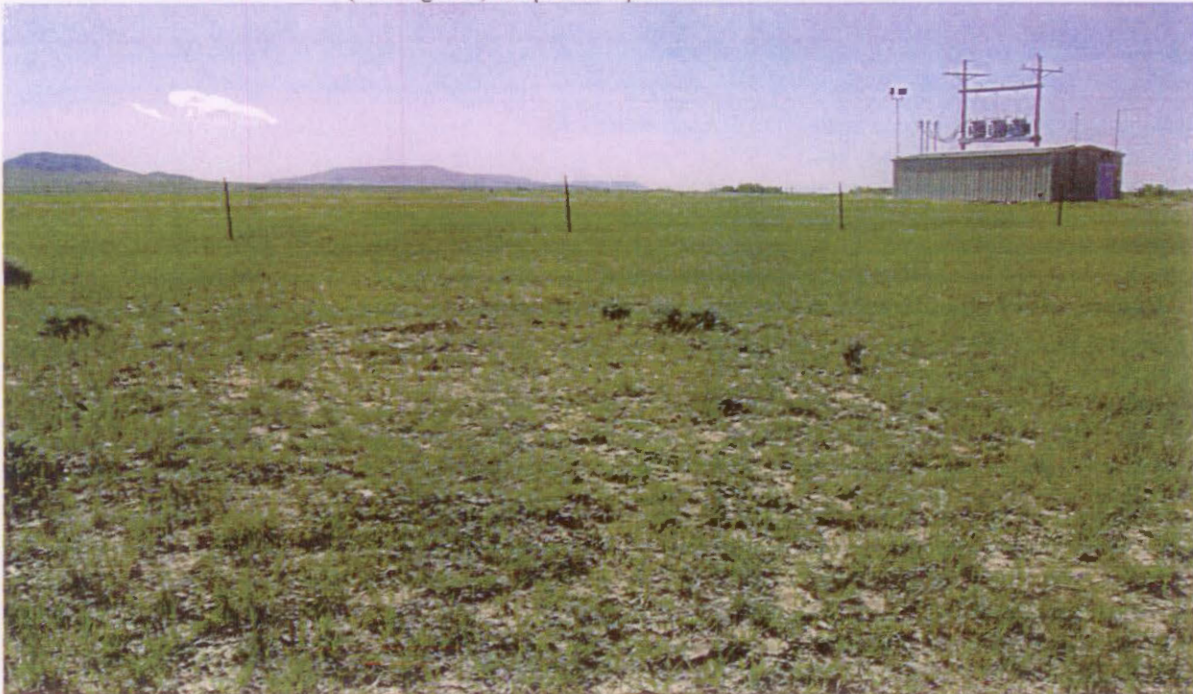
**Photo #1** – View (looking east) of spill flow path down-stream of Header House 5-5.

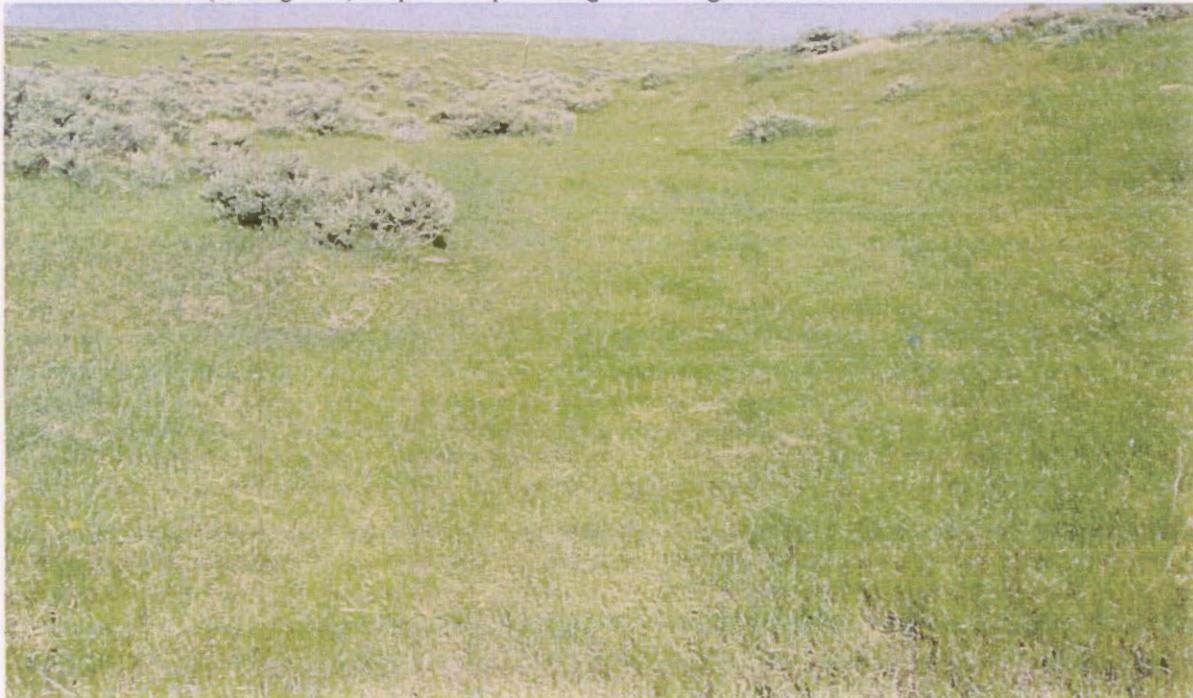
**Photo #2** – View (looking west) of spill flow path along the drainage located down-stream of Header House 5-5.

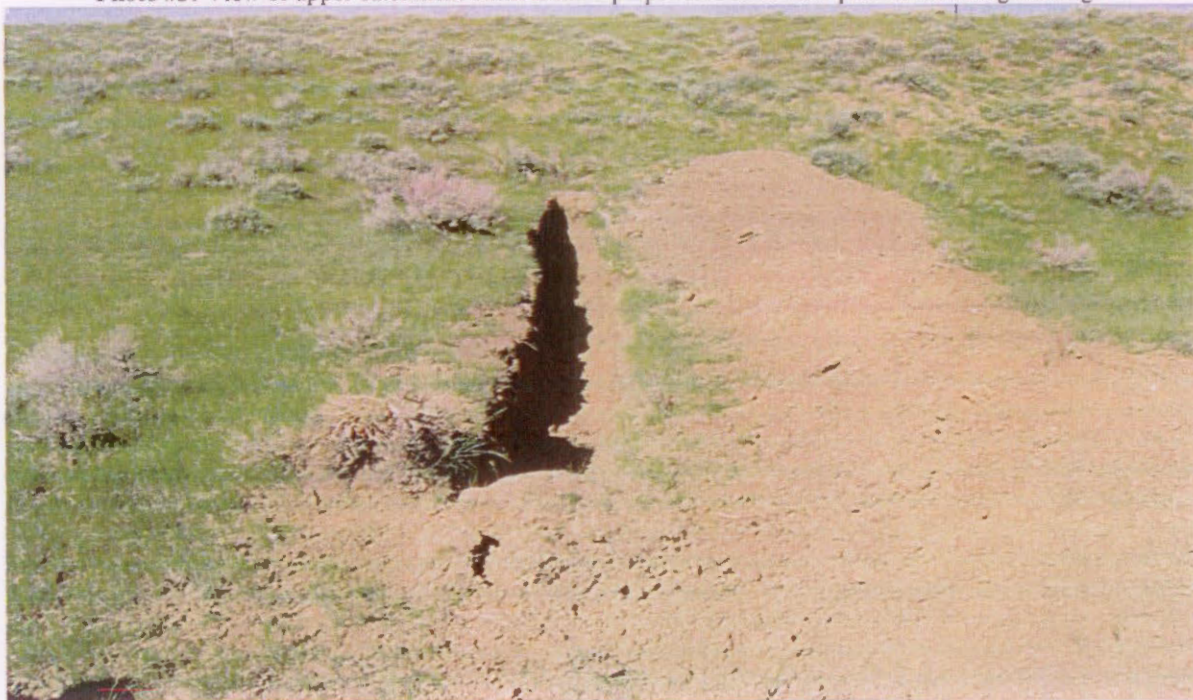
**Photo #3:** View of upper catchment basin located perpendicular to flow path in receiving drainage.

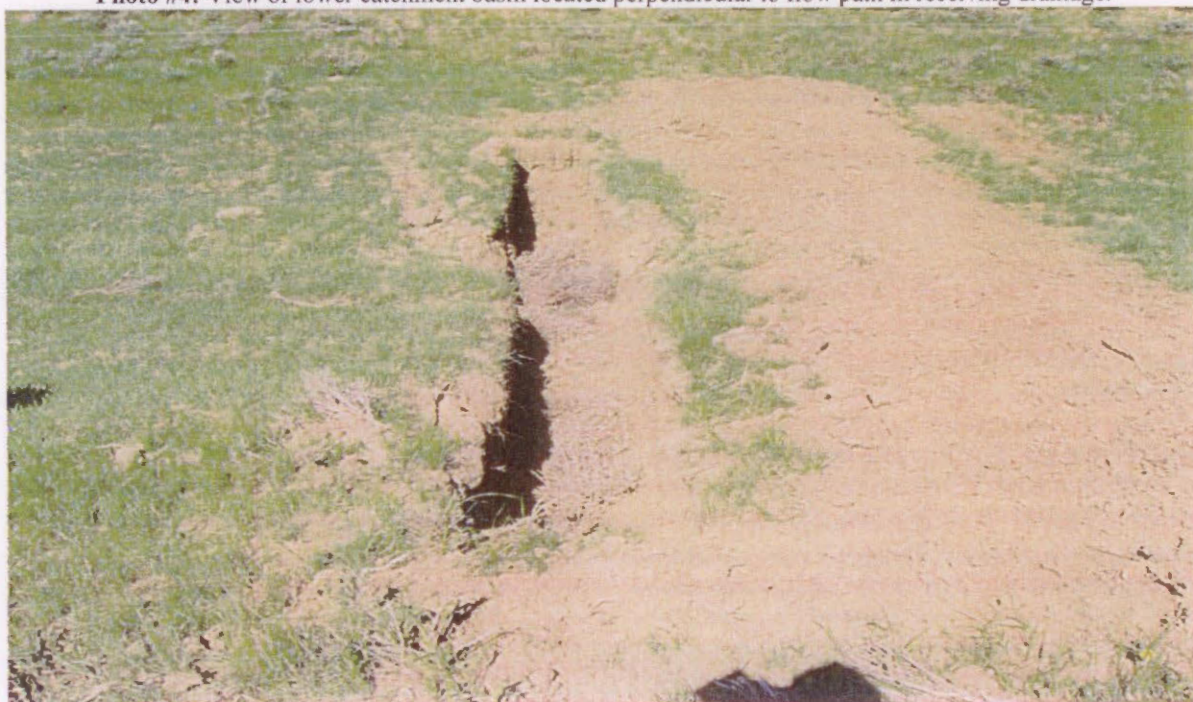
**Photo #4:** View of lower catchment basin located perpendicular to flow path in receiving drainage.

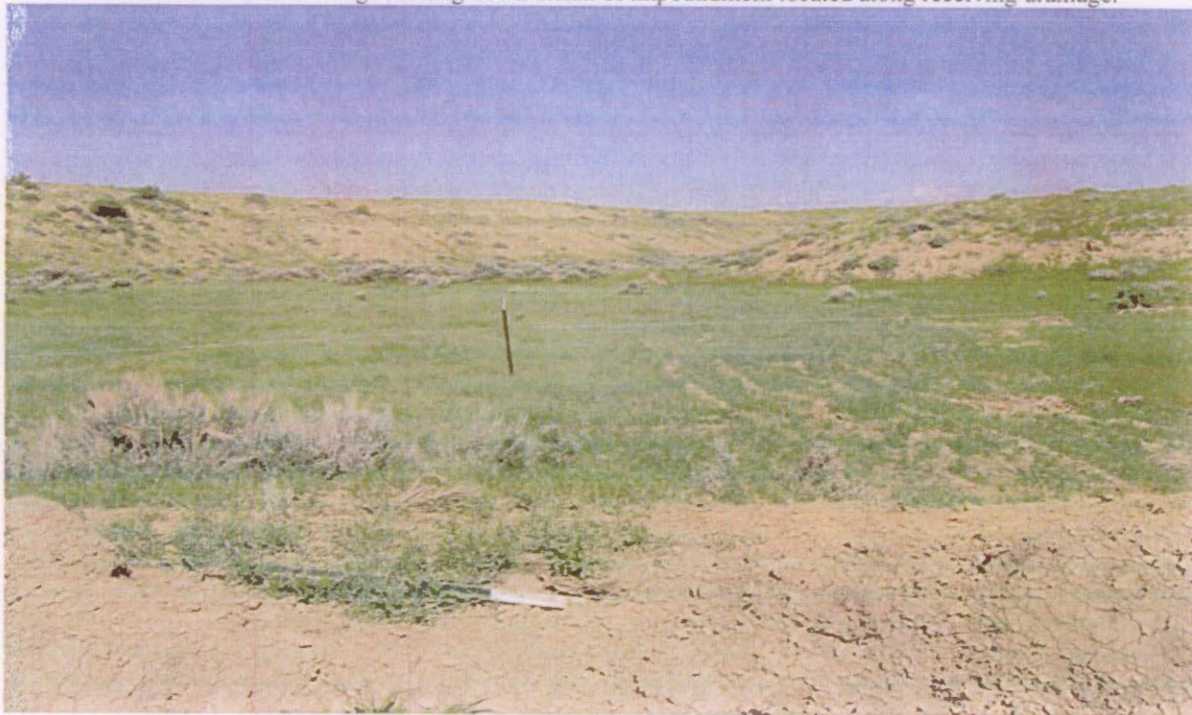
**Photo #5:** View of drainage looking down-stream of impoundment located along receiving drainage.

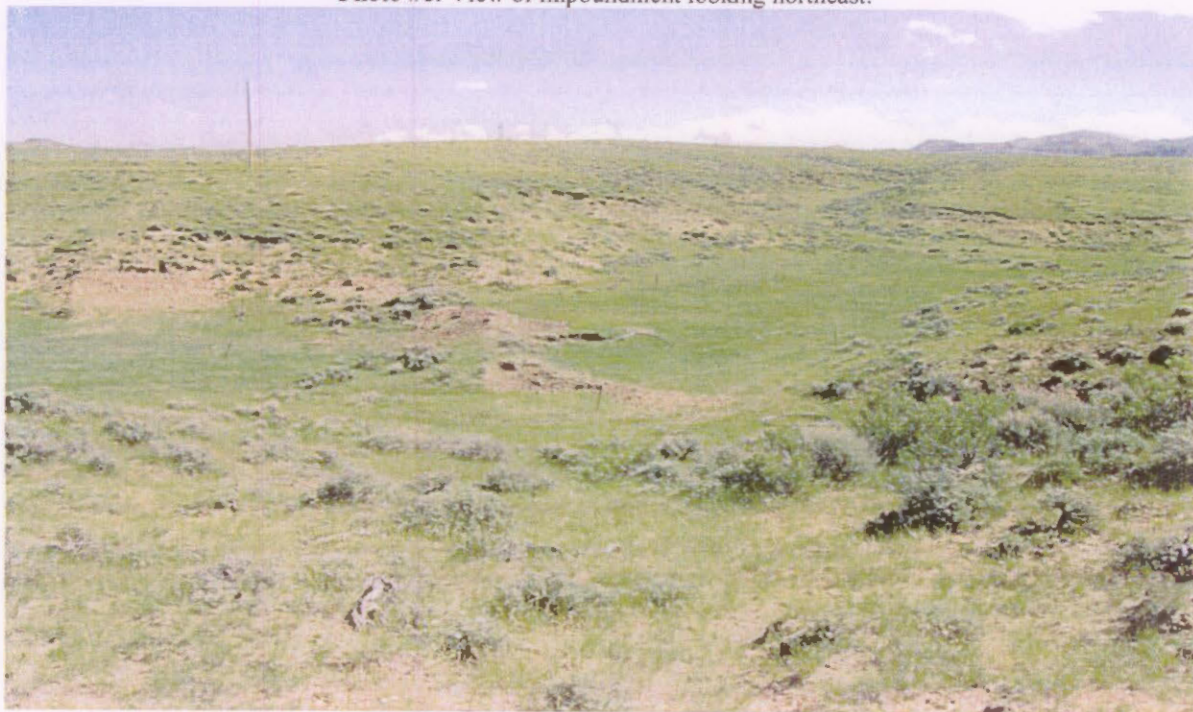
**Photo #6:** View of impoundment looking northeast.
