Part 21 (PAR)

NOTICE OF DEVIATION REGARDING K-LINE CIRCUIT BREAKER SECONDARY CLOSE LATCH

Subject: 10CFR Part 21 Notification of Deviation re. K-Line Circuit Breaker Secondary Close Latch

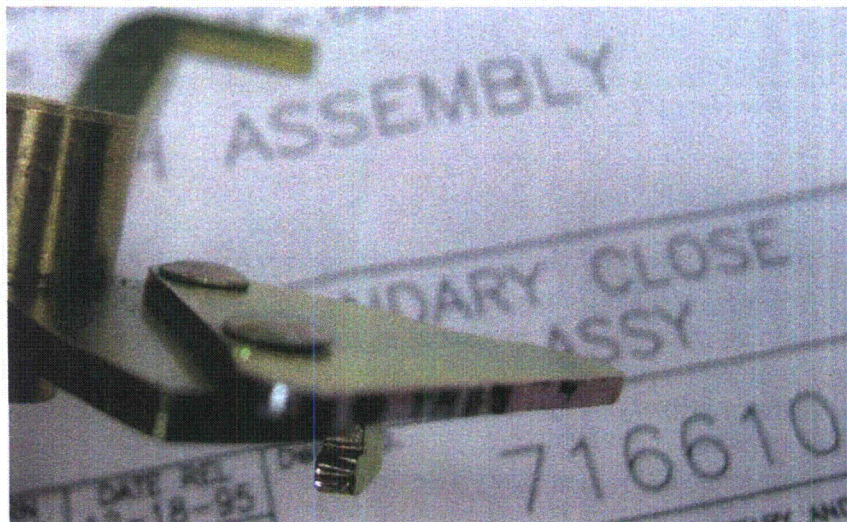
Figure 1 - Secondary Close Latch

1. This letter provides notification of a failure to comply with specifications associated with a secondary close latch, part number 716610K01 (see Figure 1), used in K-Line 225/800 and 1600/2000 amp electrically operated Model 7 circuit breakers. This does not affect previous models of these same breakers that have not been upgraded to include the interlocking primary and secondary close latches. It also does not affect manually operated Kline breakers or K3000/4000 circuit breakers. Information is provided as specified in 10CFR21 paragraph 21.21(d) (4).

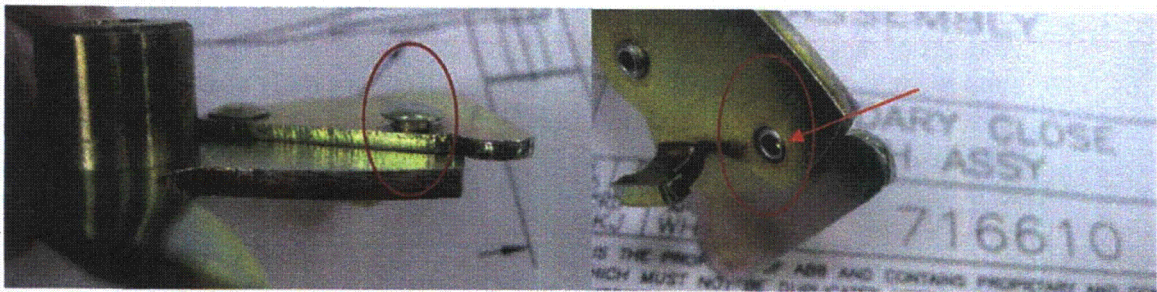
Figure 2 – Secondary Close Latch

During outgoing inspection a breaker went trip free during the operational phase of the testing procedure. The inspector found that the cam attached to the top of the secondary close latch, 716610K01, was not properly riveted in place. The head of the rivet was not pushed down flush against the side of the cam. Since the rivet was not seated properly, the other end of the rivet did not project through the other side of the latch and therefore the bradded end of the rivet was not deformed in a manner to sufficiently apply the required holding force to keep the cam in its proper and secure operating position. (see Figure 2)

- a. Perform 100% inspection all part number 716610K01 secondary close latches in inventory to identify the nonconforming latches. (Action complete)
- b. Trained inspectors and breaker assemblers on identifying this condition (Action Complete)
- c. Contact primary vendor to investigate cause and correct on future orders. (Action Complete)
- d. Verified that this is the only assembly with bradding that this vendor provides. (Action complete)
- e. Notification of the potential existence of this deviation to affected customers (Action to be completed by 18 August 2014)
