**TECHNICAL EVALUATION REPORT
CHRISTENSEN RANCH MINE UNITS 2 THROUGH 6 RESTORATION REPORT
URANIUM ONE USA, INC., WILLOW CREEK ISR FACILITY**

DATE: October 23, 2012

DOCKET NO.: 040-08502

SITE: Willow Creek Christensen Ranch, Wyoming

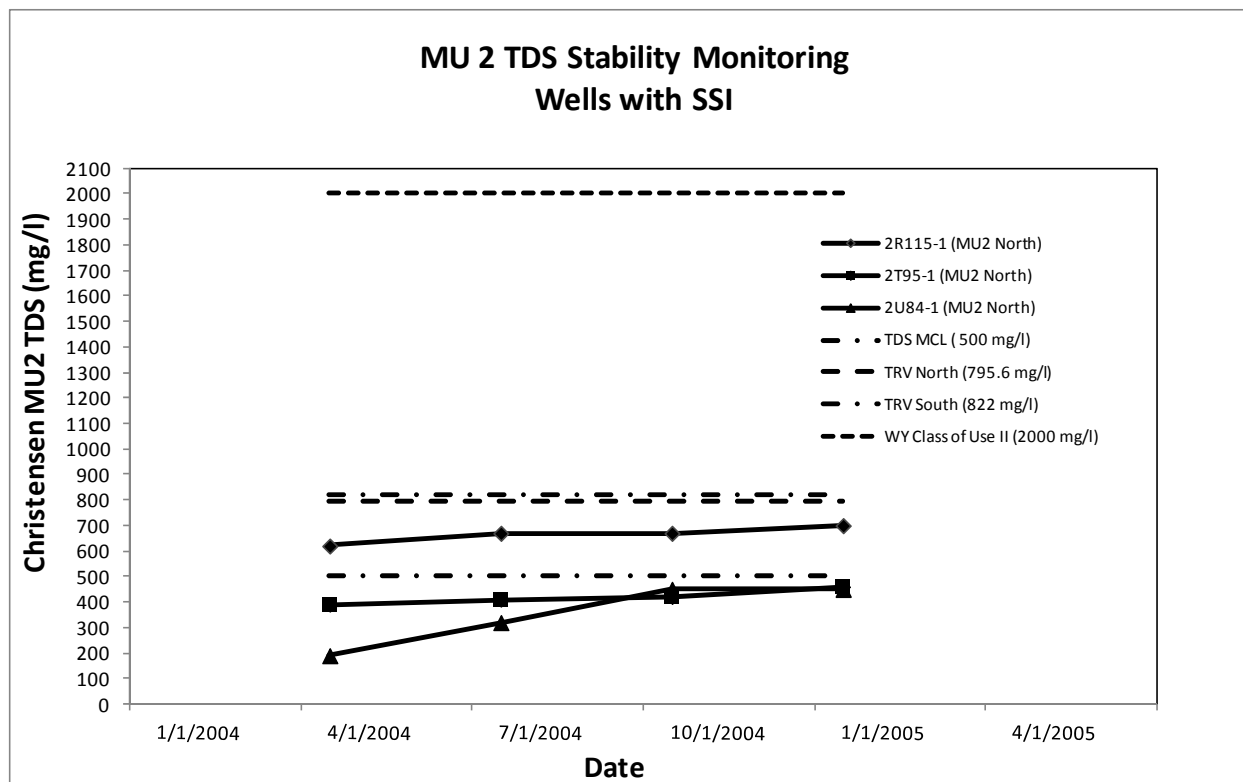
Figure 3a. MU2 North and South TDS Stability Monitoring Trend Analysis

Based on the staff's stability analysis, a SSI trend was noted in the stability data for the following wells:

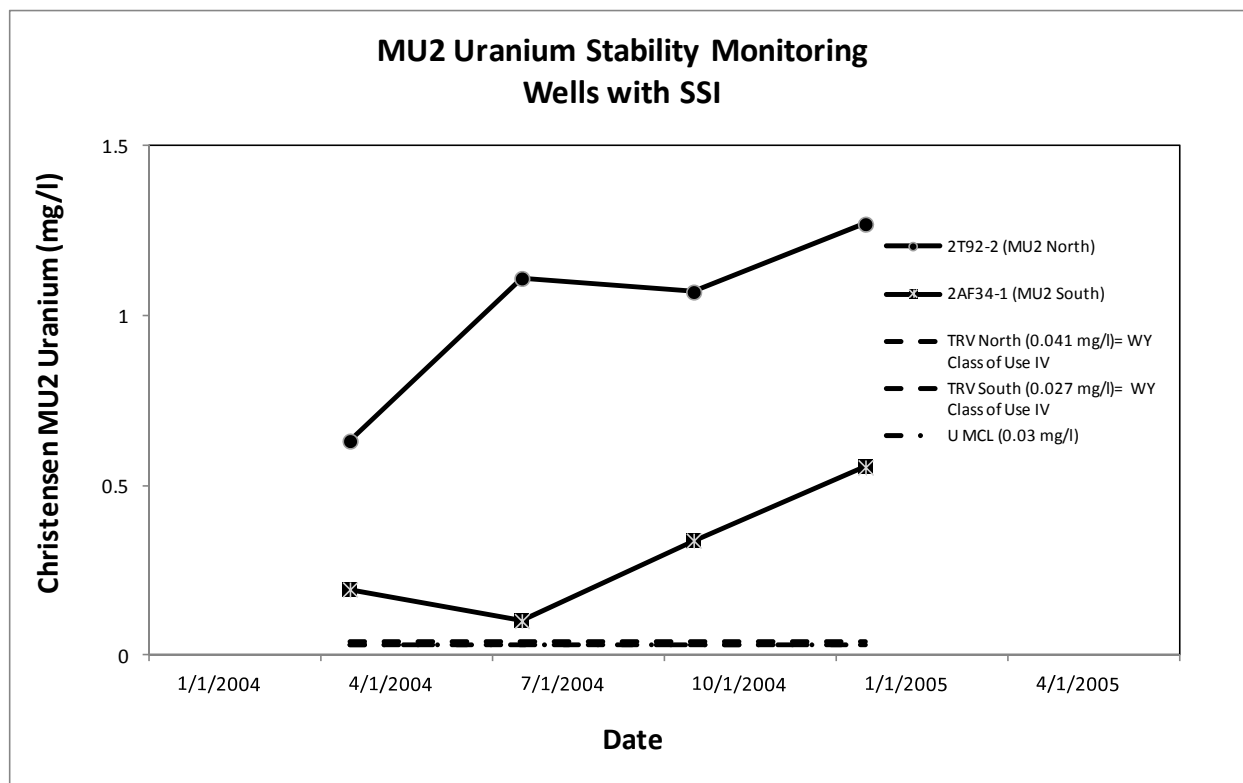
Figure 3b. MU2 North and South Uranium Stability Monitoring Trend Analysis

- (1) SSI trends noted for uranium and radium-226 at well 2T92-2 are shown to be reversed and stabilization is demonstrated.
- (2) The licensee provides a confirmatory analysis of the groundwater quality at well 2MW108 subsequent to corrective actions for the 2011 excursion that demonstrates impacts to the aquifer following the 2011

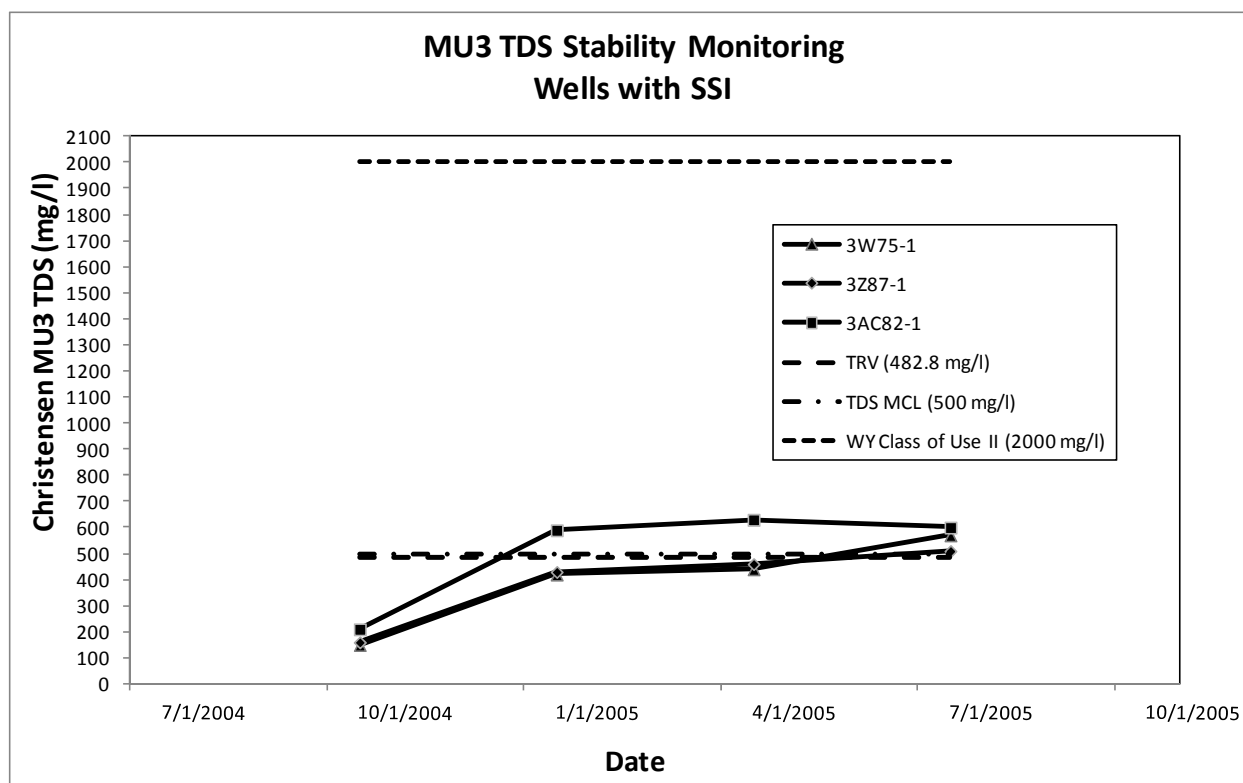
Figure 4a. MU3 TDS Stability Monitoring Trend Analysis

The SSI trends for wells in MU-3 w/o expansion and MU-3 w/ expansion (module 4A) for TDS, uranium and radium-226 are shown in Figures 4a, b, and c respectively. Based on the stability analysis, a SSI trend was noted in the stability data for the following wells in MU-3 w/o expansion:
