UNITED STATES
NUCLEAR REGULATORY COMMISSION
REGION I
2100 RENAISSANCE BLVD., SUITE 100
KING OF PRUSSIA, PA 19406-2713

EA-14-126

SUBJECT: MILLSTONE POWER STATION UNITS 2 AND 3 – NRC SPECIAL INSPECTION
REPORT 05000336/2014011 AND 05000423/2014011

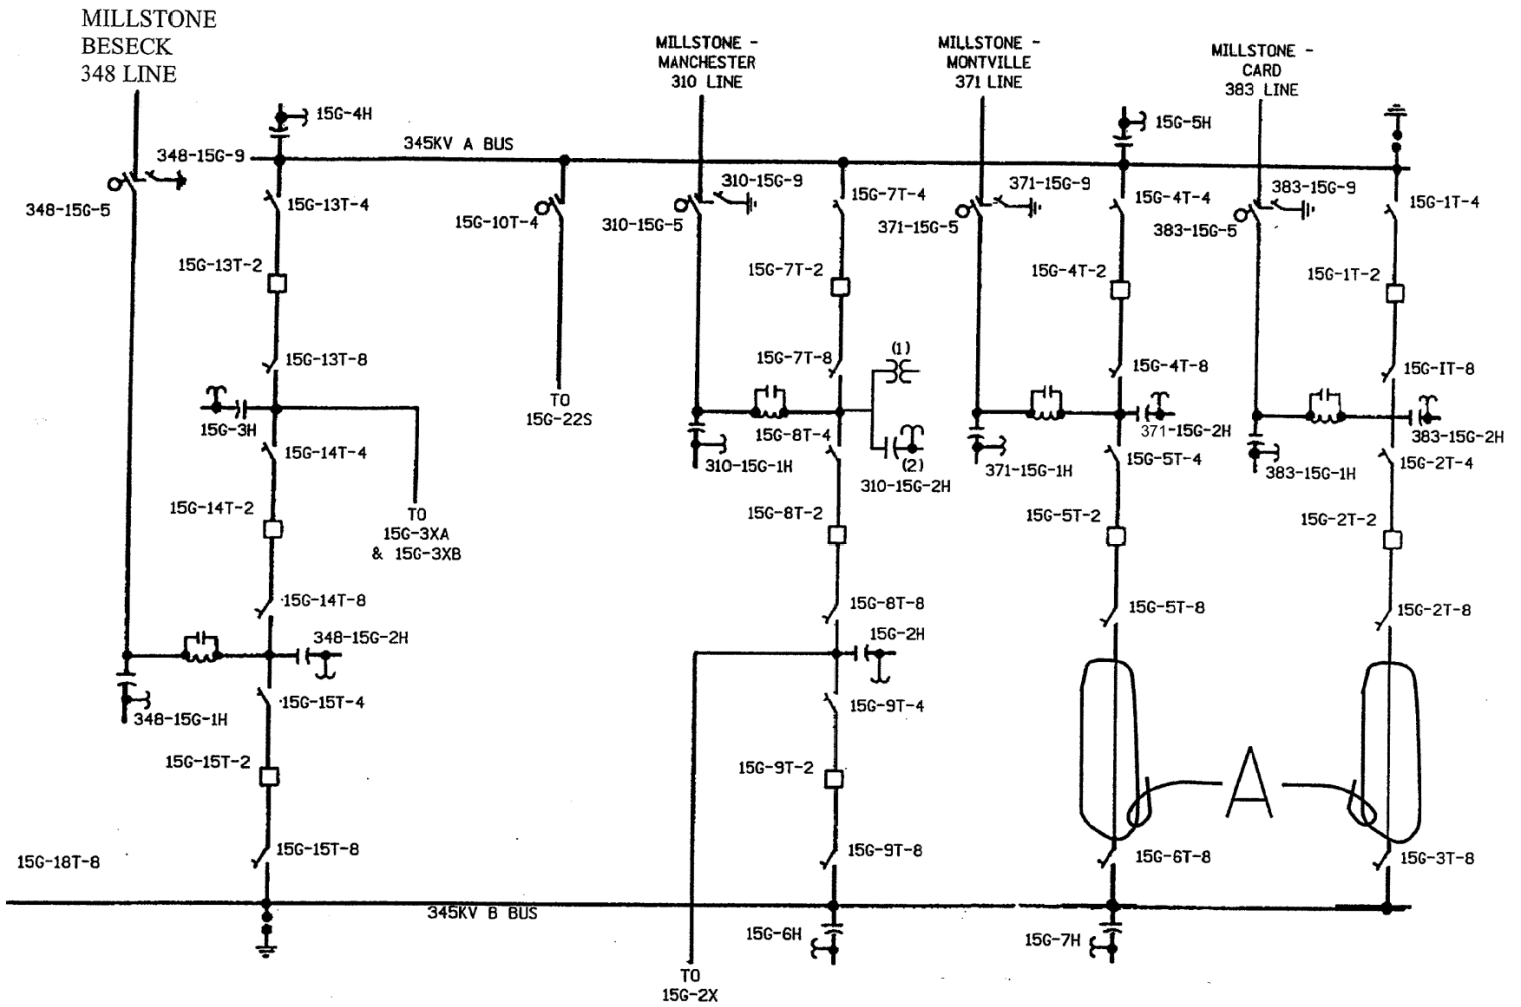
FIGURE 1 – Millstone Unit 2 and Unit 3 Switchyard

At 0701, on May 25, 2014, a dual-unit reactor trip occurred at the Millstone Station. Prior to the event, the station had one offsite line out-of-service (OOS) (Line 371) for maintenance. A suspected ground fault on the grid in the Northeast Utilities' Card substation caused the loss of offsite line 383. Line 310 tripped on instantaneous ground over current which was unexpected. The final line (Line 348) tripped on over current when both units attempted to feed the full power output of both Millstone units through the single remaining line (Line 348). All onsite emergency diesel generators (EDG) started and powered their respective safety busses. A detailed discussion of this sequence of events and a diagram of the Millstone switchyard are provided in Attachment 3 and Attachment 4, Figure 1, respectively.

On May 25, 2014, at approximately 0701, while both units were operating at 100 percent power (total output 2166 MWe Gross), Millstone experienced a dual-unit trip following a LOOP (Figure 1 of Attachment 4 provides a diagram of the Millstone switchyard). Prior to the event, one transmission line had been OOS for scheduled maintenance. A phase-to-ground fault on a disconnect switch in the Card substation, located several miles from the Millstone switchyard, caused the automatic isolation of that line. This was followed almost immediately by the loss of a third offsite transmission line through relay operations at the applicable switchyard and grid substations. Finally, because a single offsite transmission line is not capable of carrying the total generation (MWe) of both units simultaneously, this last remaining transmission line was lost (isolated) due to the expected overload condition created by both units power output being carried by a single transmission line. The team determined that if the SLOD SPS had been in service, only Unit 3 would have tripped and Unit 2 would have remained online and providing at least one offsite power source.

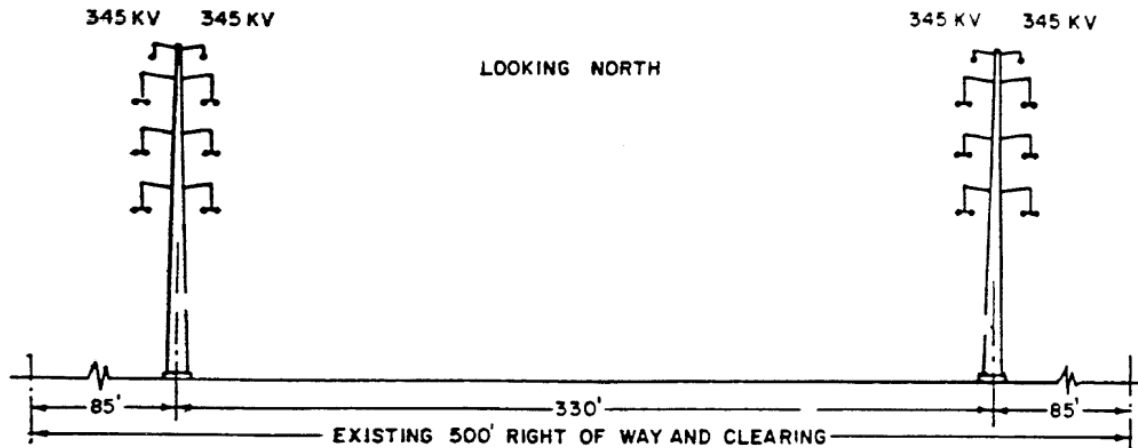
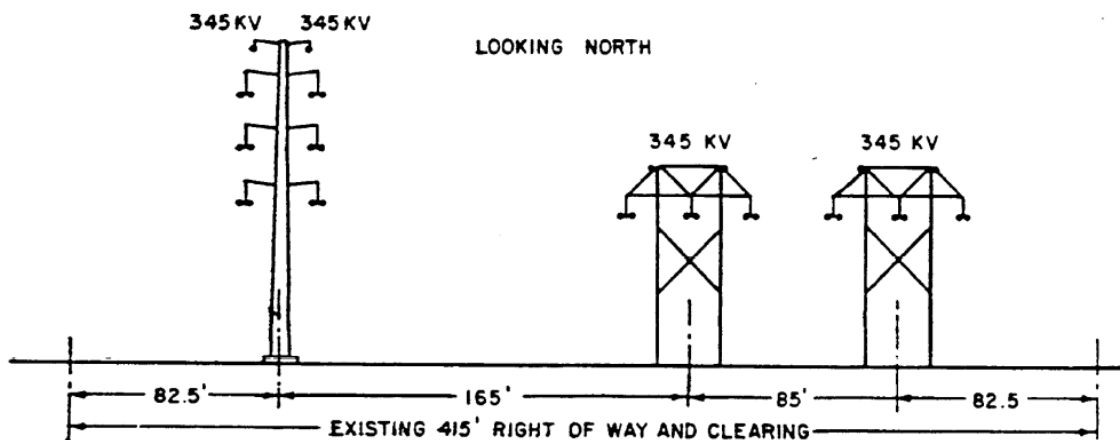
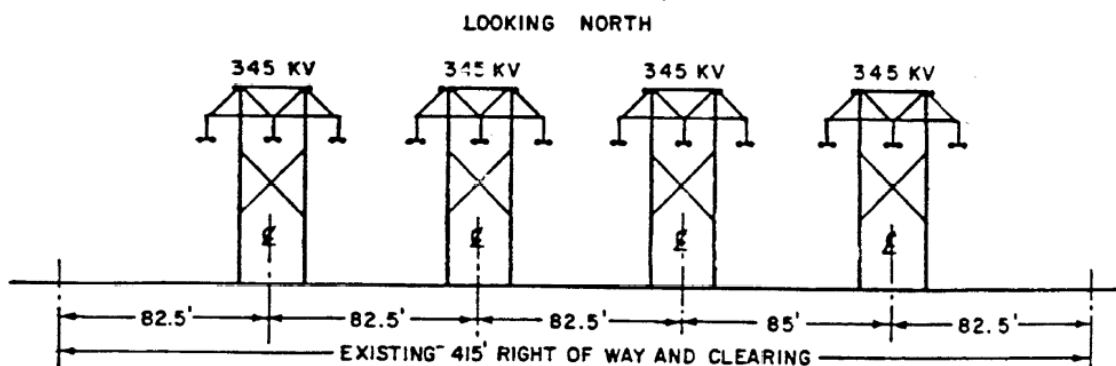
FIGURE 2 – TRANSMISSION LINE TOWERS - PREVIOUS DESIGN

The team noted the design and licensing bases of both Units 2 and 3 detailed that the DCT configuration caused Millstone to be susceptible to a simultaneous transmission tower fault scenario, either due to a line fault or due to tower collapse. Due to the possibility of this simultaneous loss of two circuits on either transmission tower, coupled with one of the two remaining circuits on the opposite DCT being OOS, Millstone utilized a generator rejection SPS known as Severe Line Outage Detection (SLOD). SLOD was described in Millstone Unit 2 and Unit 3 UFSAR Sections 8.1 and 8.2, respectively, as being credited for meeting the requirements of GDC-17. Specifically, SLOD was designed to protect the last remaining transmission line during potential grid instability conditions, and to ensure the availability of the offsite power to both units. The UFSAR further specified operability requirements for SLOD when one transmission line was taken OOS: (1) to have SLOD fully operational, and limit the net station output ≤ 2500 mega-watt (MW) and limit the output of Unit 3 to the Maximum Allowable Millstone Generation Contingency limit, if applicable, or (2) reduce load to a total station output of ≤ 1750 MW (Gross)/1650 MW (Net) within 30 minutes after the element (transmission line) is removed from service.

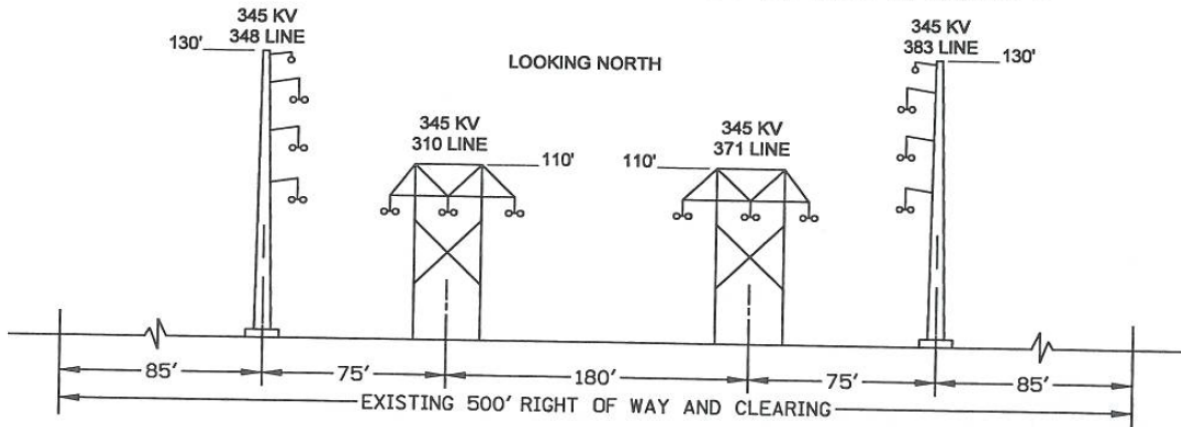
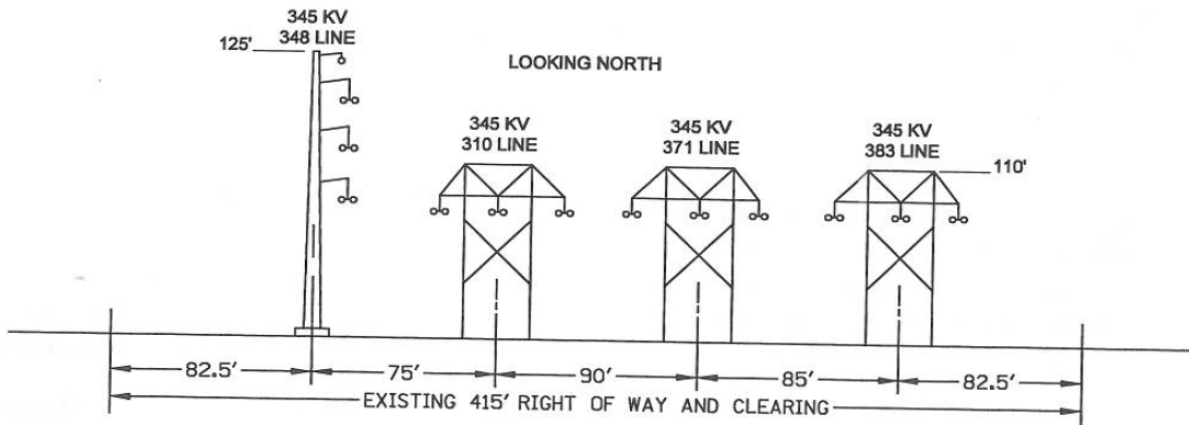
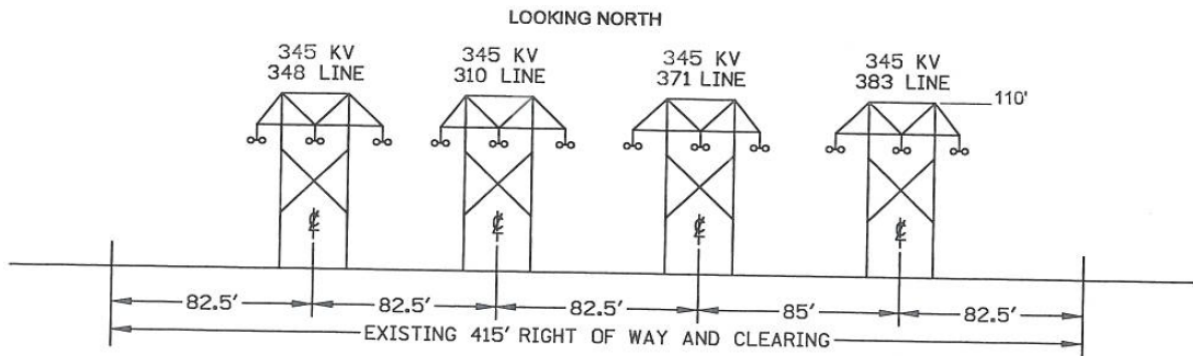
FIGURE 3 – TRANSMISSION LINE TOWERS - NEW DESIGN

The team also determined that the design change did not address the possibility of a mechanical failure of transmission line towers, such as an existing tower falling on the new tower and causing simultaneous failure of two transmission lines. The intent of the design change was to eliminate the simultaneous double-circuit tower fault scenario by separating each of the 345 kV transmission lines on its own tower and its own transmission path. The new design installed two new transmission paths that are located approximately 75 feet (average) from the existing paths within a common right-of-way. The team determined that the 75 feet separation between the existing towers and new towers may not be adequate to prevent a simultaneous double circuit fault scenario if one of the original transmission towers (130 feet tall) falls over onto the newly-installed tower (110 feet). Therefore, the new configuration of the transmission lines is also vulnerable to the same credible fault scenario resulting in loss of three out of four transmission lines. Unit 2 UFSAR Section 8.1.2.1 addressed the original tower heights and the ground clearances between towers. The UFSAR details that the 330 feet separation indicates significant enough clearance to provide adequate physical independence of the transmission lines. The team found that the design change documents did not address this failure mode in the Failure Mode and Effects Analysis section, as required by procedures.
