**UNITED STATES  
NUCLEAR REGULATORY COMMISSION**

EA-14-092

SUBJECT: MILLSTONE POWER STATION – NRC SPECIAL INSPECTION REPORT  
05000423/2014008 WITH PRELIMINARY WHITE FINDING

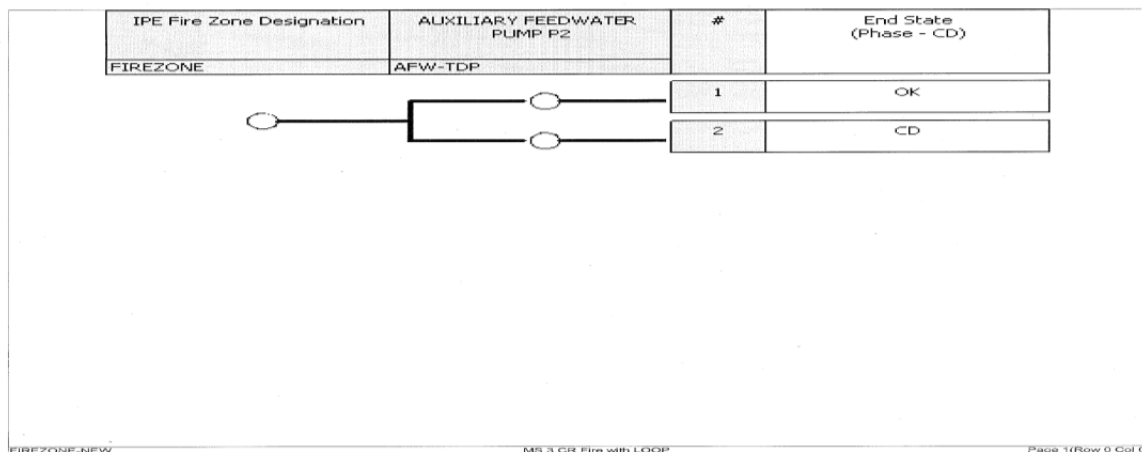
The SRA used a simplified event tree (see below) to represent the external fire risk per affected fire zone. As stated above, the fire frequencies were taken from IPE Table 3.5-4. The nominal TDAFWP fail to start (FTS) probability (6.49E-3) was taken from the Millstone 3 SPAR Model. The individual fire zone contributions are summarized in the following table.

Fire Zone	Fire Frequency	Nominal CDF Case (FTS = 6.49E-3)	Condition CDF Case (FTS = 0.12)	Delta CDF
CB-9	4.48E-4/year	2.91E-6/year	5.38E-5/year	5.09E-5/year
CB11A and 11B	1.50E-4/year	9.74E-7/year	1.8E-5/year	1.70E-5/year
CB-8	4.52E-5/year	2.93E-7/year	5.42E-6/year	5.13E-6/year
			Total	7.30E-5/year

To account for the exposure period of 173 days, the total fire zone contribution value of 7.30E-5/year is multiplied by 173/365 or 0.474 to calculate the external event delta CDF value of 3.46E-5/year.
