DESCRIPTION:  
Ltr re their 7-24-72 ltr and our 9-20-72 ltr  
..furnishing addl info on abnormal occurrence  
regarding dilution of the boron injection of  
tank below the concentration specified in  
Tech Specs w/attached System Diagram....

PLANT NAMES: H. B. Robinson, Unit # 2

H. B. ROBINSON UNIT NO. 2  
LICENSE DPR-23  
BORON INJECTION TANK DILUTION

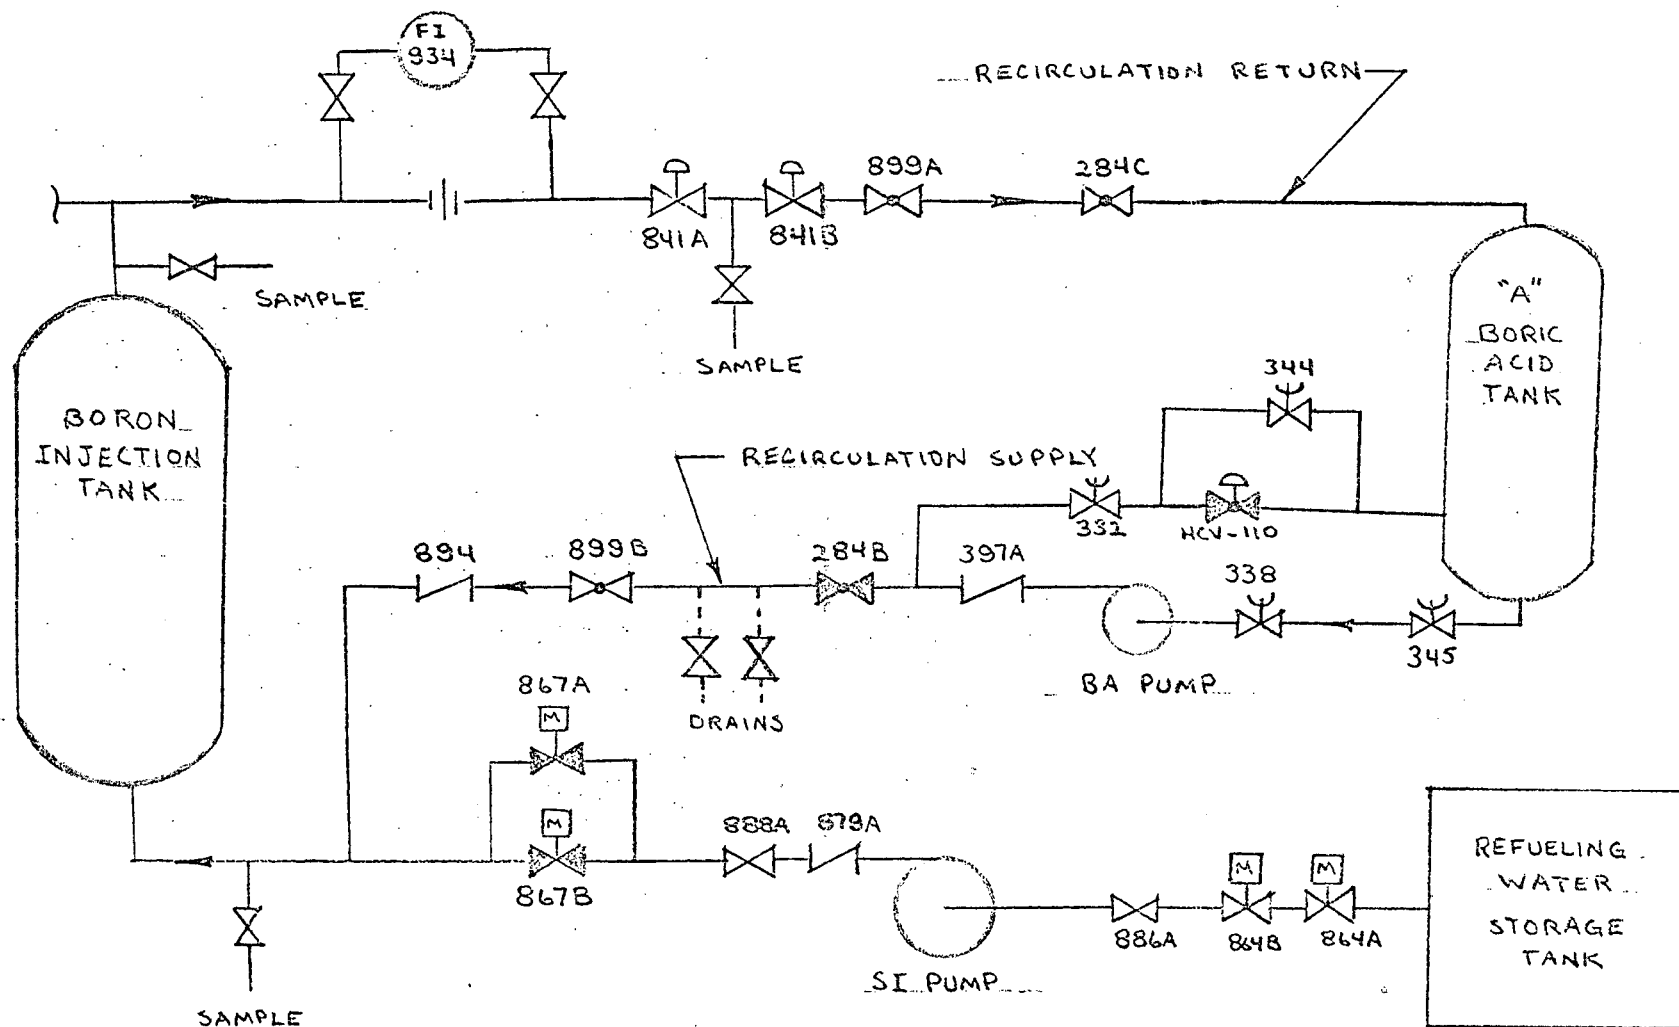
BORON INJECTION TANK RECIRCULATION FLOW PATH

It is believed that the dilution of the boric acid concentration in the boron injection tank occurred as a result of a combination of two contributing factors. These factors were the failure of safety injection valve 867A to seat completely and the plugging of the recirculation between the boron injection tank and the boric acid tanks with solidified boric acid. (Refer to enclosed system diagram for valve and piping orientation.)

In summary, it is concluded that the primary cause of boron injection tank dilution was leakage from the refueling water storage tank through valve 867A. Crystallization of boric acid in the recirculating lines was the major contributing factor to the malfunction of this valve

To prevent recurrence of this incident, plant personnel have been instructed to verify recirculation flow as indicated on the local flow meter, FI-934, located in the same room as the boron injection tank. The results of this flow verification are being recorded in the Shift Foreman's daily log. The boron injection tank is being sampled on a weekly basis rather than on a monthly basis as per Technical Specifications. All plant operators have been cautioned to monitor all heat tracing circuits associated with high concentration boron solutions more closely. Provisions have been made to assist in unplugging the recirculation lines with nitrogen pressure, should further crystallization occur. The reactor vendor, Westinghouse, has been consulted and their engineers are making a careful inspection of the entire system. Those heat tracing circuits on high concentration boron lines are being carefully checked by plant personnel and actual temperature profiles taken on questionable sections of piping. Until complete assurance can be obtained that all heat tracing circuits are performing as designed and that plugging of the recirculation lines is unlikely, recirculation flow is being verified once a shift.

and to the blocking of several sections of the normal recirculation flow paths. The adequacy of the heat tracing on all piping and components containing high concentration boric acid is being carefully investigated. Until this investigation is complete and there is assurance that the high concentration boric acid will remain in solution at all times, the system is being verified for proper flow once a shift. Carolina Power & Light Company is being assisted and advised in this investigation by Westinghouse.
