H. B. ROBINSON UNIT NO. 2
LICENSE DPR-23

INTEGRITY OF STEAM GENERATORS UNDER ACCIDENT CONDITIONS

DESCRIPTION OF PRESENT STATUS OF STEAM GENERATORS

H. B. ROBINSON UNIT NO. 2

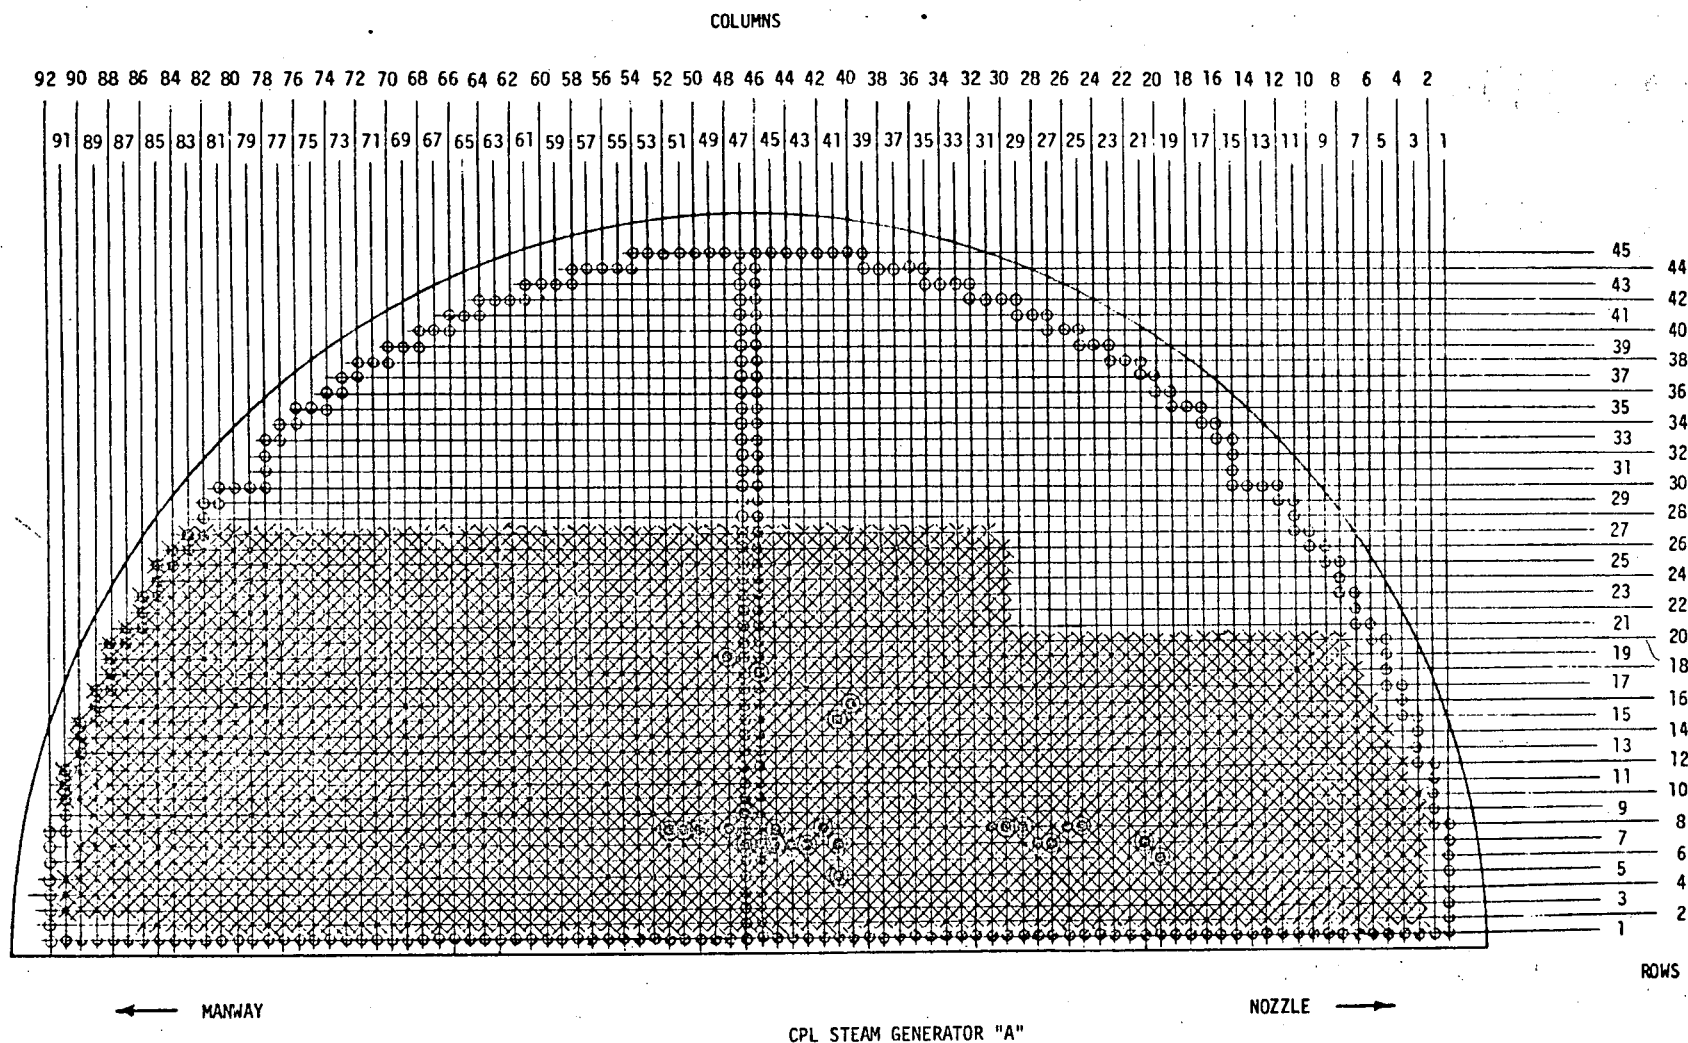
FIGURE 1

The EC test program for steam generator "A" provided for inspection of 2029 inlet side tubes up to and through the first tube support. The area of the tube sheet tested is shown graphically in Figure 1. Of the total 2029 tubes tested, 23 tubes were found to contain eddy current indications of varying degrees of outside-diameter originated wall penetration. Table 1 lists the EC indications observed during the inspection of steam generator "A".

X - Indicates tube eddy current probed May, 1972
● - Indicates tube plugged May, 1972

○ - Eddy current indications of wall penetration

In summary, a total of 4,481 tubes were inspected with the eddy current technique in the three steam generators and 29 tubes were found to have positive indications. Three tubes were removed from steam generator "A" for further examination and all tubes with indications and the three locations where tubes were removed were plugged. The unit was subsequently leak tested from the secondary side at 800 psi.

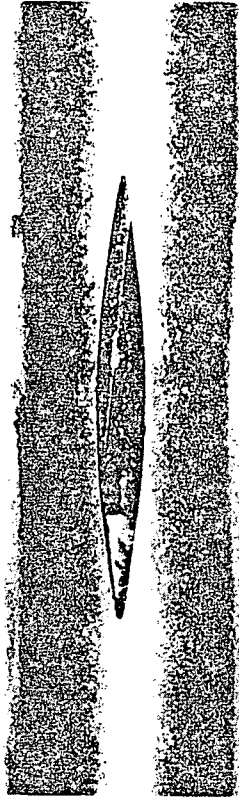
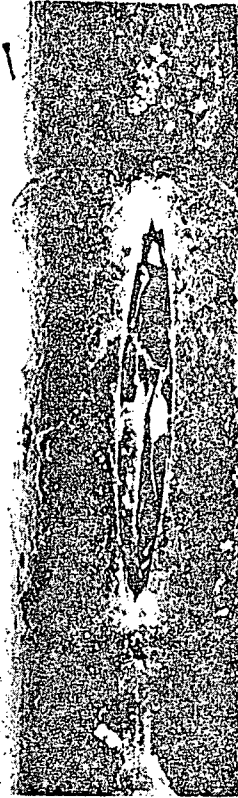
The failure mode of a through-wall defect is shown in Figure 4 for both new and service-exposed tubes. The failure is a plastic deformation or bulge of the area adjacent to the crack. This deformation mechanism is in direct support of the in-plant experience of the orderliness of the leakage. Note from the figure that there is essentially no difference in the appearance of the deformation between new and service-exposed tubing. Bulge pressure is plotted as a function of through-wall slot length in Figure 5 for operating temperatures. For a given crack length, as long as the pressure differential across the tube is less than the bulge pressure, the crack opening or displacement will be elastic and the opening will return to its original dimensions as the pressure is reduced. If the bulge pressure is exceeded the material will yield and the crack opening will take a permanent set.

Bulge
Pressure
1230 psi

Figure 4. Deformation of new and service exposed tubing upon reaching the bulge pressure. Tubes contained machined through wall slots of 1.5 inches.

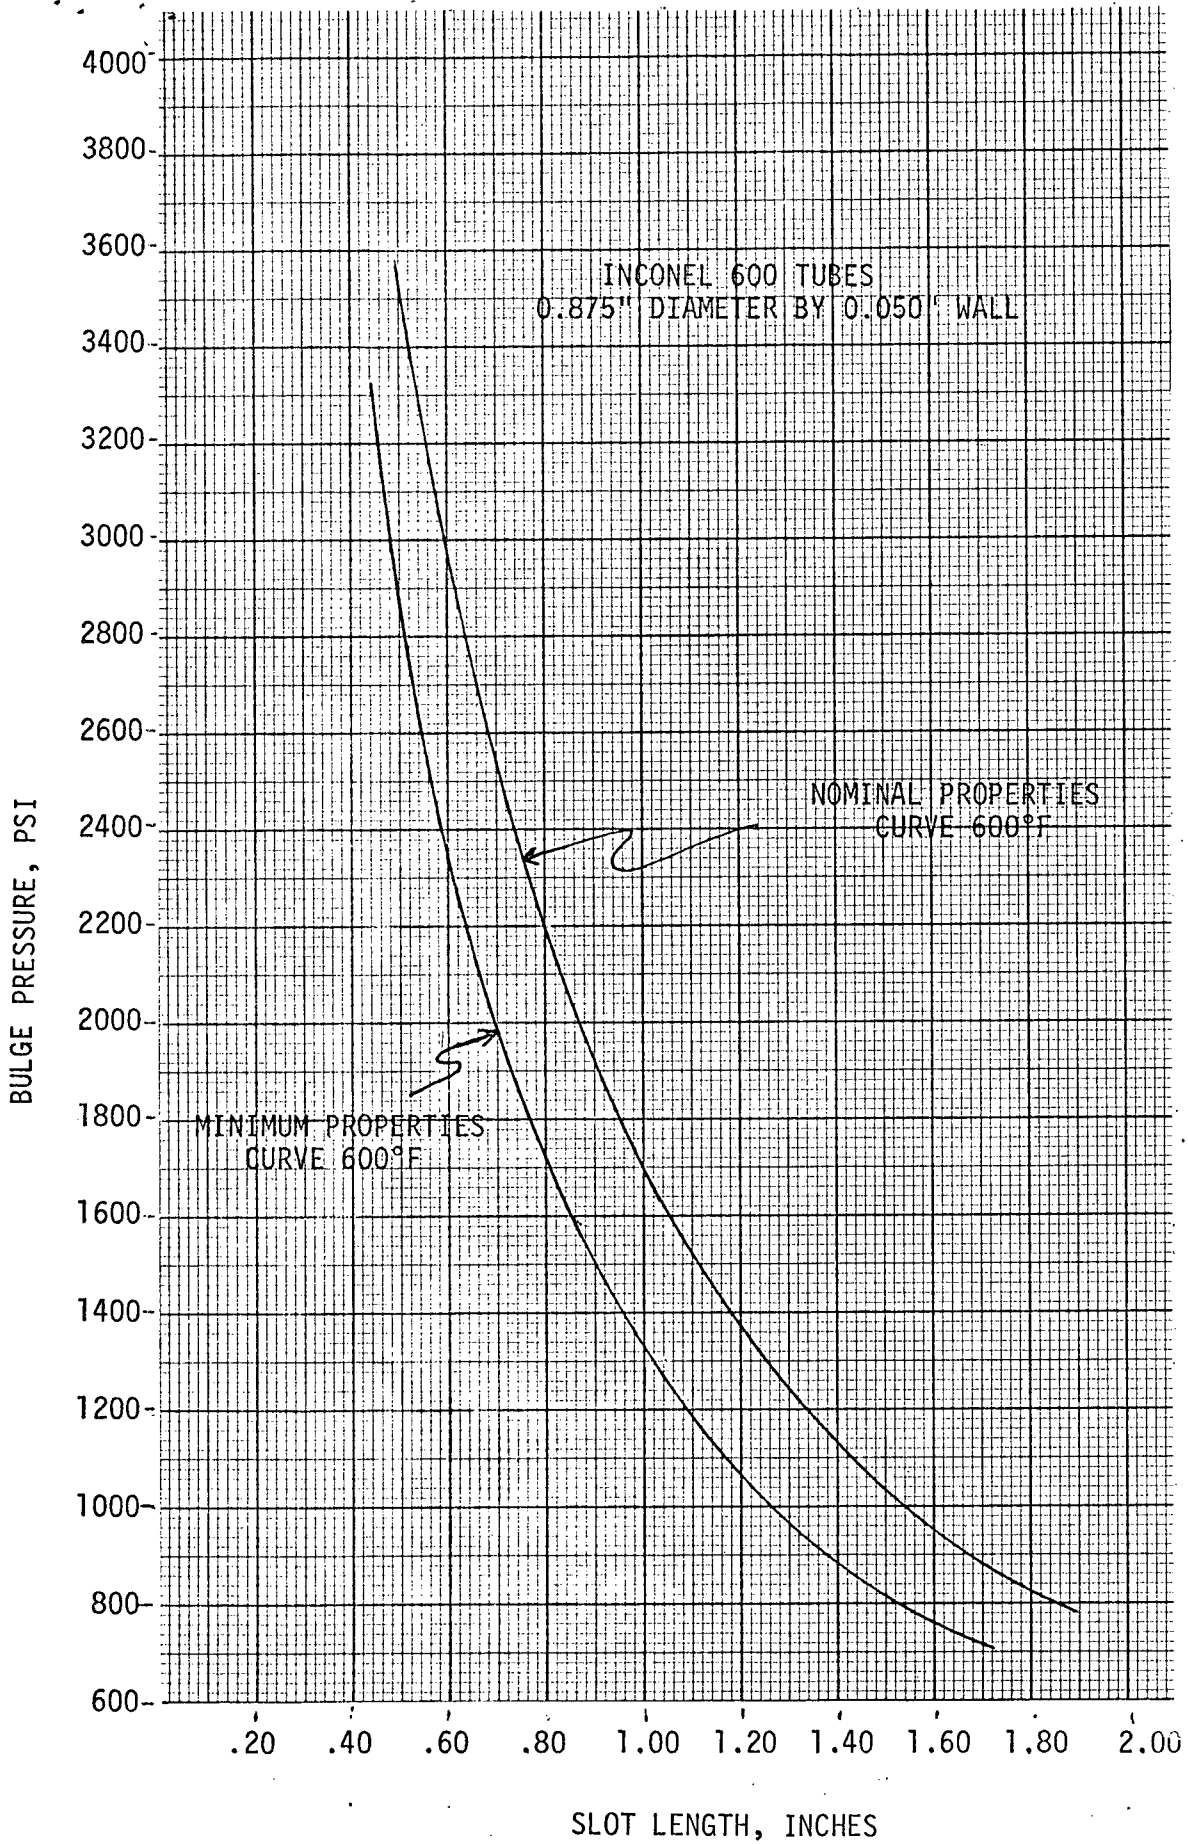
Figure 5 BULGE PRESSURE VERSUS THROUGHWALL
DEFECT LENGTH

The results of these tests on the 7/8" diameter tubing indicated that the bulge pressure as a function of through-wall defect length for both new and service exposed tubes exhibited the same behavior, as was expected. Figure 5 is a plot of bulge pressure versus through-wall crack length. It is noted from this plot that the bulge pressure increased with decreasing crack length. A crack 0.6 inches long could be supported without bulging of the tubing at a pressure above 2300 psi with minimum allowable material properties at 600°F. With nominal properties of the material a pressure of 3000 psi can be supported without bulging.

tubing in the CP&L plant a .6" through wall crack would have a bulge pressure of 2300 psi based on minimum material properties (Figure 5) and 3000 psi based on nominal properties. This leak rate is well in excess of that at which it is currently required⁽¹⁾ (.3 gpm) that the plant be shutdown and the leak repaired.

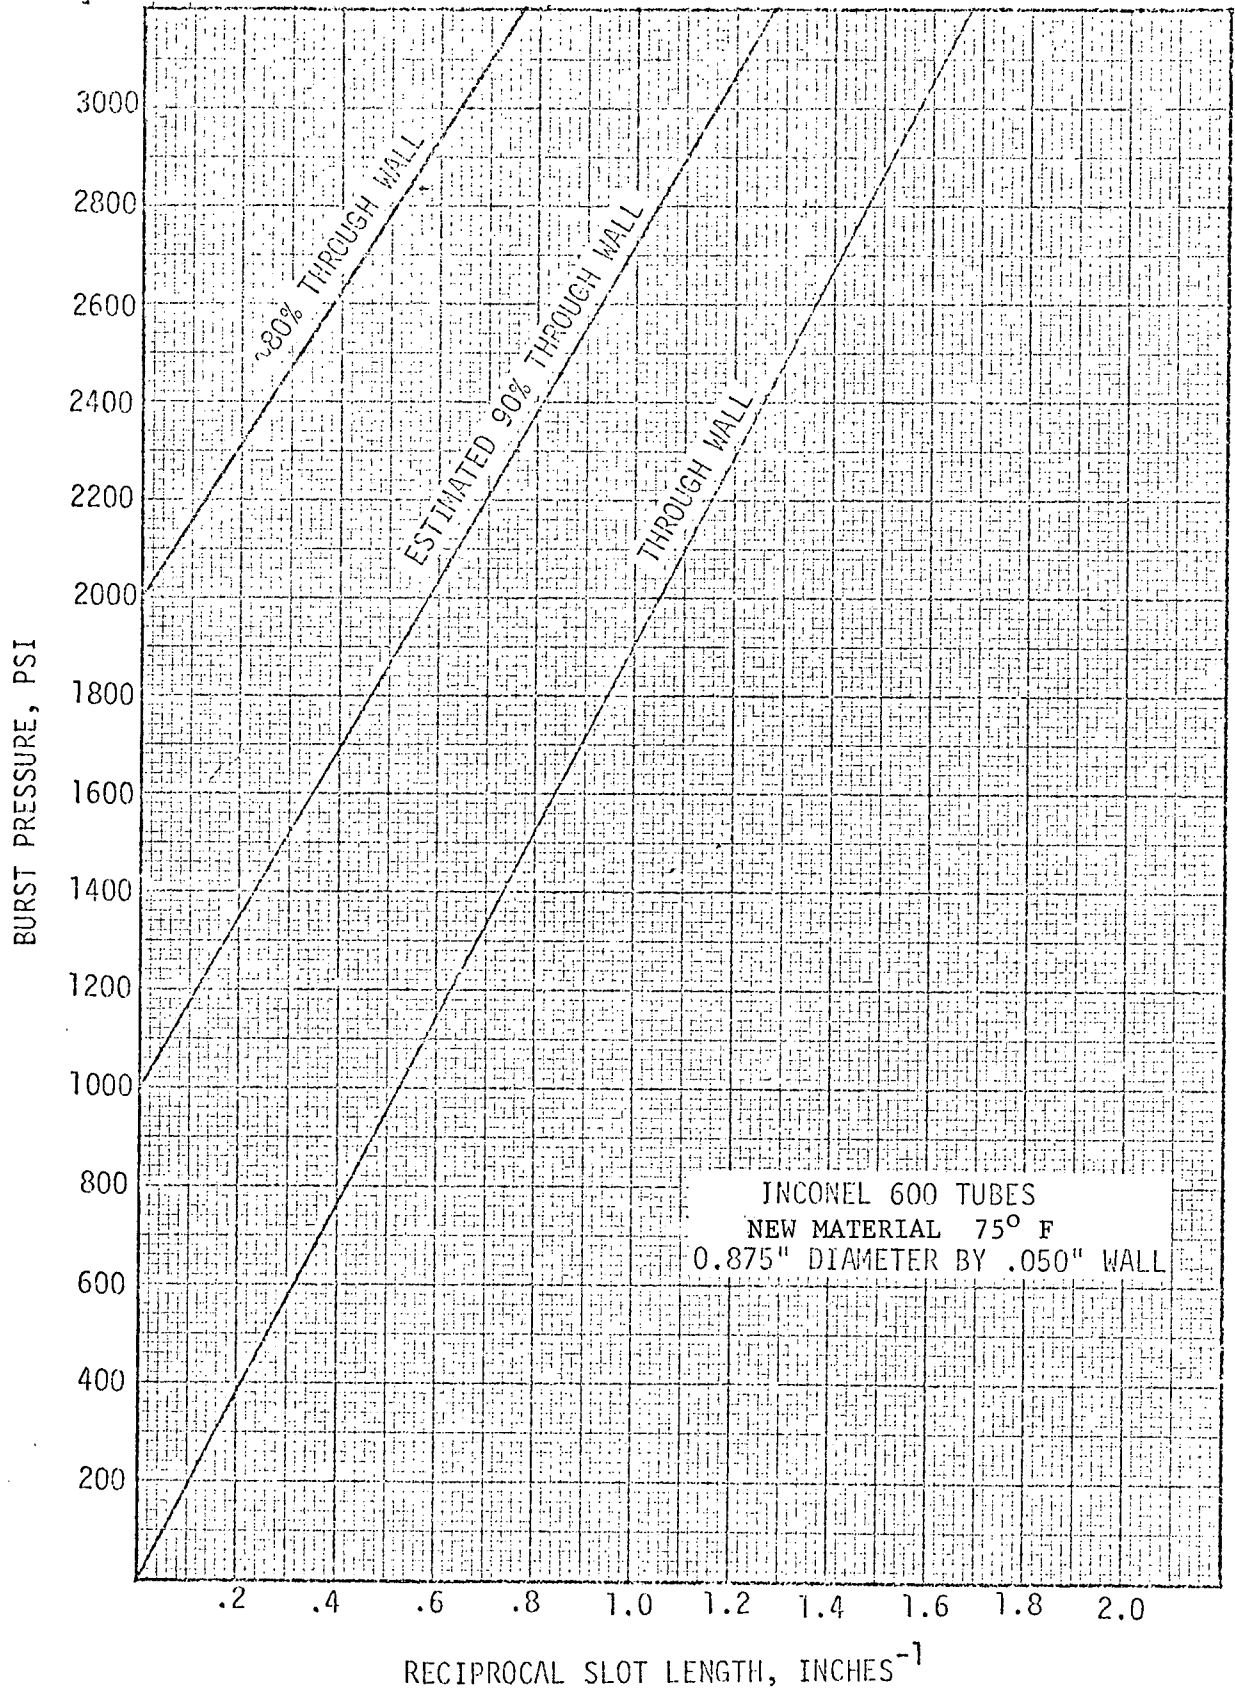
In order to further characterize the strength of Inconel 600 tubes in the presence of flaws, burst tests were conducted on tubes having electric discharge machined (EDM) defects part way through the wall. In general, the slots were performed with 7/8" O.D. tubing. Figure 6 is a plot of burst pressure versus reciprocal crack lengths. It will be noted from this data that tubing with 80 and 90% through-wall penetration has substantial additional strength as compared to the through-wall data. For comparison the through-wall defect data is plotted on this figure also.

BURST PRESSURE VS RECIPROCAL
SLOT LENGTH FOR VARIOUS SLOT DEPTHS

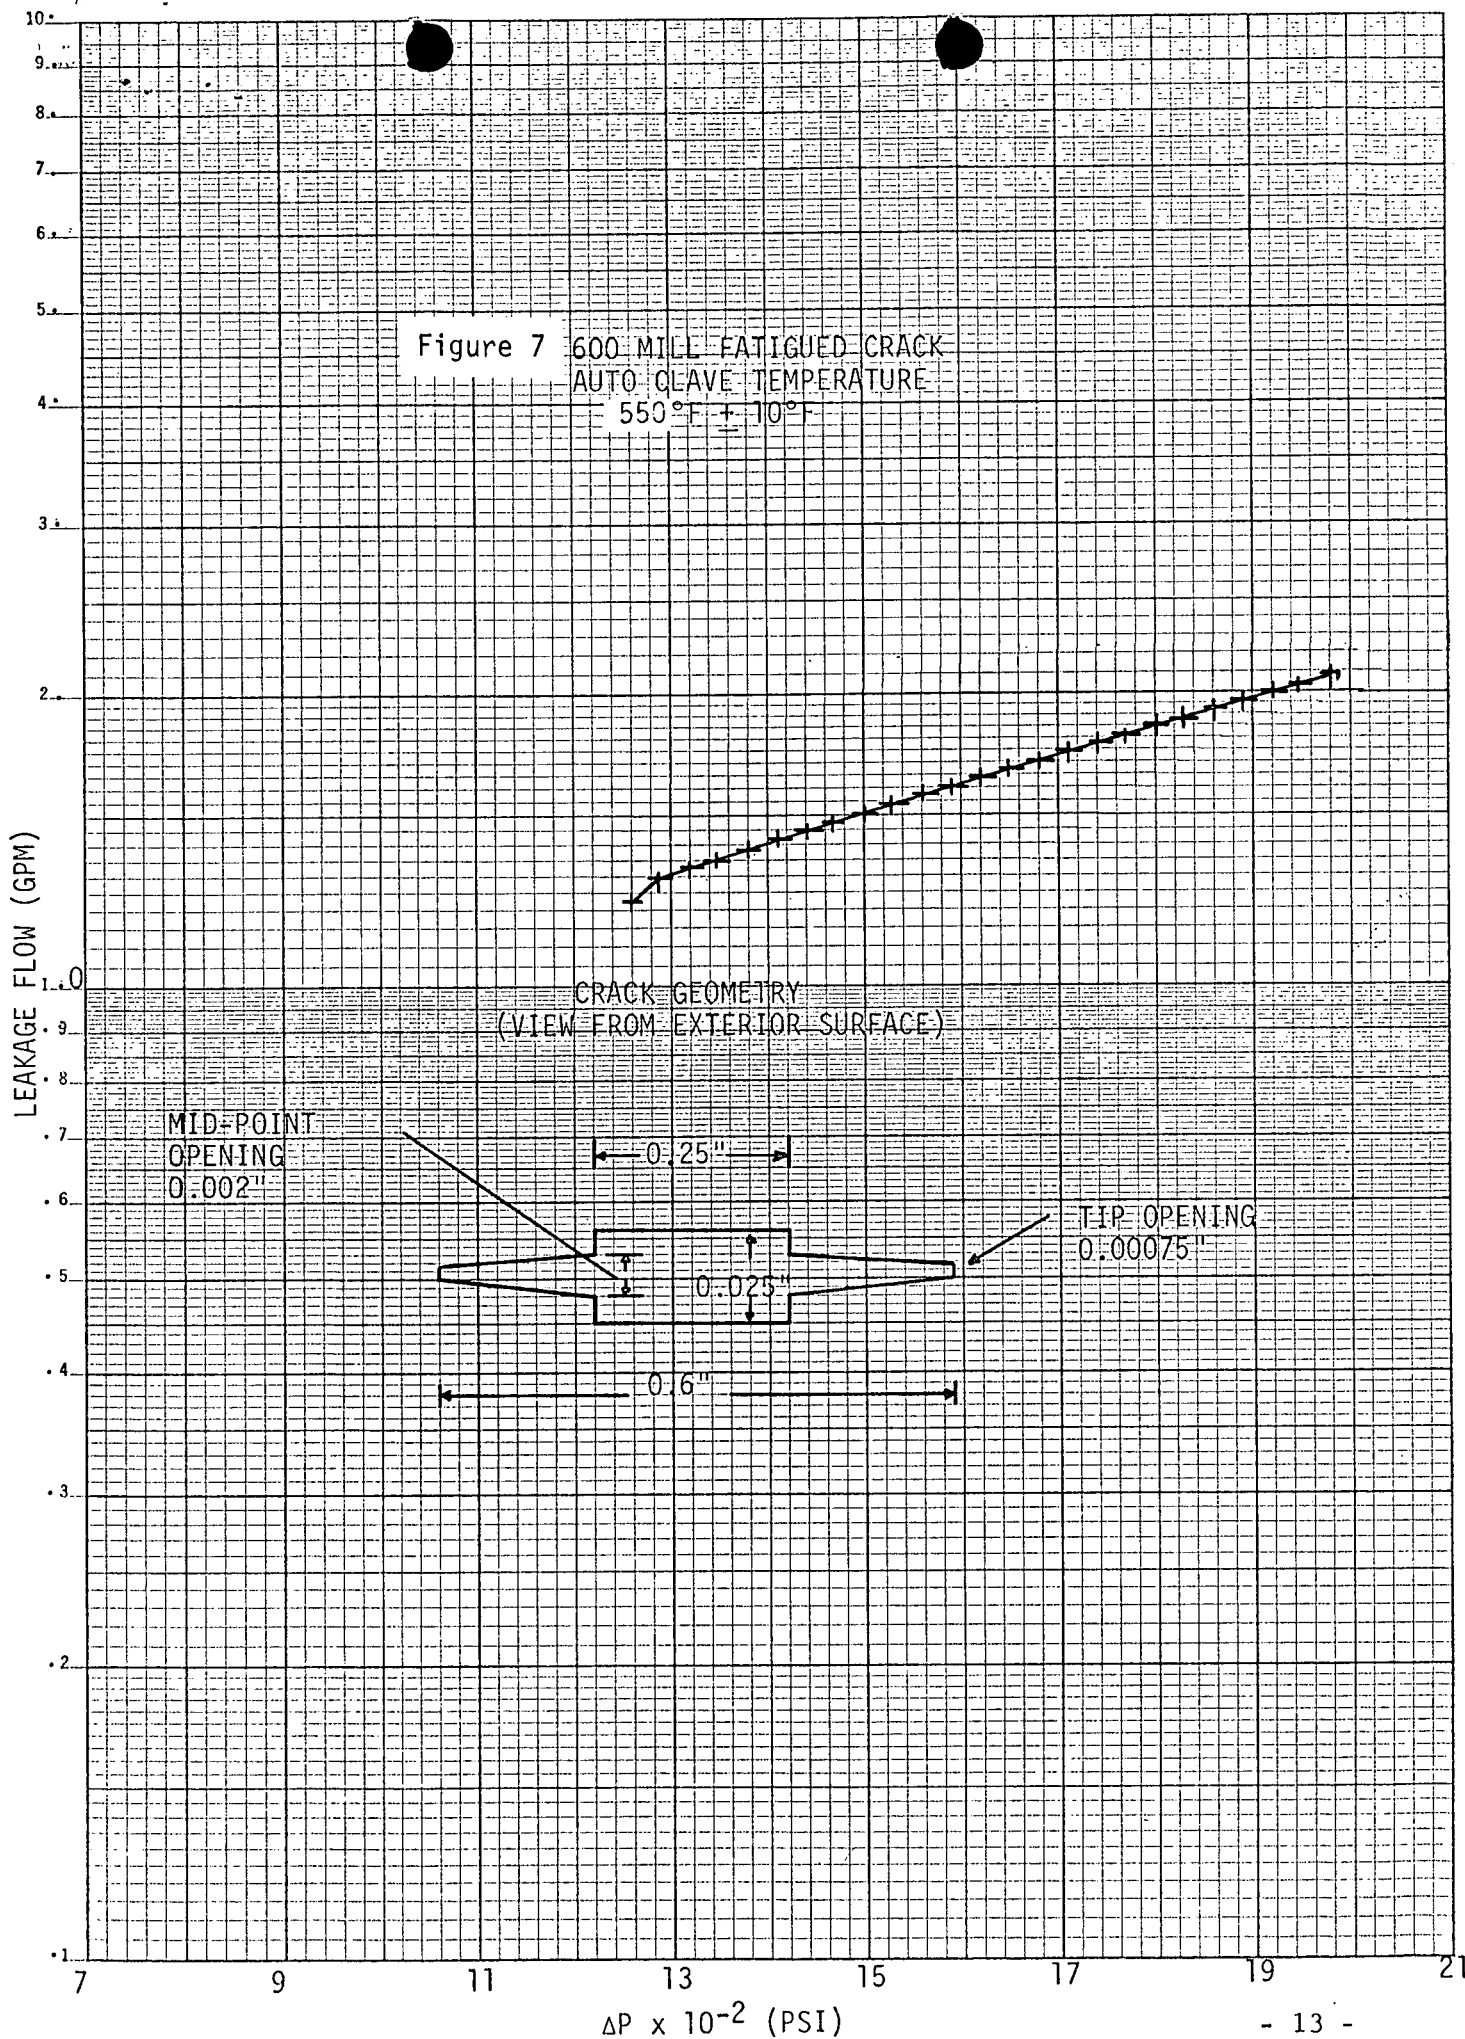
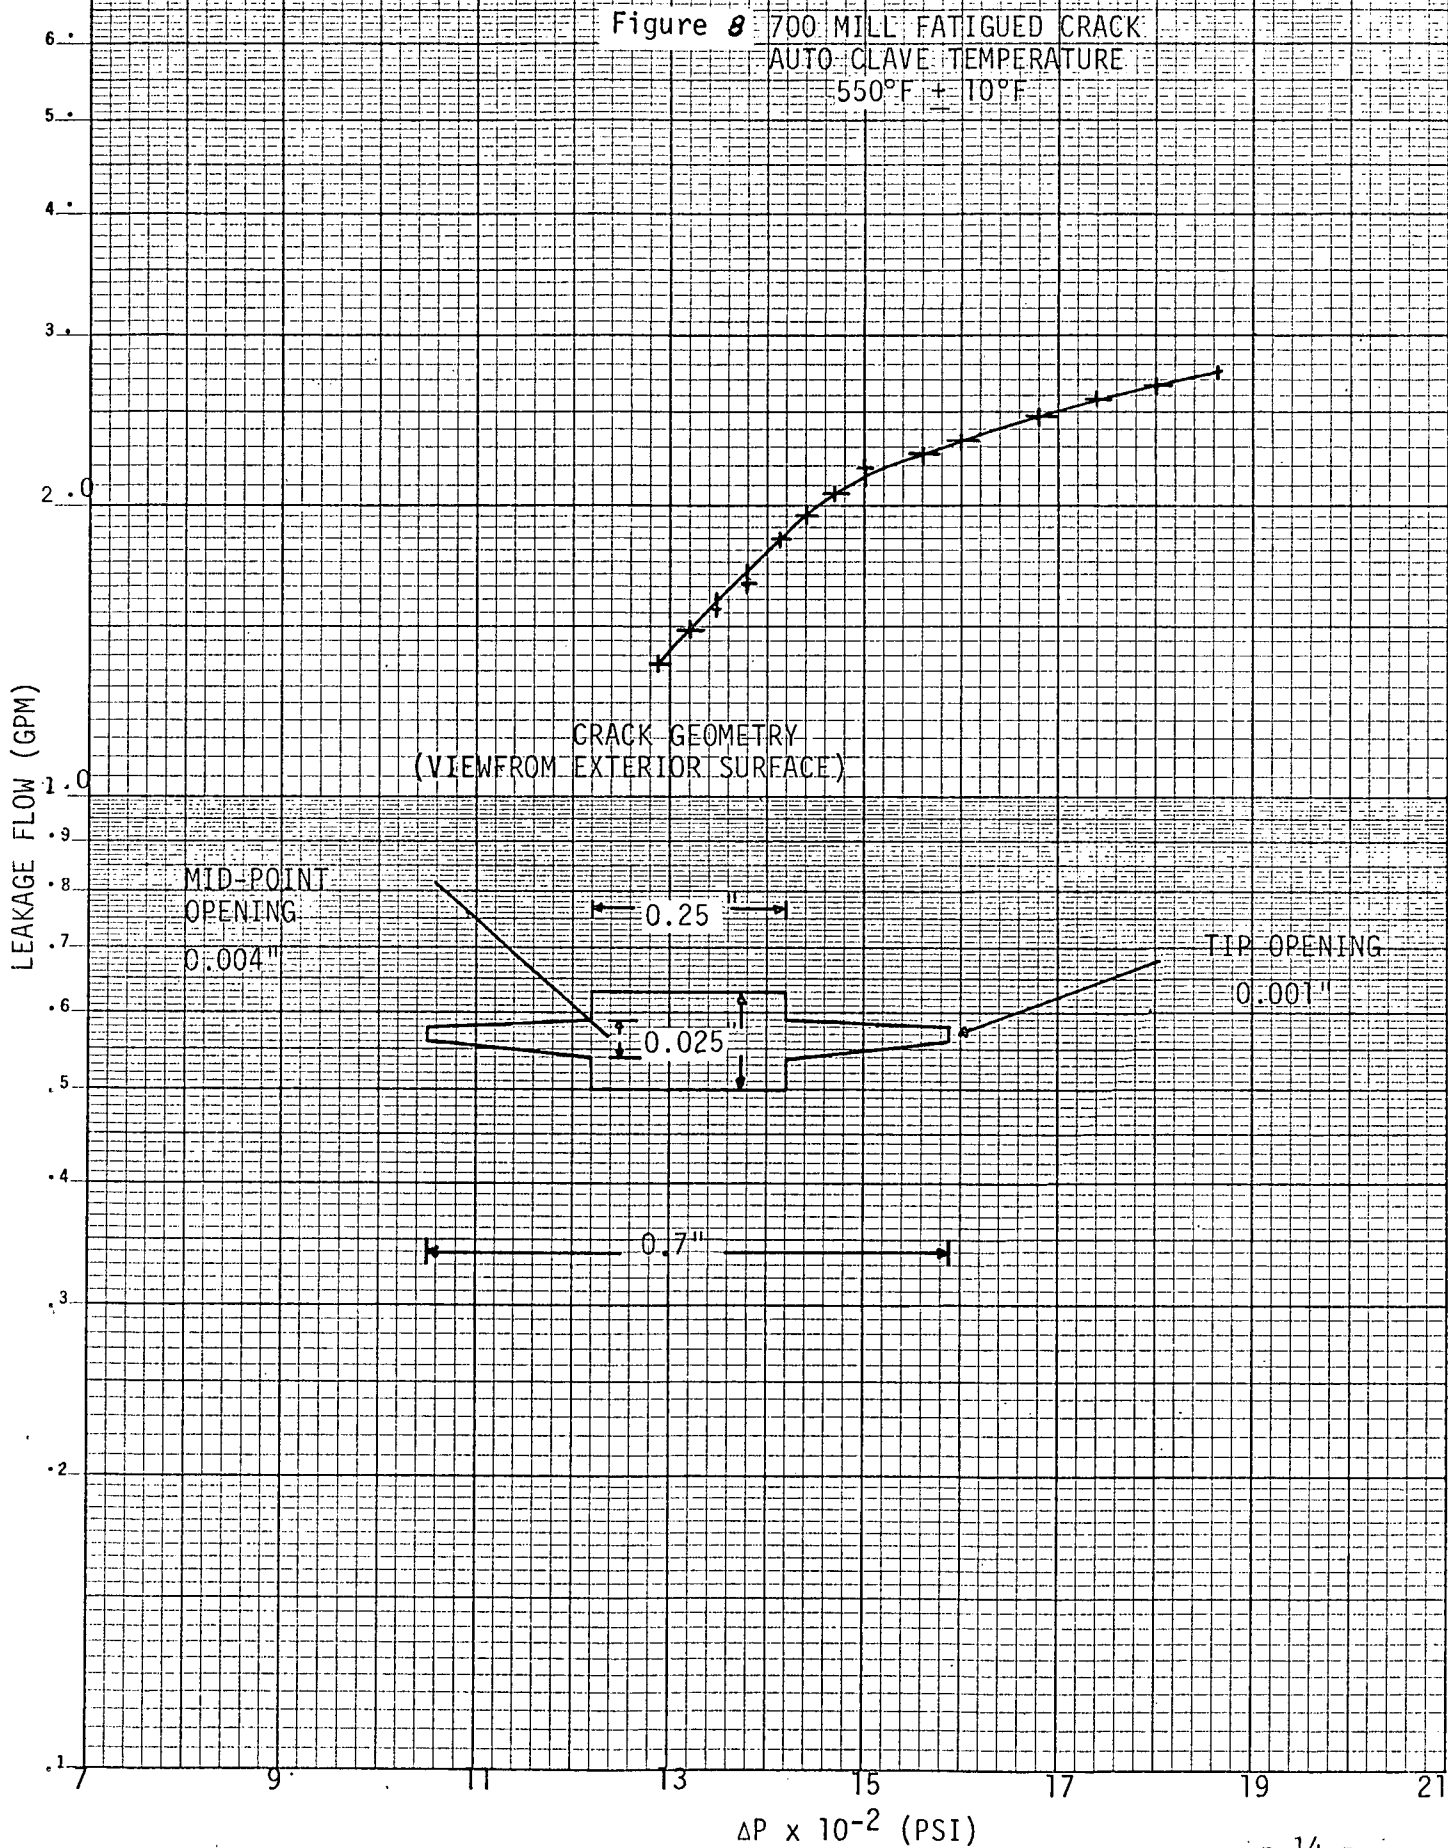
The results of these tests for a .6" and .7" crack are shown on Figures 7 and 8 respectively. It will be noted that in both cases, at 1400 psi which is the operating pressure differential across the steam generator tubes at power, the leak rates are in excess of 1 gpm. In addition for all the tubes tested (.5" through .8" long cracks) the tubes retained their original round shape after the maximum pressure (2000 psi) was relieved from the system. The results confirm the results of the through-wall pressure testing previously discussed in the Mechanical Testing Program Section and further indicate the ability of the tube to withstand this pressure differential.

At a pressure differential of 1400 psi, which corresponds to the normal operating pressure differential, with a .6" through wall tight fatigue crack, a leak rate of approximately 1.4 gpm has been measured. For the
