PART 21 REPORT - DEFECTIVE BARTON DIFFERENTIAL PRESSURE SWITCHES

PRODUCT ADVISORY

Model 288A, 289A, 580A and 581A Differential Pressure Switch Defect

DOCUMENT NO.: 210052426.01

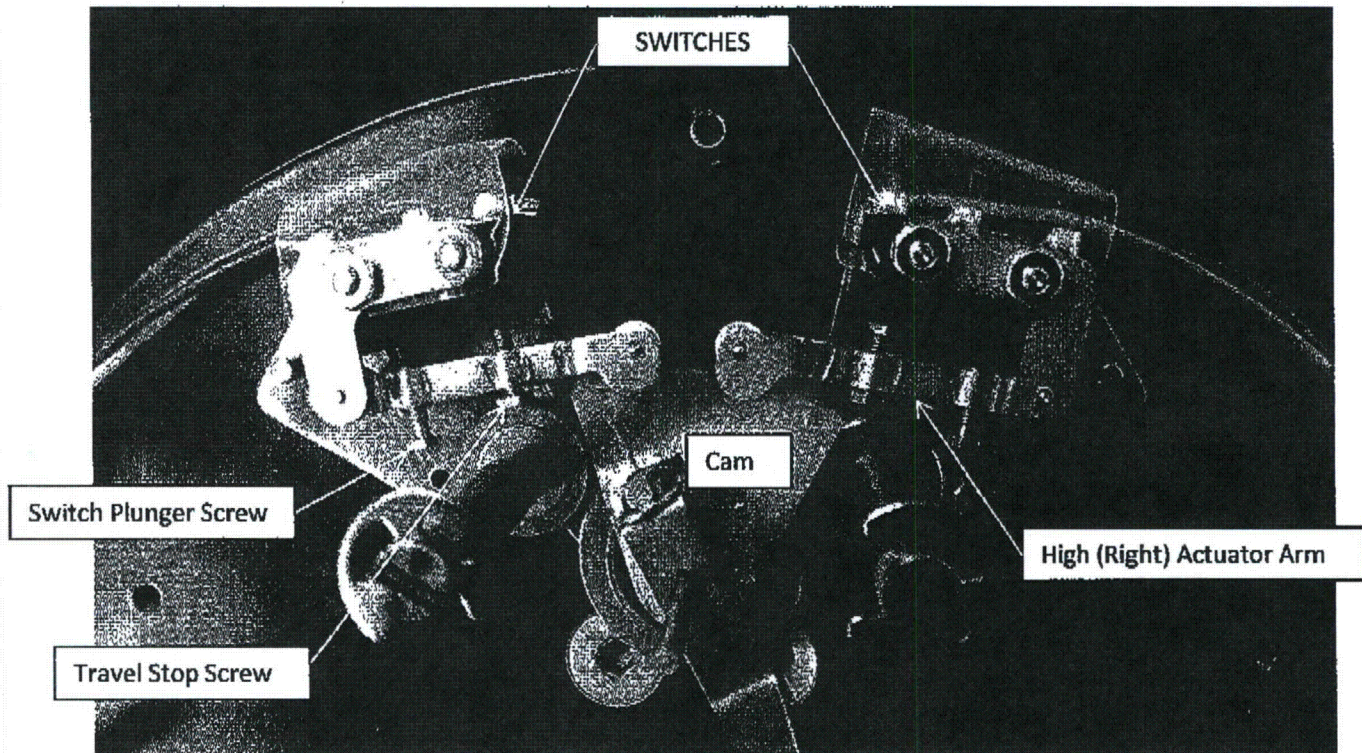
MODEL 288A/289A SWITCH OPERATING MECHANISM MOCKUP
(Model 580A/581A Switch Operating Mechanism is similar)

During routine receipt inspection of a recent purchase of the screws in question, some screws with undersized screw threads were discovered. During an investigation into our existing stock, Cameron discovered that the same condition also existed in some of these parts which were procured earlier this year.

Testing performed to evaluate the significance of the of the non-conforming condition revealed that the force of the miniature switch internal operating features can cause the thread "locking" material to be displaced allowing an undersized plunger screw to change its set position resulting in a change in the point where the switch will actuate (change in contact position). Screws with conforming threads did not demonstrate the same issue. The maximum change in screw position observed during this testing effort equates to a switch set point change of approximately 8.4% of the instrument's factory calibrated span.

Cameron recommends that utilities perform increased switch set point verifications on the instruments affected by this notification. It is not possible to determine which of the switches might have nonconforming switch plunger screws. Therefore, Cameron recommends that new switch actuator arm assemblies be replaced on any unit that is evaluated to be a concern by our customers. These replacement parts are available in the Cameron stock system and will be supplied free of charge for any of the products included within the scope of this notification. The P/N's for the replacement assemblies are identified on the following page.
