LICENSEE EVENT REPT (RO 50-261/78-06) ON 03/05/78 CONCERNING INDICATIONS AT
NINE LOCATIONS IN THE INLET AND OUTLET PIPING OF THE BORON INJECTION TANK
WERE FOUND.

PLANT NAME: H B ROBINSON - UNIT 2

H. B. ROBINSON STEAM ELECTRIC PLANT, UNIT NO. 2
DOCKET 50-261
LICENSE NO. DPR-23
LICENSEE EVENT REPORT 78-06

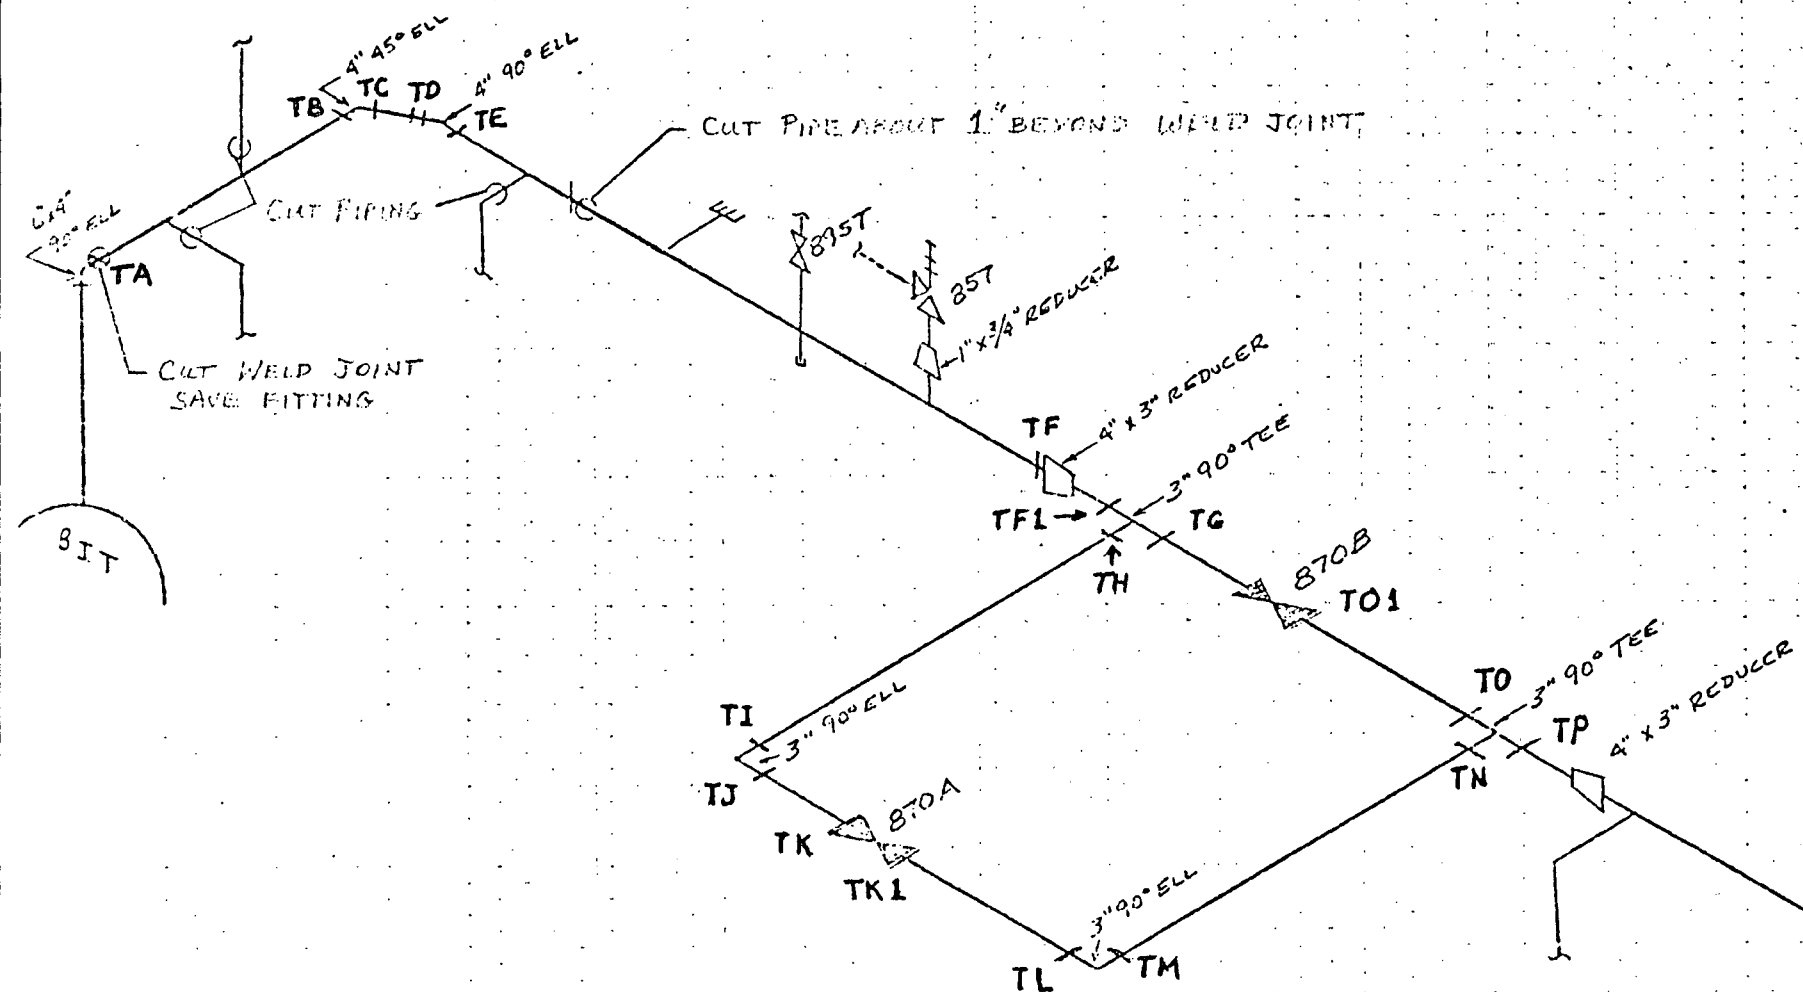
BORON INJECTION TANK OUTLET PIPING

Referring to the attached isometric drawings of the BIT inlet and outlet piping, the ultrasonic examination revealed indications at pipe to fitting welds BA, BB, BC, BF, BH on the inlet piping and TA, TB, TC on the outlet piping. An indication at pipe to pipe butt weld TD was also discovered.

It should be noted that the indications found were only on the pipe side of heat affected zones of weldments. The heavier bodied fittings of the same material do not show any indications.

INDICATIONS ON TA, TB, TC, AND TD

Immediate action taken was to replace the affected portion of the safety injection system piping. Type 316L stainless steel is being used to replace the type 316 material affected. The 316L material is less susceptible to the type of corrosion cracking found in other plants which has led to these type indications. The attached isometric piping drawings define the portion of the piping system being replaced. Replacement will be completed before the end of 1978 refueling outage and subsequent return to full power conditions.

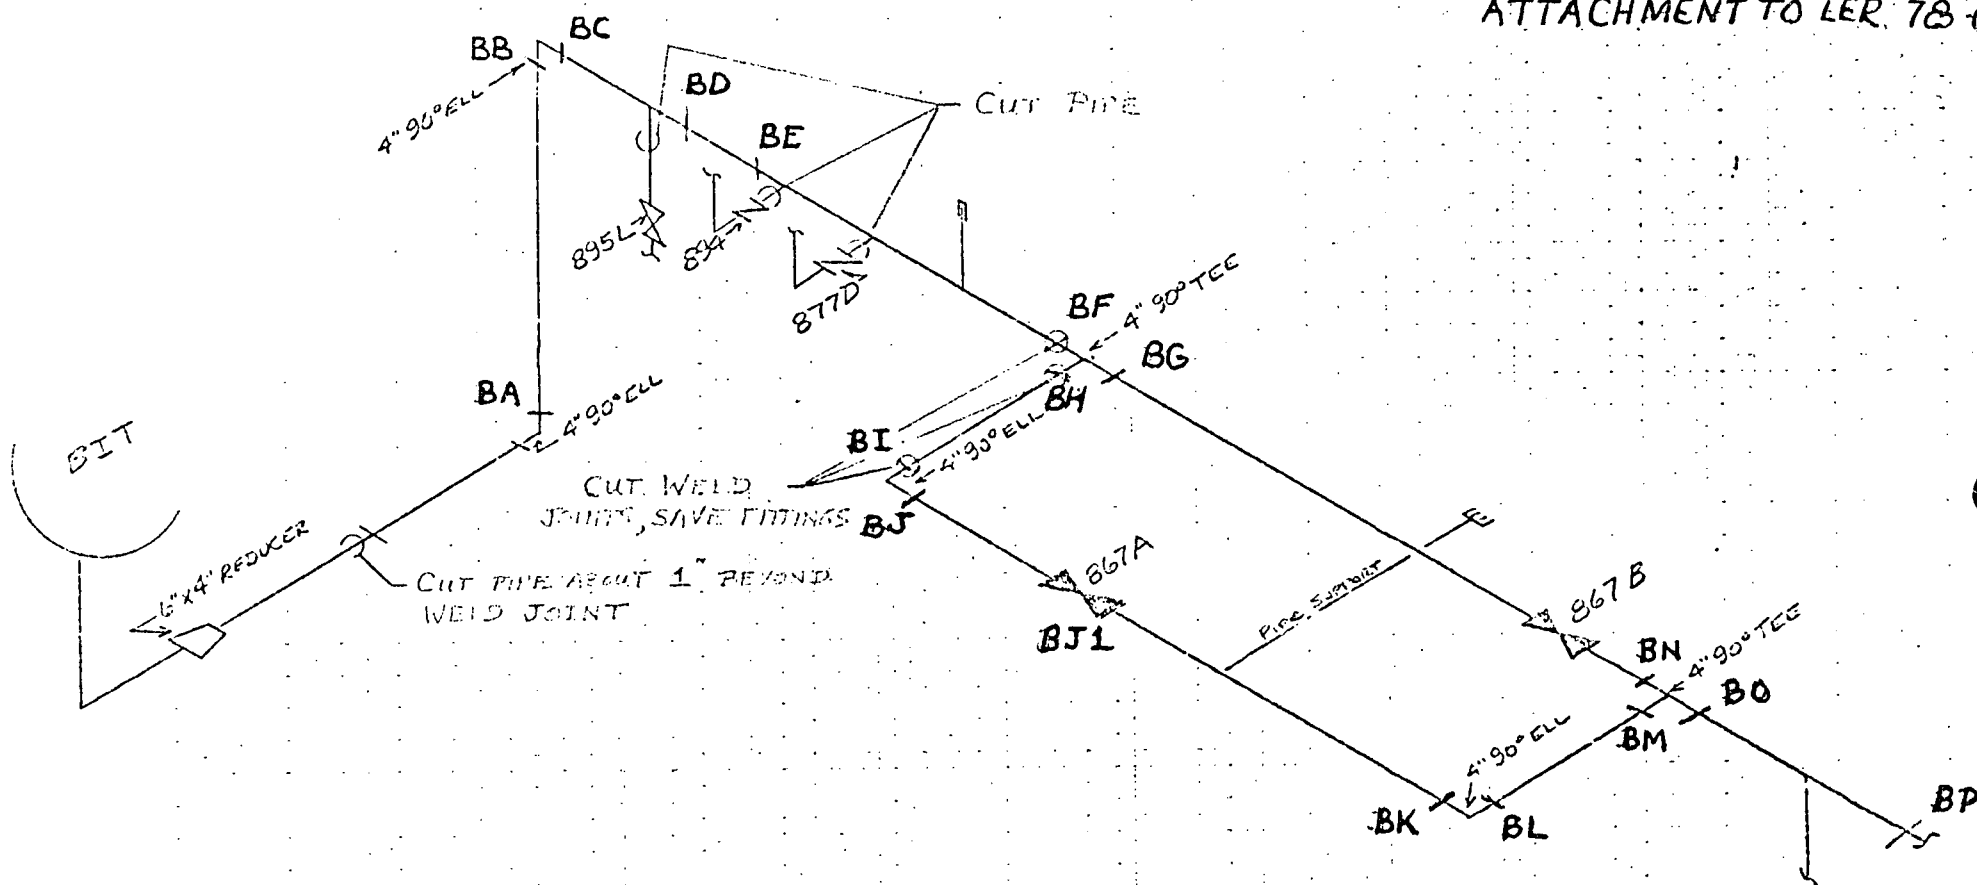
BORON INJECTION TANK INLET PIPING

INDICATIONS ON BA, BB, BC, BF, BH
