**SUBJECT: PALISADES NUCLEAR PLANT, NRC INSPECTION REPORT 05000255/2014010,
PRELIMINARY WHITE FINDING**

Report No: 05000255/2014010

Facility: Palisades Nuclear Plant

Inspection Report 05000255/2014010, 8/11/2014 – 10/30/2014, Palisades Nuclear Plant, Occupational Dose Assessment.

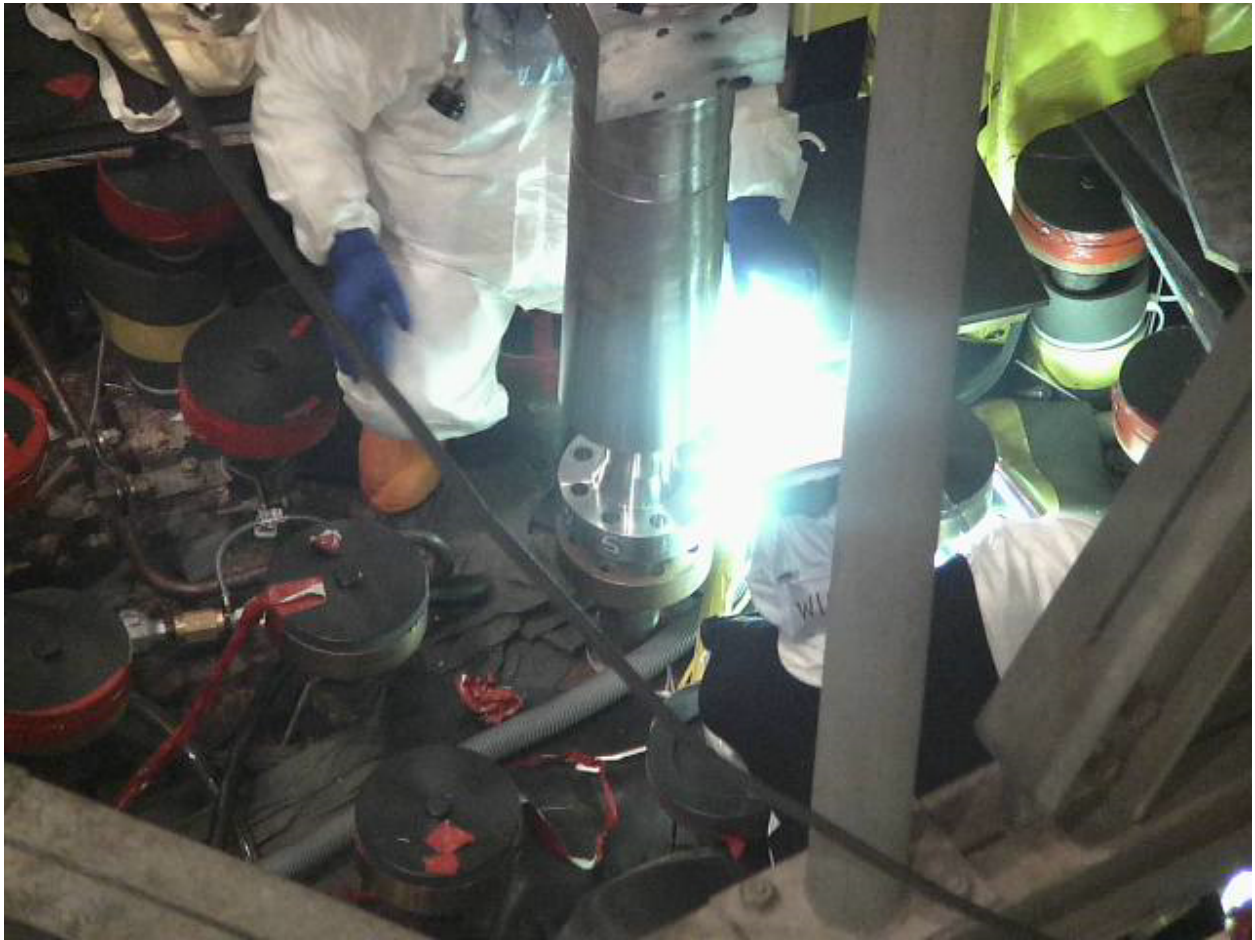
Worker at 11 o'clock not wearing a shield vest and appears to be seated.

Worker at 5 o'clock wearing a shield vest and appears to be seated.

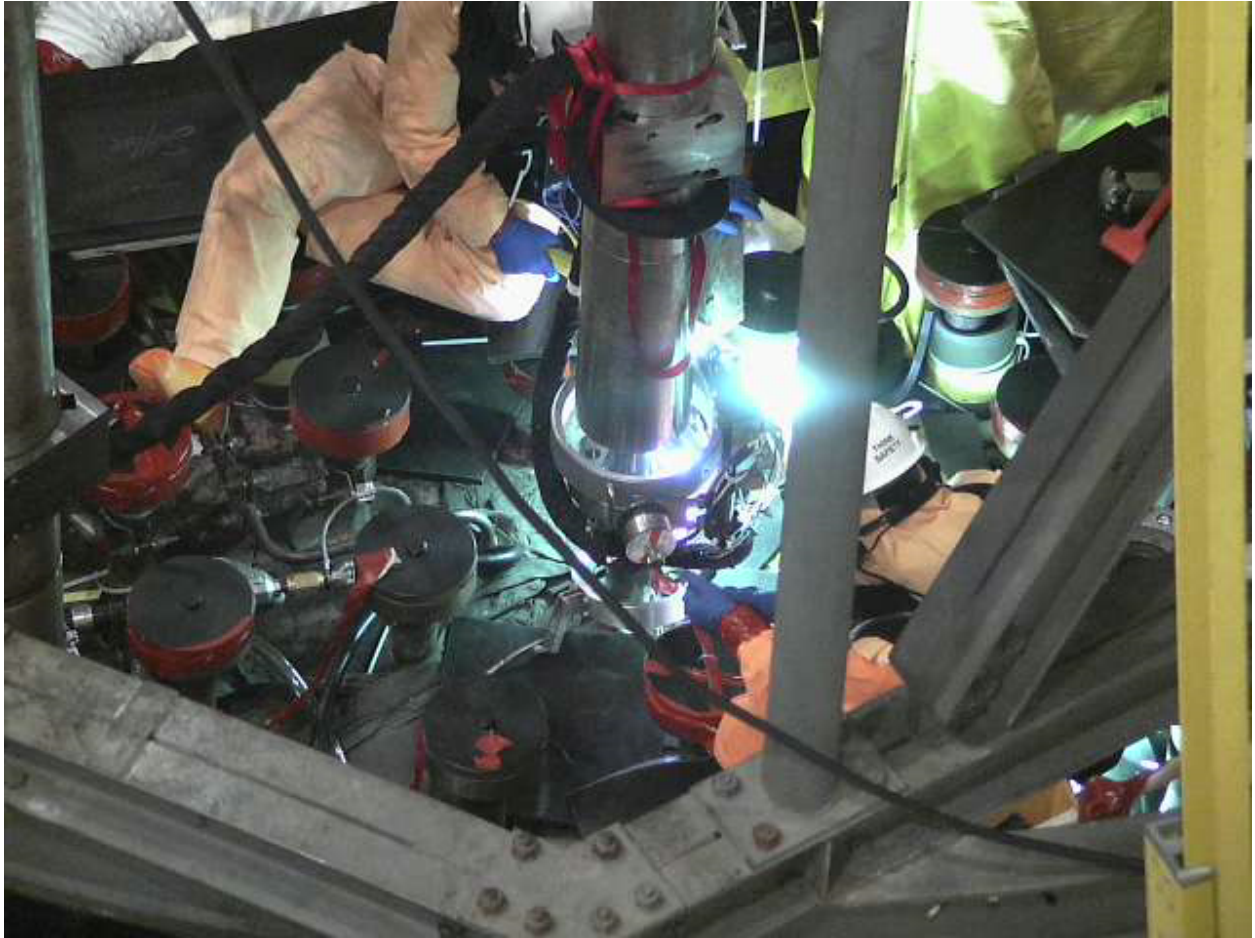
Worker at 11 o'clock wearing a shield vest and appears to be seated.

Worker at 5 o'clock wearing a shield vest and appears to be seated.

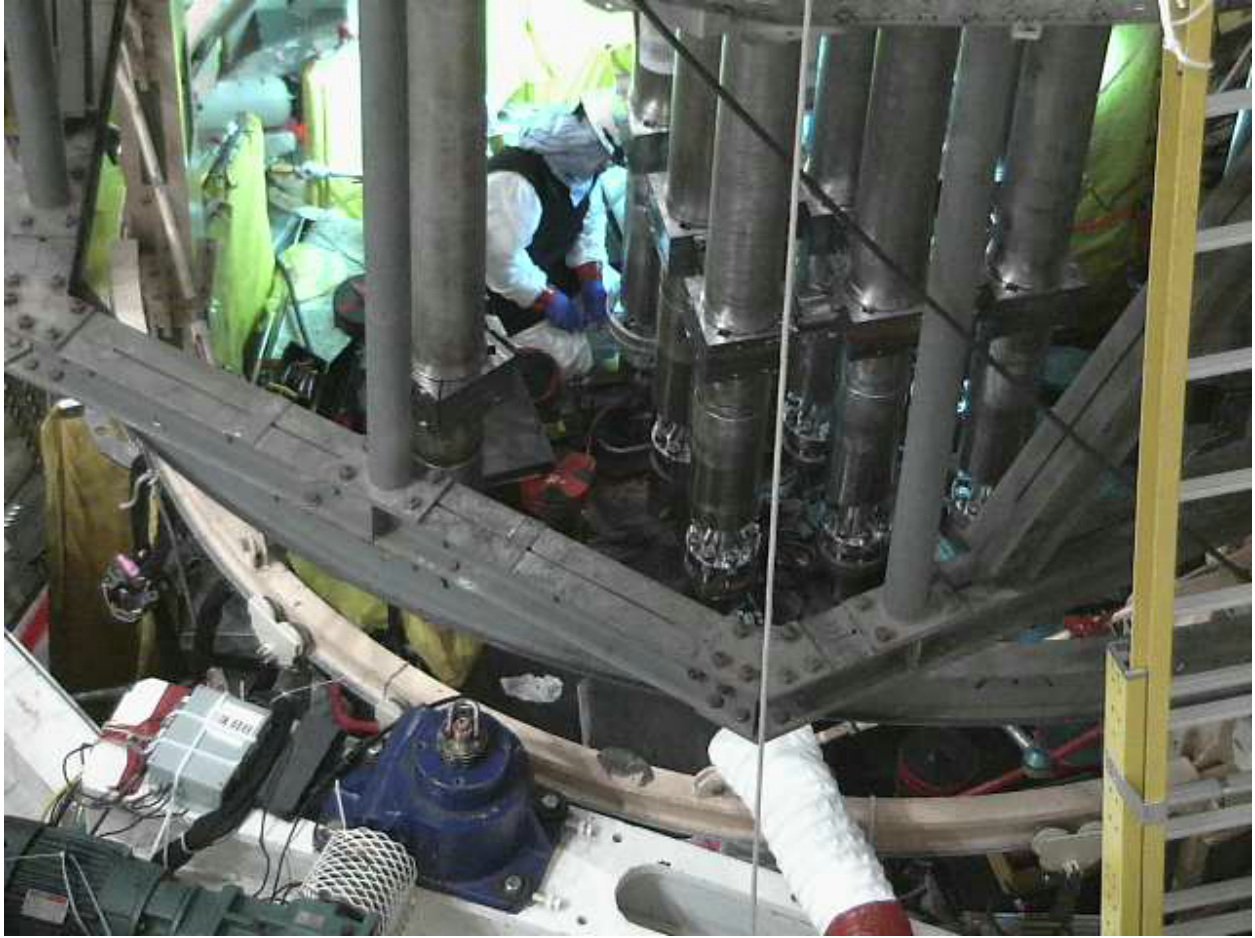
Worker at 11 o'clock wearing a shield vest with an apparent gap between the front vest and side back vest and appears to be seated.
