**UNITED STATES
NUCLEAR REGULATORY COMMISSION**
REGION IV
1600 E LAMAR BLVD
ARLINGTON, TX 76011-4511

EA-14-228

**SUBJECT: WATERFORD STEAM ELECTRIC STATION, UNIT 3 – NRC COMPONENT
DESIGN BASES INSPECTION REPORT 05000382/2014007 AND PRELIMINARY
GREATER THAN GREEN FINDING**

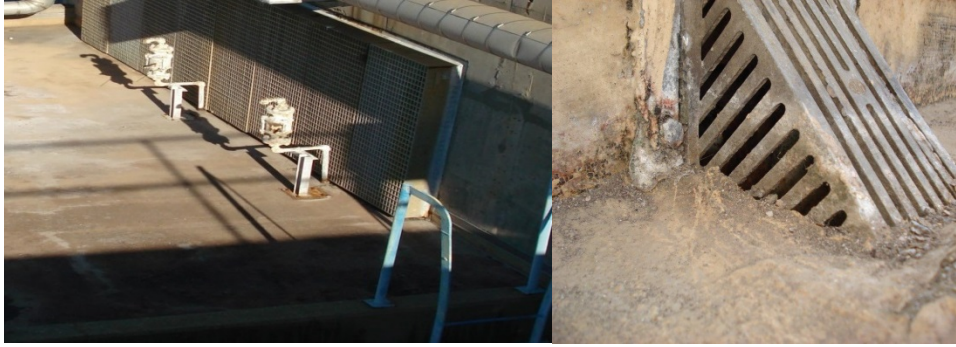
Both the train A and B vents were located on the roof of the same structure. The roof has a berm along the top of the perimeter. The photo on the right captures the scupper enclosure. All of the roof water would drain through this single drainage point. A piece of foreign material was also found on the roof. This material could block a portion of the scupper.

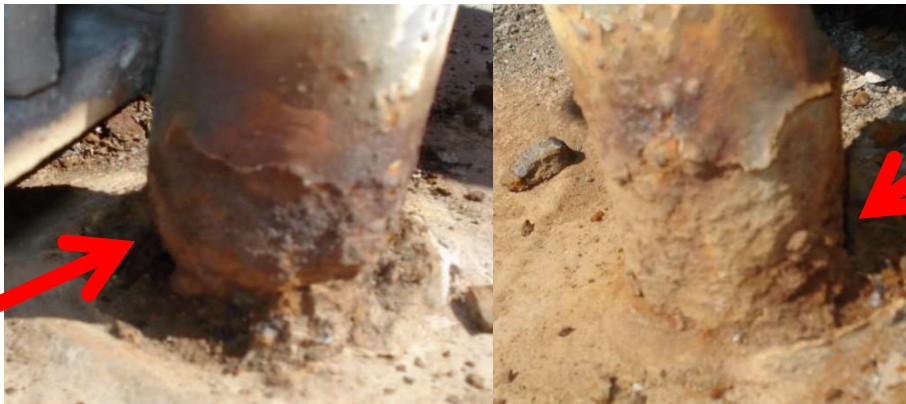
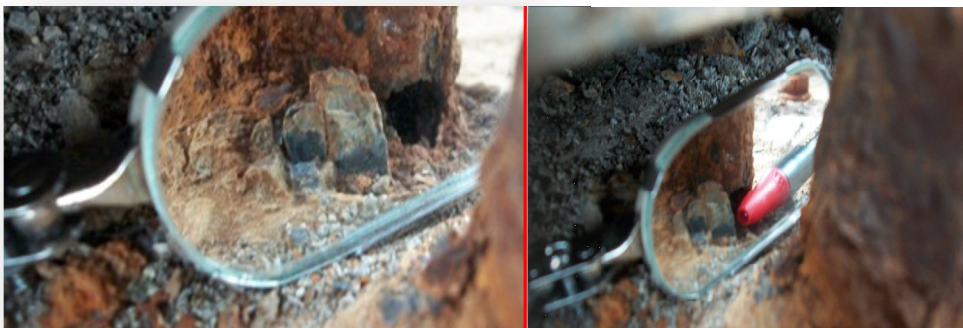
The above photos capture the thru-wall holes at the base of each 1 inch diameter vent pipe, where they exit the roof. A head-on view of the West vent hole is provided in the two pictures below. The East hole is not shown and was reported by the team as being the larger hole. An ink pen is shown in the right picture for perspective.

Third, the vendors assumed that the holes were $\frac{1}{4}$ inch in diameter. This was based on the pen that was used for perspective and appeared to be a best judgment case. There were no dimensions given for the pen. The hole appeared to be larger than the diameter of the pen. The team estimated that the holes could be $\frac{1}{2}$ inch in diameter.

The licensee performed an immediate operability determination and concluded that the diesel and its support systems were operable based on no severe weather in the area. While evaluating permanent corrective actions, the licensee installed a temporary repair to the vent pipes using a rubber wrap and installed a small concrete berm to minimize the potential amount of water in the immediate area. This finding was entered in to the licensee's corrective action program as CR-WF3-2014-05413.

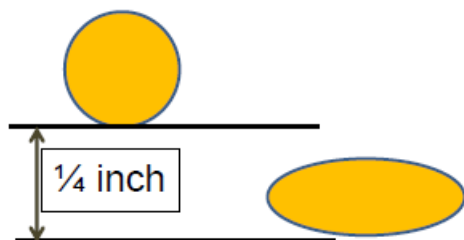
The following diagram demonstrates the differences between the hole position and the shape, discussed above. The vendor's representation is the circular hole whereas the oblong hole was that described by the inspection team. As one can see, water will start to enter the oblong hole earlier and a larger cross section would be exposed to the surface water. Considering that the most important variable is the water level at the edge of a hole, the importance of this assumption can't be minimized. In addition, the elevation of water near the hole is dependent on the rain intensity and the rate at which water drains away from the vents. It's important to note that an inch per hour increase in rain intensity only amounts to a fraction of an inch change in water level at the piping holes.

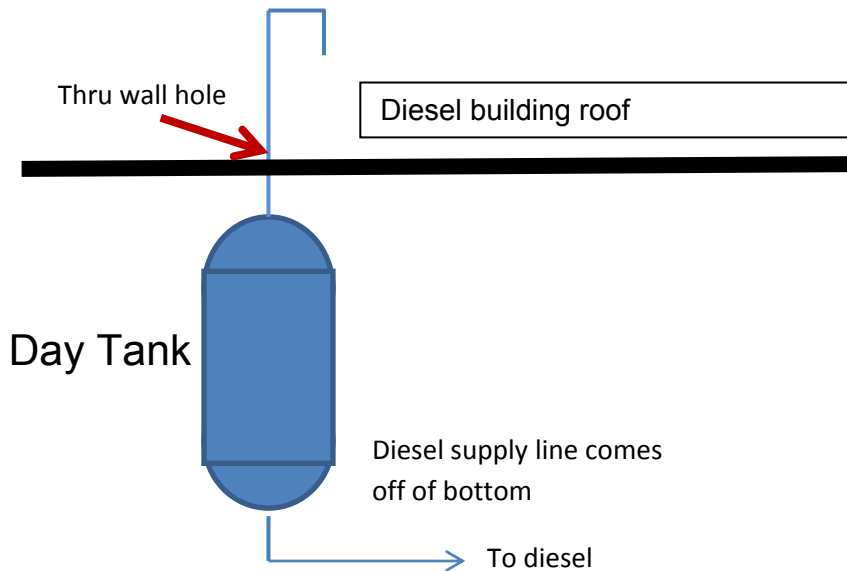
- The simplified drawing below is typical of both day tank configurations. The vents protrude through the diesel generator building roof and into the same drainage area.

- During a heavy rainfall event, water entering the through-wall vent holes would fall into the day tank. Since water is heavier than oil, the water would proceed to the bottom of the day tank. The fuel oil supply lines were attached to the very bottom of the tanks. Consequently, water that entered the tanks would transit directly to the supply lines and to the diesels. Both diesel generators were vulnerable to this problem.
