Robinson File No.: 13510
Serial: RNP-RA/96-0189

H. B. ROBINSON STEAM ELECTRIC PLANT, UNIT NO. 2
DOCKET NO. 50-261/LICENSE NO. DPR-23
INFORMATION REGARDING WATER HAMMER EVENT
ON SAFETY INJECTION LINES DURING TESTING

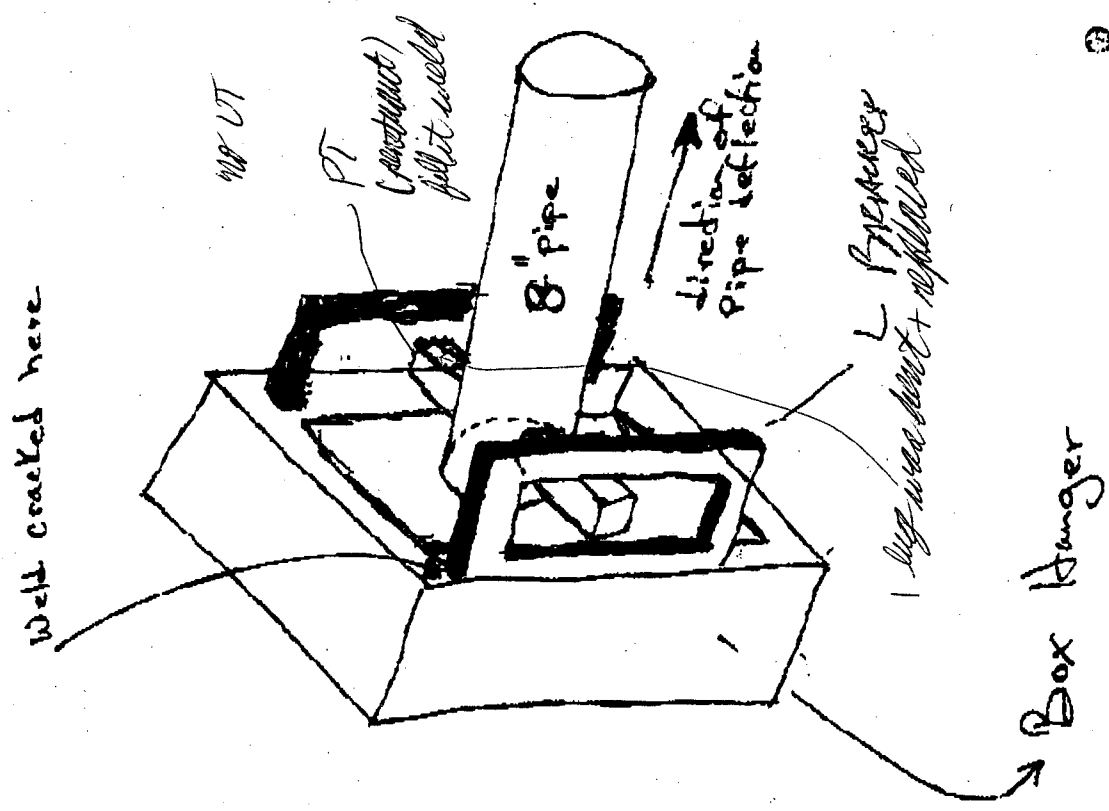
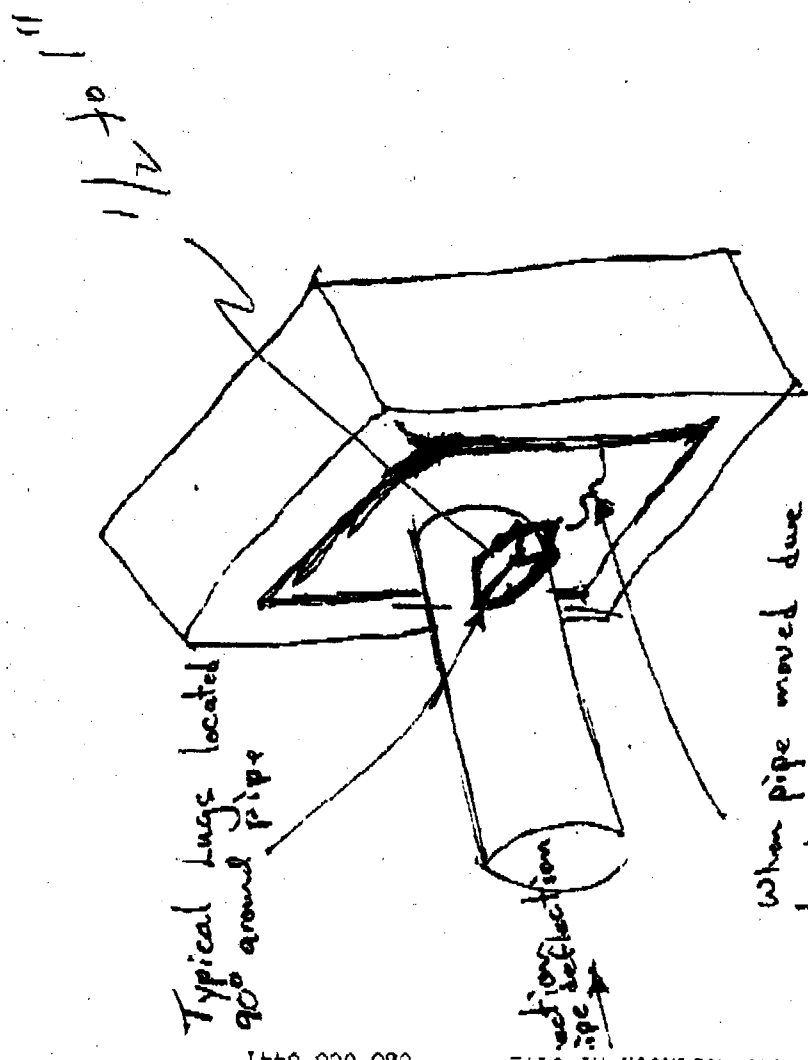
The damage to seismic restraint Support SI-2-2434 consisted of a bent lug capture plate, a bent abandoned welded pipe attachment, and minor spalling of grout and concrete at the embedment plate with no undercutting of the embedment noted. Welded pipe attachments on the remaining seismic restraint supports were visually inspected and no signs of damage were found. Hot load spring settings for spring Supports SI-2-443 and SI-2-451 were observed to be well within the required range. The hot load spring setting for spring Support SI-2-6020 could not be observed due to difficult access conditions; however, the information from spring Supports SI-2-443 and SI-2-451 located upstream and downstream of spring Support SI-2-6020 indicate that spring Support SI-2-6020 is acceptable.

Since seismic restraint Support SI-2-2434 was modified to add the capture plates during Refueling Outage (RO) 16, and no damage to the welded attachments was observed at that time, we have concluded that the damage to seismic restraint Support SI-2-2434 was the result of this water hammer event. The damage to this support and eyewitness accounts of the event indicate that this event was of greater magnitude than minor pressure transients that have been known to occur during past performance of this test; however, the repairs to the piping and supports have restored the piping and supports to the original design qualification.

The damage to the abandoned welded pipe attachment on seismic restraint Support SI-2-2434 was repaired by grinding down the broken welded pipe attachment. The bent lug capture plate on seismic restraint Support SI-2-2434 was repaired. The pipe wall and welded attachment welds were examined utilizing the dye penetrant examination method and were found to be acceptable. The seismic restraint Support SI-2-2434 was inspected visually (i.e., VT-3), and after retorquing of anchor bolts, was found to be acceptable. The bolts on seismic restraint Support SI-2-6021 were retorqued. Additionally, insulation was removed and remaining welded pipe attachments on remaining SI piping within the scope of the walkdowns were observed on October 18, 1996, and no damage was noted.
