**Subject: Palo Verde Nuclear Generating Station (PVNGS) Unit 1
Docket No. STN 50-528
License No. NPF-41
Steam Generator Tube Inspection Report**

Unit 1 – 18th Refueling Outage Steam Generator Tube Inspection Report

Palo Verde Nuclear Generating Station

UNIT 1
U1R18

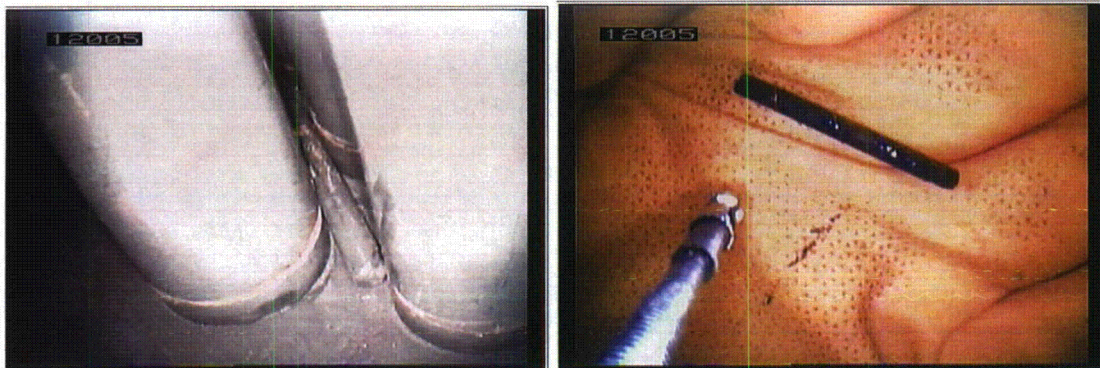
As a result of the inspections performed in SG 12, 5 items were logged as foreign objects. The inspection results were documented in PVAR 4586454. Of the 5 items logged, one foreign object was removed from the SG. Part 12-005 was found on the cold leg side in between tubes R1C6, R2C5 and R3C6 and was successfully retrieved. No wear was identified visually or by ECT in the area of these tubes. Part 12-005 is rod shaped and appears to be a dowel pin as shown in Figure 8-1. Of the 4 objects that were not retrieved from SG 11:

Figure 8-1 – Part 12-005 – Rod Shaped Object (Dowel Pin) Left: In Bundle; Right: After Retrieval

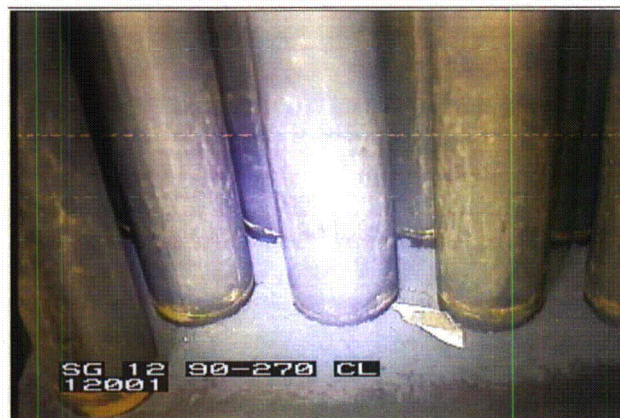
- Parts 12-001 and 12-002 appear to be non-metallic chips. Part 12-001 was identified lying next to tube R23C2 and in the annulus on the cold leg side and measured approximately 0.4 in X 0.2 in X 0.04 in (Figure 8-2). Part 12-002 was identified lying in the annulus near tube R170C115 on the cold leg side and measured approximately 0.35 in X 0.3 in X 0.2 in (Figure 8-3). Since these objects are likely non-metallic (ECT did not identify a part in the areas), the threat to tube integrity is considered very low. There was no wear associated with these tubes. PVNGS has historically taken the position that if a loose part is detected by ECT or FOSAR without the presence of wear, it is reasonable to conclude that the required conditions to promote wear do not exist. Per the PVNGS SG Program, trending of these locations will continue in future outages.

Figure 8-2 – Part 12-001 – Non-Metallic Chip

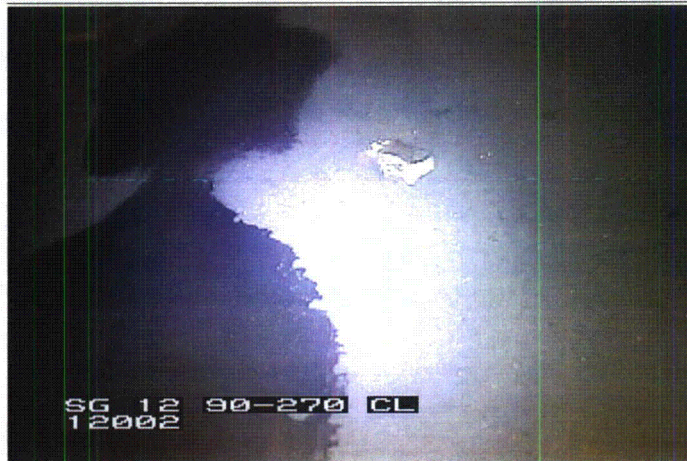
Figure 8-3 – Part 12-002 – Non-Metallic Chip

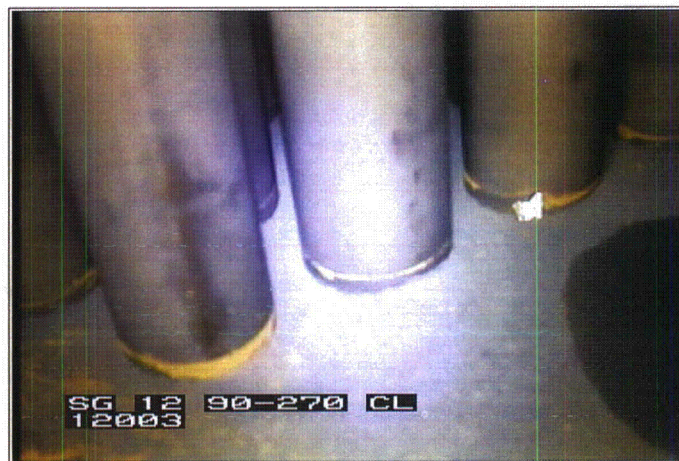
- Part 12-003 appears to be an extremely small sludge rock located in the cold leg annulus near tube R160C137. Part 12-003 measured approximately 0.15 in X 0.04 in X 0.15 in (Figure 8-4). There was no wear associated with these tubes. PVNGS has historically taken

the position that if a loose part is detected by ECT or FOSAR without the presence of wear, it is reasonable to conclude that the required conditions to promote wear do not exist. Per the PVNGS SG Program, trending of these locations will continue in future outages.

Figure 8-4 – Part 12-003 – Sludge Rock

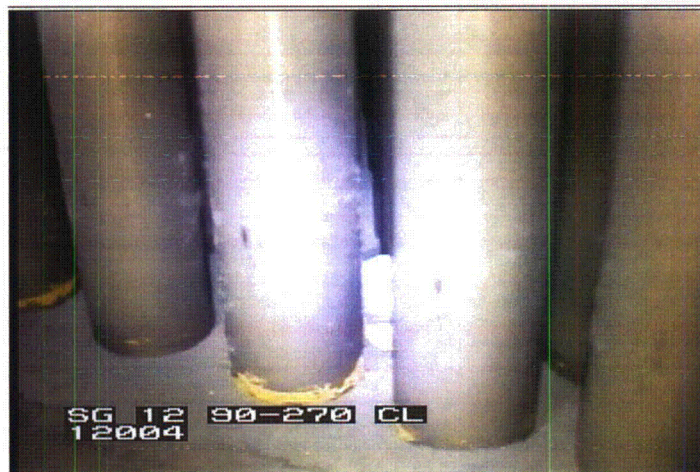
- Part 12-004 was originally thought to be a sludge rock; however, Plus Point ECT testing did not identify an object in this location, indicating that the material may be graphite. Part 12-004 is located in between tubes R154C59 and R153C60 on the cold leg side. Part 12-004 measured approximately 0.25 in X 0.12 in X 0.12 in (Figure 8-5). Attempts to retrieve this item were unsuccessful. There was no wear associated with these tubes. PVNGS has historically taken the position that if a loose part is detected by ECT or FOSAR without the presence of wear, it is reasonable to conclude that the required conditions to promote wear do not exist. Per the PVNGS SG Program, trending of these locations will continue in future outages.

Figure 8-5 – Part 12-004 – Sludge Rock (possibly graphite material)

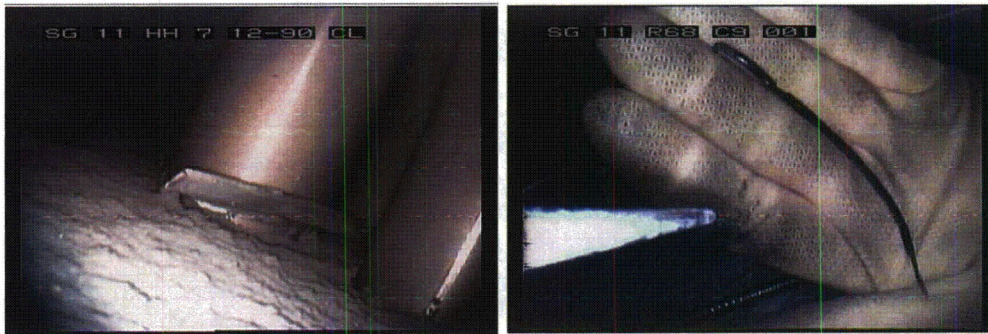
As a result of the inspections performed on top of the FDP in SG 11, 1 item was logged as a foreign object. The inspection results were documented in PVAR 4586212. This was the only foreign object found in SG 11. The object was successfully retrieved from the SG. The object (Part ID 11-001) measures approximately 4 in X 0.128 in X 0.01 in and is metallic and could not be picked up by a magnet (Figure 8-6). The part's origin is unknown. It was located in between tubes R68C9, R66C9, R67C10, R65C10, R66C11, R65C12, and R63C12. No wear was detected on these tubes or in the area surrounding these tubes by bobbin or plus point ECT.

Figure 8-6 – Part 11-001 – Unknown Metallic Object - Left: In Bundle; Right: After Retrieval

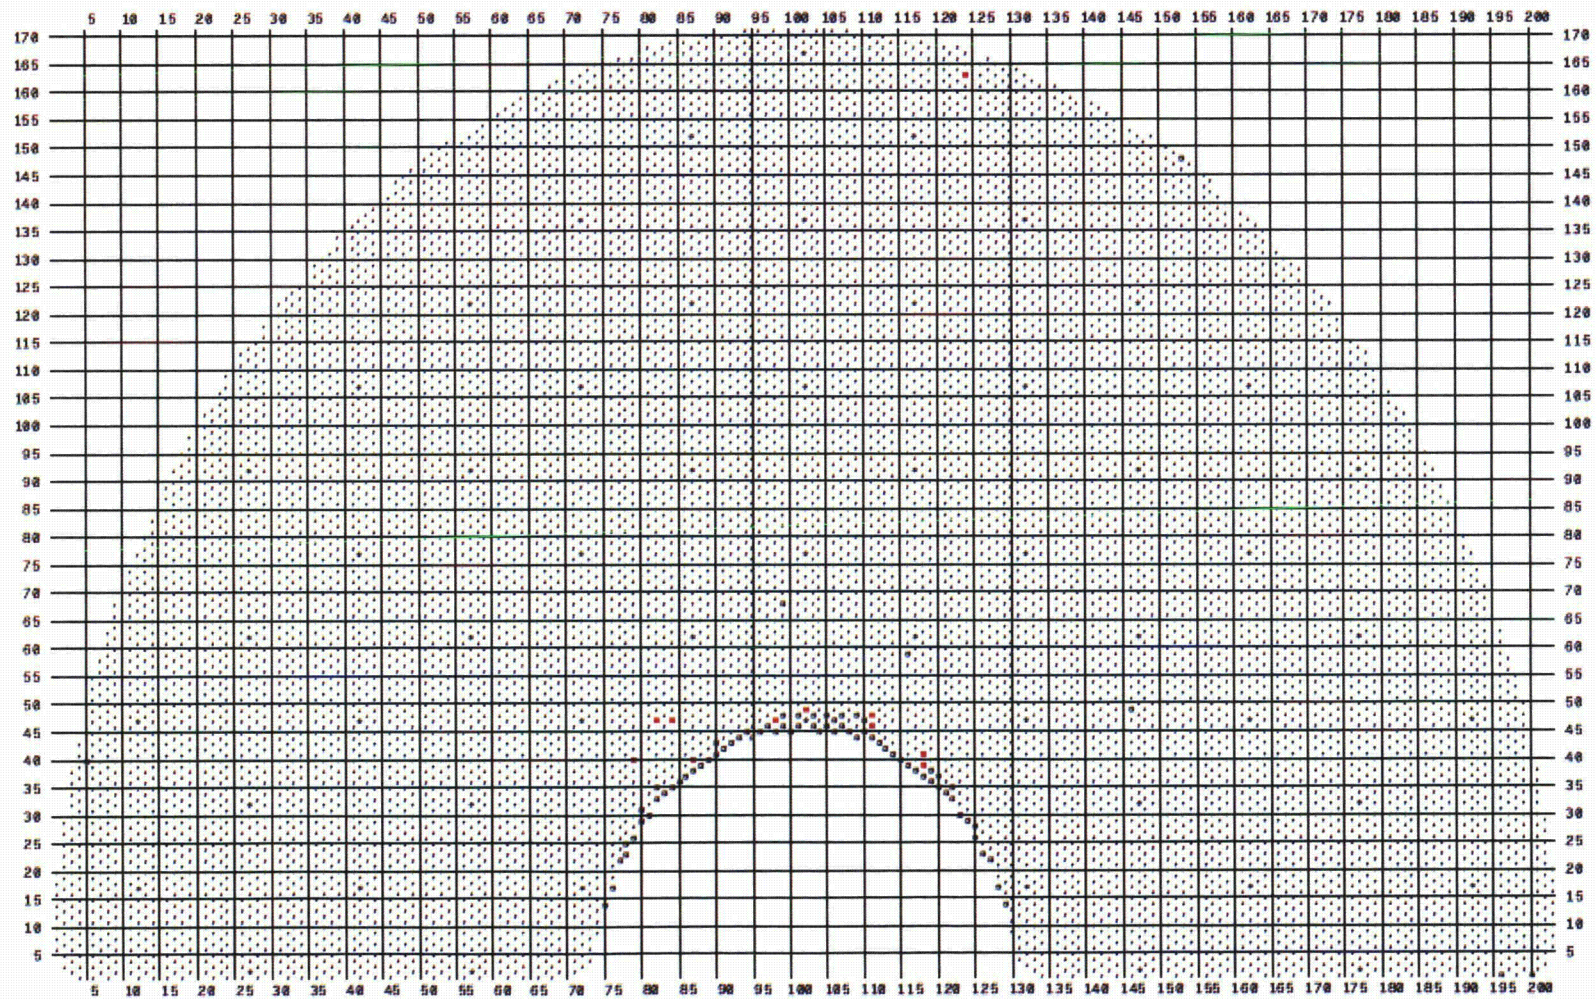
SG - 11 Tubes Plugged in U1R17

- 11 Tubes Plugged in U1R17
- 53 Stay Rod
- 77 Plugged Tube

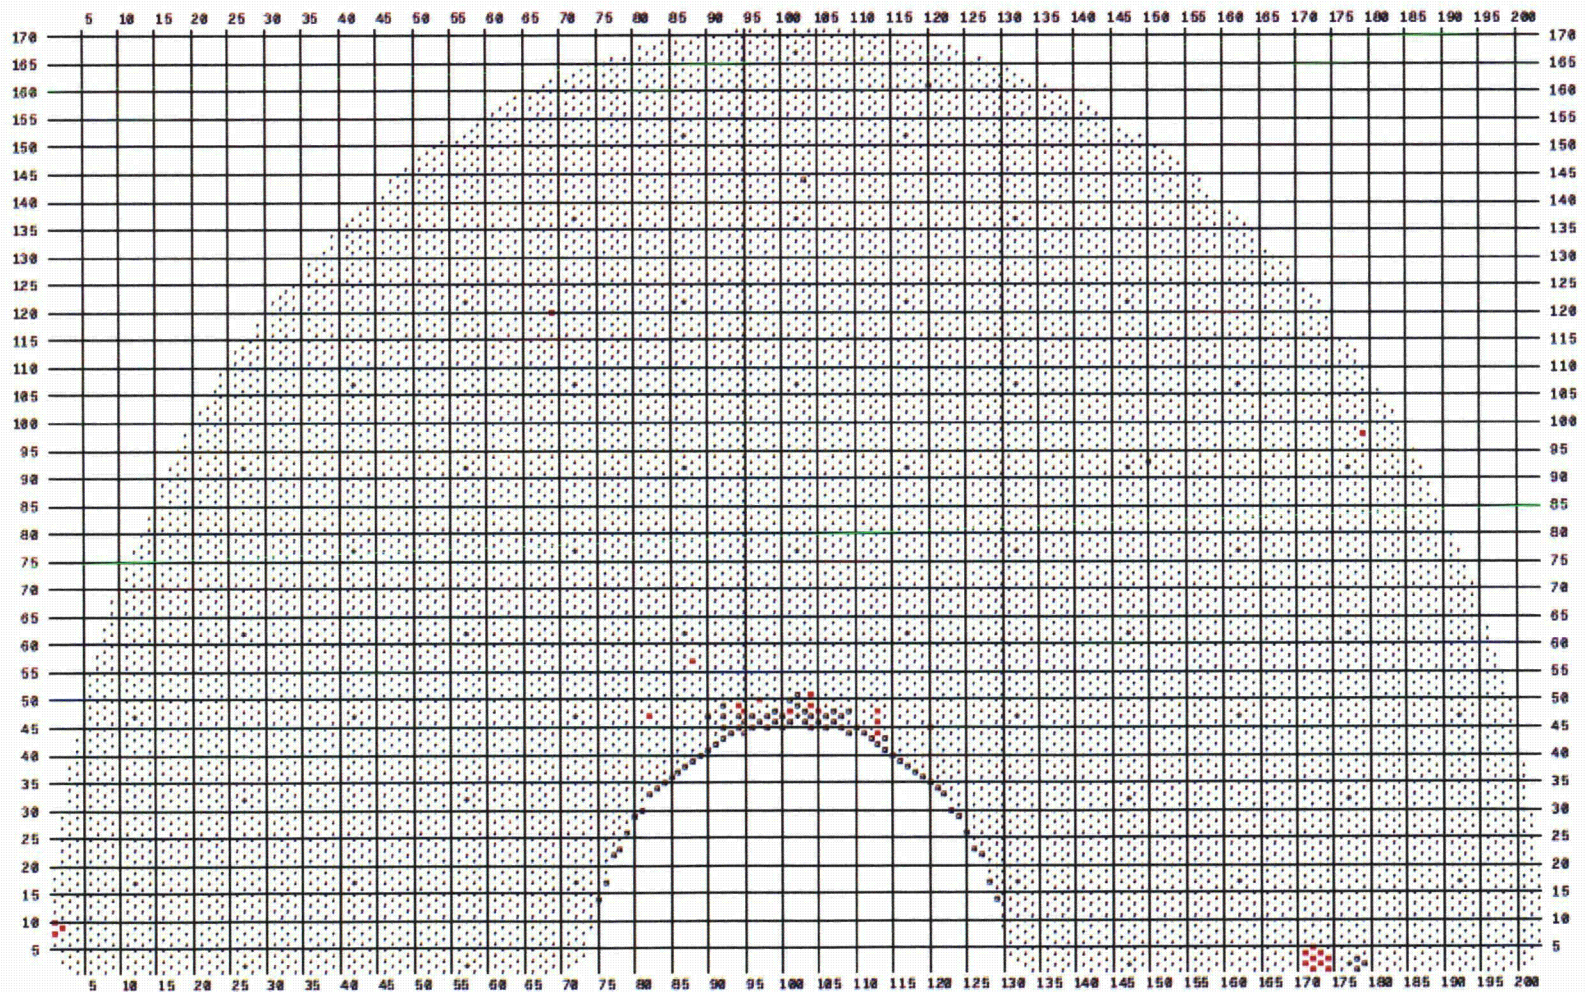
SG - 12 Tubes to Plug in U1R17

- 27 Tubes Plugged in U1R17
- 53 Stay Rod
- 80 Plugged Tube
