REFERENCE: Docket No. 50-186
 University of Missouri-Columbia Research Reactor
 License R-103

SUBJECT: Written communication as required by University of Missouri
 Research Reactor Technical Specification 6.1.h(2) regarding a
 deviation from Technical Specifications 3.2.a and 3.4.c

Licensee Event Report No. 15-01 – March 21, 2015
University of Missouri Research Reactor

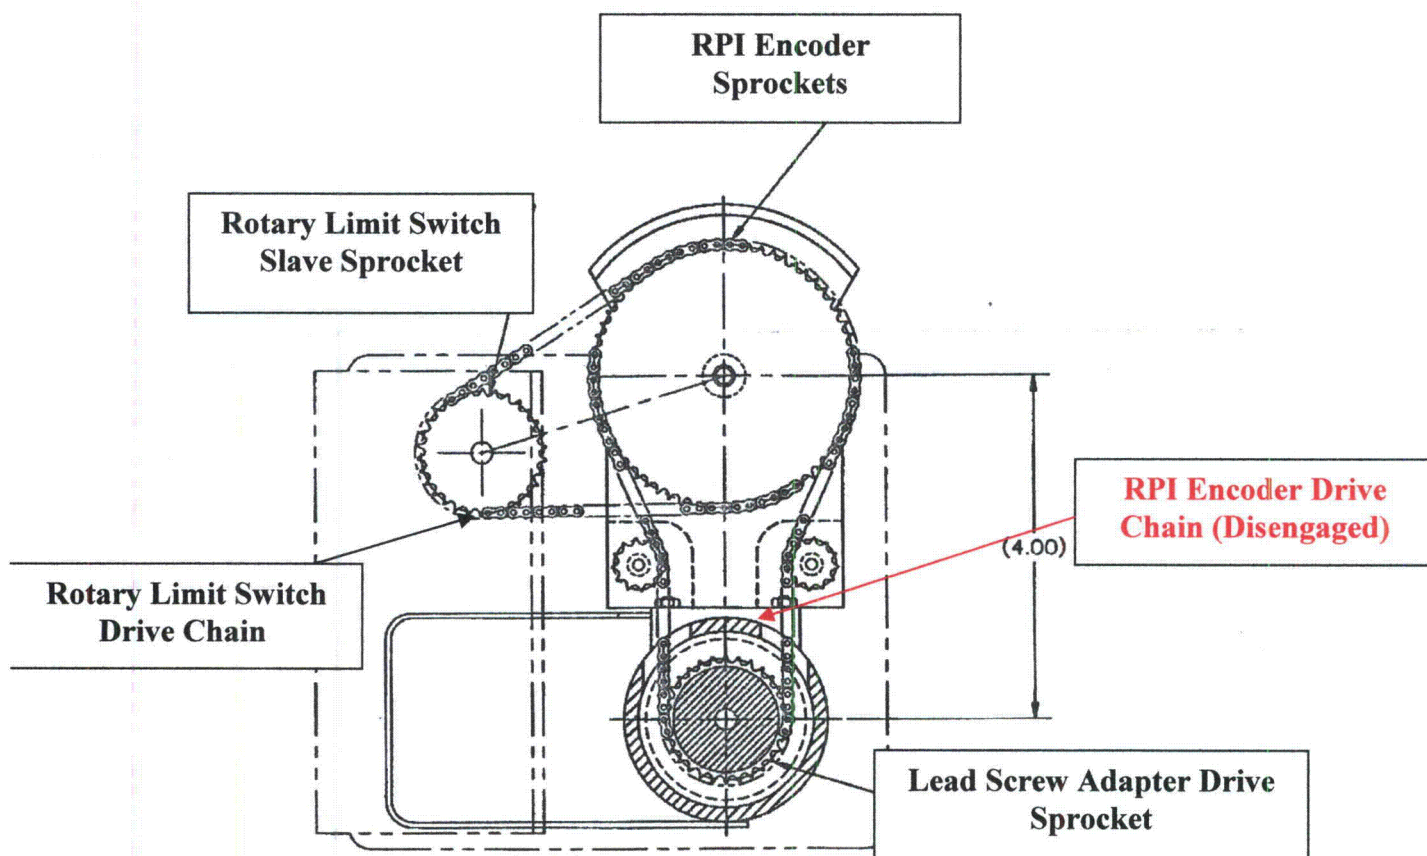
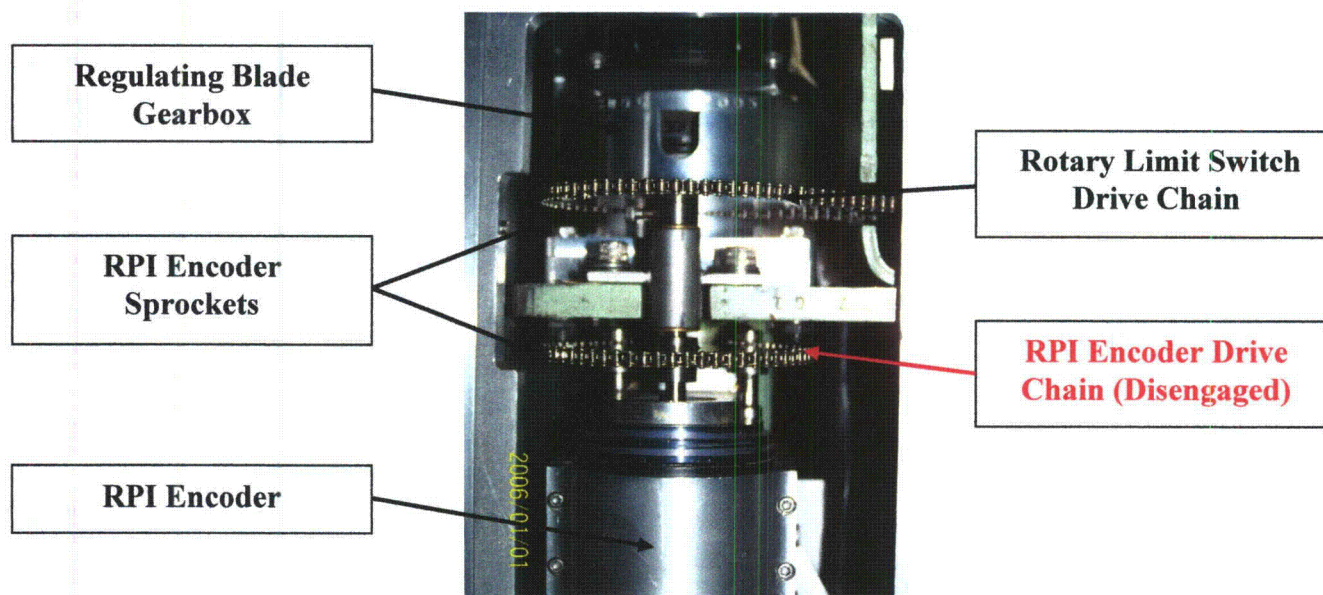
Regulating Blade Drive Assembly

After the reactor was shut down and secured, the regulating blade drive mechanism was removed for inspection and troubleshooting. It was determined that a sufficient minor misalignment had occurred over an extended period of time to allow the chain tension to vary slightly with the rotational motion of the RPI encoder sprockets. This lack of a correct, consistent tension allowed the drive chain to disengage from the RPI encoder sprocket.

The reactor was shut down by manual scram when it was determined that the regulating blade was inoperable. After the reactor was shut down and secured, the regulating blade drive mechanism was removed for inspection and repairs. A complete alignment was performed on the chain drives and sprocket assemblies for the regulating blade RPI encoder, rotary limit switch assembly, regulating blade drive assembly, and idler arms. Chain tension was adjusted on all drive chains after the alignments were completed. The shaft bushings supporting the RPI encoder sprockets were also replaced. The "Regulating Blade Operation And Rod Run-In Function Test" portion of form FM-57, "Long Form Startup Checksheet," were completed satisfactorily to verify proper operation of the regulating blade rotary limit switch assembly and regulating blade RPI.

To prevent further failures of this type, more detailed instruction will be provided during the performance of FM-57, "Long Form Startup Checksheet," as to the type of inspections required. This will ensure that a check of regulating blade chain tension is performed at least weekly.
