**LOST CREEK ISR, LLC**

**Re: Spill Report "HH1-8 Trunk"**  
**Lost Creek ISR Project SUA-1598**

**FIGURE 1:**  
**HH1-8 Trunk**  
**March 11, 2015**

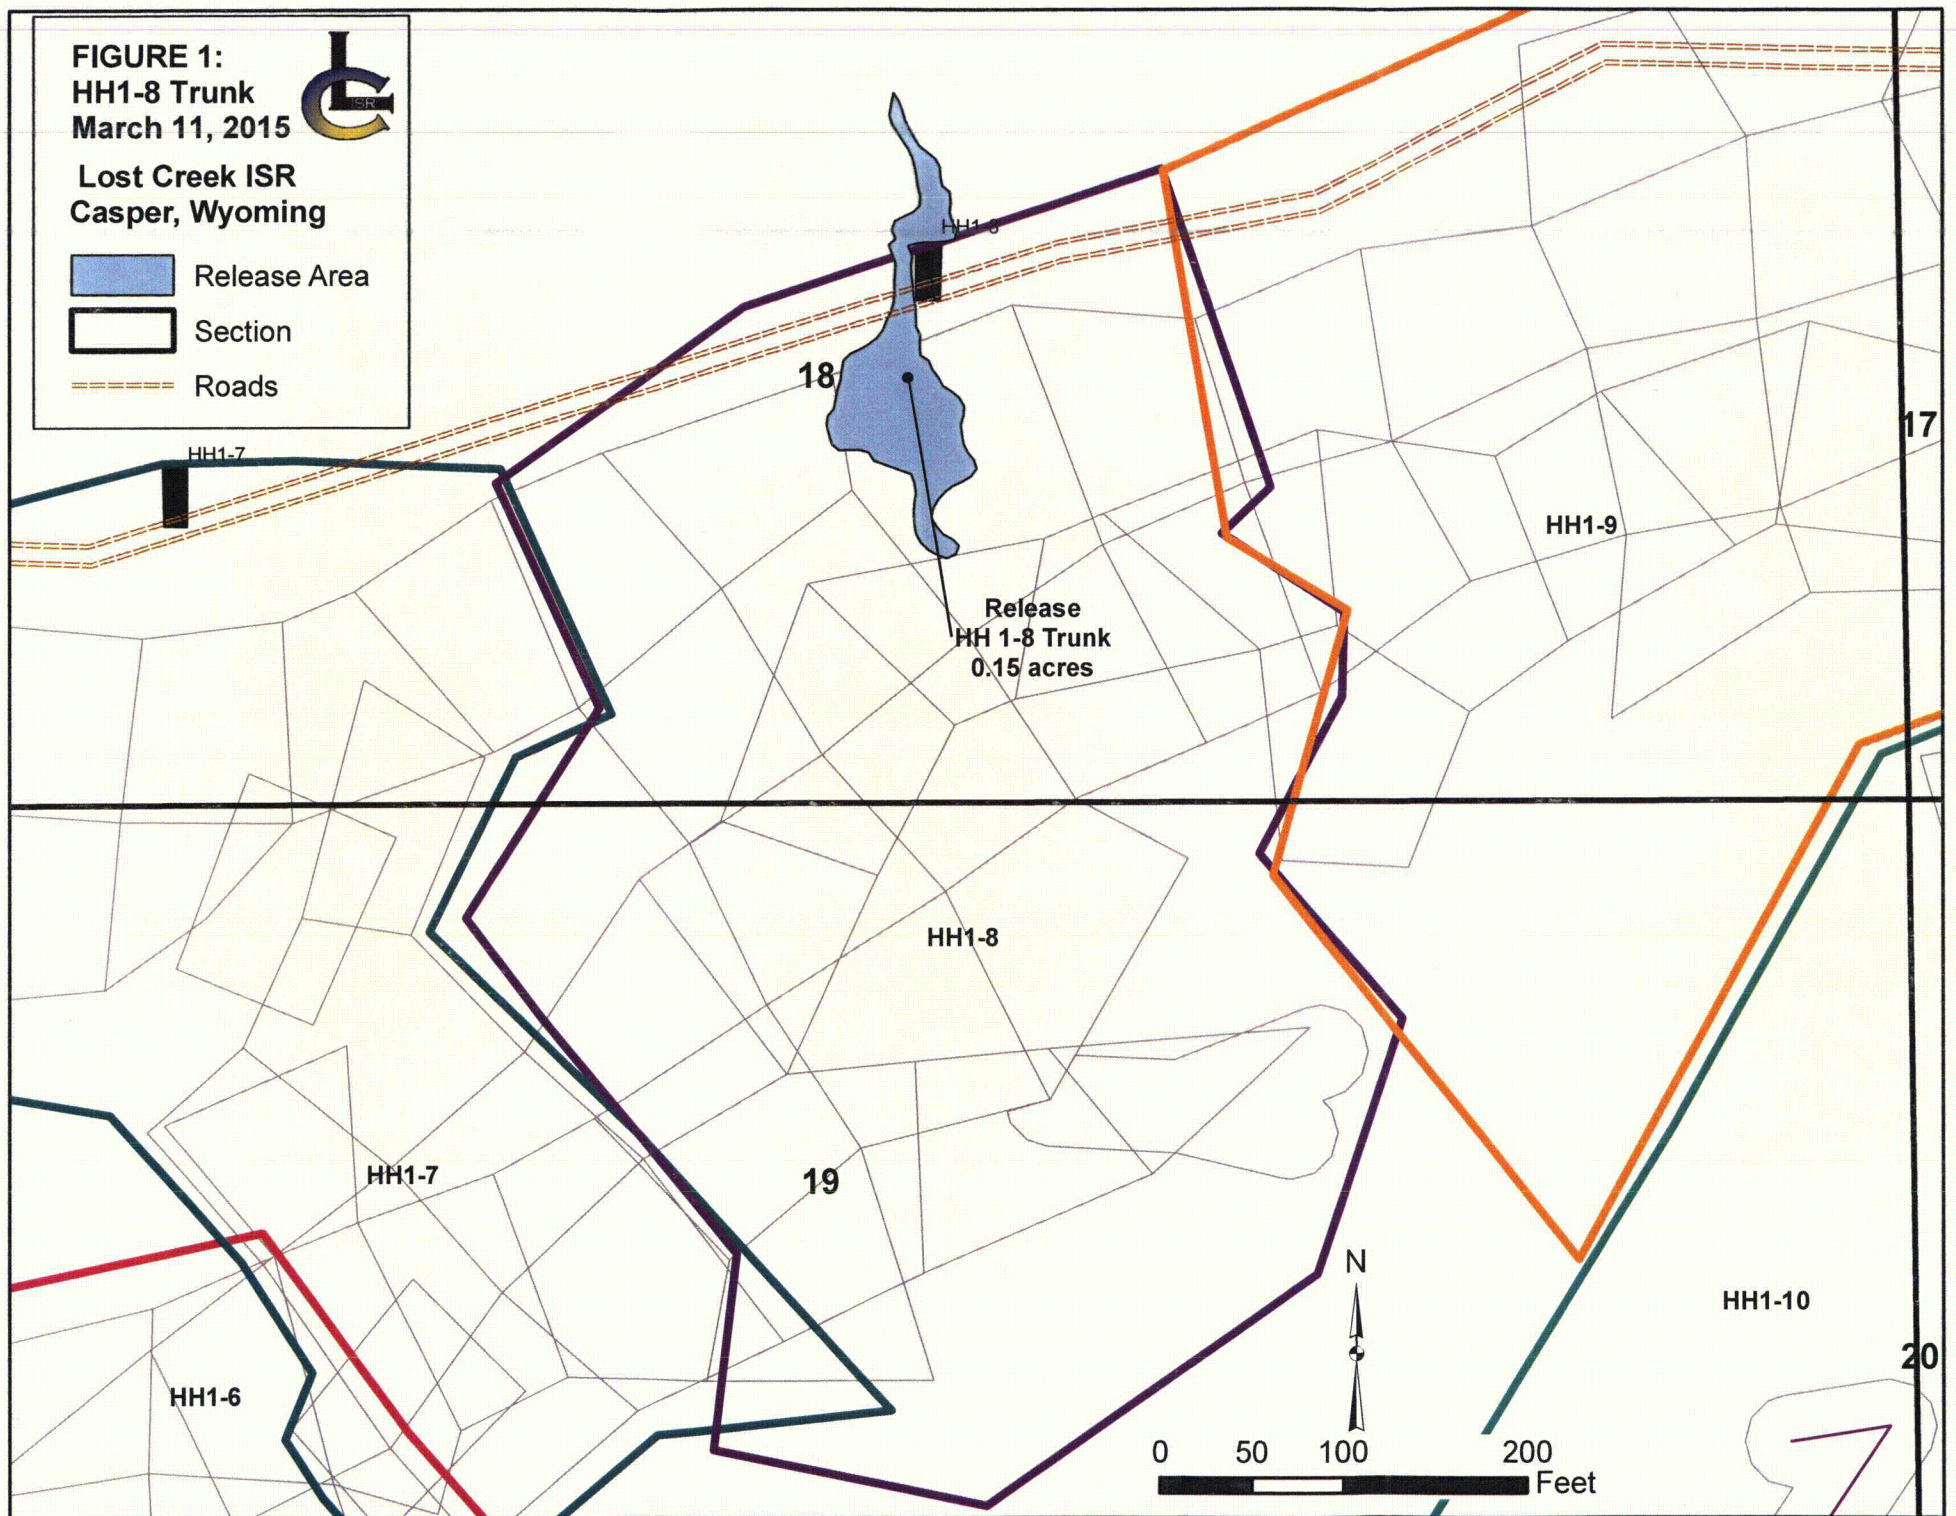
Pursuant to License Condition 11.6, Lost Creek ISR, LLC ("LCI") hereby provides a written report detailing a release of injection fluid that was reportable to the Wyoming Department of Environmental Quality. Using the spill report webpage, LCI notified WDEQ of the spill on March 11, 2015 (Incident ID 1503116-161137). Additionally, LCI notified WDEQ-LQD (Brian Wood) and NRC (John Saxton and Linda Gersey) of the release via email on the same day it was reported to the WDEQ. Spill volume was estimated to be approximately 915 gallons. The release originated from a break in the injection trunk line to HH1-8 and was located just north of HH1-8 in T25N R92W Section 18, SE qtr-qtr of the SE qtr and is shown on **Figure 1** attached.

The release of injection fluid was discovered immediately by a Wellfield Operator at approximately 0447hrs on March 11, 2015 originating from the trunk line associated with Header House 1-8 (HH1-8). The Operator noticed water surfacing just north of HH1-8 and the water flow was immediately shut off. The determination of cause was a break in the polyethylene (poly) pipeline due to failure of a fusion-welded joint. The release occurred for approximately 3 minutes prior to discovery. The estimate of release volume of 915 gallons was determined by the maximum potential flow rate (183 gpm) and duration of flow (5 min). There was very little infiltration of fluid into the ground due to icy conditions. The concentration of uranium in the injection fluid at the time of release was 1.2 ppm. Soil samples were collected for analysis of uranium and Ra-226 the results of which are pending.

- Emergency shutdown of HH1-8 to stop the release.
- The line was excavated and repaired the same day.

- Tests have been conducted on the fusion equipment and fusion weld procedure in a controlled environment. The equipment and procedures were deemed acceptable.

- Post weld tests have been conducted on segments of pipe in a controlled environment. The welds have been deemed acceptable.
- It is theorized that environmental conditions in the field at which some welds may have been performed could have contributed to a substandard weld. Procedures will be adjusted to describe the additional measures for performing a fusion weld on polyethylene pipe in extreme temperature conditions in accordance with manufacturers' (for both HDPE pipe and fusion equipment) recommendation. Procedure edits will be incorporated by April 30, 2015.
