Braidwood Station, Unit 2
Facility Operating License No. NPF-77
NRC Docket No. STN 50-457

Subject: Response to Request for Additional Information Regarding the Steam Generator
Tube Inspection Report for Braidwood Station, Unit 2, Refueling Outage 17

Response to Request for Additional Information Regarding the Steam Generator Tube Inspection Report for Braidwood Station, Unit 2 Refueling Outage 17

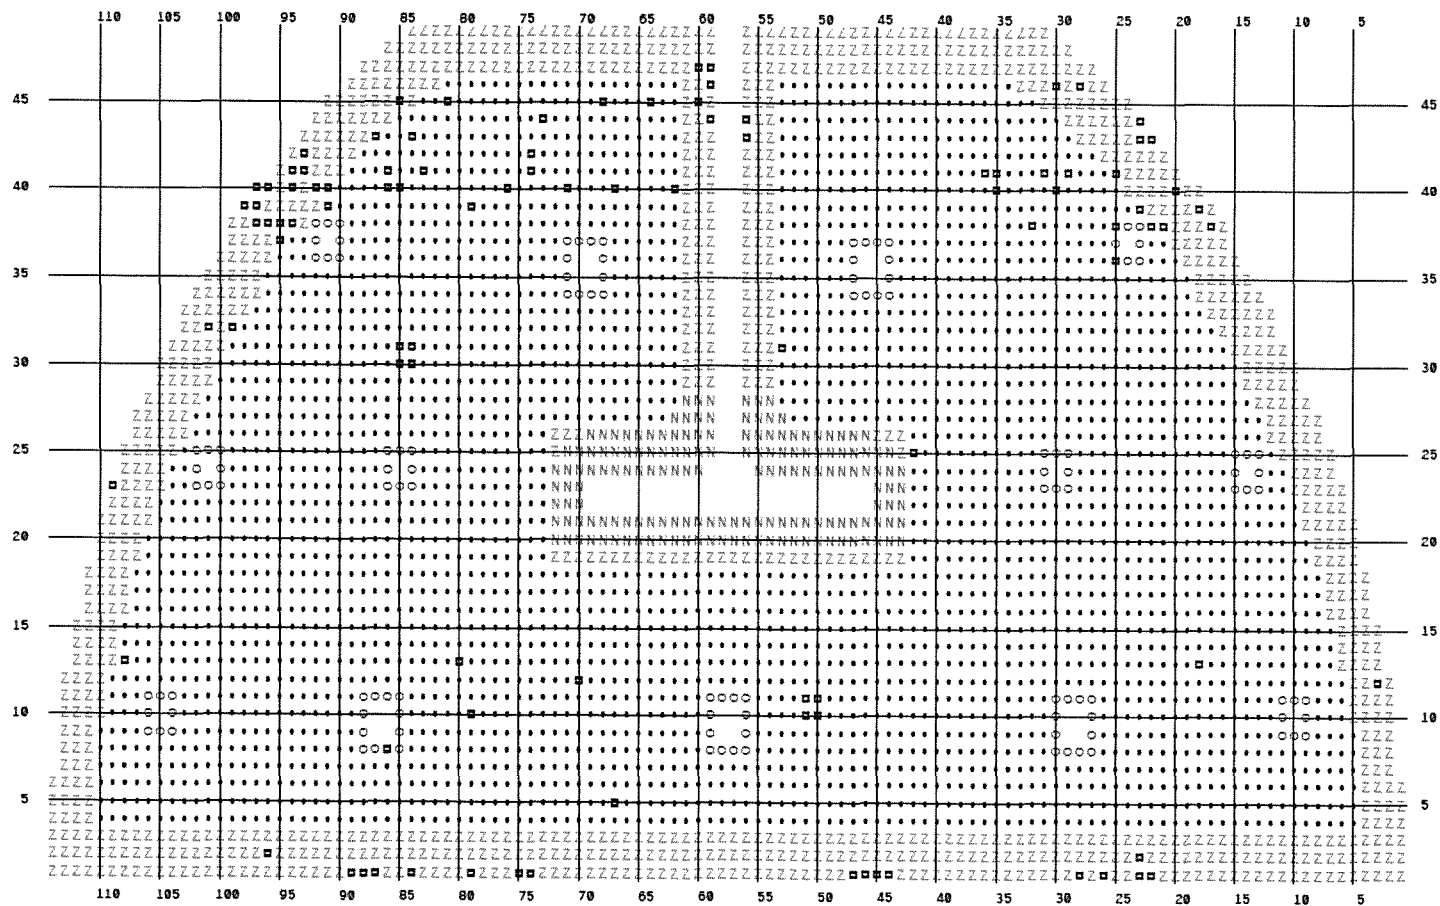
SG - A HOT LEG 3-TUBE PERIPHERY .610 ARRAY PROGRAM

Z 1025 TEST (01H - TSH -1")

N 160 TEST (03H - TSH -1")

□ 100 PLUGGED TUBE

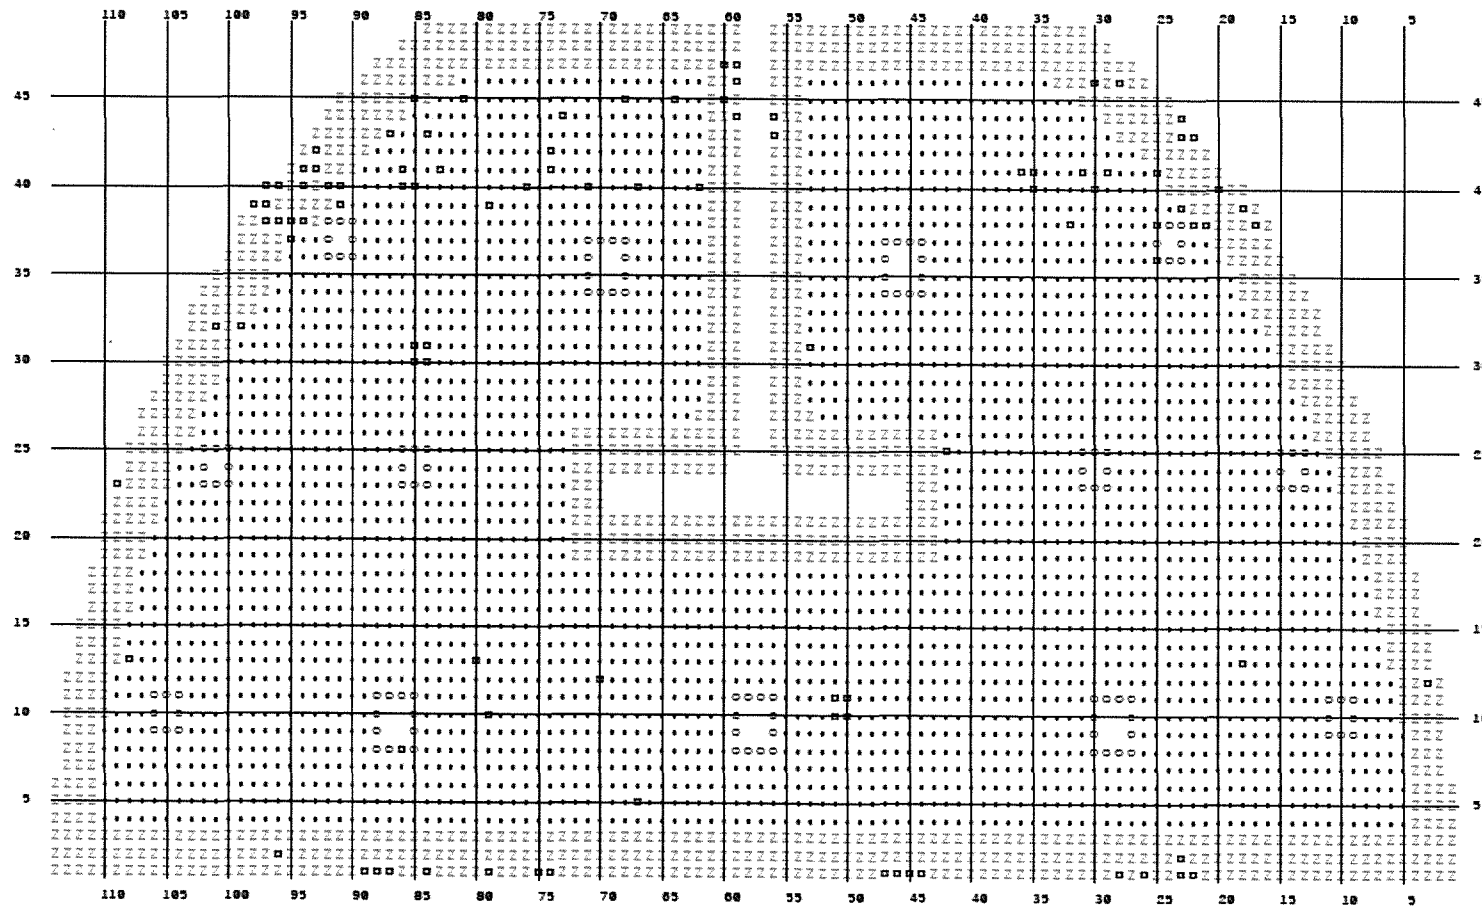
SG - A COLD LEG 3-TUBE PERIPHERY .610 ARRAY PROGRAM

Z 1185 TEST (01C - TSC -1")

□ 100 PLUGGED TUBE

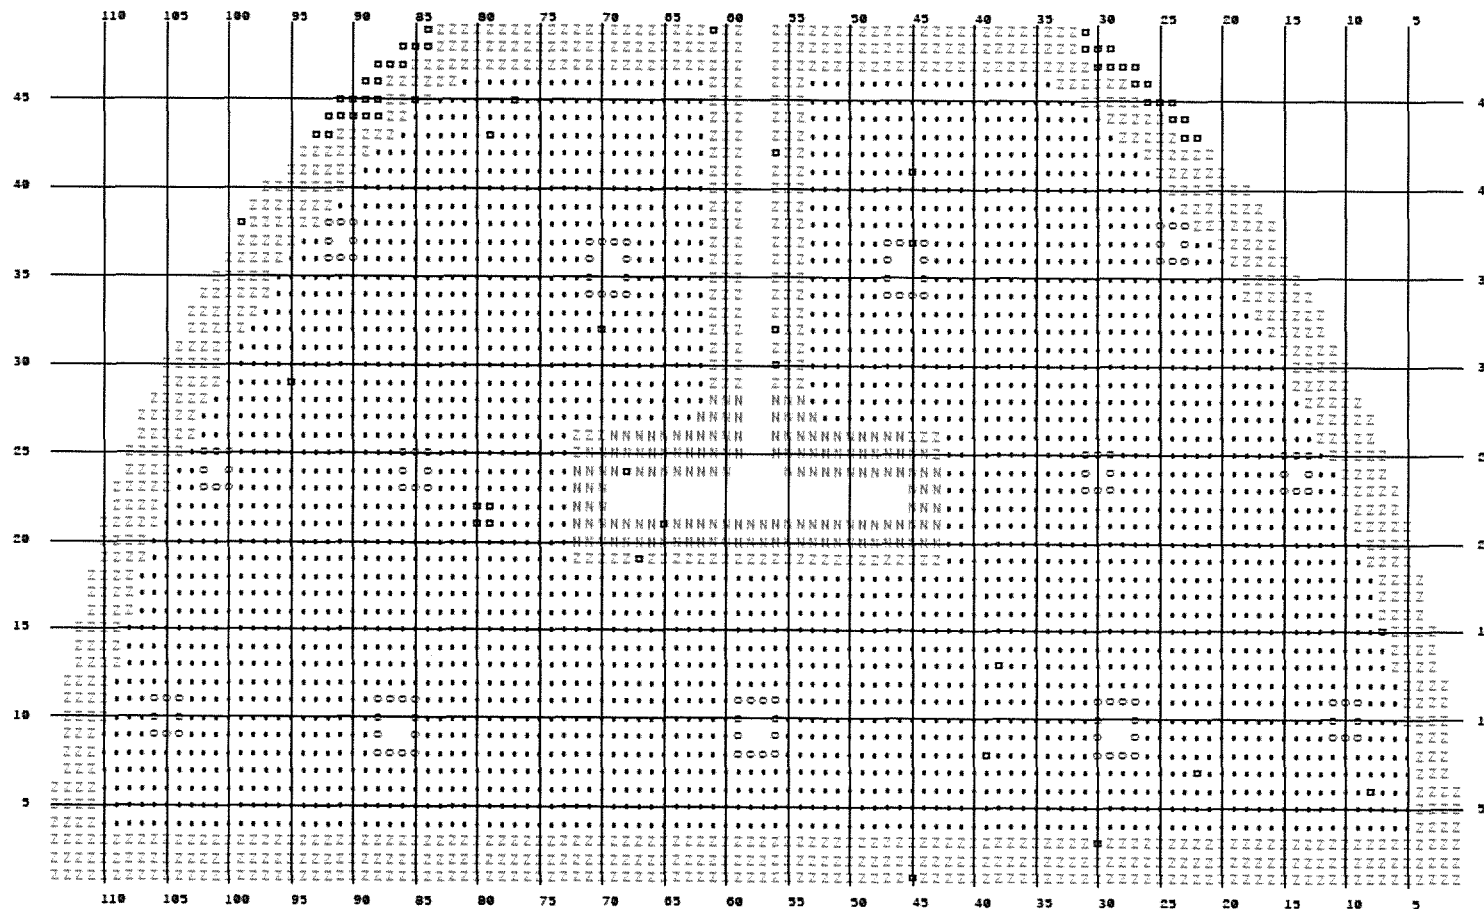
SG - B HOT LEG 3-TUBE PERIPHERY .610 ARRAY PROGRAM

Z 1036 TEST (01H - TSH -1")

N 158 TEST (03H - TSH -1")

□ 63 PLUGGED TUBE

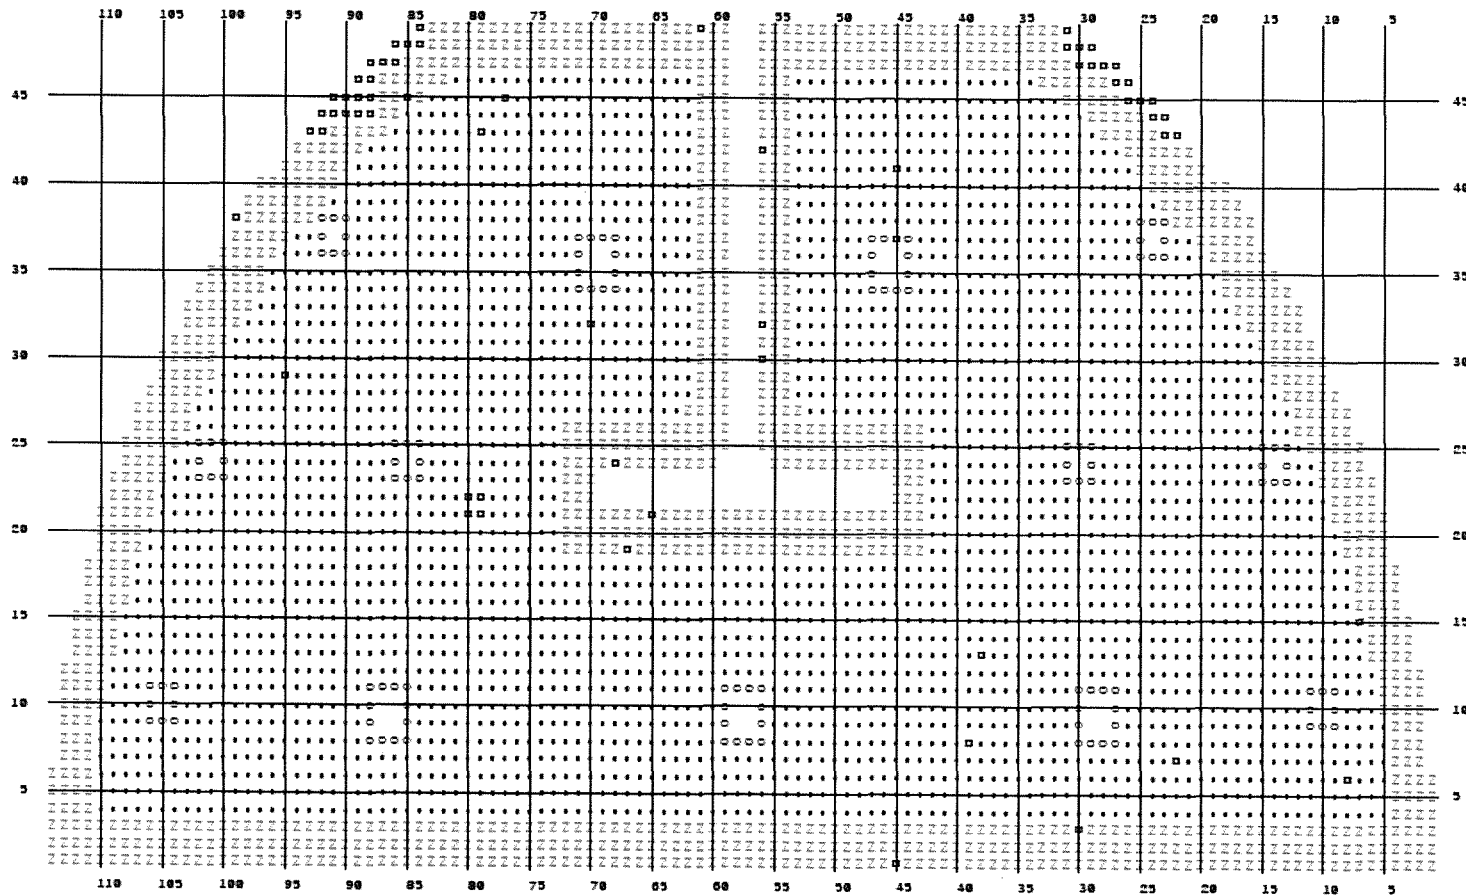
SG - B COLD LEG 3-TUBE PERIPHERY .610 ARRAY PROGRAM

Z 1194 TEST (010 - TSC -1")

□ 63 PLUGGED TUBE

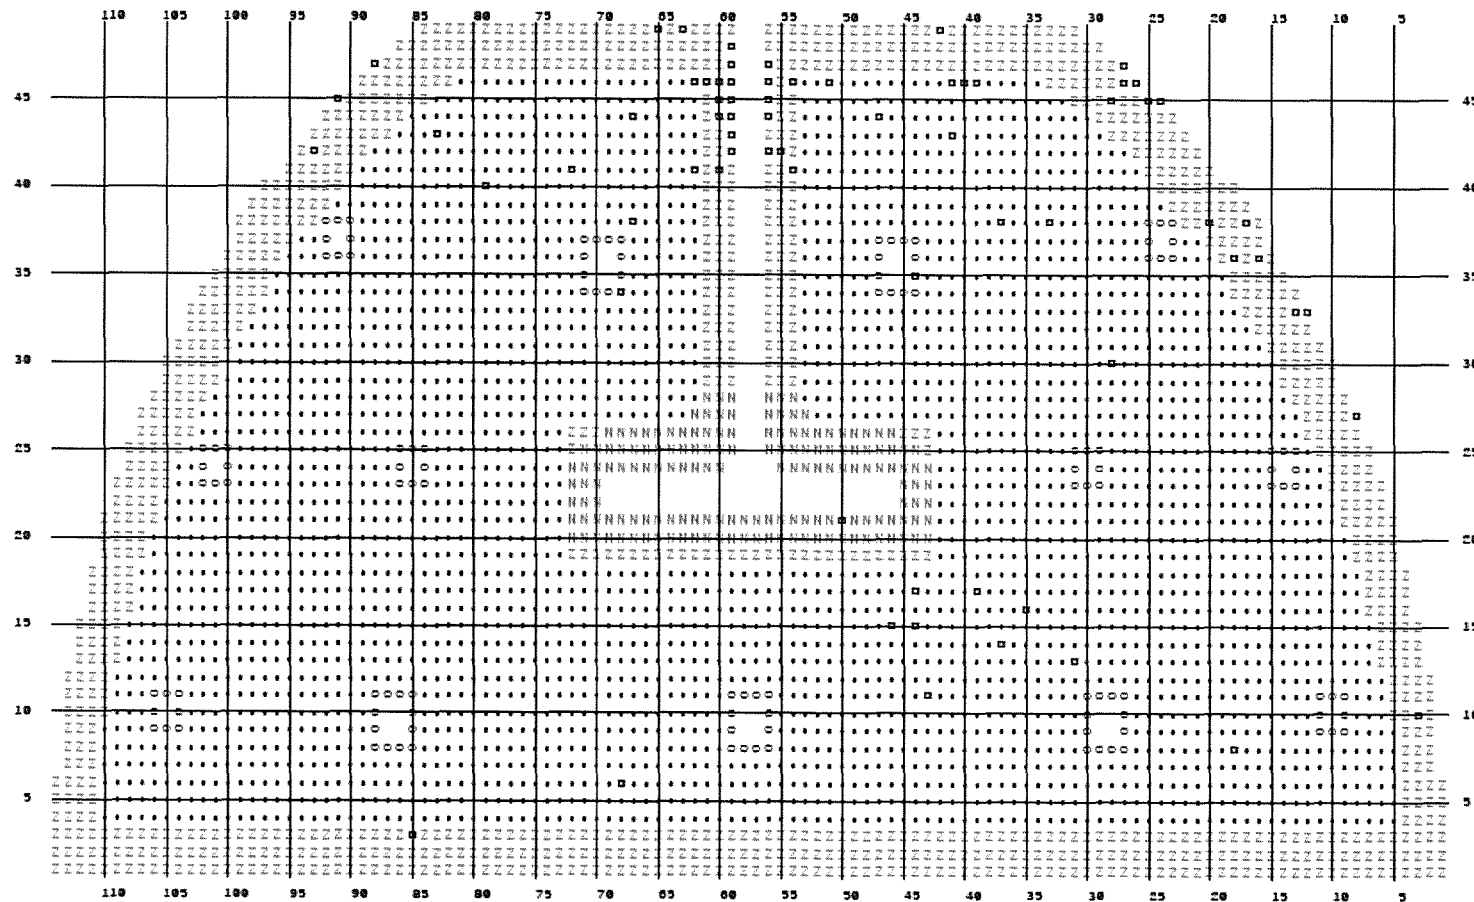
SG - C HOT LEG 3-TUBE PERIPHERY .610 ARRAY PROGRAM

Z 1041 TEST (01H - TSH -1")

N 159 TEST (03H - TSH -1")

□ 70 PLUGGED TUBE

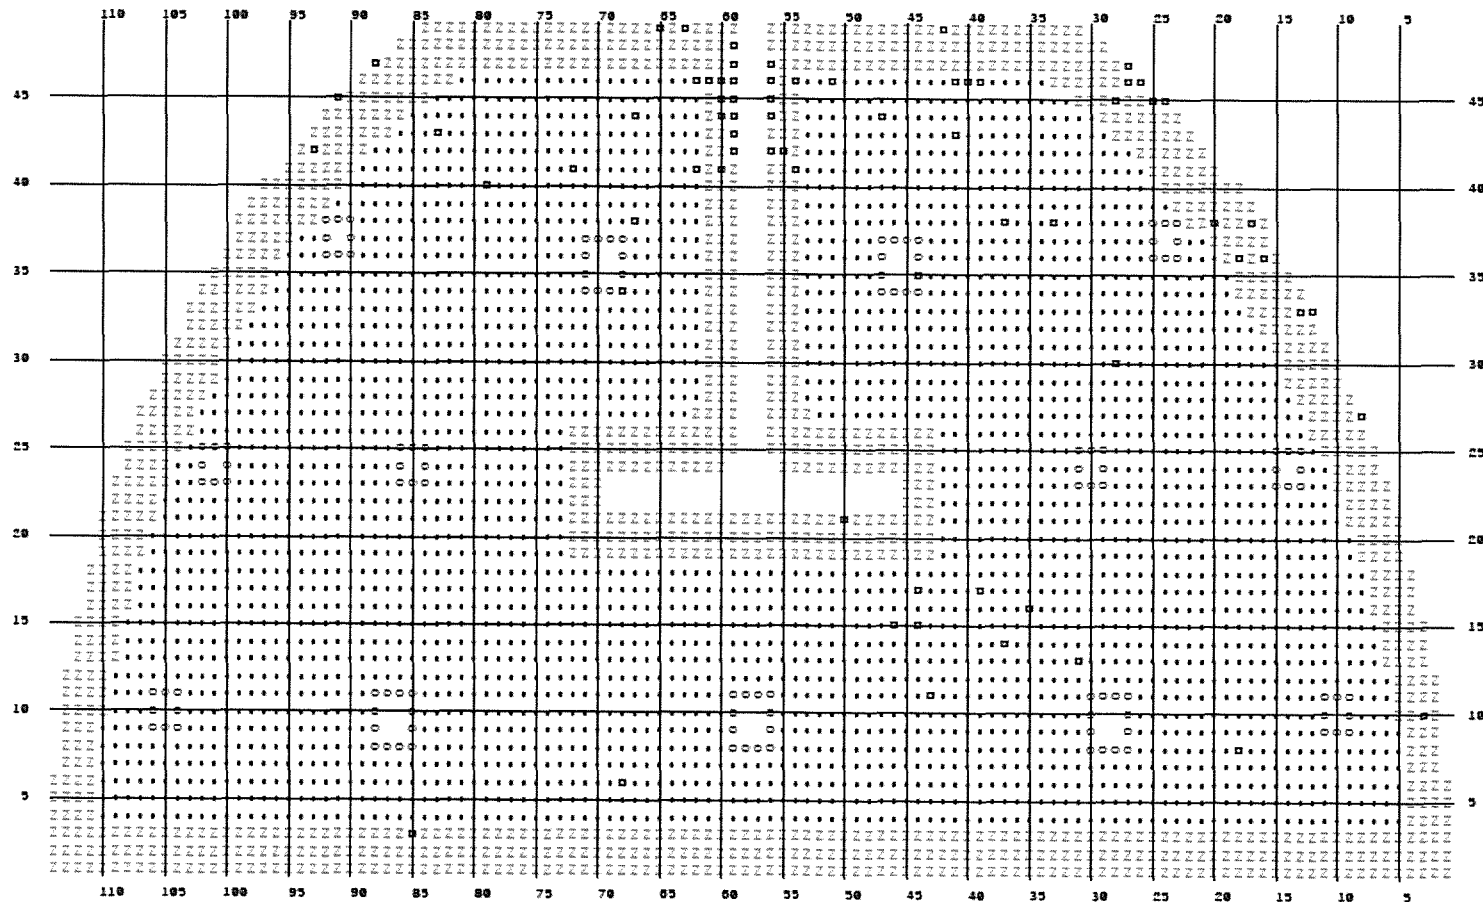
SG - C COLD LEG 3-TUBE PERIPHERY .610 ARRAY PROGRAM

Z 1200 TEST (01C - TSC -1")

□ 70 PLUGGED TUBE

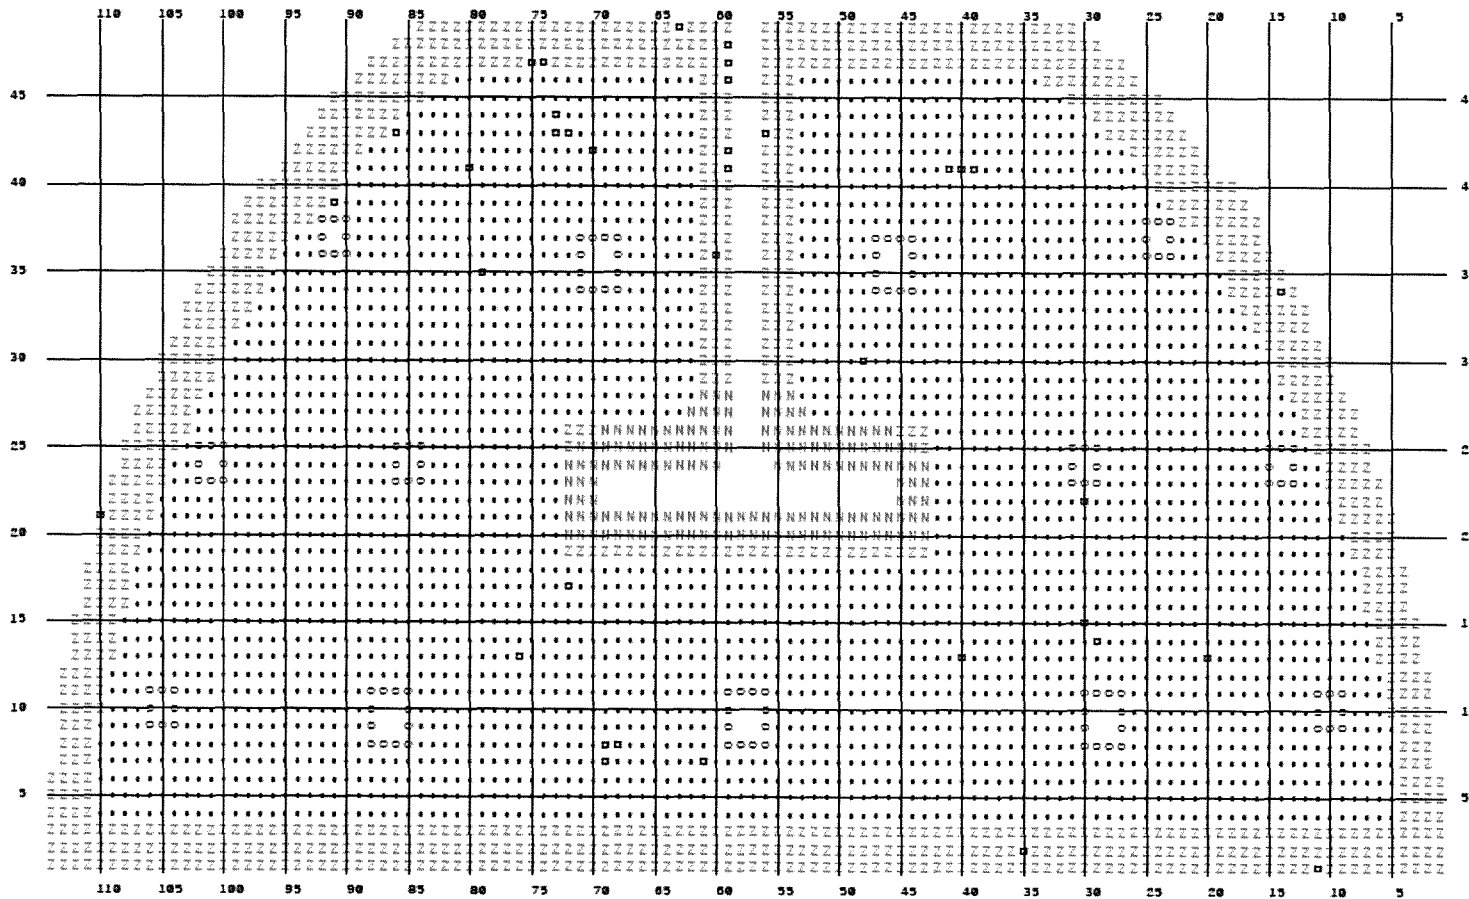
SG - D HOT LEG 3-TUBE PERIPHERY .610 ARRAY PROGRAM

Z 1068 TEST (01H - TSH -1")

N 160 TEST (03H - TSH -1")

□ 37 PLUGGED TUBE

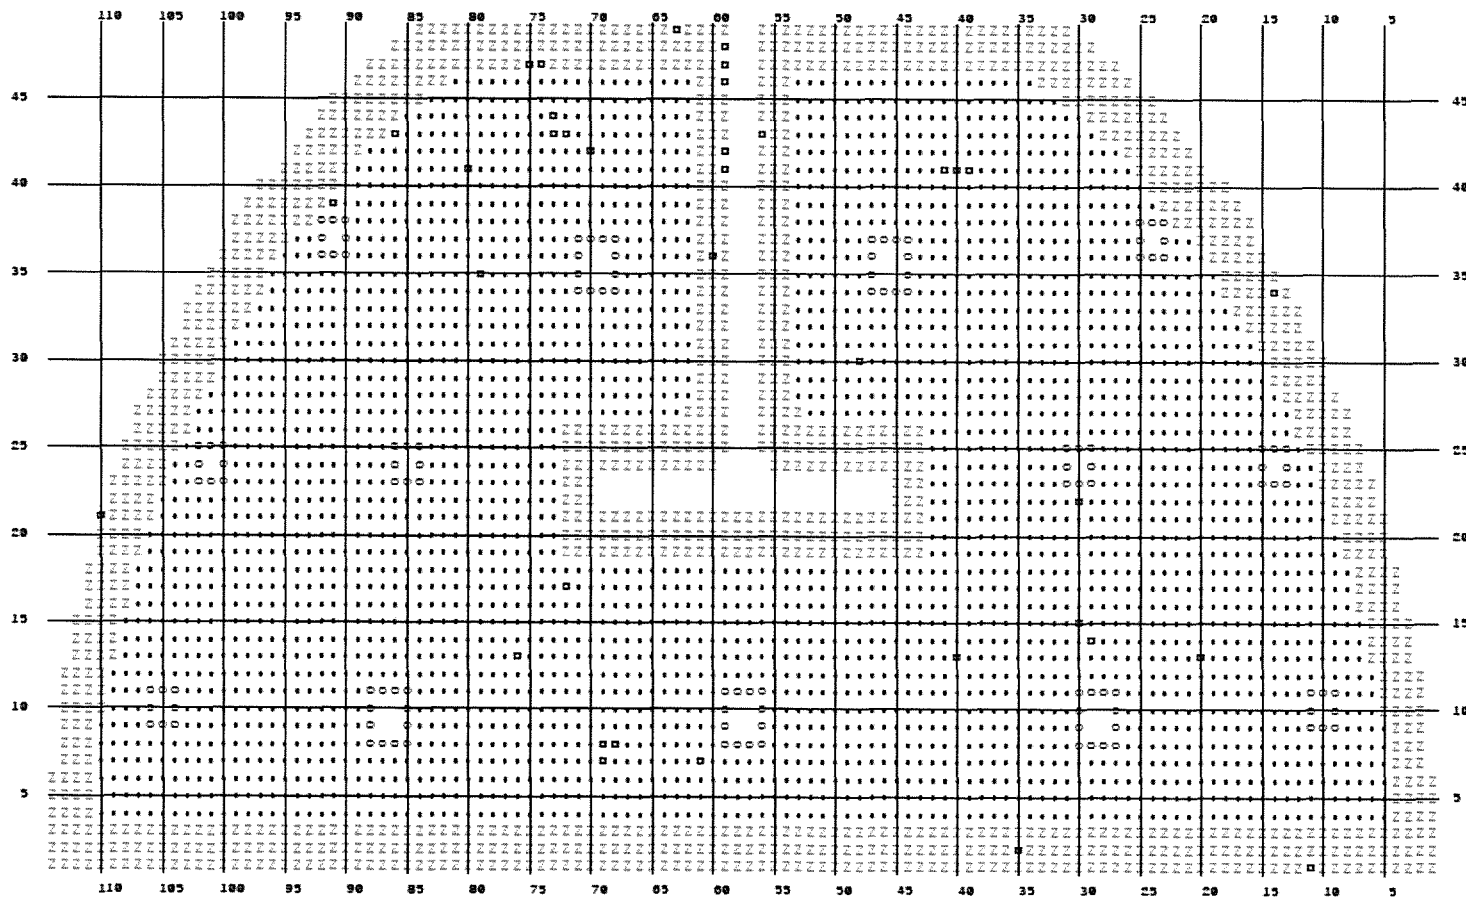
SG - D COLD LEG 3-TUBE PERIPHERY .610 ARRAY PROGRAM

2 1228 TEST (01C - TSC -1")

□ 37 PLUGGED TUBE
