DUKE POWER COMPANY

TECHNICAL REPORT

Ultrasonic Examination of Oconee Unit 3 Safe
End 3A1 and Unit 2 2A1 Piping

Attachment 2
Revised Information Regarding Question 1d, 2a, 4e, & 4f
in May 5, 1997
NRC Request for Additional Information

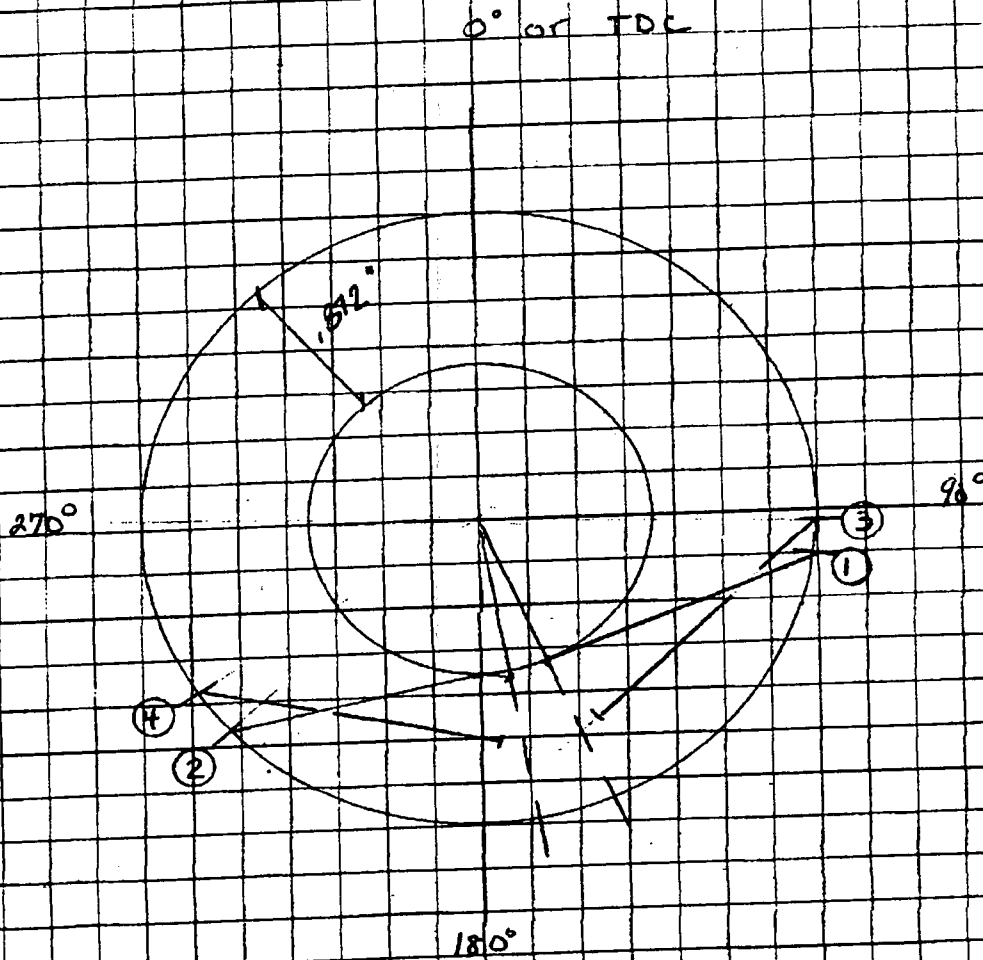
Station OCORCE Unit 3 Rev. _____ File No. _____ Sheet _____ Of _____
Subject RE-PLOT OF INDICATIONS WITH NEW THICKNESS OF .872"
REF. CAL SHTS. 9703001 FO & 9703020 By James W. Styles III Date 5-19-97
Prob No. 3A1-SAFE END PC-47 Checked By _____ Date _____

The results of the examination showed two suspected crack indications at 157° and 171° outside circumference azimuth location, (Figure 1). These indications were recorded as 0.5 in. long and between 2.25 in. and 3.05 in. from the edge of the safe end taper. They are located in the safe end base material adjacent to the nozzle-to-safe end weld parallel with the axis of the safe end. No other indications were recorded. The accuracy of the location of these indications is ± 0.1 in. along the safe end axis and ± 0.4 in. in the circumferential direction.

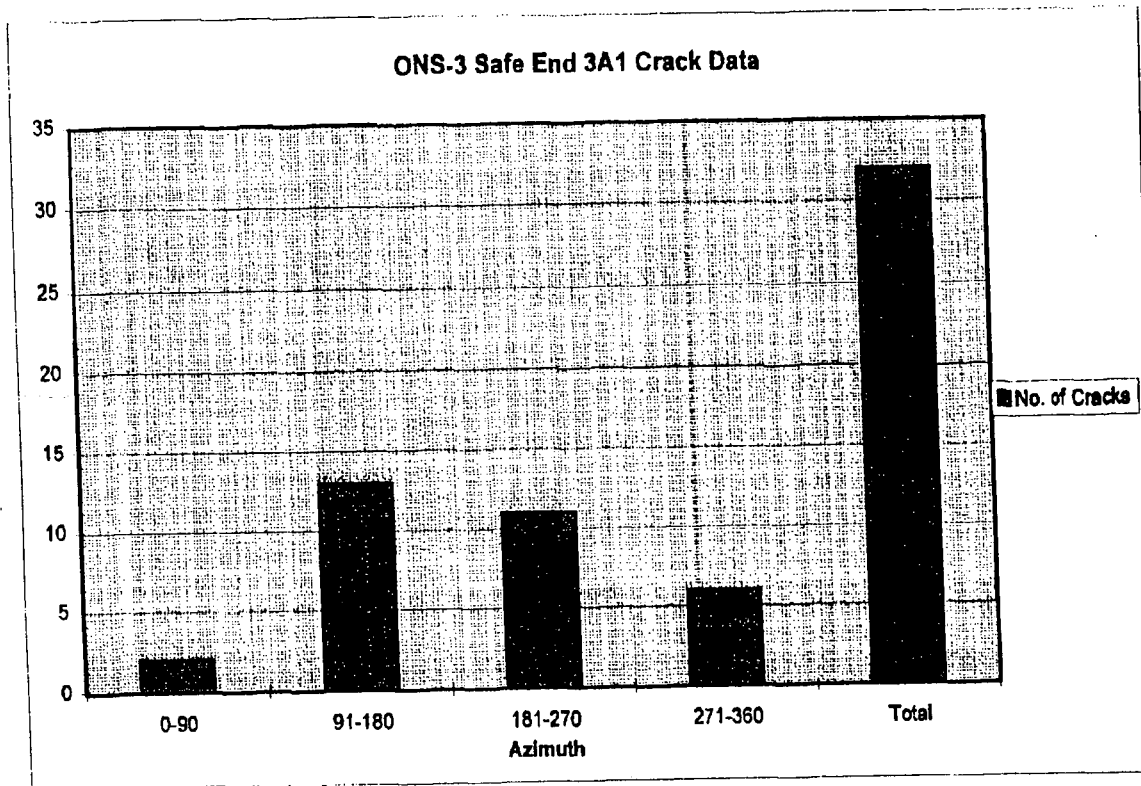
ONS-3 Safe End Crack Data

The safe end was sectioned at two locations in the cracked region. The first section was made approximately 0.5 inch from the field cut. Metallographic examination at this location shows thirty-two cracks around the inside circumference. There are five cracks greater than 10% through wall, and the deepest crack is 17% through wall (0.1474 in.). The cracks are more concentrated in the 91°-180° and 181°-270° azimuth locations than any other areas. The attached charts show more detailed information.

Azimuth	No. of Cracks
0-90	2
91-180	13
181-270	11
271-360	6
Total	32

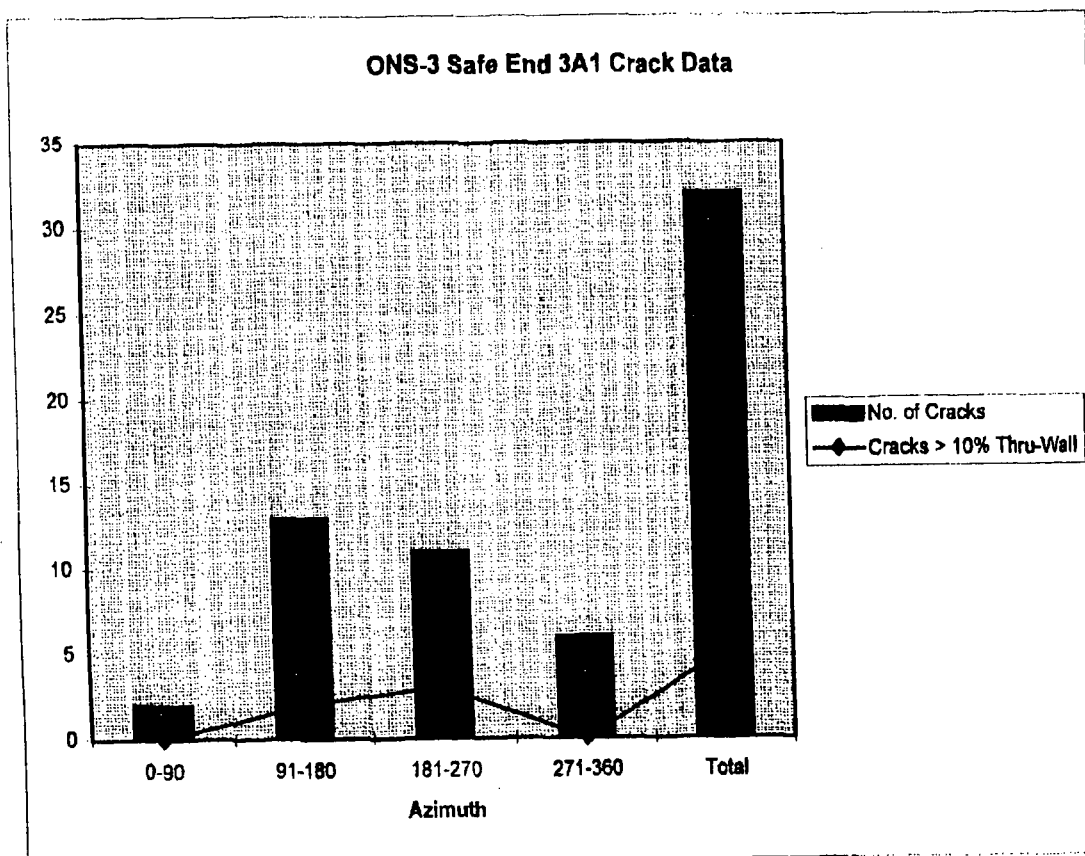
Azimuth	No. of Cracks	Cracks > 10% Thru-Wall
0-90	2	0
91-180	13	2
181-270	11	3
271-360	6	0
Total	32	5

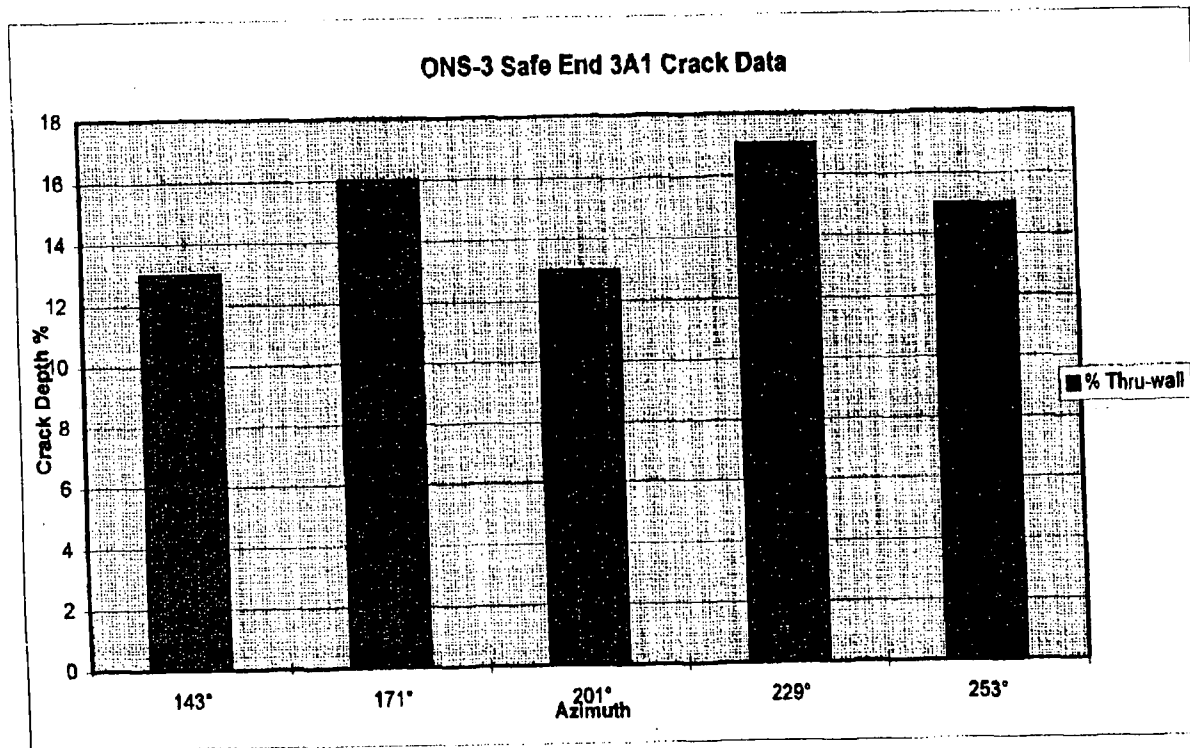
Twenty-seven other cracks with dimensions less than 10% through wall were not recorded. Three cracks with through wall dimensions greater than 10% were not recorded. They are located at 229° (17% tw), 253° (15% tw) and 201° (13% tw). All of the cracks are located at a change in section thickness on the safe end inside diameter. All three cracks were contained in a circumferential length of 0.8 in. on the inside surface. Factors, such as poor search unit contact, inside surface geometry and the skew angle of the cracks are being investigated as possible causes for not detecting these cracks. The most likely reason for not recording the three cracks at 229°, 253° and 201° is poor search unit contact.

Azimuth Location of Cracks > 10%	% Thru-wall
143°	13
171°	16
201°	13
229°	17
253°	15
