Title: BRIEFING BY IIT ON LOSS OF IRIIDIUM-192
SOURCE AND THERAPY MISADMINISTRATION AT
INDIANA REGIONAL CANCER CENTER, INDIANA,
PA., NOVEMBER 16, 1992

Date: FEBRUARY 8, 1993

BRIEFING BY IIT ON LOSS OF IRIDIUM-192 SOURCE
AND THERAPY MISADMINISTRATION AT INDIANA
REGIONAL CANCER CENTER, INDIANA, PA.,
NOVEMBER 16, 1992

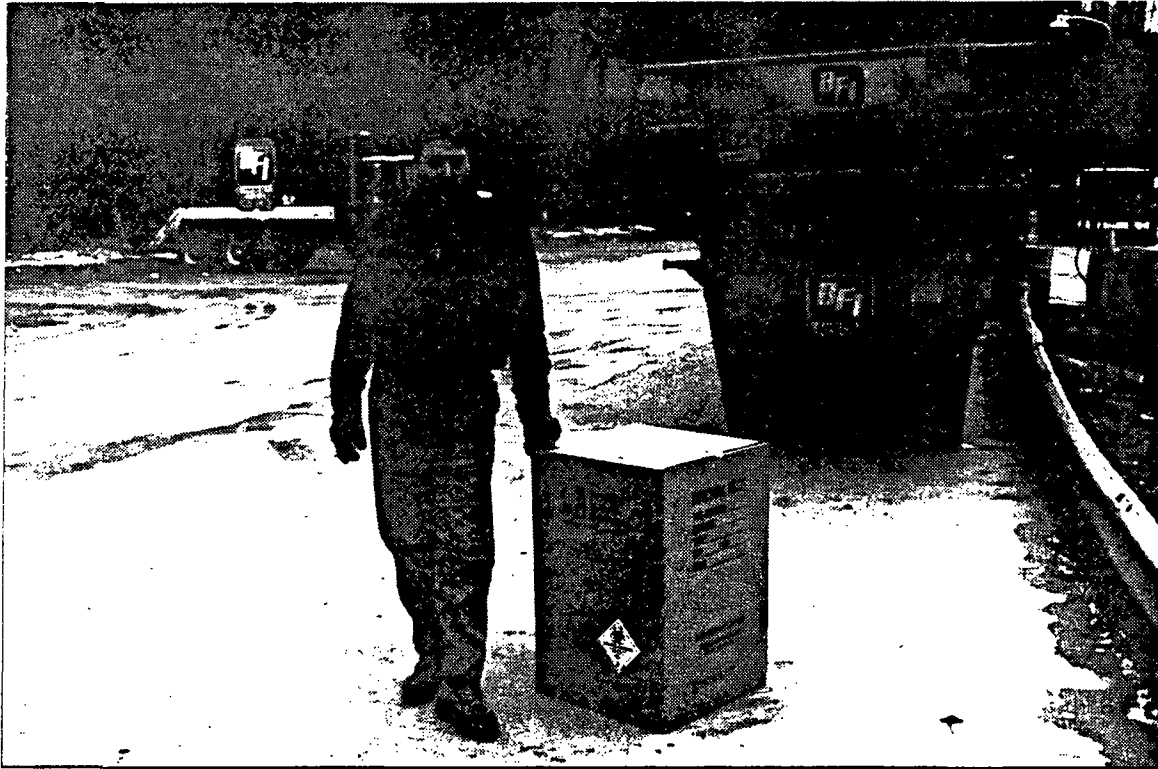
Figure 2.19 Location of Isolated Biohazard Box Containing Source

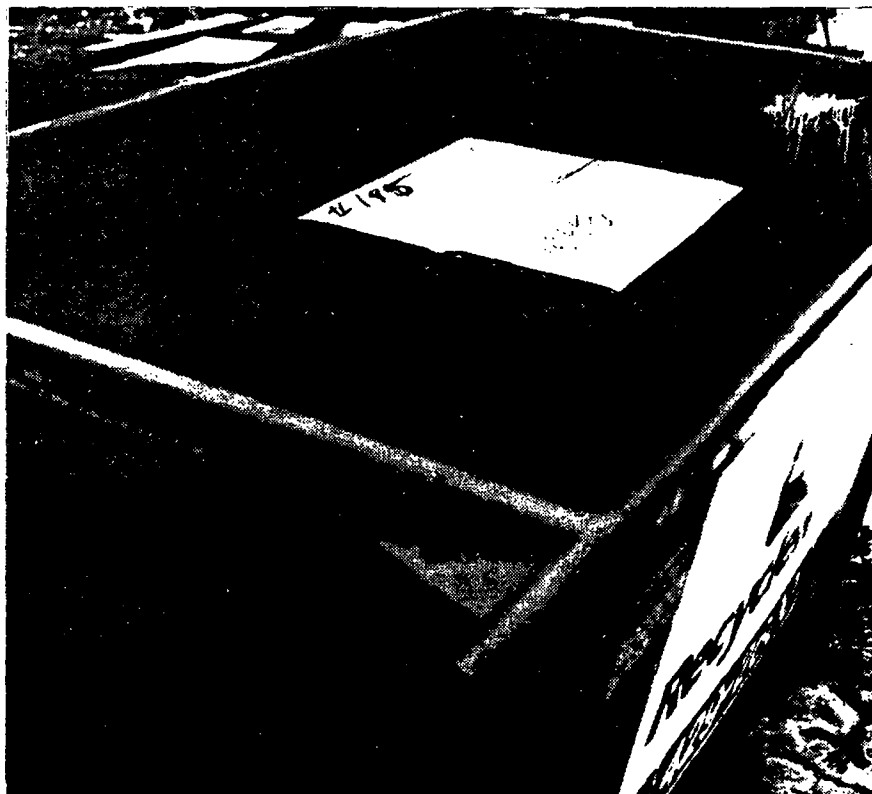
Figure 2.21 Interior of BFI Waste Container Where Radioactive Source Was Stored

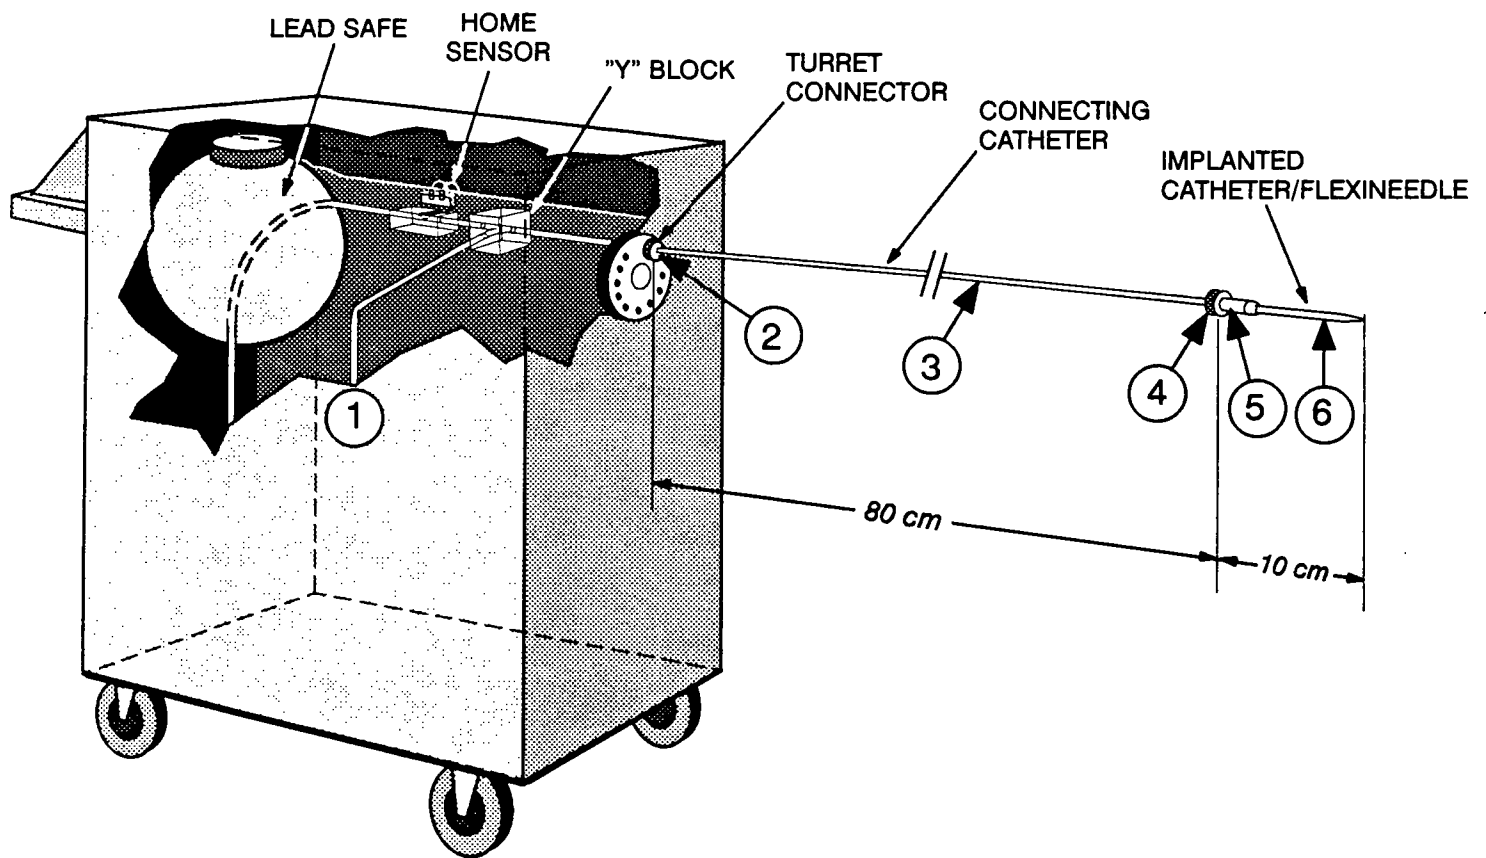
Figure 4.1 Source Wire – Possible Failure Areas

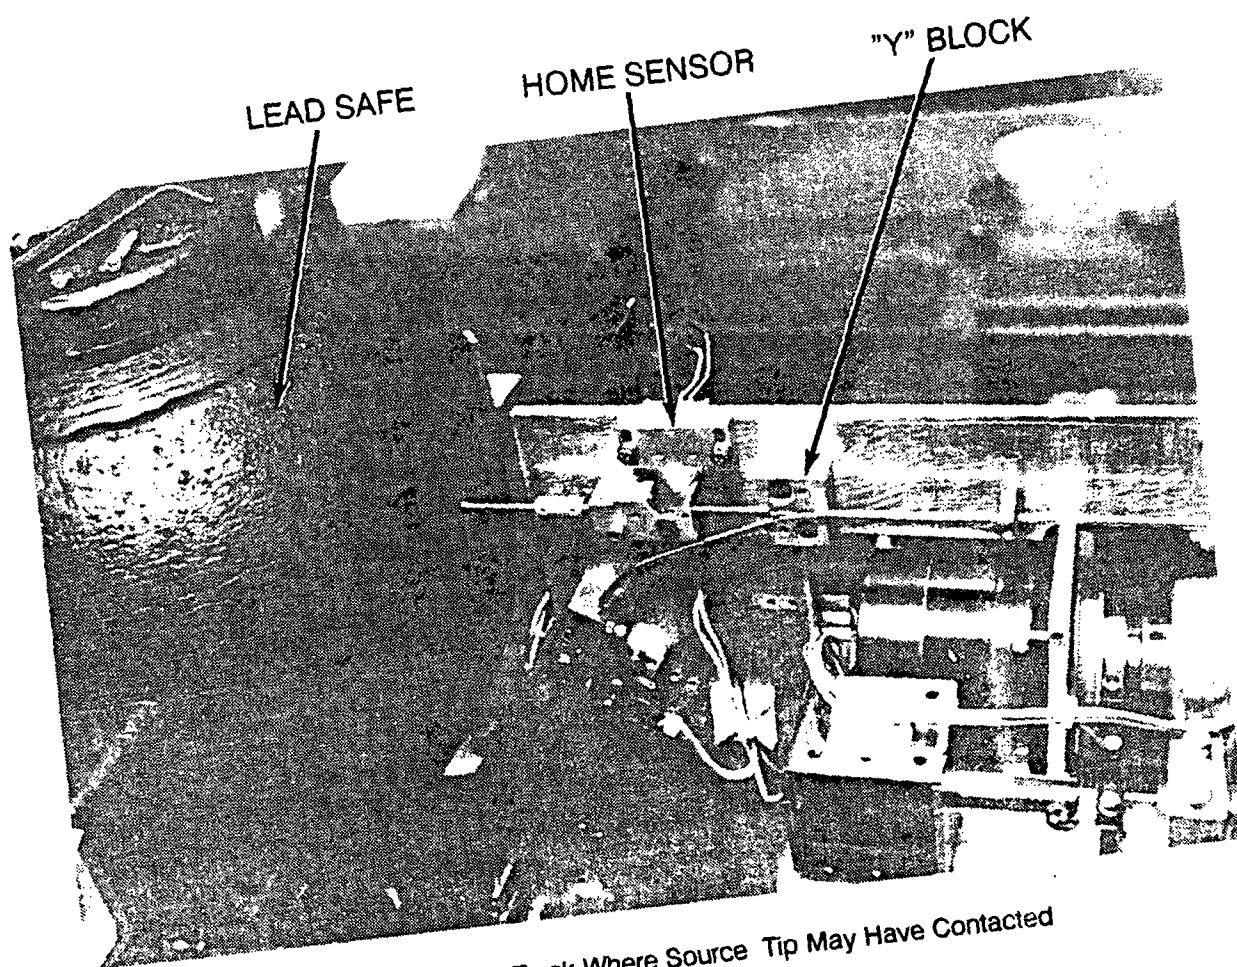
Figure 4.2 Track Where Source Tip May Have Contacted Parts of the Afterloader

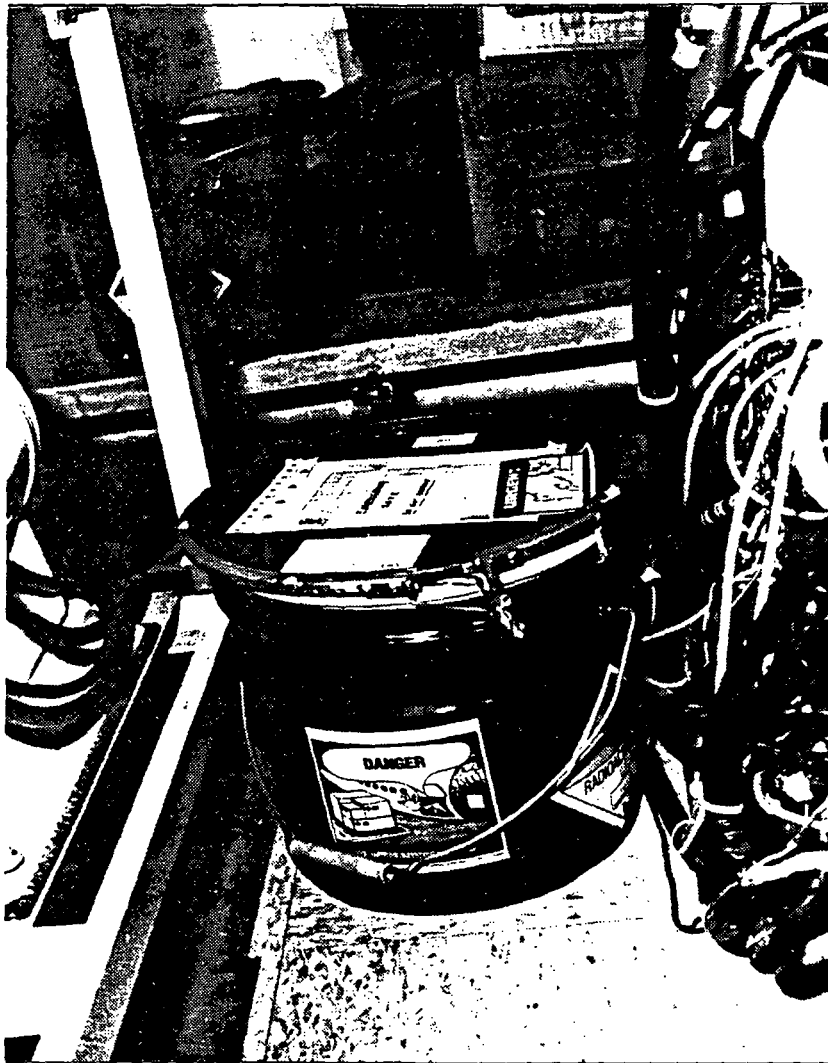
19 In September of 1992, Omnitron, this is a
20 couple months before these breaks occurred, Omnitron
21 identified degradation of the teflon liner in source
22 shipping containers and started to replace teflon with
23 stainless steel. At the end of December, Omnitron
24 looked at an old used wire that had been stored in a
25 teflon-lined shipping container and found it broken at

1 the cavity. The current hypothesis being evaluated is
2 that storage of a source wire in teflon in the
3 presence of moisture causes decomposition of the
4 teflon and formation of either fluorine or
5 hydrofluoric acid. This, either directly or
6 indirectly, results in embrittlement of the wire.

Figure 4.4 Shipping Container for Iridium-192 Source

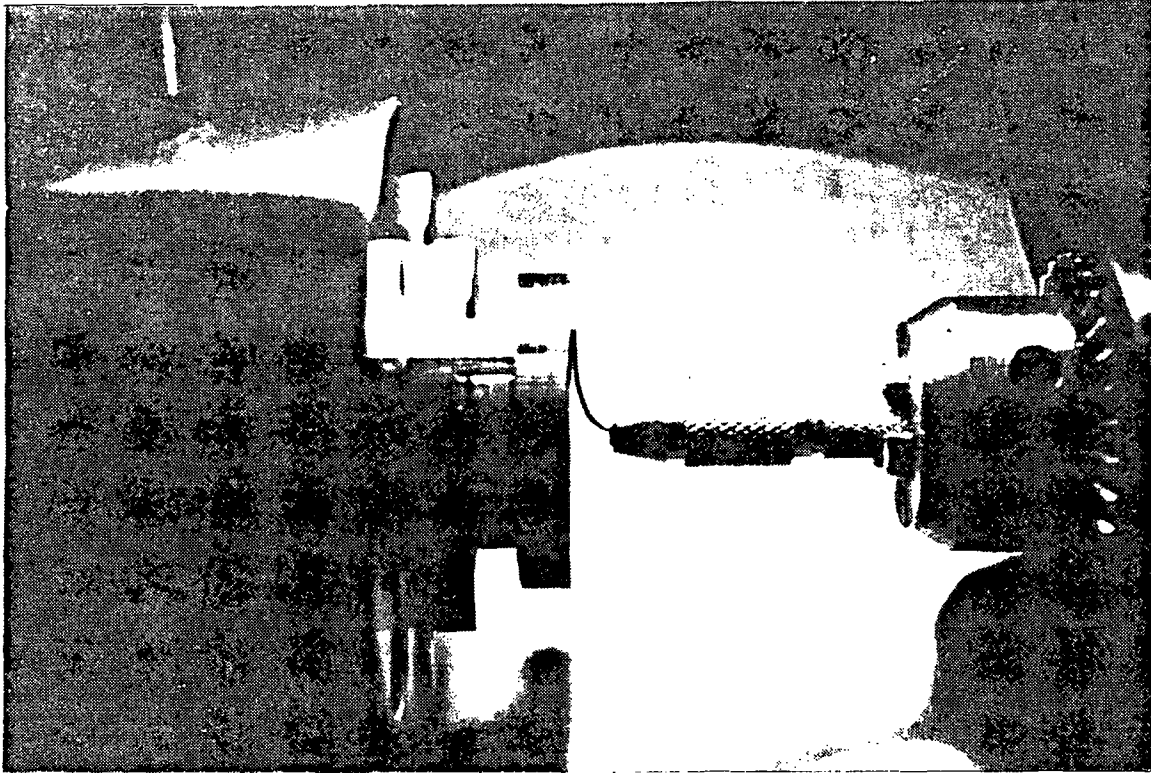
Figure 4.5 Testing of a Sample Wire

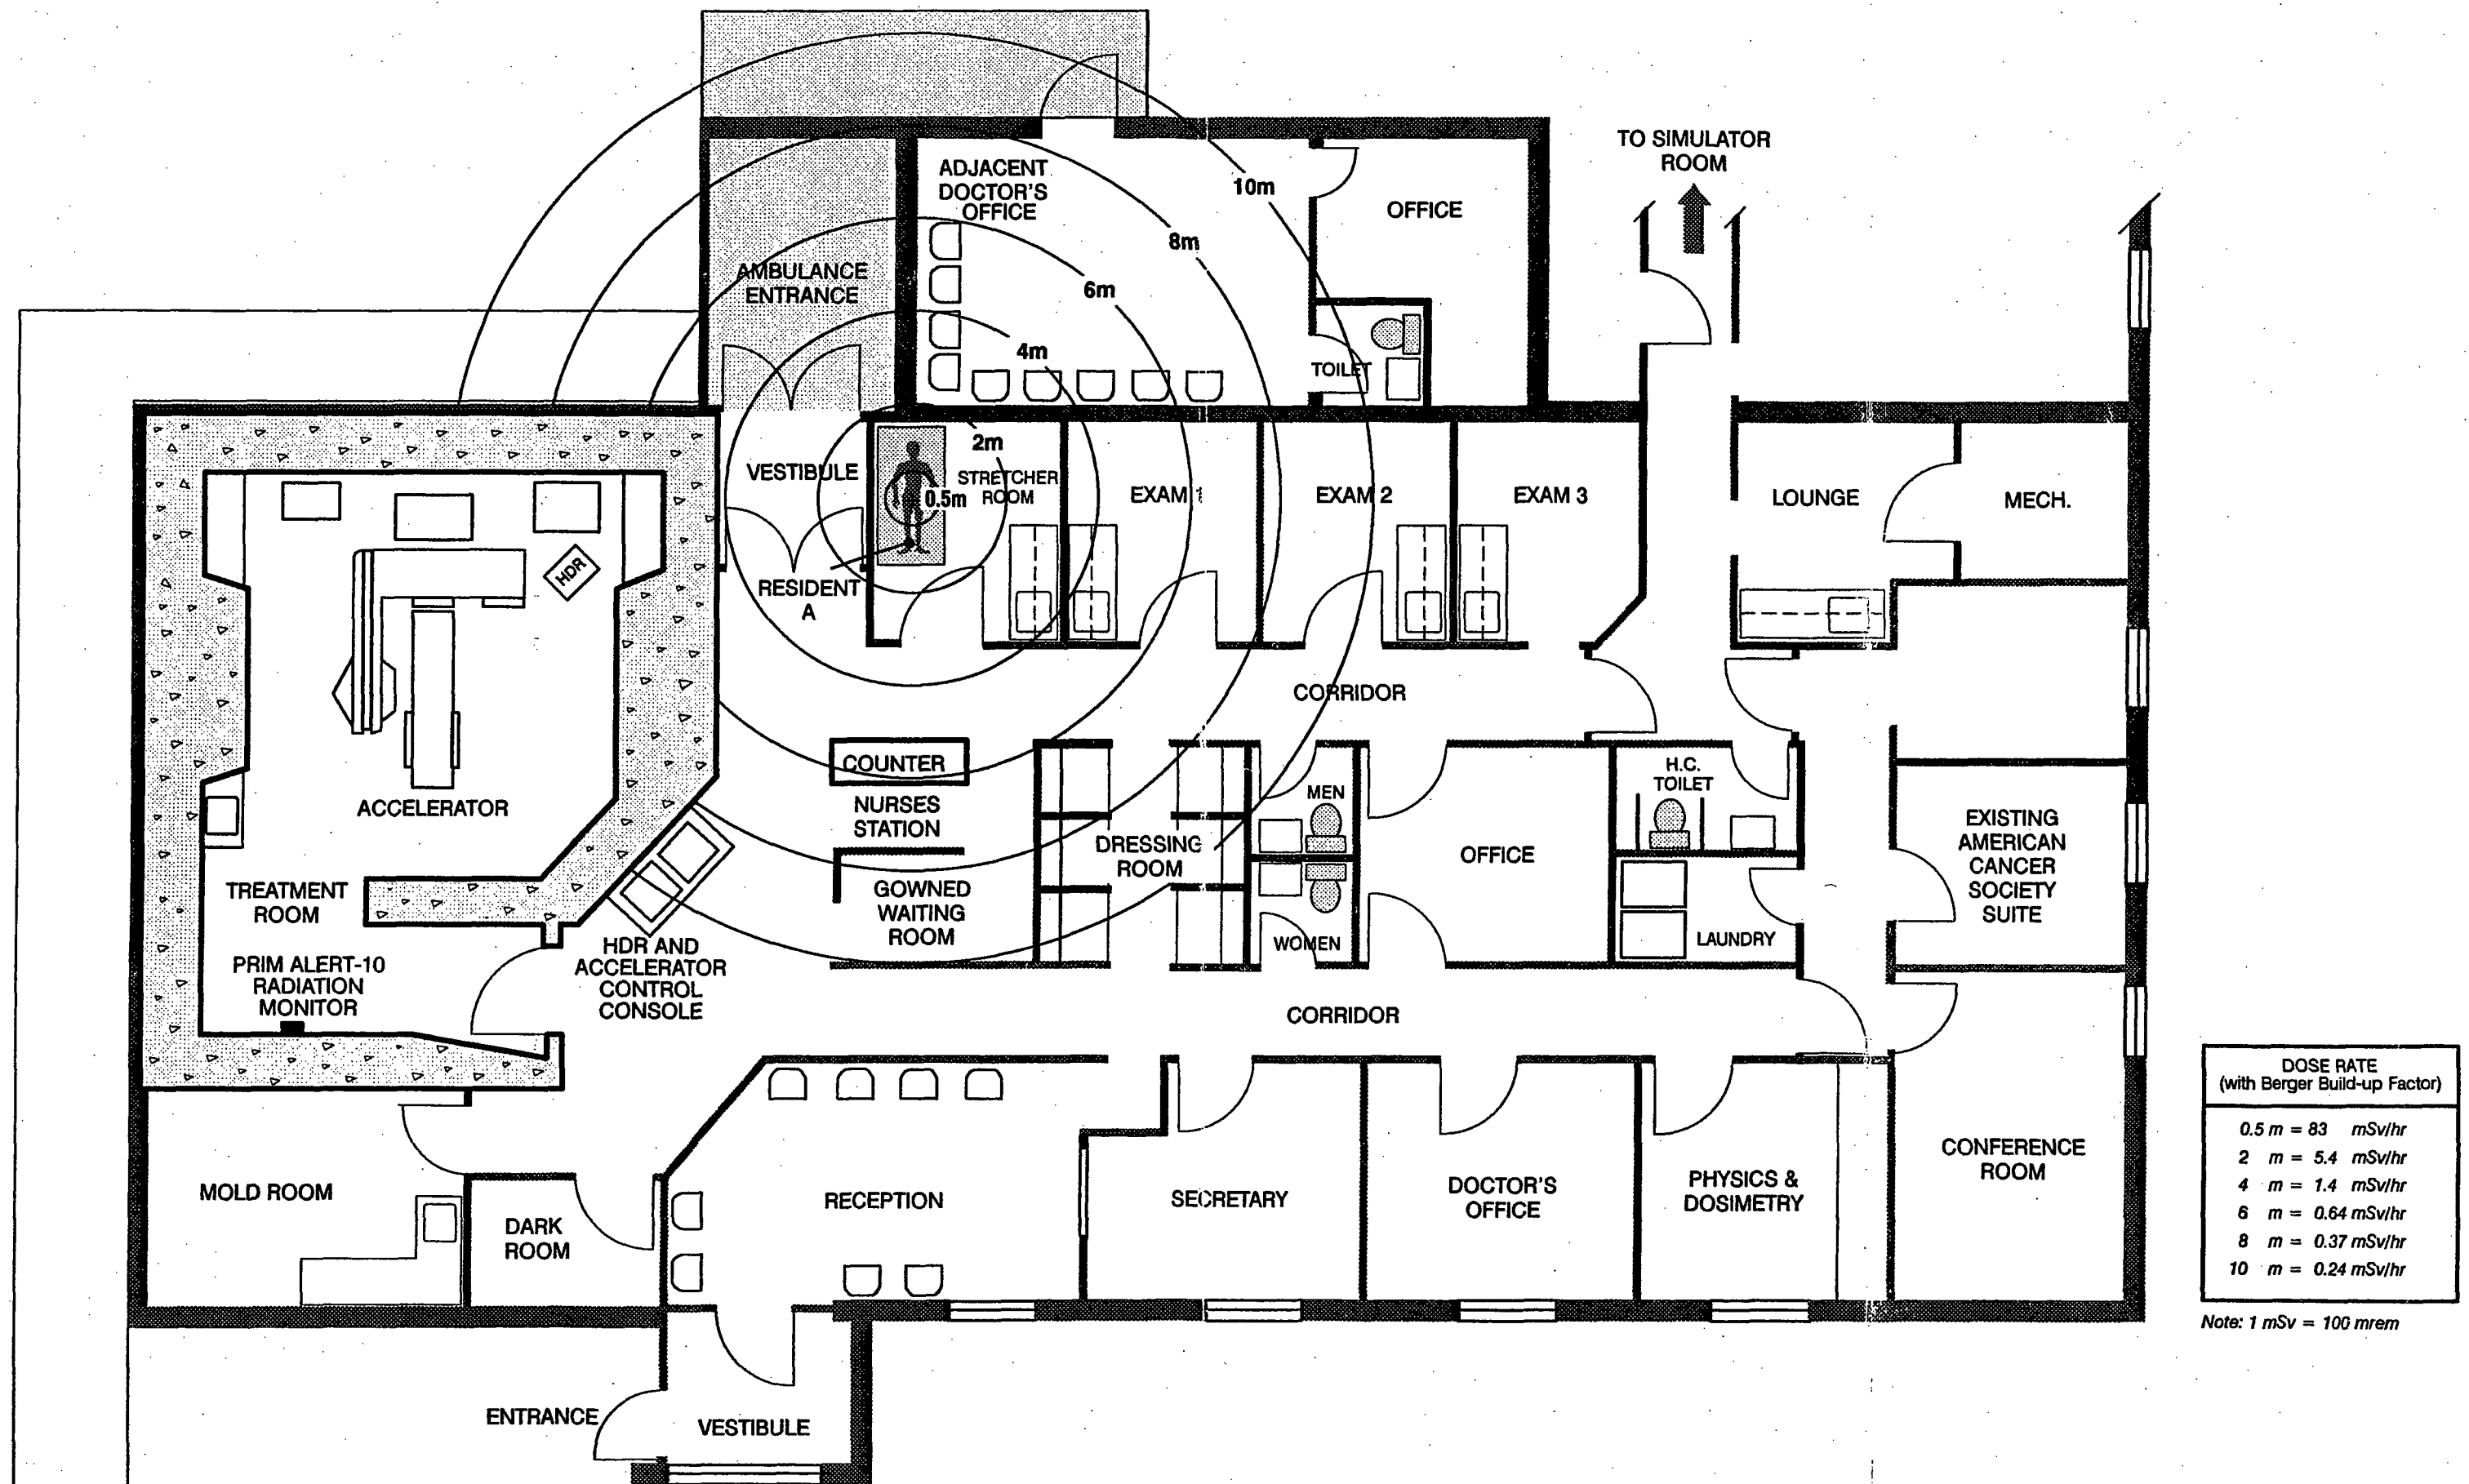
Figure 6.1 Diagram of the Indiana Regional Cancer Center Showing Isodose Curves from the Iridium-192 Source on November 16, 1992.

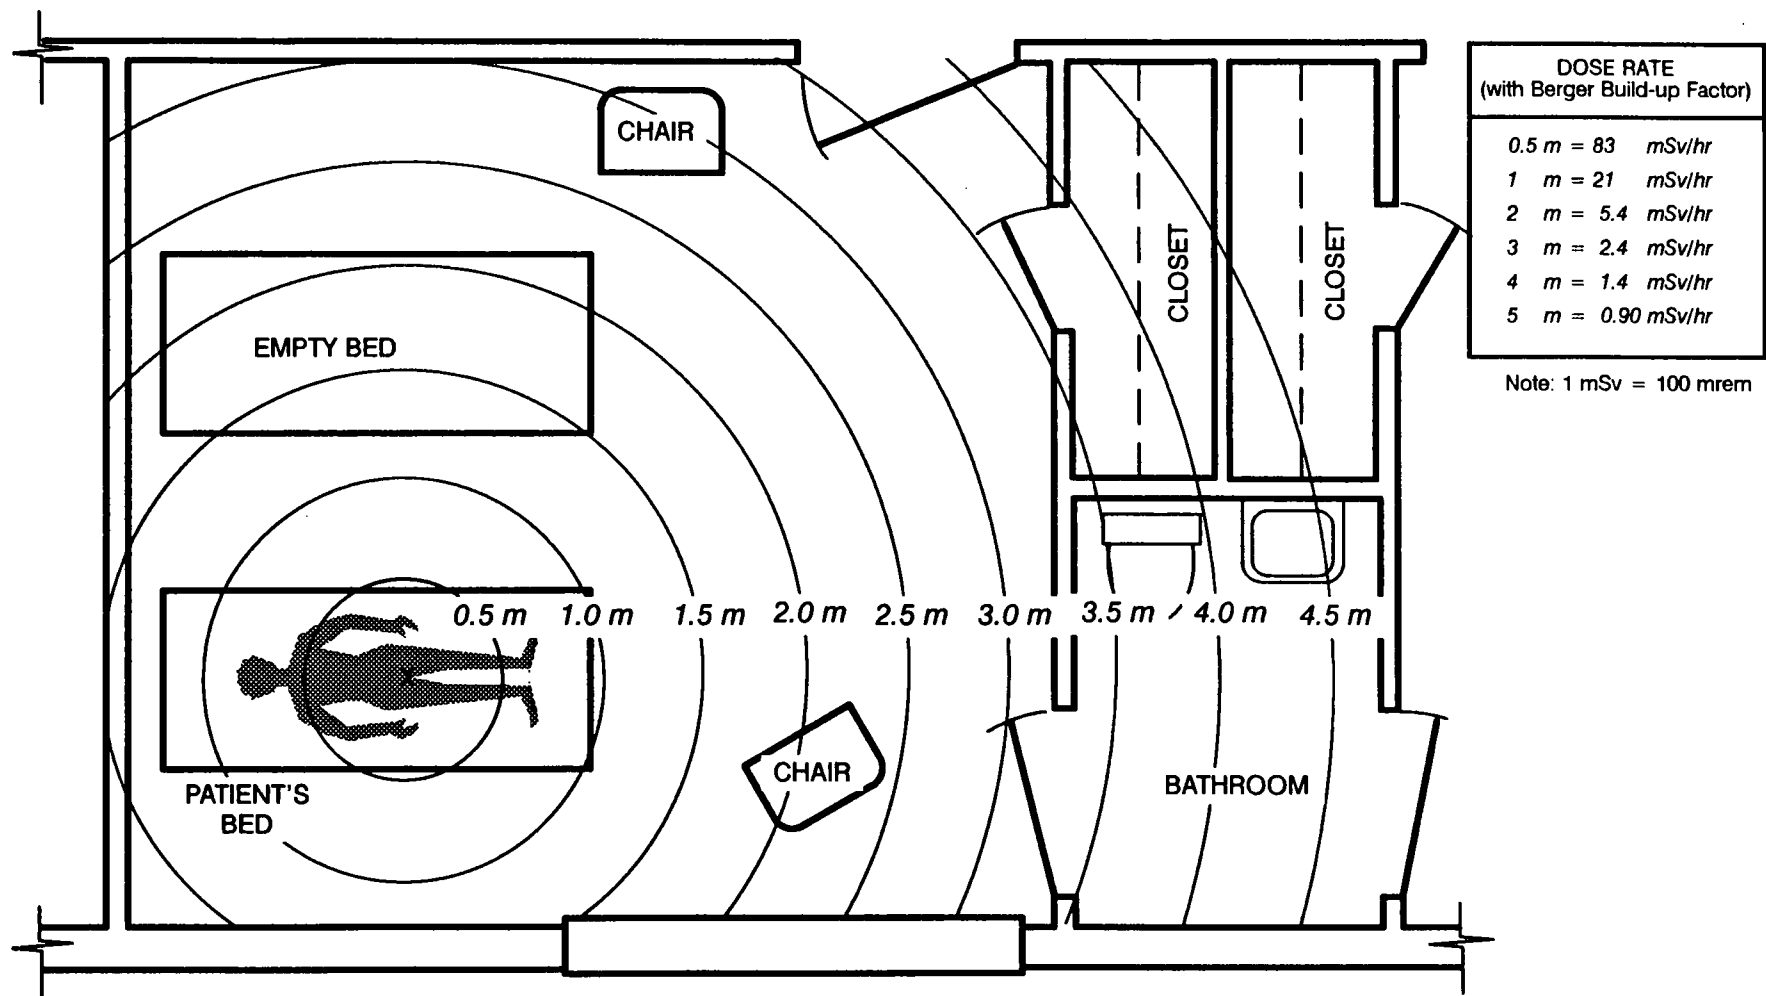
Figure 6.3 Diagram of Room 4B at the Scenery Hill Manor Nursing Home Showing Isodose Curves from the Iridium-192 Source on November 16, 1992

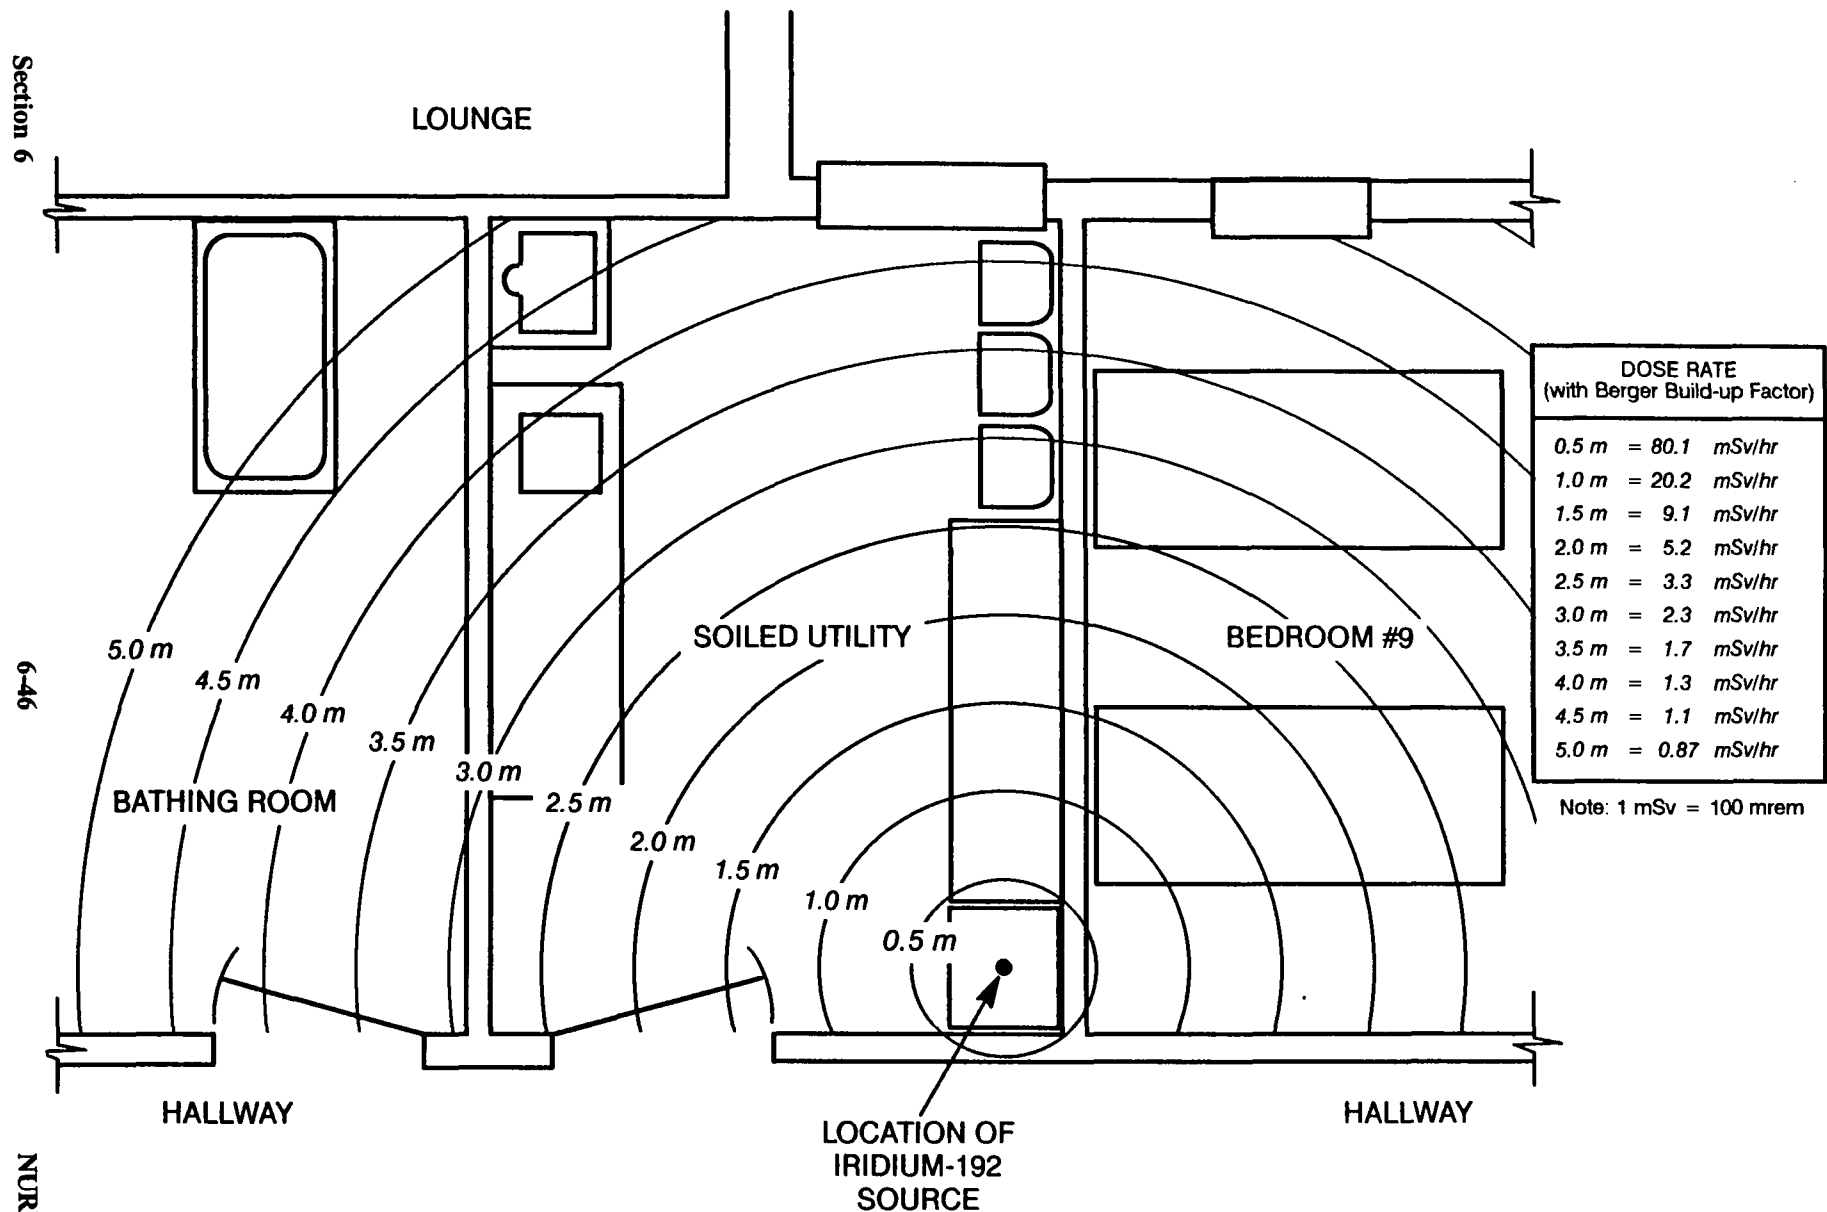
Figure 6.4 Diagram of the SHM Nursing Home Soiled Utility Room Showing Isodose Curves from the Iridium-192 Source on November 20, 1992

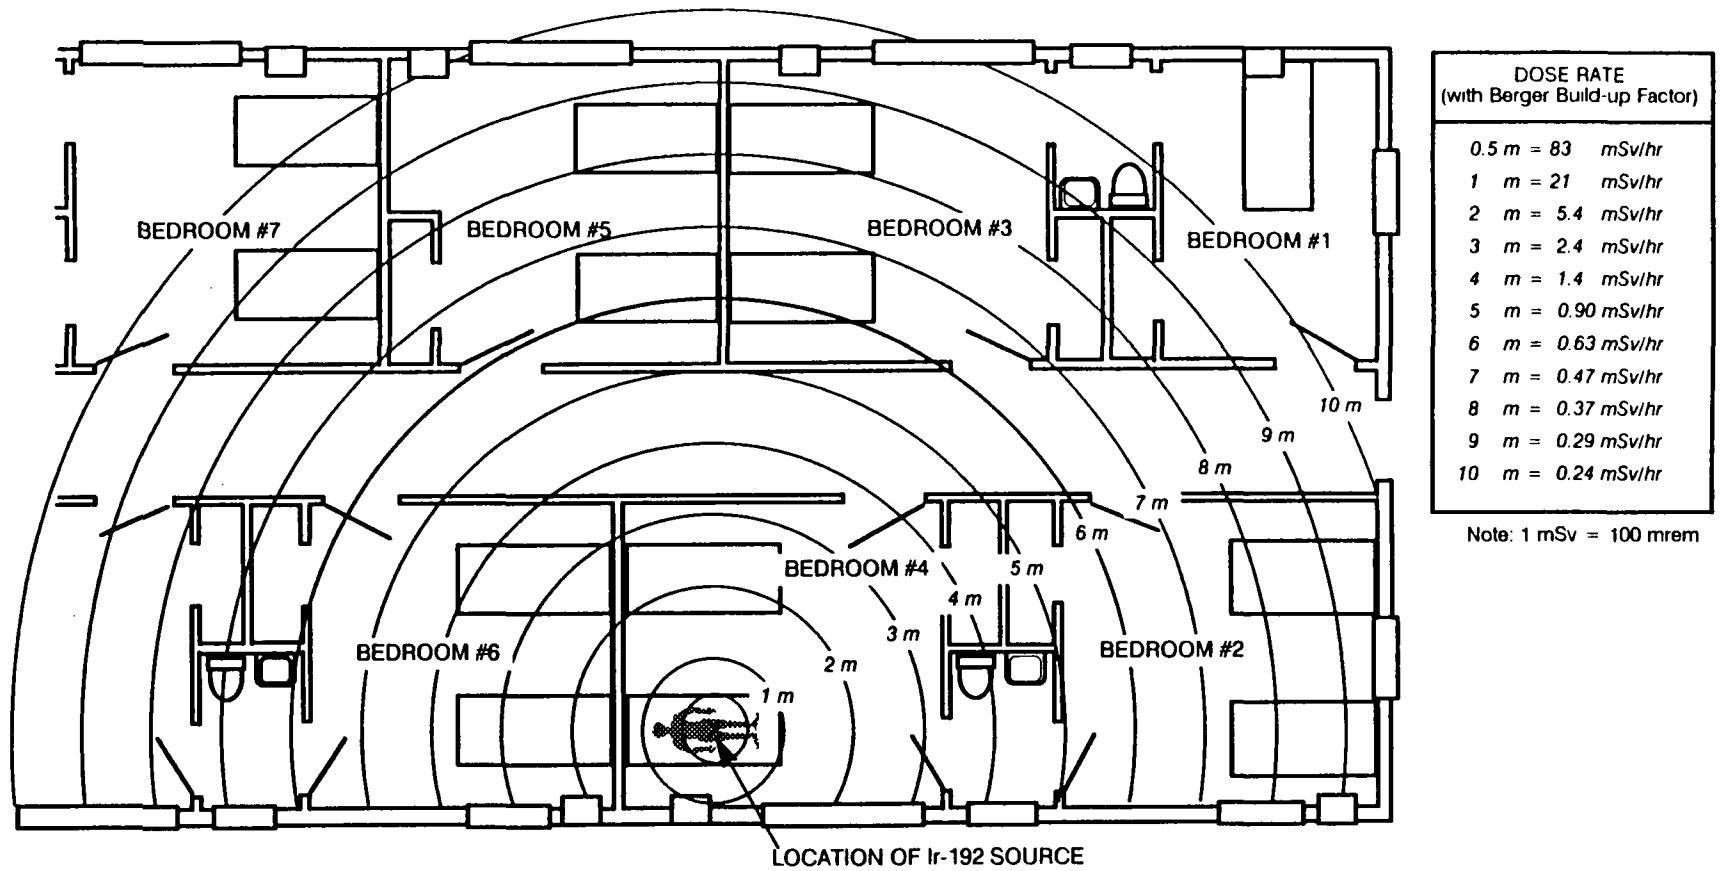
Figure 6.5 Diagram of Rooms Adjacent to Patient Room 4B Showing 1-Meter Isodose Curves from the Iridium-192 Source on November 16, 1992

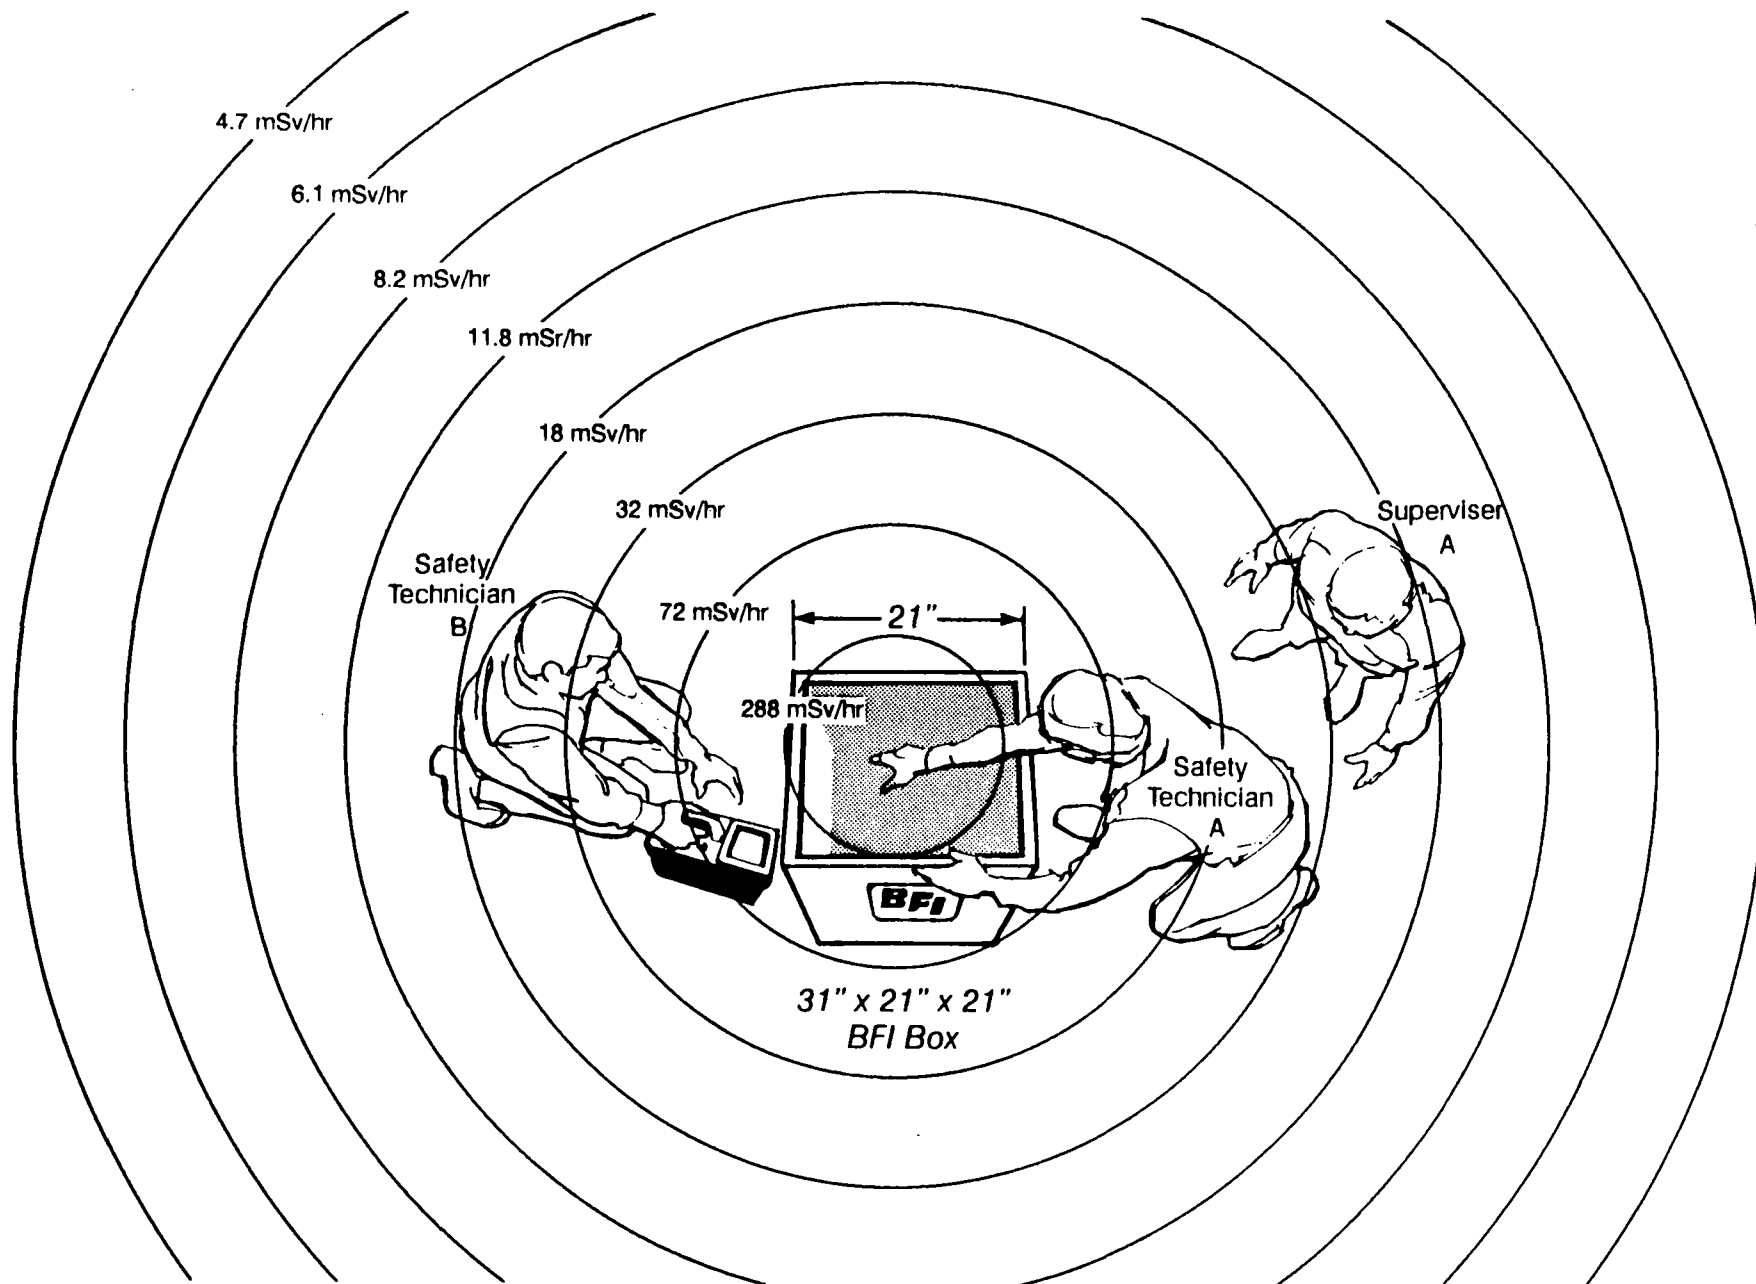
Figure 6.8 Aerial View of the Positions of Supervisor A, Safety Technician A, and Safety Technician B Around the Box Containing the Iridium-192 Source on December 1, 1992, Showing Isodose Curves in mSv per Hour

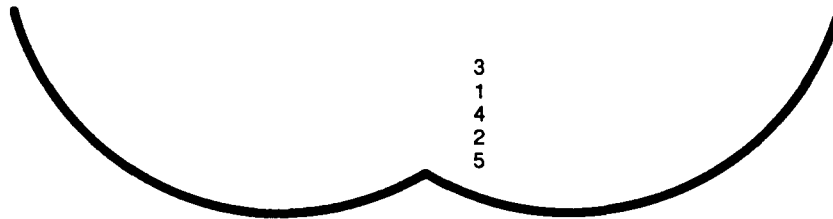
Figure 7.1 Treatment Plan Catheter Location

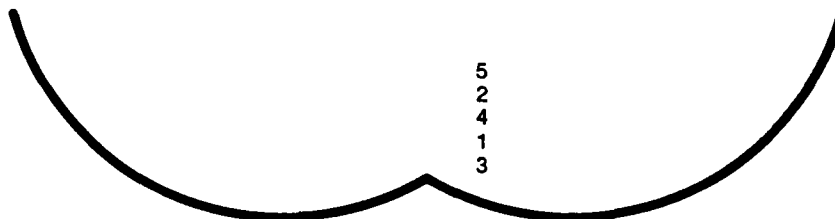
Figure 7.2 Actual Catheter Location
