Examination of Steam Generator Tubes Removed from Beaver Valley Unit 2

Prepared for the  
FirstEnergy Nuclear Operating Company

**SG-CCOE-14-4-NP**  
**Revision 1**

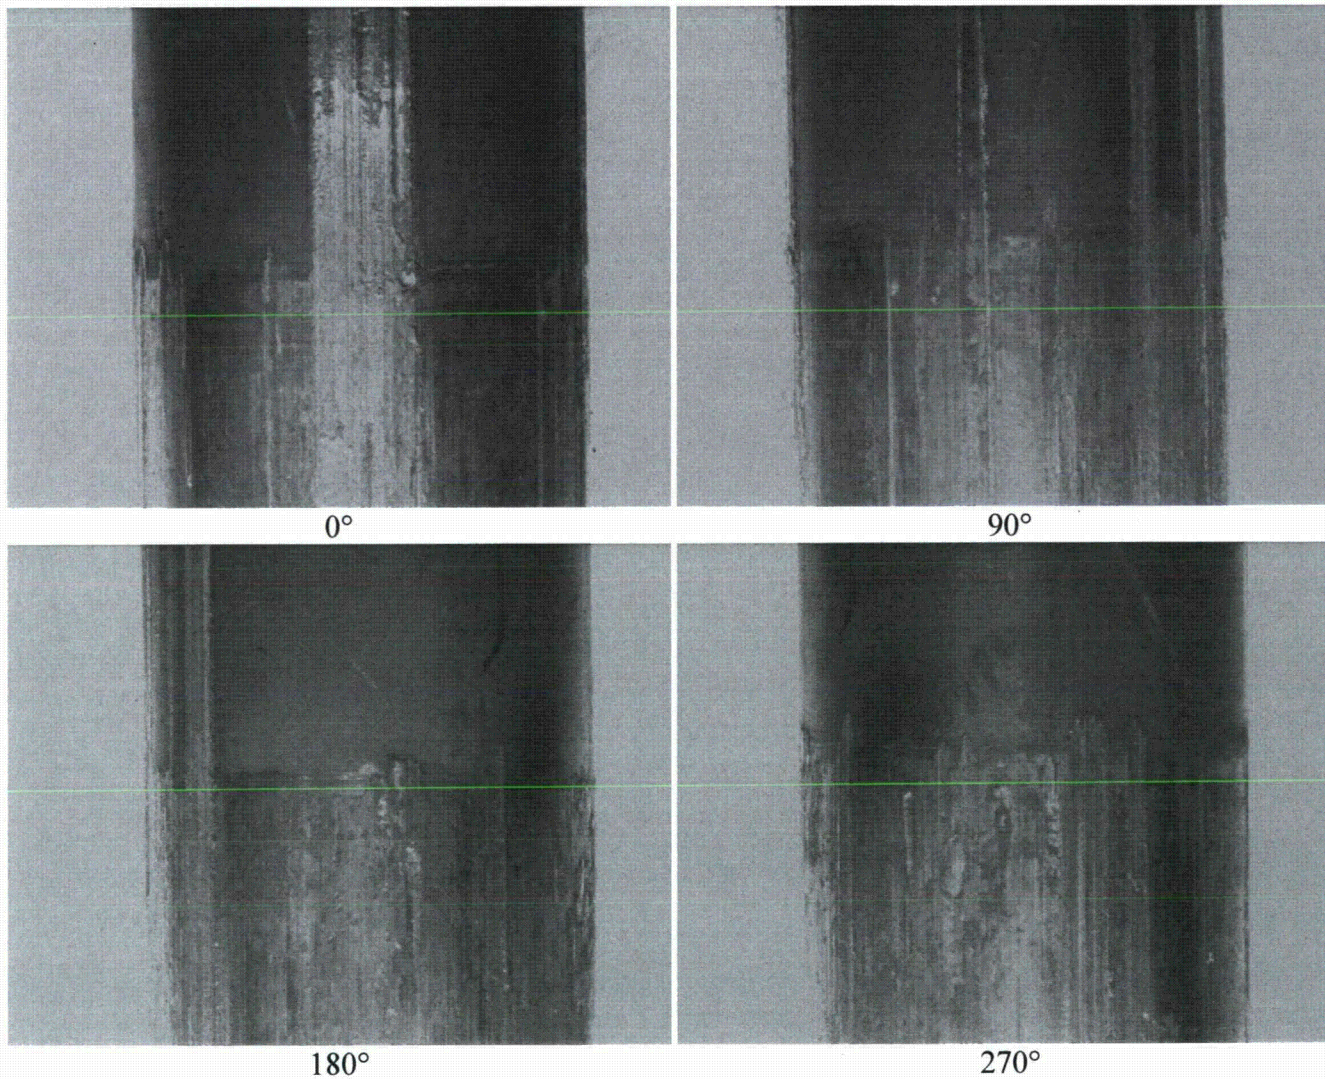
A stereomicroscope examination of the area did not identify any evidence of corrosion on the TTS region of R19C38; deposits above the TTS and scrapes below the TTS obscured a direct, unblemished view of the surface. There was no evidence of a sludge collar.

Figure 2-2: As-Received Views of R19C38 TTS Region

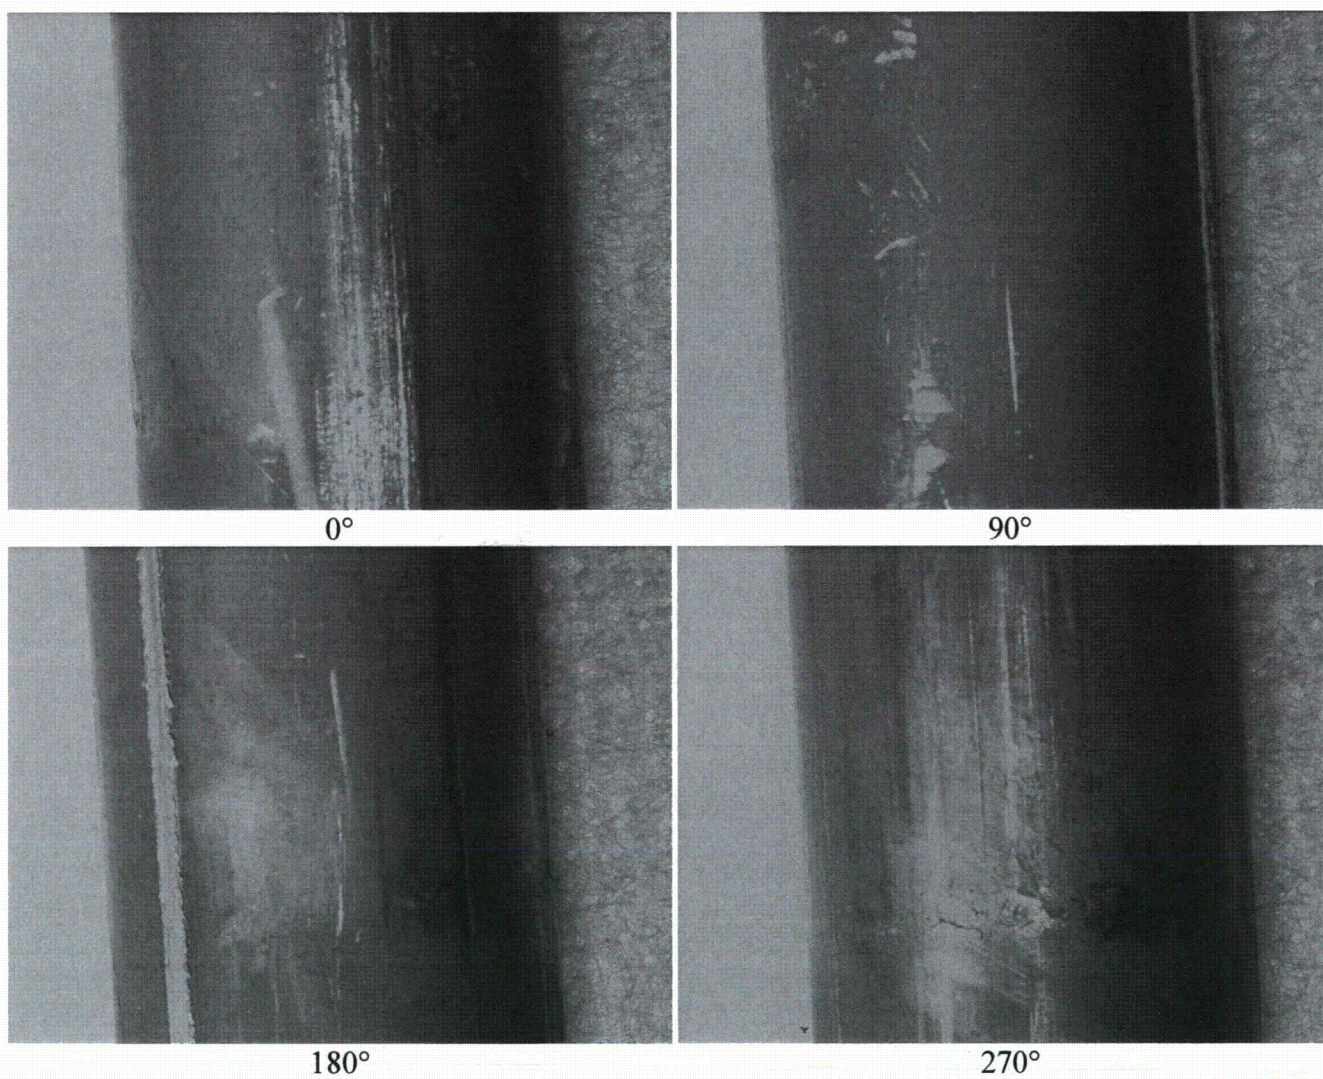
A stereomicroscope examination of the area did not identify any evidence of corrosion on the FDB region of R19C38; most of the tube surface was covered by a thin layer of adherent black deposit which obscured the surface.

Figure 2-3: As-Received Views of R19C38 FDB Region

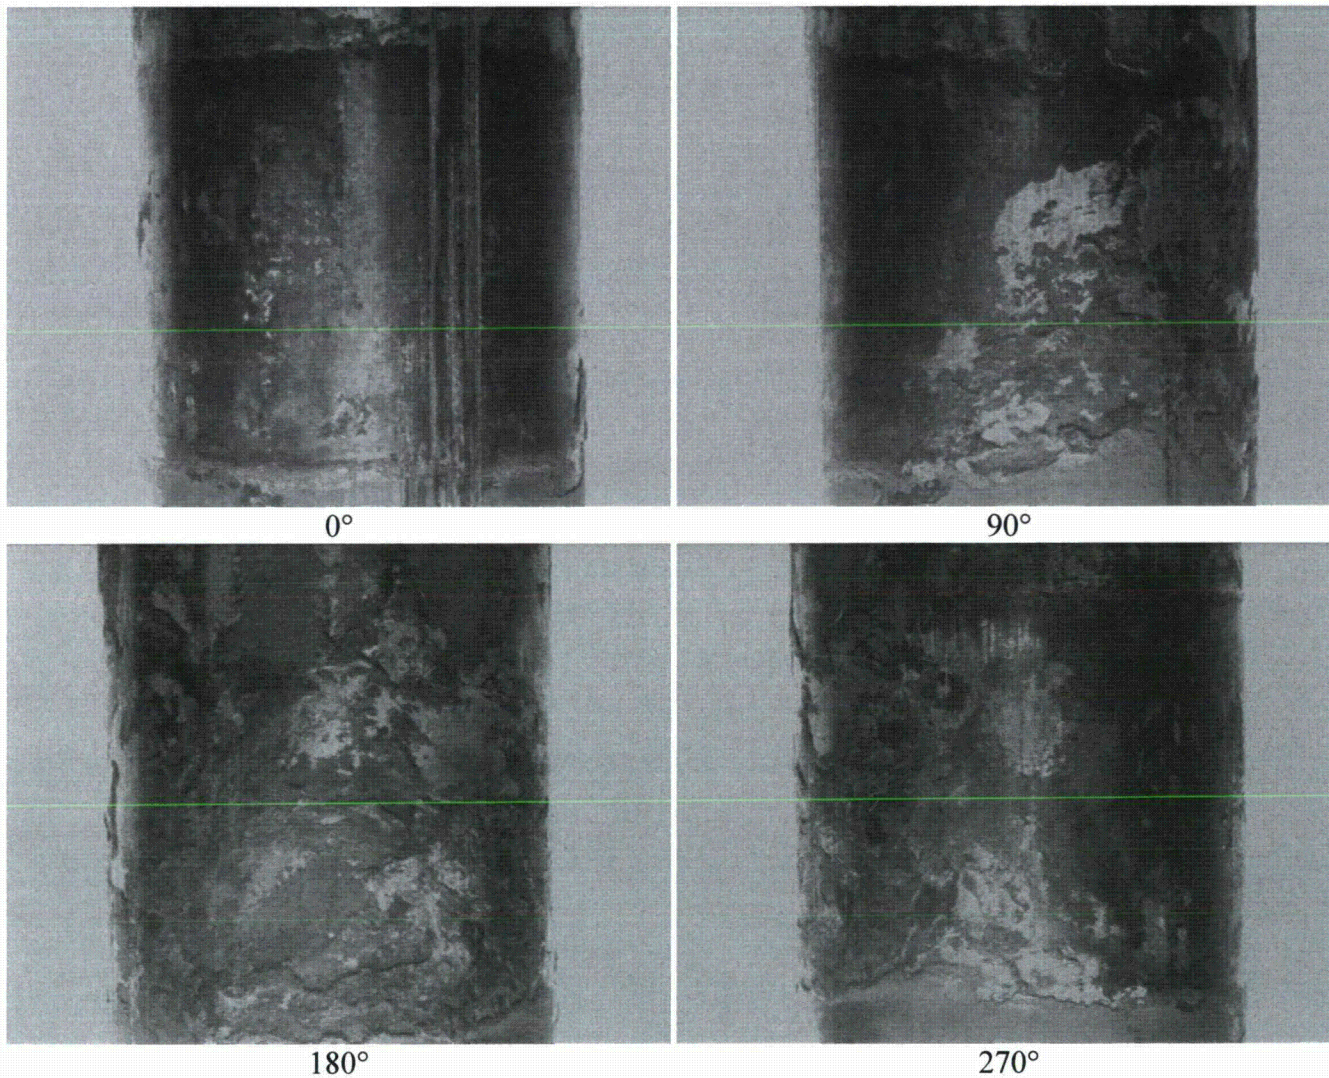
A stereomicroscope examination of the area did not identify any evidence of corrosion on the 02H TSP region of R19C38, although much of the surface was obscured by deposits. The top and bottom of the TSP region had raised deposits around most of the circumference. The TSP region contained areas of raised deposits as well as bare tubing. There was a brownish-tinge to the bare tubing, extending from ~270-0°-90°. The rest of the TSP region had small patches of deposits.

Figure 2-4: As-Received Views of R19C38 02H TSP Region

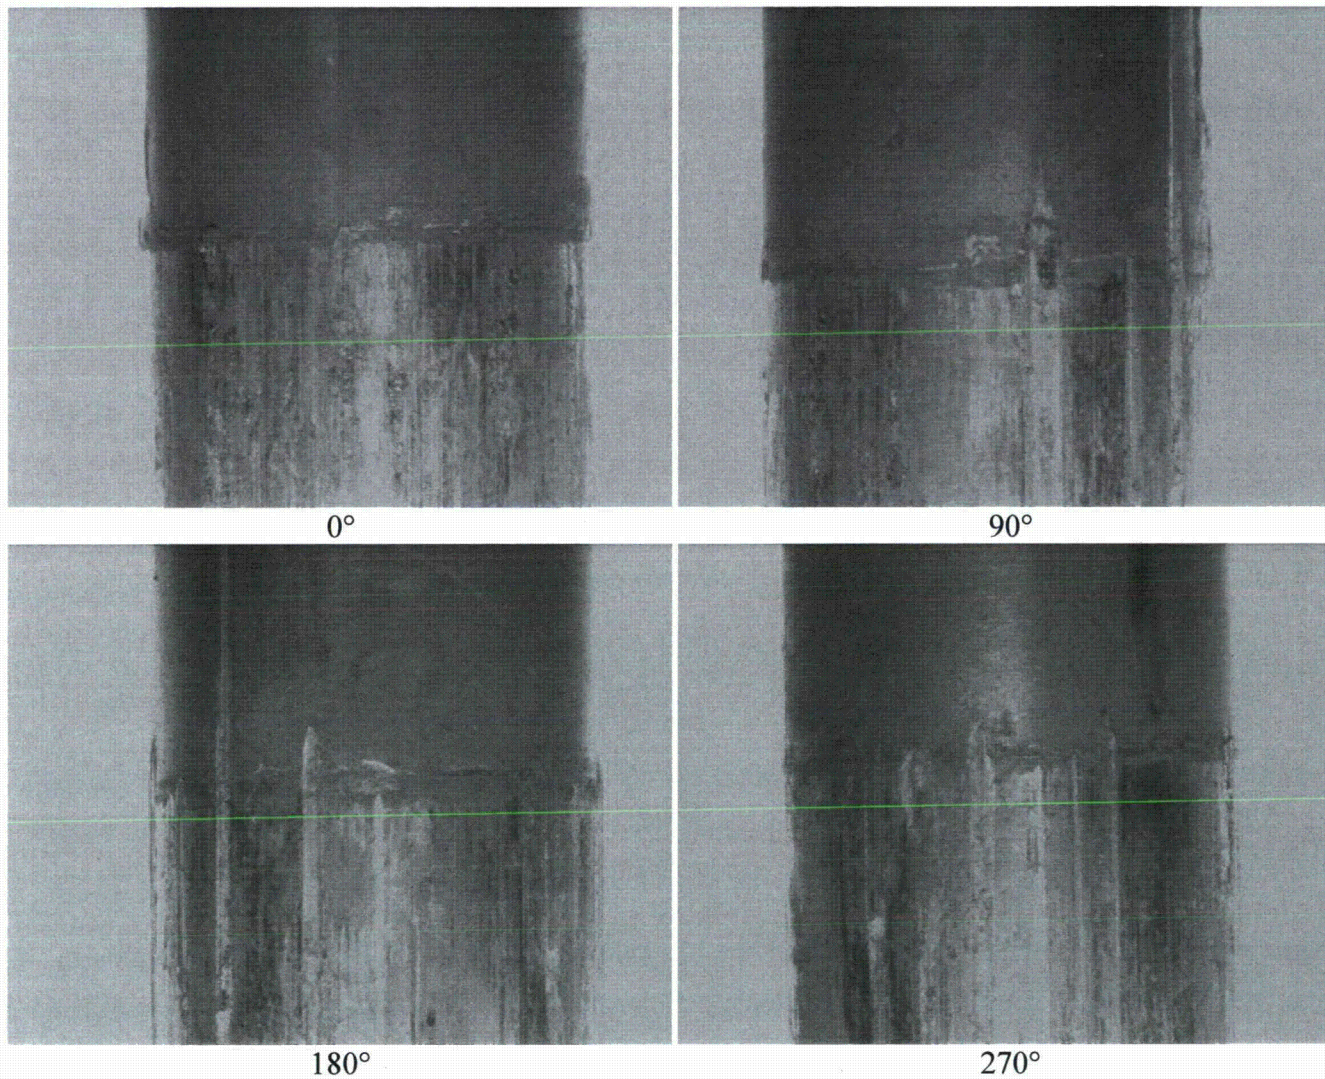
Figure 2-6 shows four views of the TTS region around the circumference of the tube. In the photos, the yellow color is attributed to the light source. The reddish regions are rust-colored deposits. Since these rust-colored deposits are located within fresh scratches, it is concluded that they were introduced to the tube surface by the tube pulling operation.

A stereomicroscope examination of the area did not identify any evidence of corrosion on the TTS region of R24C41. There was no evidence of a sludge collar. At the TTS, there was a narrow ridge of raised deposits that extended around the circumference. There were several fresh shallow scrapes, attributable to the pulling operation, which ran along most of the length of the segment, starting below the TTS and extending above the TTS. A single tube installation scratch was observed at the 315° orientation. Below the TTS, the entire surface was covered with fresh shallow scrapes; typical for a pulled tube and attributable to the tube pulling operation.

Figure 2-6: As-Received Views of R24C41 TTS Region

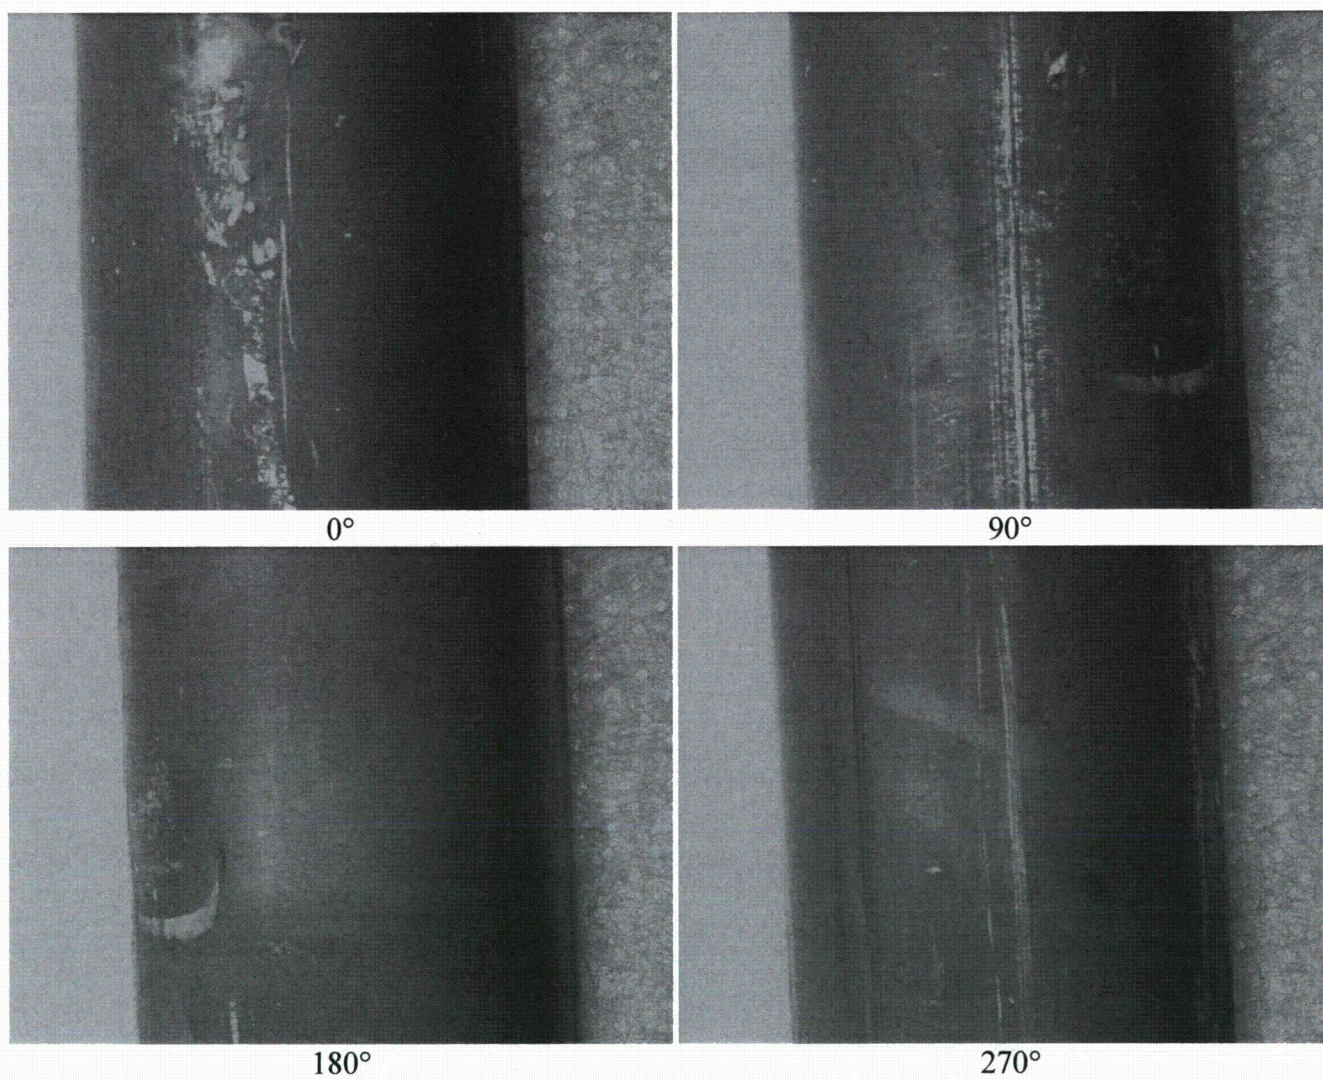
A stereomicroscope examination of the area did not identify any evidence of corrosion on the FDB region of R24C41.

Figure 2-7: As-Received Views of R24C41 FDB Region

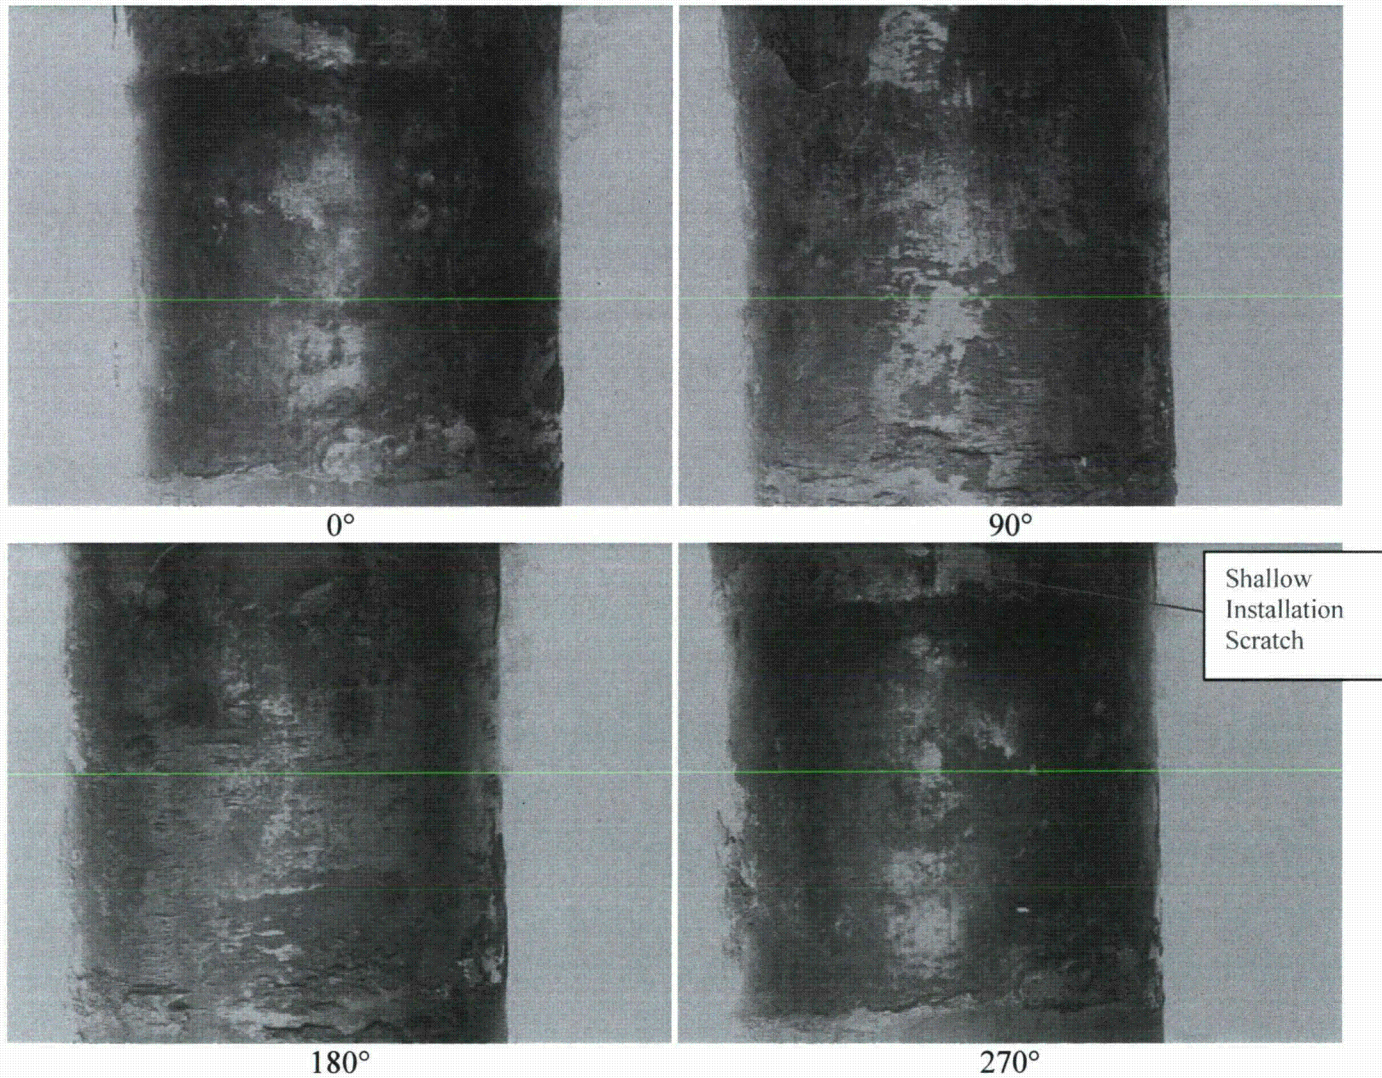
Segment 3 contained the 02H TSP region. The TSP region was easily identified by unaided visual means as a region of non-uniform deposit. The TSP was centered 15.8-inches above the bottom of Segment 3. Segment 3 was mostly covered with a thin uniform adherent layer of black deposit, except in the region of the TSP and several inches of area just below the TSP region that may have been scraped off during the tube pulling operation. One light tube installation scratch was observed at the 270° orientation.

A stereomicroscope examination of the area did not identify any evidence of corrosion on the 02H TSP region of R24C41, although some of the surface was obscured by deposits. The top and bottom of the TSP region had patches of raised deposits around most of the circumference. The rest of the TSP region also had small patches of deposits, but large portions of the TSP region were free of deposits.

Figure 2-8: As-Received Views of R24C41 02H TSP Region

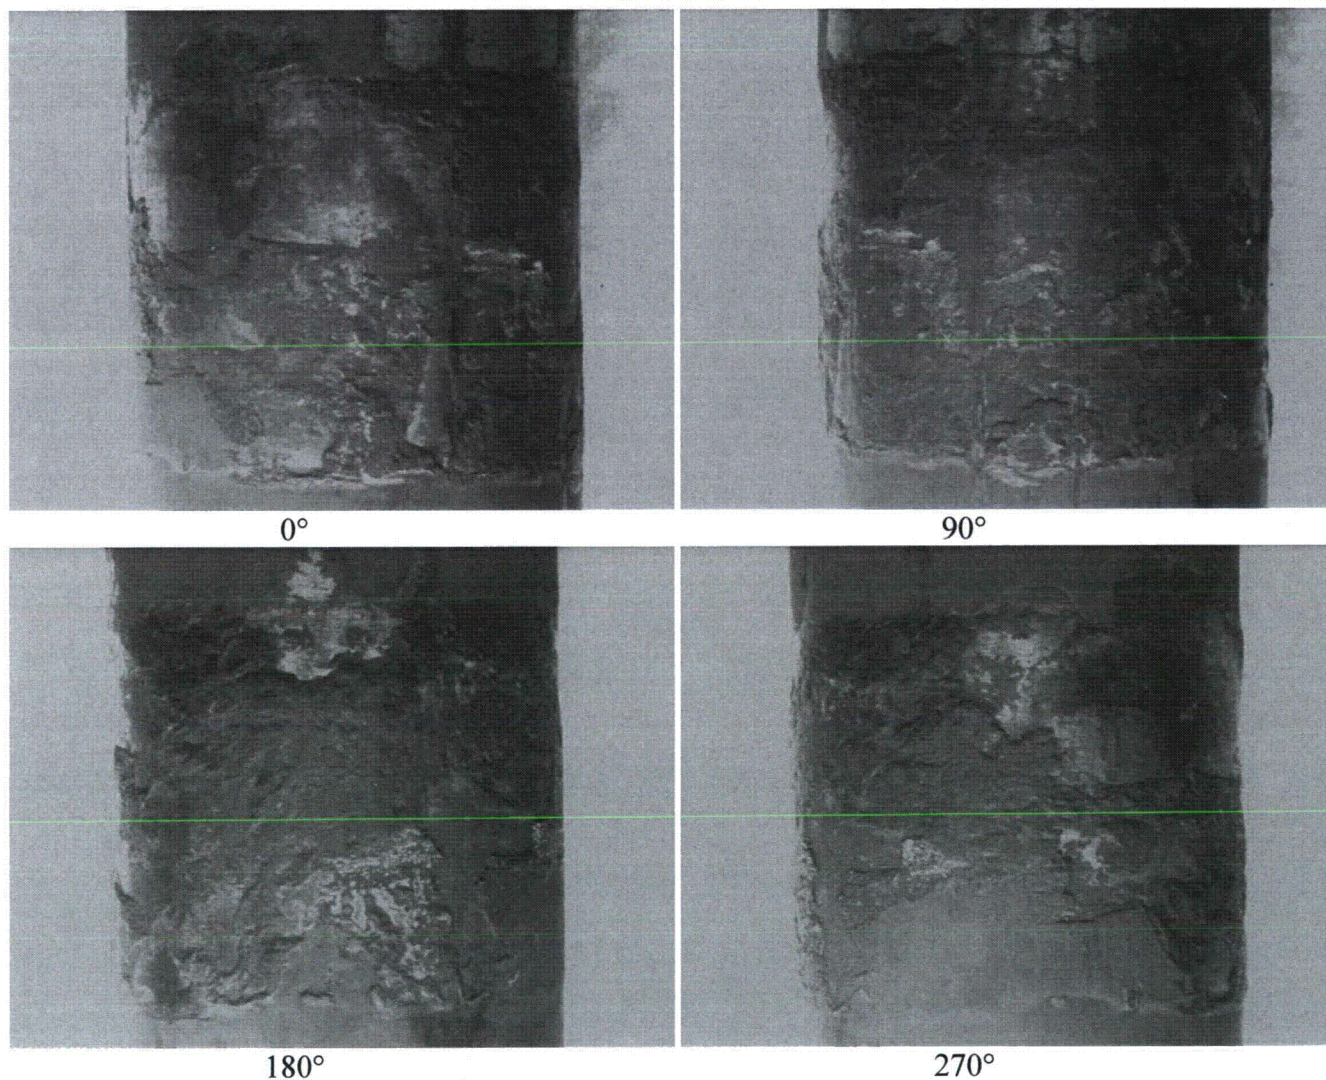
Segment 5 contained the 03H TSP region. The TSP region was easily identified by unaided visual means as a region of non-uniform deposit. The TSP was centered 4.8-inches above the bottom of Segment 5. Segment 5 was mostly covered with a uniform adherent layer of black deposit, except in the region of the TSP and a small region just above the TSP. Several light tube pull scratches were observed.

A stereomicroscope examination of the area did not identify any evidence of corrosion on the 03H TSP region of R24C41, although nearly the entire surface was obscured by deposits. The top and bottom of the TSP region had patches of raised deposits around most of the circumference.

Figure 2-10: As-Received Views of R24C41 03H TSP Region

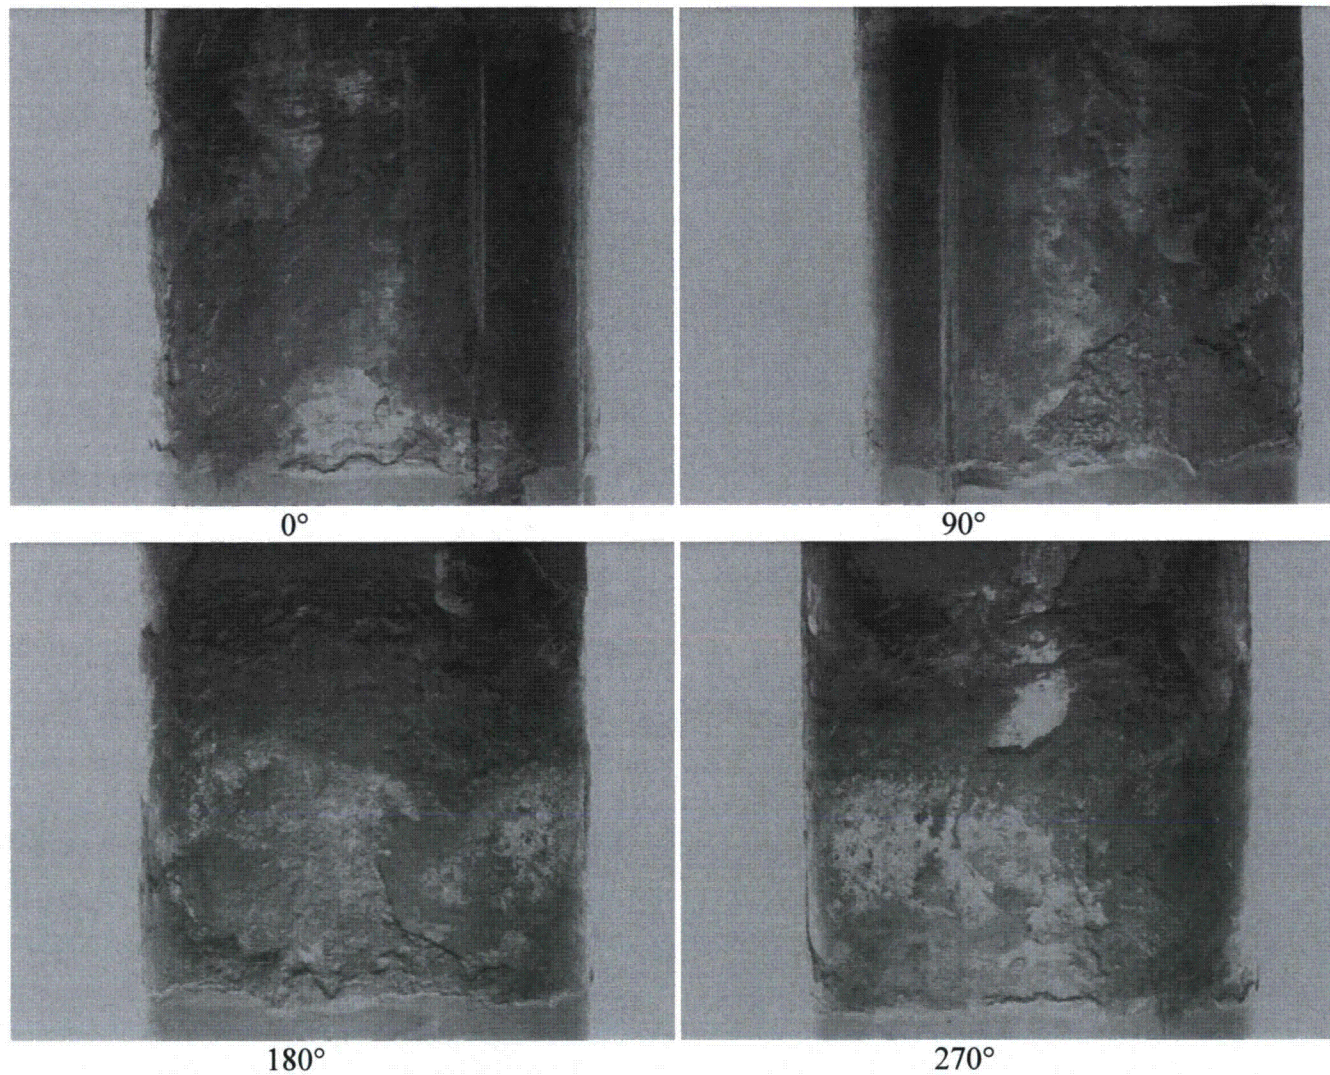
Segment 6 contained the 04H TSP region. The TSP region was easily identified by unaided visual means as a region of non-uniform deposit. The TSP was centered 23.0-inches above the bottom of Segment 6. Segment 6 was mostly covered with a uniform adherent layer of black deposit, except in the region of the TSP. Several light tube pull scratches were observed.

A stereomicroscope examination of the area did not identify any evidence of corrosion on the 04H TSP region of R24C41, although much of the surface was obscured by deposits. The top and bottom of the TSP region had patches of raised deposits around most of the circumference. In several areas of the bare tubing within the TSP region, the tube surface

has a brownish color. At the 90°-180° orientations, spots of brown were observed on top of the deposits.

Figure 2-11: As-Received Views of R24C41 04H TSP Region

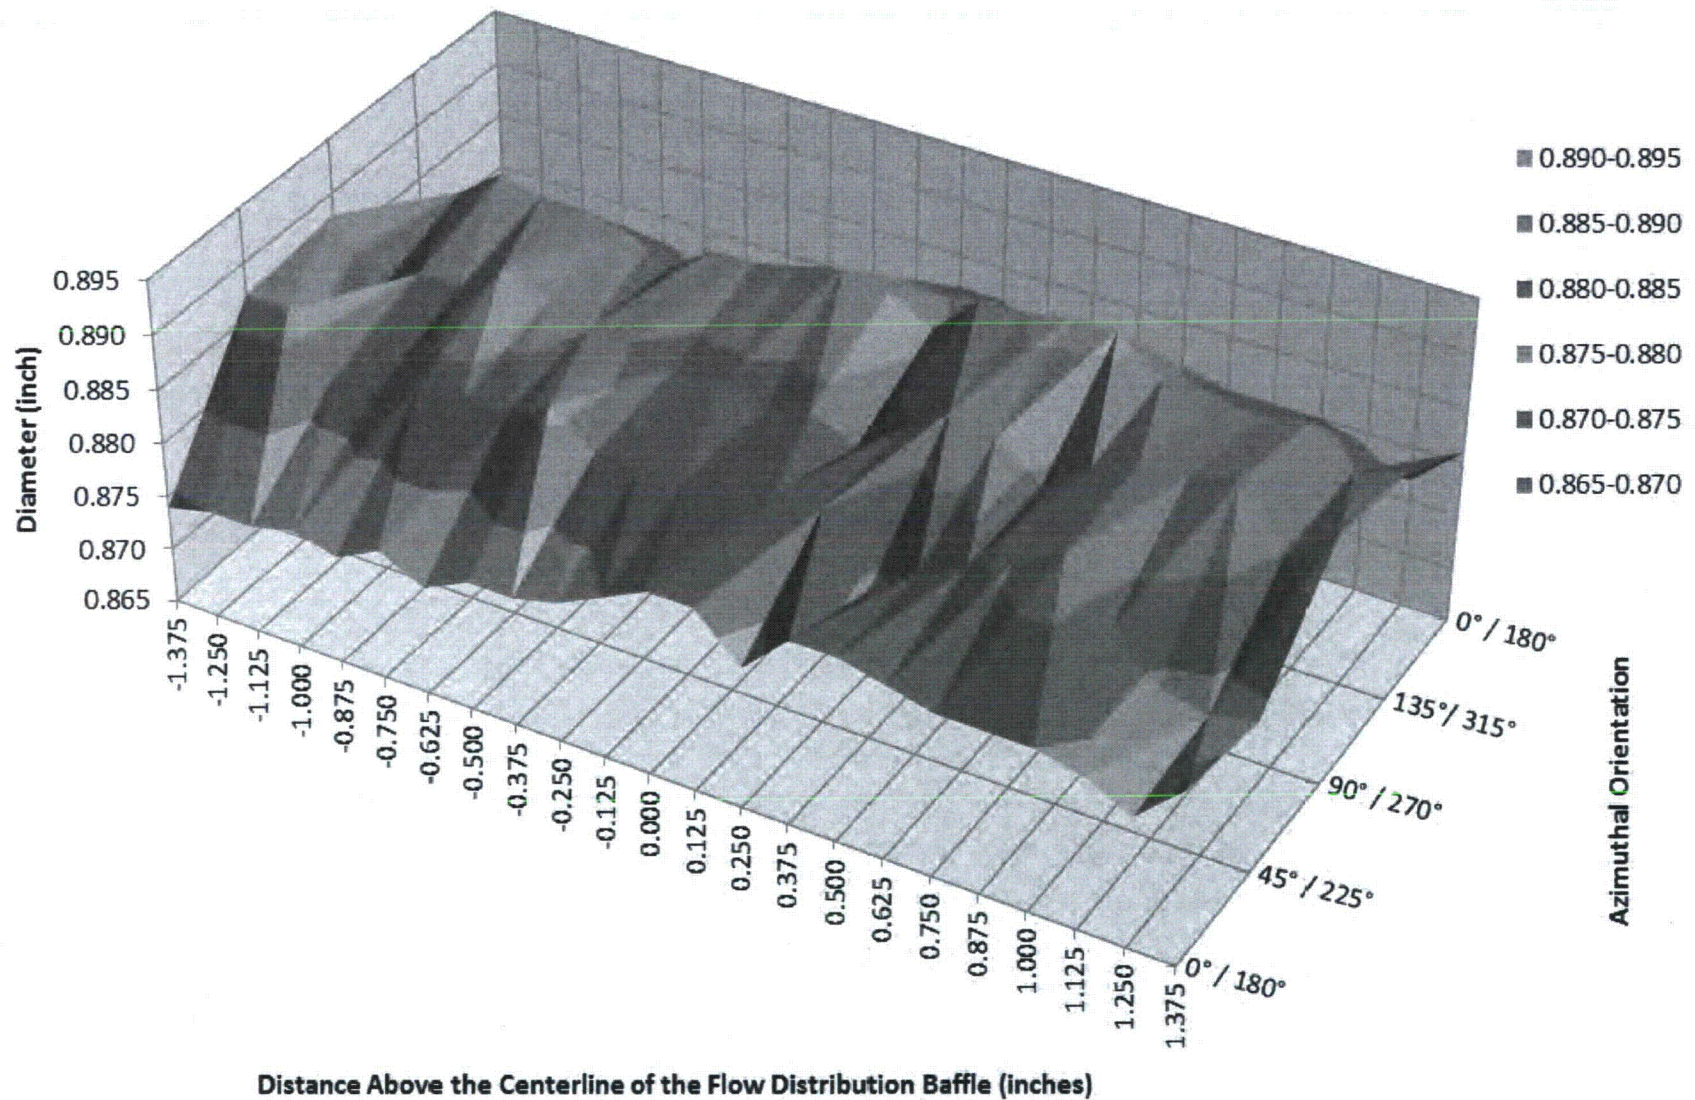
Figure 2-14 presents a profile of the diameter in the FDB region of R19C38. Deposits partially interfere with the tube diameter measurements. The wide tube pull scrape at the 0° orientation (see Figure 2-3) was responsible for reduced diametrical measurements at the 0°/180° orientation along the entire measured length. A scratch with raised edges at about the 145° orientation caused slightly elevated diameter measurements. In general, the FDB region diametrical profile is indistinguishable from the freespan tubing above and below the region.

Figure 2-14: Diameter Profile of FDB Region of R19C38

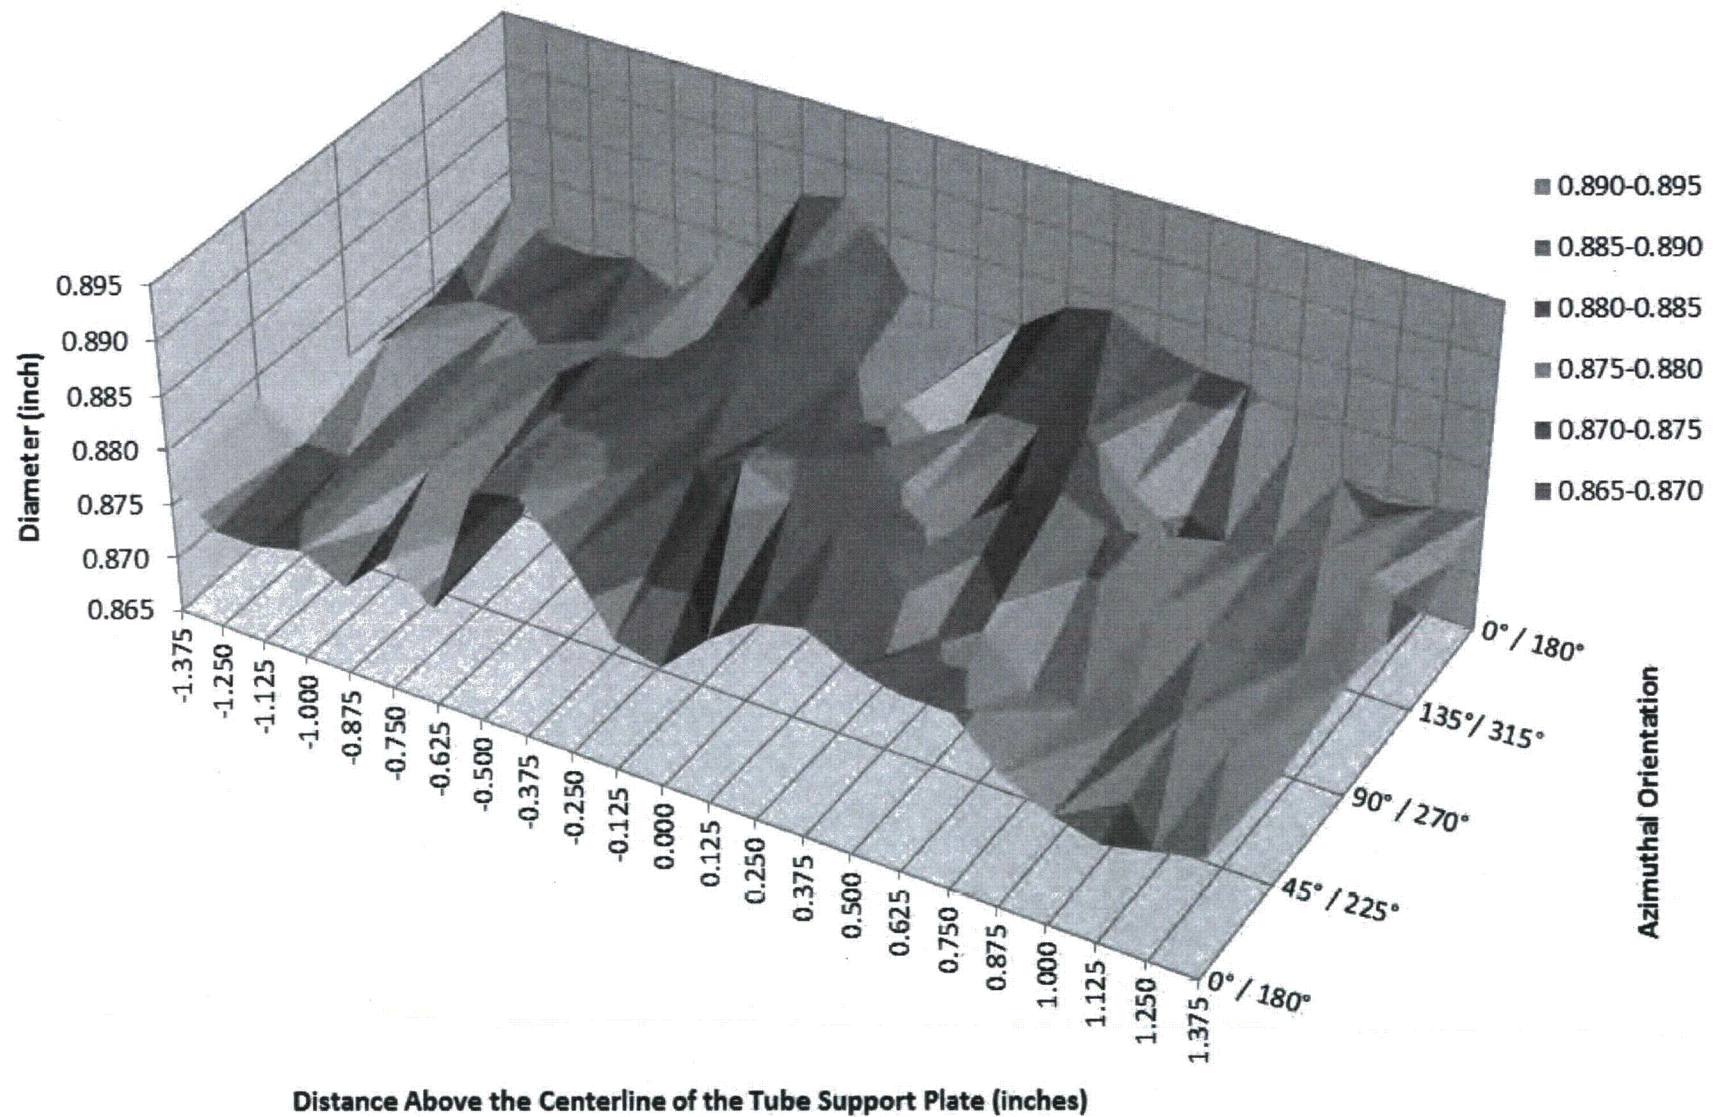
Figure 2-19 presents a profile of the diameter in the 03H TSP region of R24C41. As Figure 2-10 shows, almost the entire region was covered with deposits, which were 5-9 mils thick. Since the tube-TSP drilled hole diametrical clearance is a nominal 16 mils, it seems that a significant fraction of the crevice deposits were retained on the 03H TSP region. Any sign of denting was covered by deposit.

Figure 2-19: Diameter Profile of 03H TSP Region of R24C41

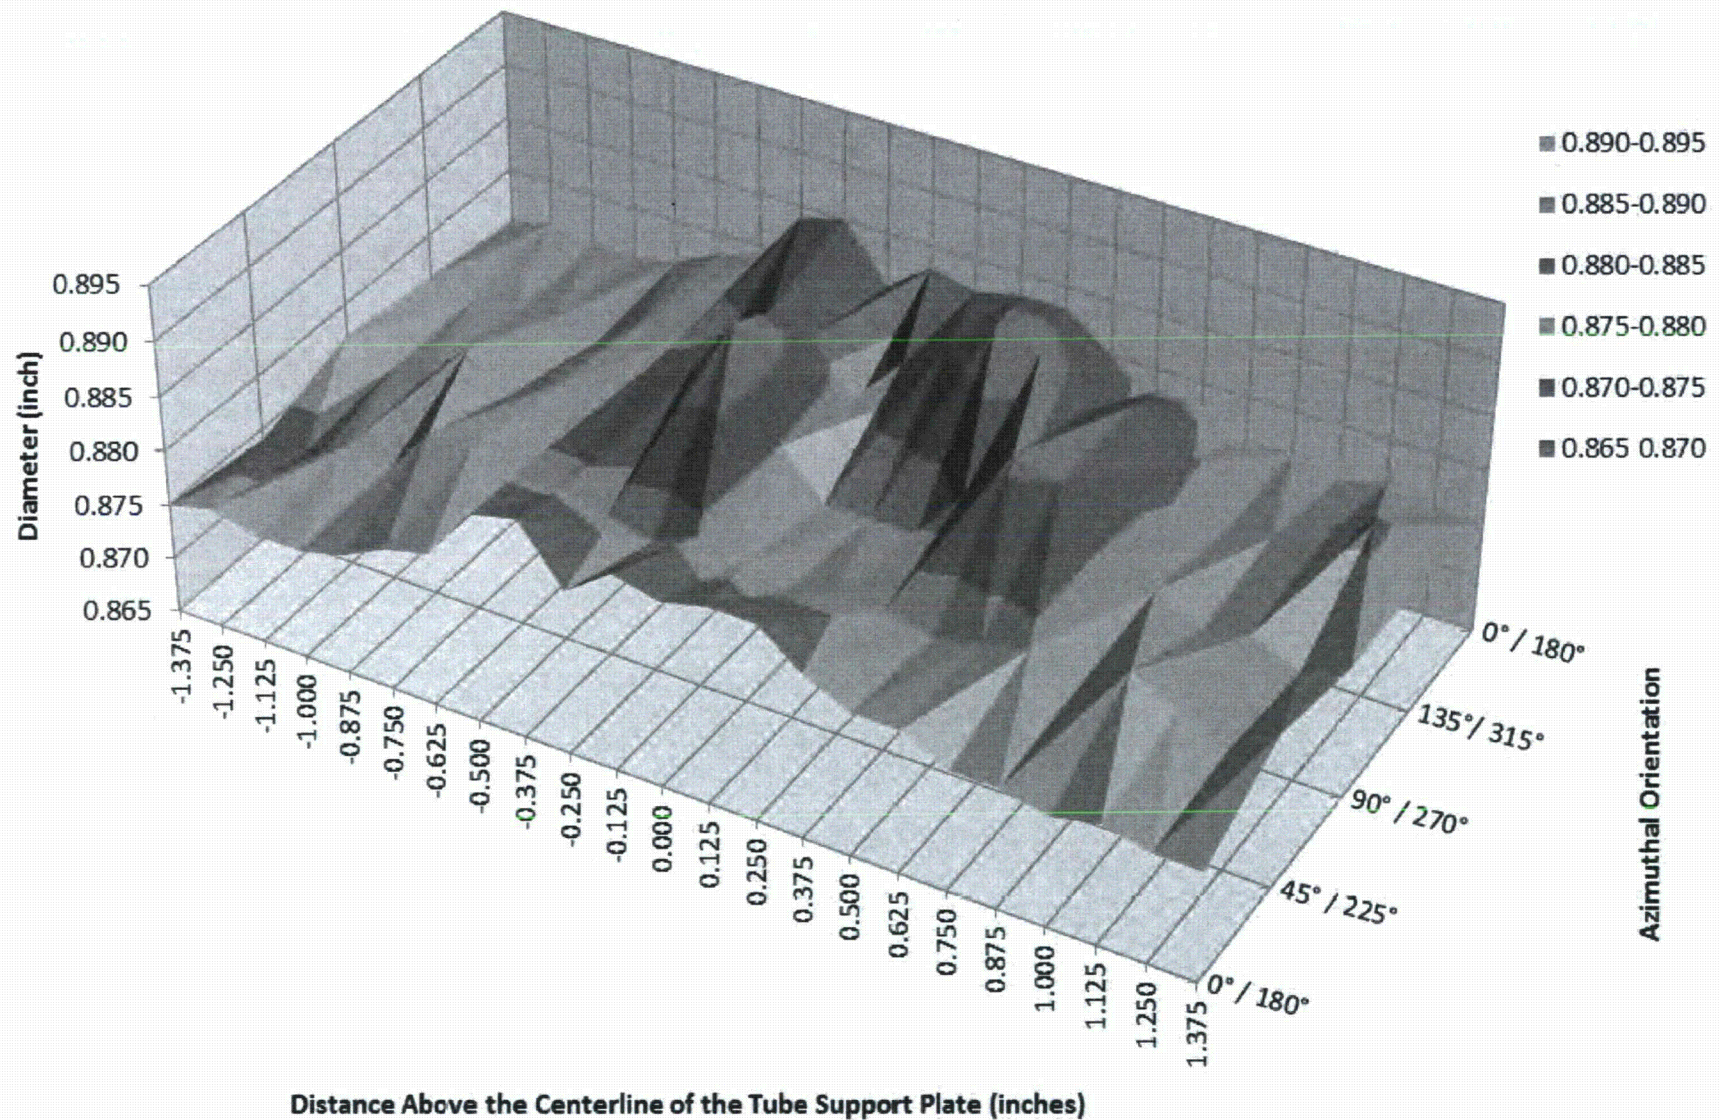
Figure 2-20 presents a profile of the diameter in the 04H TSP region of R24C41. As Figure 2-11 shows, most of the region was covered with deposits, except in the vicinity off the 45° orientation. The deposits, where present, were 4-8 mils thick. Any sign of denting was covered by deposit.

Figure 2-20: Diameter Profile of 04H TSP Region of R24C41

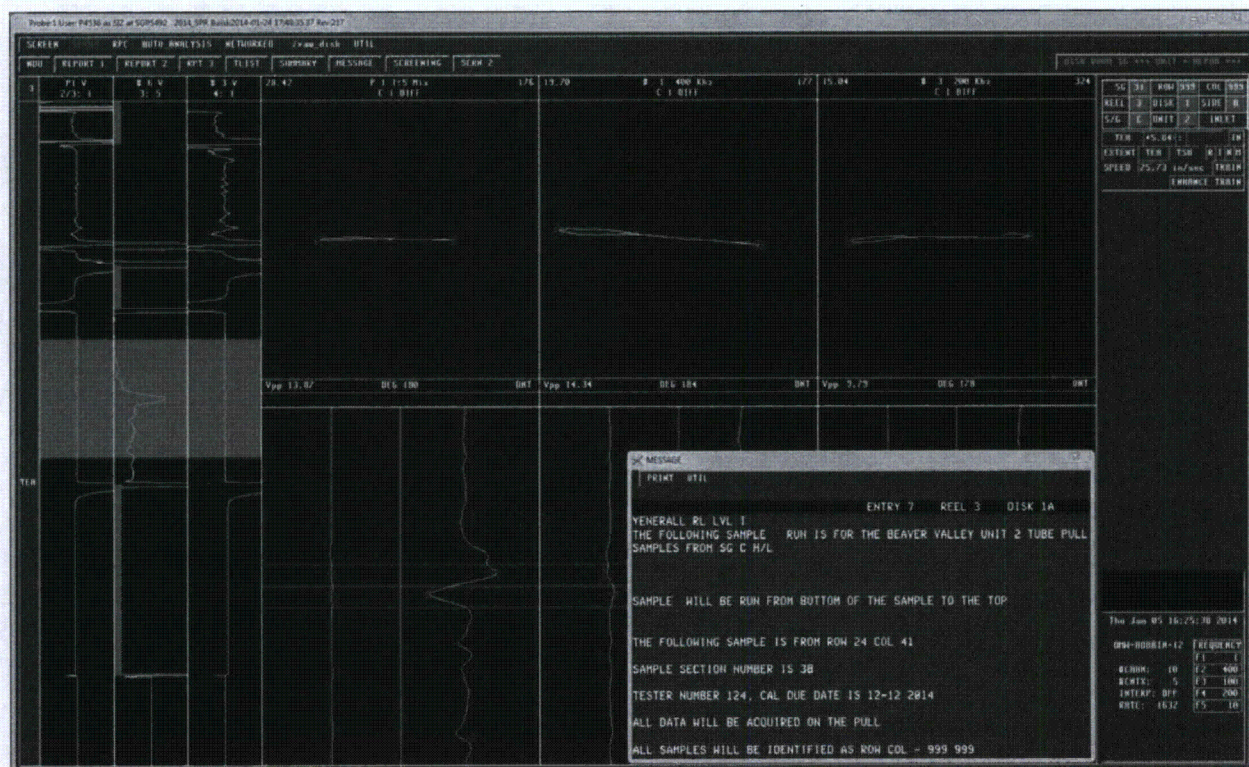
The field indication identified by bobbin coil at R24C41-3B (02H), which was not confirmed by field +Point probe, was also found to be NDD by both laboratory rotating probes as well.

Figure 3-4: Laboratory Bobbin – R24C41-3B (02H) - DNT

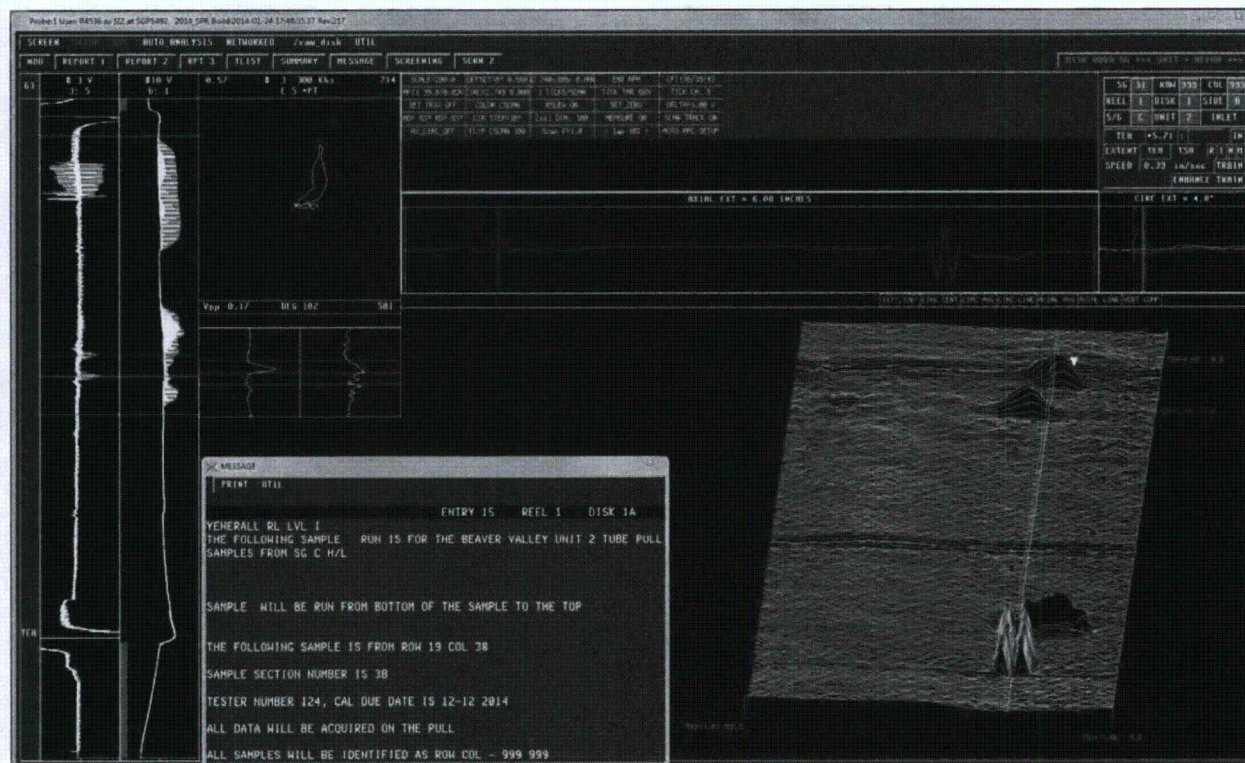
Section R19C38-3B (02H) was evaluated as having SAIs located at the top and bottom locations of the support plate. Section R24C41-6B (04H) was reported in the field ECT as having two single axial indications (SAI) in the same axial location (Table 3-2), which is actually the definition of a multiple axial indication (MAI). Each ligament of the MAI was evaluated with similar amplitudes to what was reported in the field (see Figure 3-13 and Figure 3-14). The dent-like response observed during the laboratory bobbin testing of R24C41 did not affect detectability for this +Point technique in the laboratory. The results of the remaining four sections were consistent with what was reported in the field prior to pulling the tubes (NDD).

Figure 3-8: Laboratory +Point Probe – R19C38-3B (02H) – Bottom – SAI

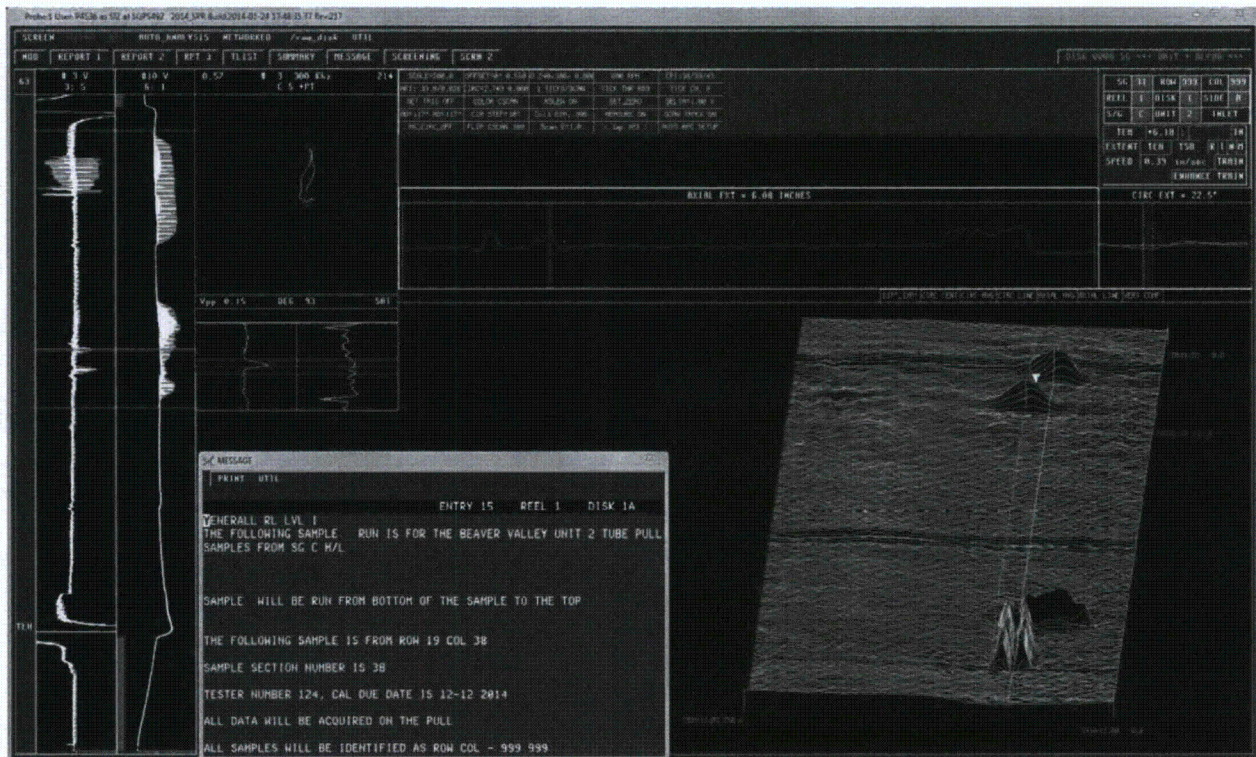
Figure 3-9: Laboratory +Point Probe – R19C38-3B (02H) – Top – SAI
