Examination of Steam Generator Tubes Removed from Beaver Valley Unit 2

Prepared for the  
FirstEnergy Nuclear Operating Company

**SG-CCOE-14-4-NP**  
**Revision 1**

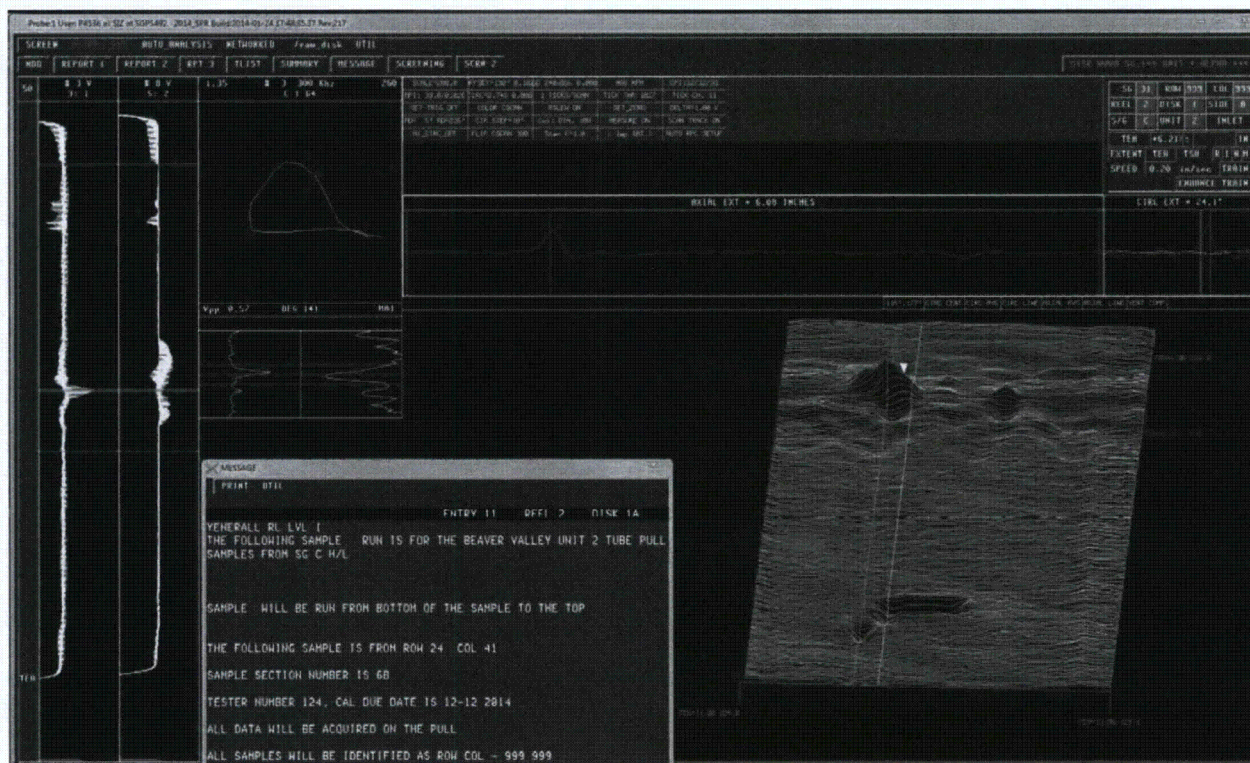
Section R19C38-3B (02H) was evaluated as having SAIs located at the top and bottom locations of the support plate. The Ghent response for section R24C41-6B (04H) revealed three ligaments for the MAI, with the additional ligament (3) being small in voltage (0.10 volts). The dent-like responses observed during the laboratory bobbin testing of R24C41 did not affect detectability for this Ghent probe technique in the laboratory. The results of the remaining four sections were consistent with what was reported in the field prior to pulling the tubes (NDD).

Figure 3-21: Laboratory Ghent Probe – R24C41-6B (04H) – Ligament # 1 – MAI

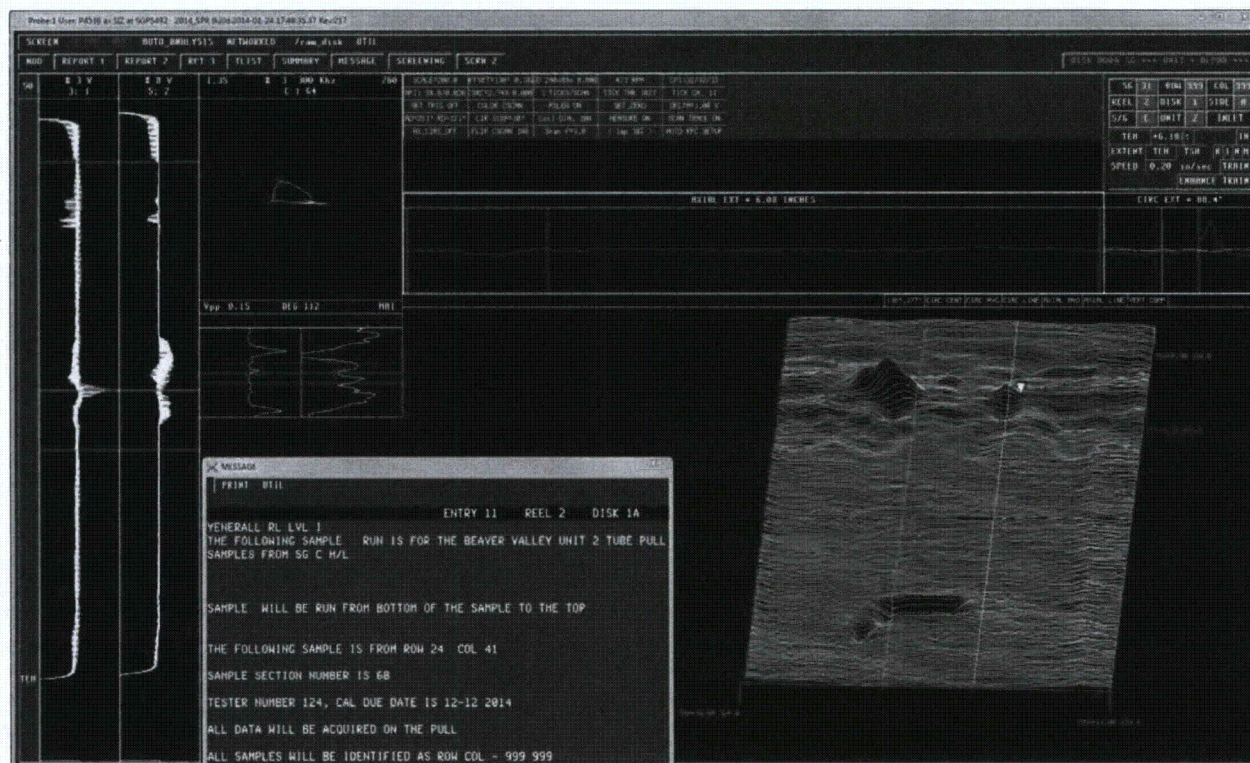
Figure 3-22: Laboratory Ghent Probe – R24C41-6B (04H) – Ligament # 2 – MAI

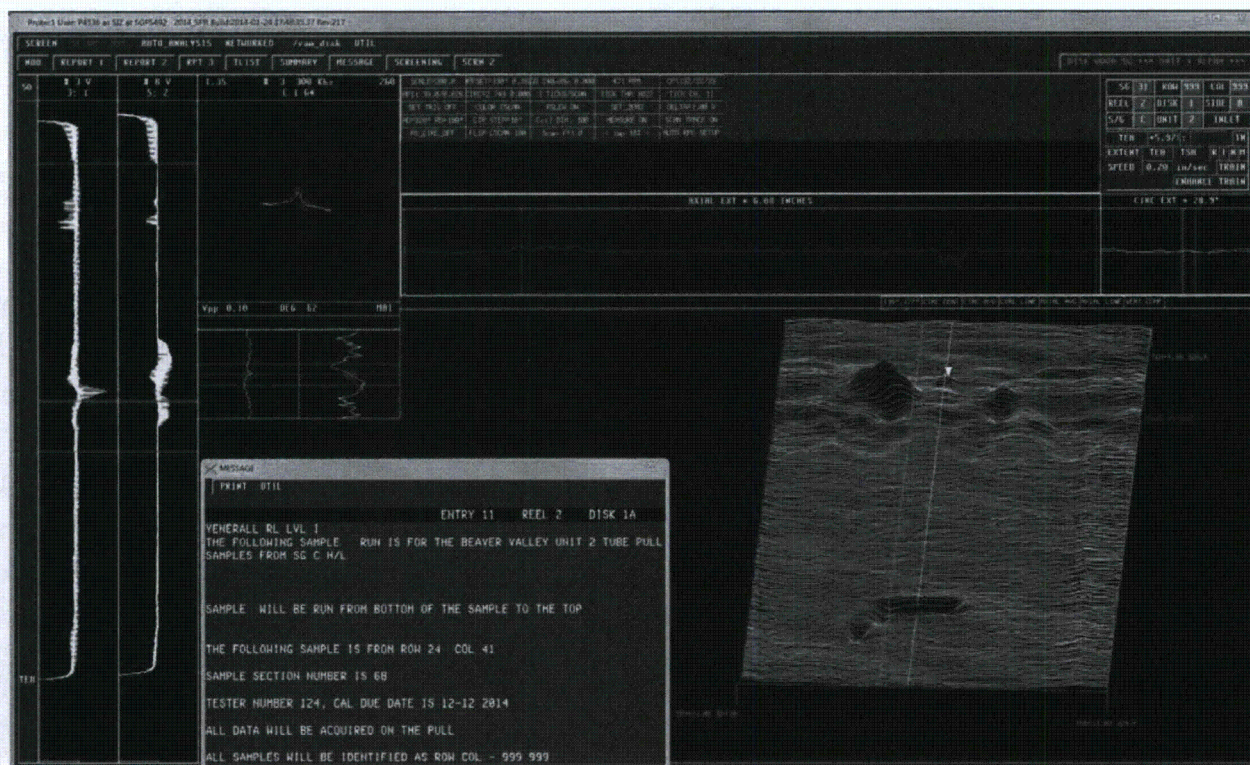
Figure 3-23: Laboratory Ghent Probe – R24C41-6B (04H) – Ligament # 3 – MAI

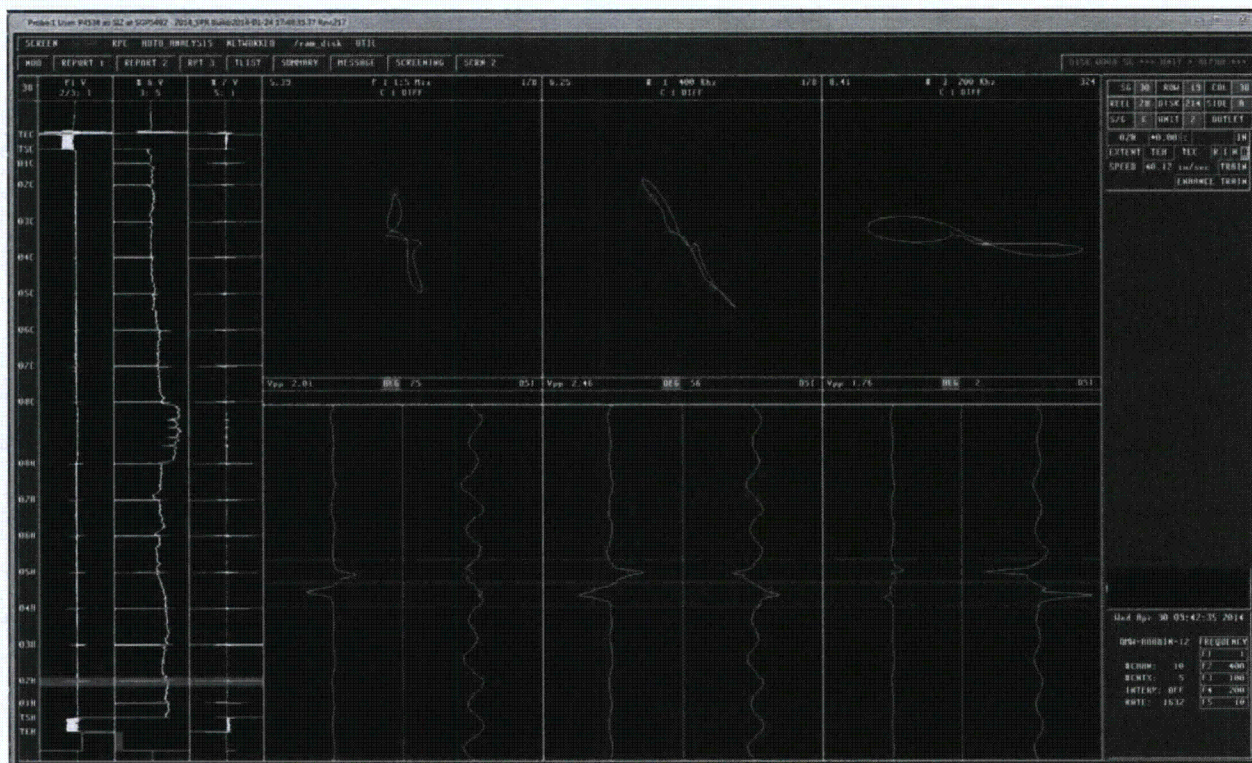
A comparison of pre-pull and post-pull rotating probe voltages shows little change from the tube-pull process. In the case of R19C38-3B (02H), the bobbin voltage increased by a factor of 3.5 most likely from the pulling operation, which is typical of Westinghouse experience for pulled tubes with small voltage axial indications and does not indicate a significant alteration in the pre-pull condition from the pulling operation. The pulling operation likely had little effect on the crack-like indications. The post-pull bobbin examination performed in the laboratory revealed significant dent-like indications at all three TSP locations of R24C41 that were not reportable prior to the tube pull. These dent-like responses of tube R24C41 masked laboratory bobbin detectability of the DSIs that were reported in the field data prior to the tube pull.

Figure 3-25: In-Generator Bobbin Probe – R19C38-3B (02H) – DSI
