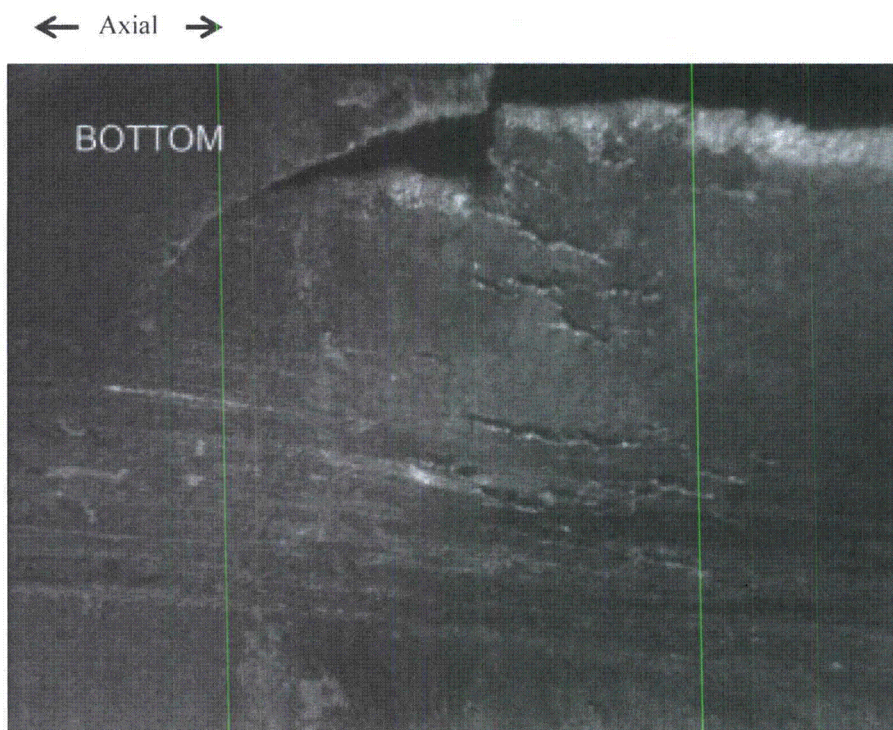
Figure 5-15: Short Cracks near the Bottom of the 02H TSP of R19C38 (0° Orientation)

The 02H TSP region of tube R19C38 burst in the TSP region. The center of the burst was skewed about 0.2 inches above the TSP centerline and the burst opening extended above and below the TSP region. The burst occurred at the 350° orientation. There were several regions of short (<0.15 inch) axial cracks around the circumference, most of which were located near the burst opening. These are shown in the Figure 5-14 diagram. Some of

these short cracks can be seen near the burst opening as shown in Figure 5-8; others are shown in Figure 5-15, Figure 5-16 and Figure 5-17.

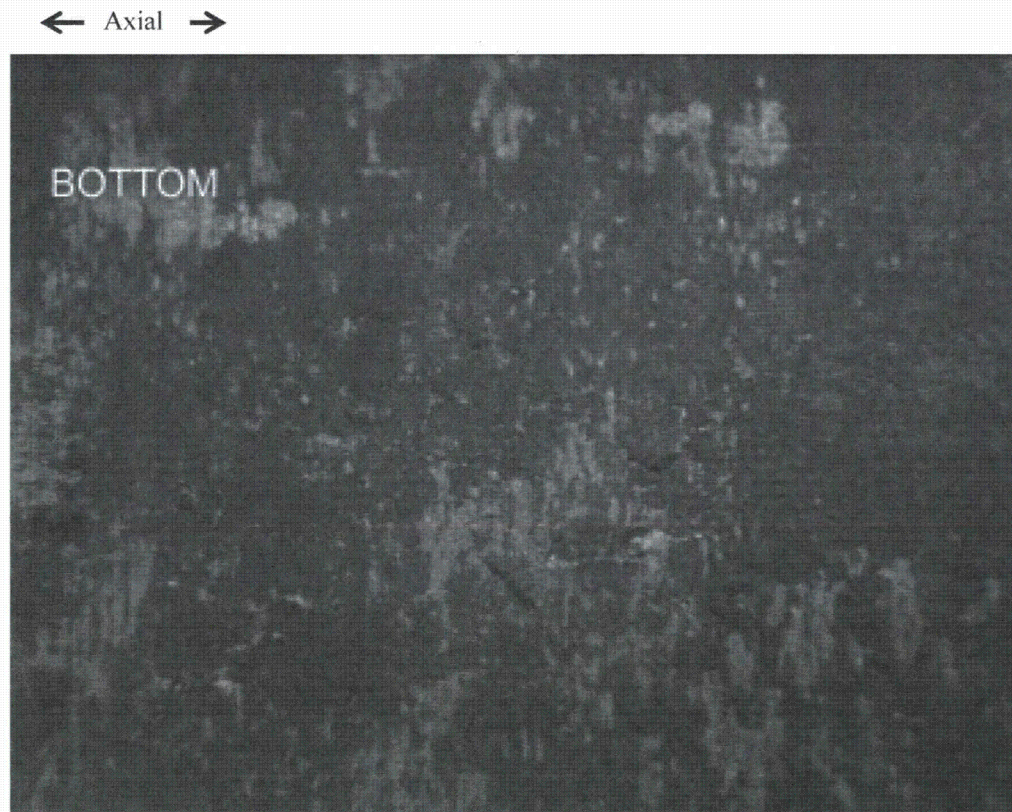
Figure 5-19: Shallow Corrosion Partially Obscured by Surface Deposits, Near the 0° Orientation of R24C41 02H

The 02H TSP region of tube R24C41 did not have a burst. There was a region of marginally-discernable (shallow) corrosion that was partially obscured by surface deposits, and was either a patch of short axial cracks or IGA. It also had another region with shallow corrosion that was discernable as axial cracks. These are shown in the Figure 5-18 diagram and in the Figure 5-19 photo.

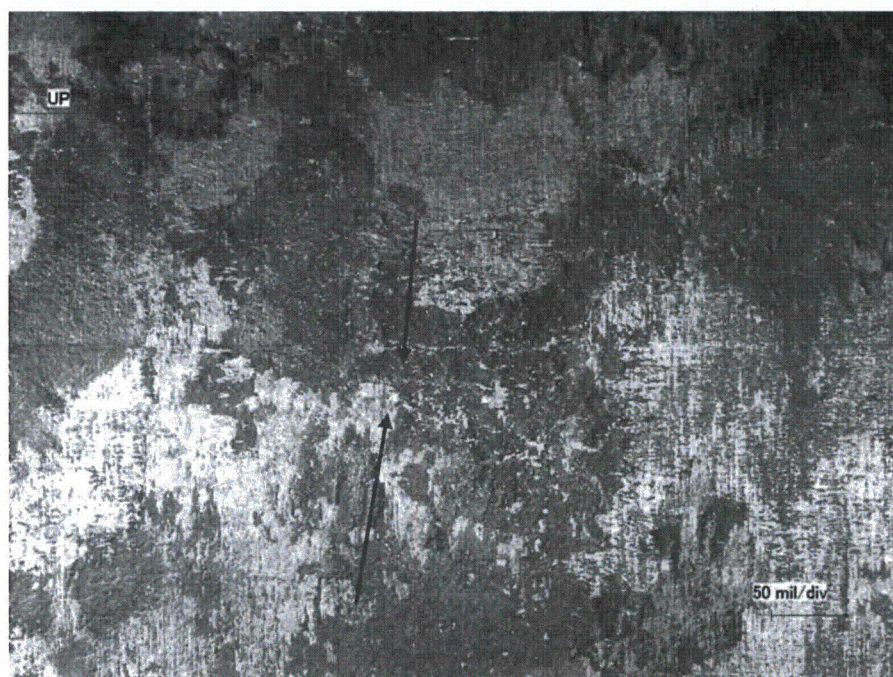
Figure 5-21: Shallow Axial Cracks (Marked with Arrows) Near Center of R24C41 03H TSP Region (180° Orientation)

The 03H TSP region of tube R24C41 did not have a burst. There were two regions with shallow cracks. These are shown in the Figure 5-20 diagram. The photo in Figure 5-21 shows the shallow axial cracks located near the 180° orientation, as indicated by the two arrows. Figure 5-22 shows the shallow cracks at the top of the TSP region near the 0° orientation. These cracks are all less than 50 mils long and are primarily axial. The axial crack nearest the bottom of Figure 5-22 appears to have a circumferential element, but this is a shadow cast by raised surface deposits and is not a crack.

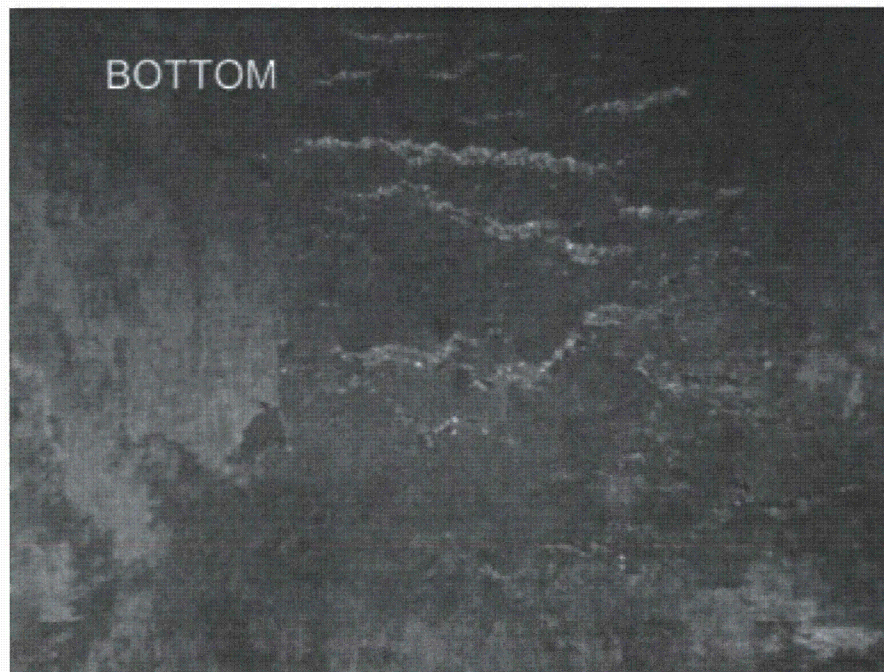
Figure 5-24: Larger Axial Cracks Near the Centerline of R24C41 04H TSP Region, Between 335°-350°

The 04H TSP region of tube R24C41 burst in the TSP region. The center of the burst was aligned with the TSP centerline and the burst opening extended above and below the TSP region. The burst occurred at the 90° orientation. There were several regions of small axial cracks around the circumference, most of which were located near the centerline of the TSP region. There was another region of larger axial cracks, located between 315° and 360°, all within the center third (0.25-inch long) portion of the TSP length. These are shown in the Figure 5-23 diagram. Figure 5-24 and Figure 5-25 show the region of the larger cracks. These cracks are significantly oriented in the axial direction. Figure 5-12 shows some cracking adjacent to the burst opening; Figure 5-26 shows a closer view of these cracks.

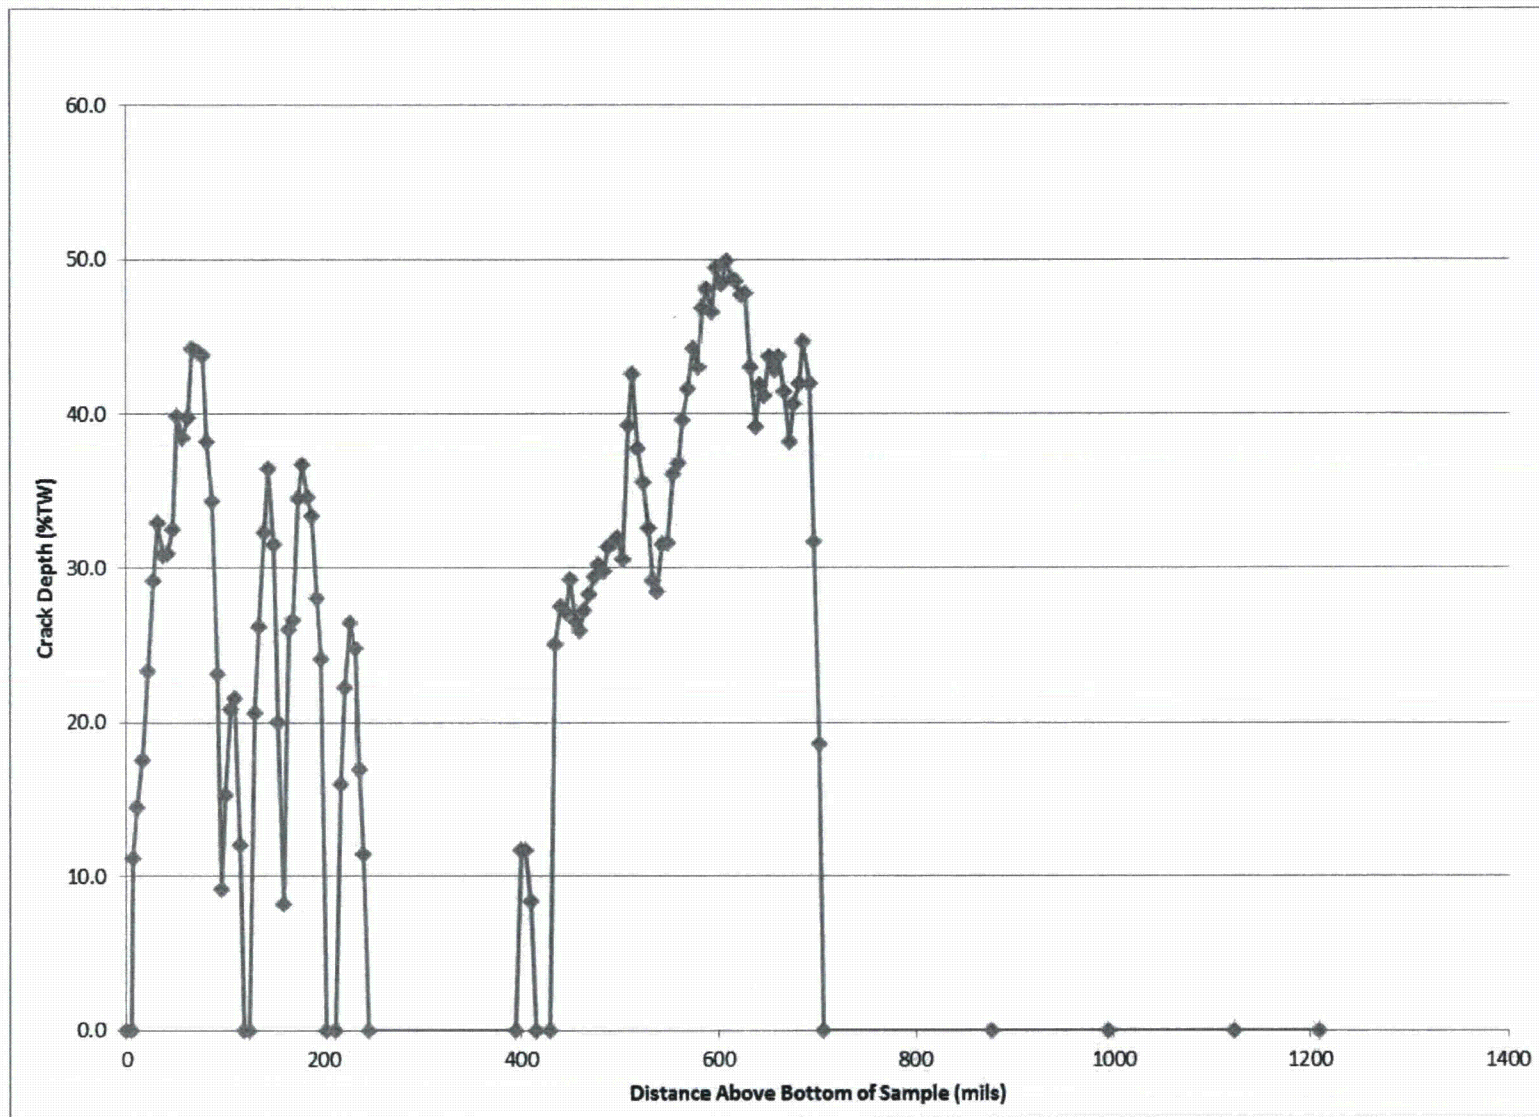
Figure 7-3: R19C38-3B (02H) Burst Opening Depth Profile

Appendix A presents the crack depth and ligament size data. The depth profiles of the cracks in these two burst openings are shown in Figure 7-3 and Figure 7-4, respectively. Crack depth measurements were taken along the axial direction of the burst opening, starting at the lowest elevation of the burst opening (bottom of the sample, located at the bottom tip of the burst opening) and proceeding up the tube, in the axial direction, to the upper tip of the burst opening. Figure 7-1 shows how one crack depth measurement was obtained at the indicated distance from the bottom of the sample. Table 7-1 summarizes the ligament sizing results.

Table 7-2 provides a summary of the depth profiles for the burst openings. R19C38-3B (02H) had the deepest corrosion, at 49.9%TW. The burst opening of R24C41-6B (04H) had a maximum depth of corrosion of 48.6%TW.

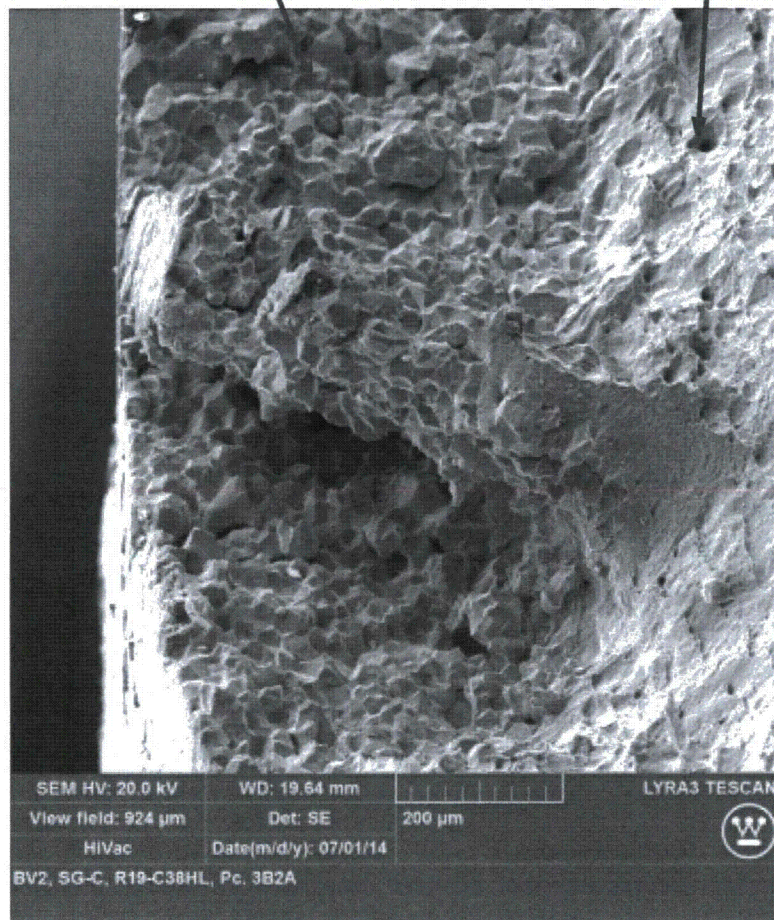
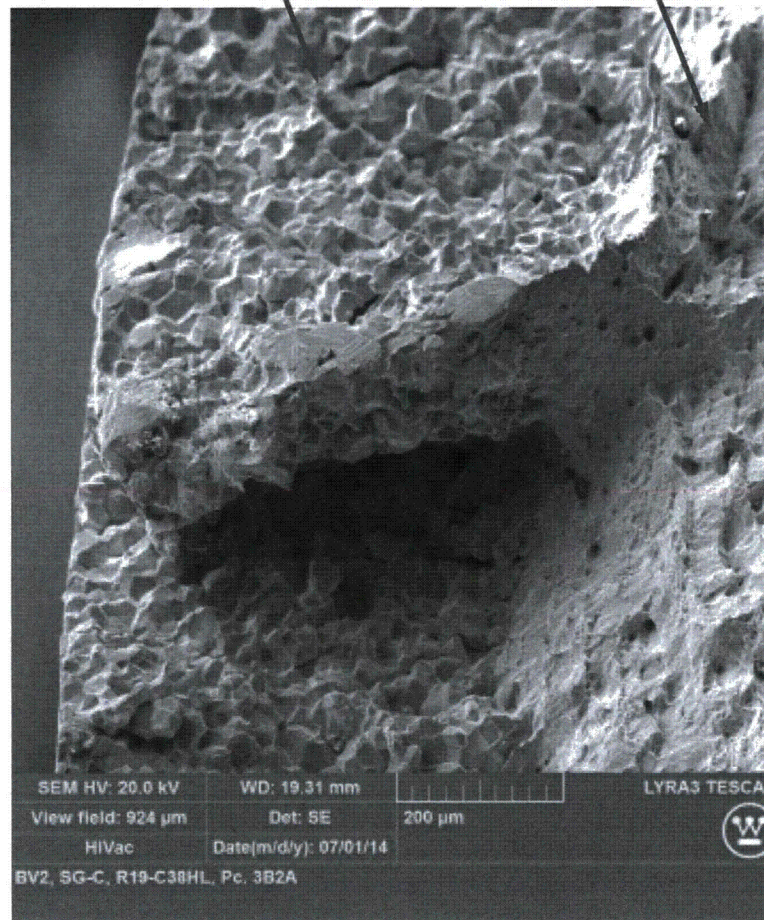
Figure 7-5: Example of R19C38-3B Burst Opening Fracture Surface (Near Top End of Crack)

Figure 7-5 presents an example of the crack surface of the R19C38-3B burst opening. The surfaces having the rock candy appearance is intergranular cracking – this degradation of the tube wall occurred during in-service operation. The dimpled surface is ductile tearing - the part of the tube wall that mechanically failed during the burst test. Figure 7-6 presents another region of the fracture surface with intergranular cracking. The entire R19C38-3B burst opening was composed of ductile tearing and intergranular cracking of varying depth.

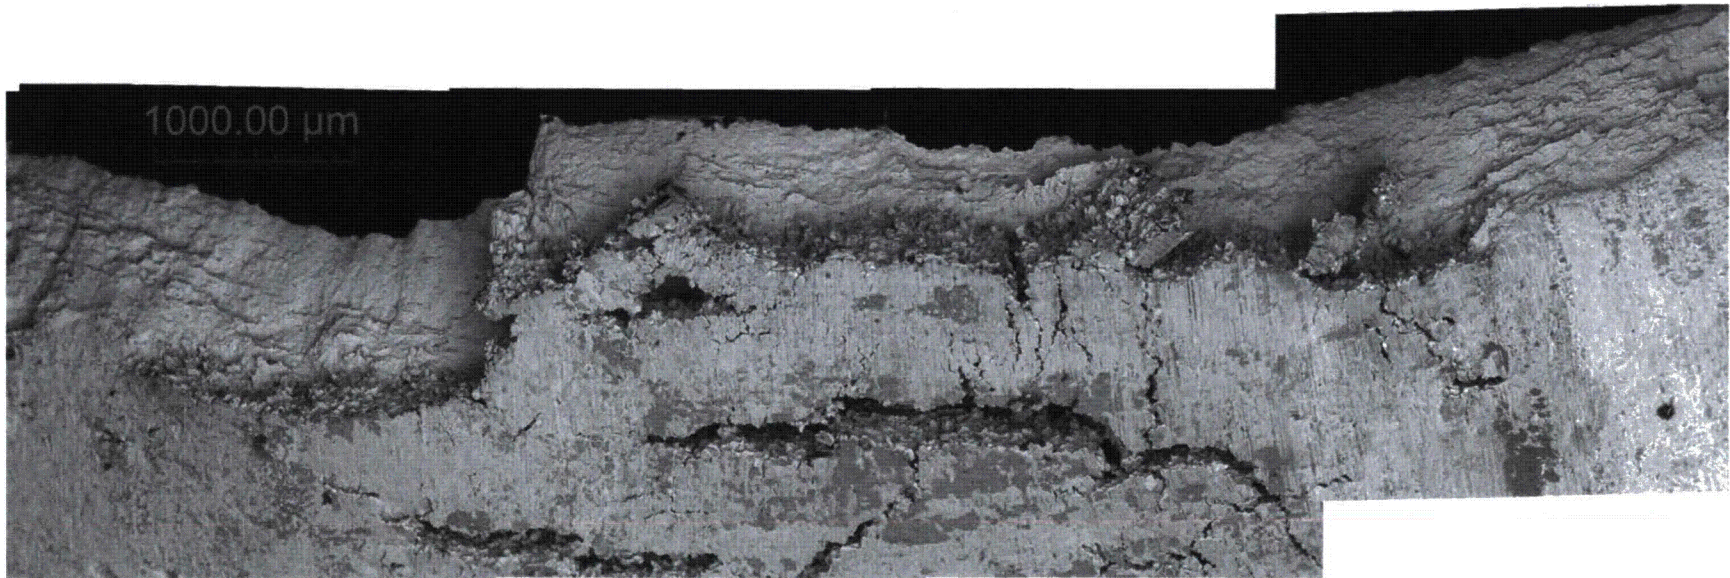
Figure 7-7: OD Surface of R19C38 02H, Adjacent to Burst Opening (Axial Direction is Horizontal)

Figure 7-7 shows the OD surface of R19C38 02H near the burst opening. In this view, the axial direction is horizontal. This fractographic montage shows several secondary axial cracks with some minor branching and a small patch of intergranular attack (IGA). All of the secondary cracks are intergranular. This surface is typical of axial OD initiated stress corrosion cracking (ODSCC).

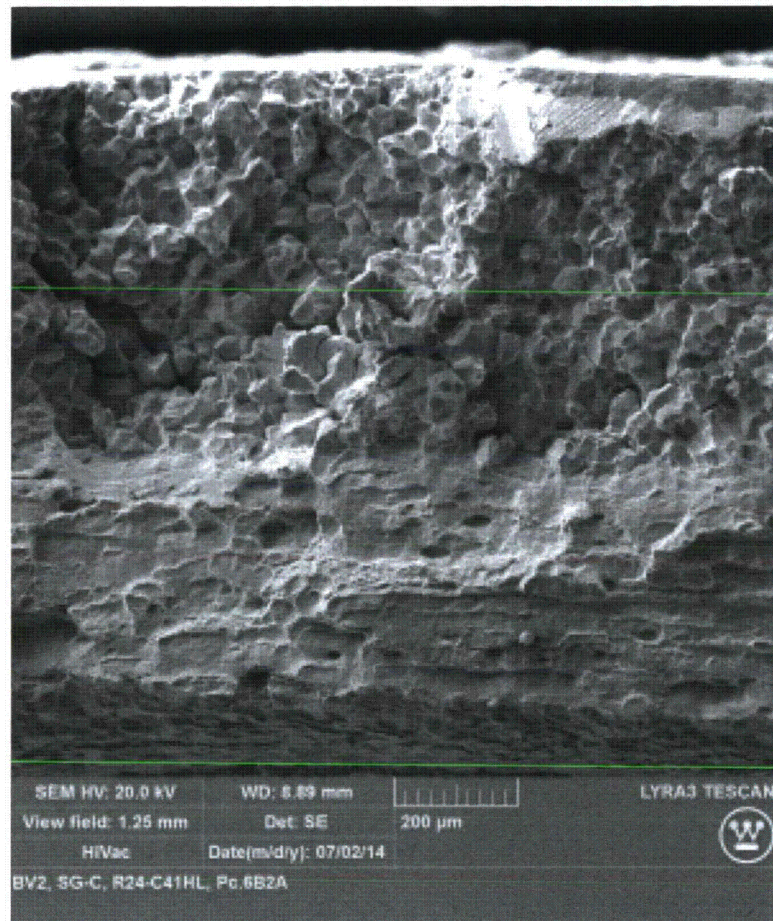
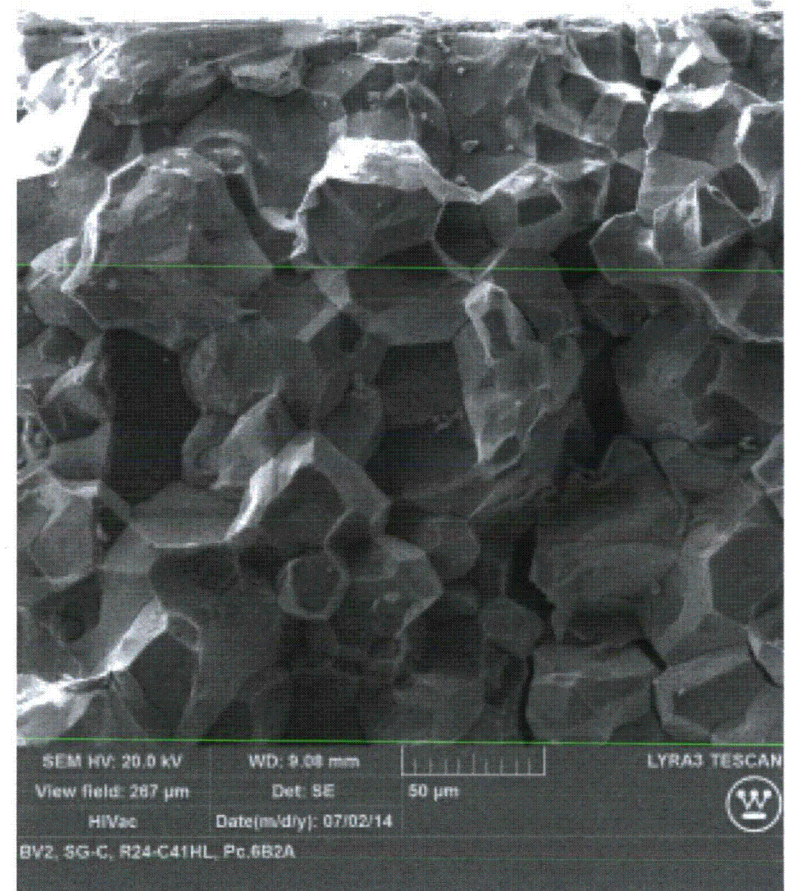
Figure 7-8: Example of R24C41-6B Burst Opening Fracture Surface

Figure 7-8 shows an area on the crack surface of the R24C41-6B burst opening. The figure shows both intergranular cracking (the rock candy topography) and ductile tearing. The figure shows a higher magnification view of the intergranular fracture surface. The entire R24C41-6B burst opening was composed of ductile tearing and intergranular cracking of varying depth.

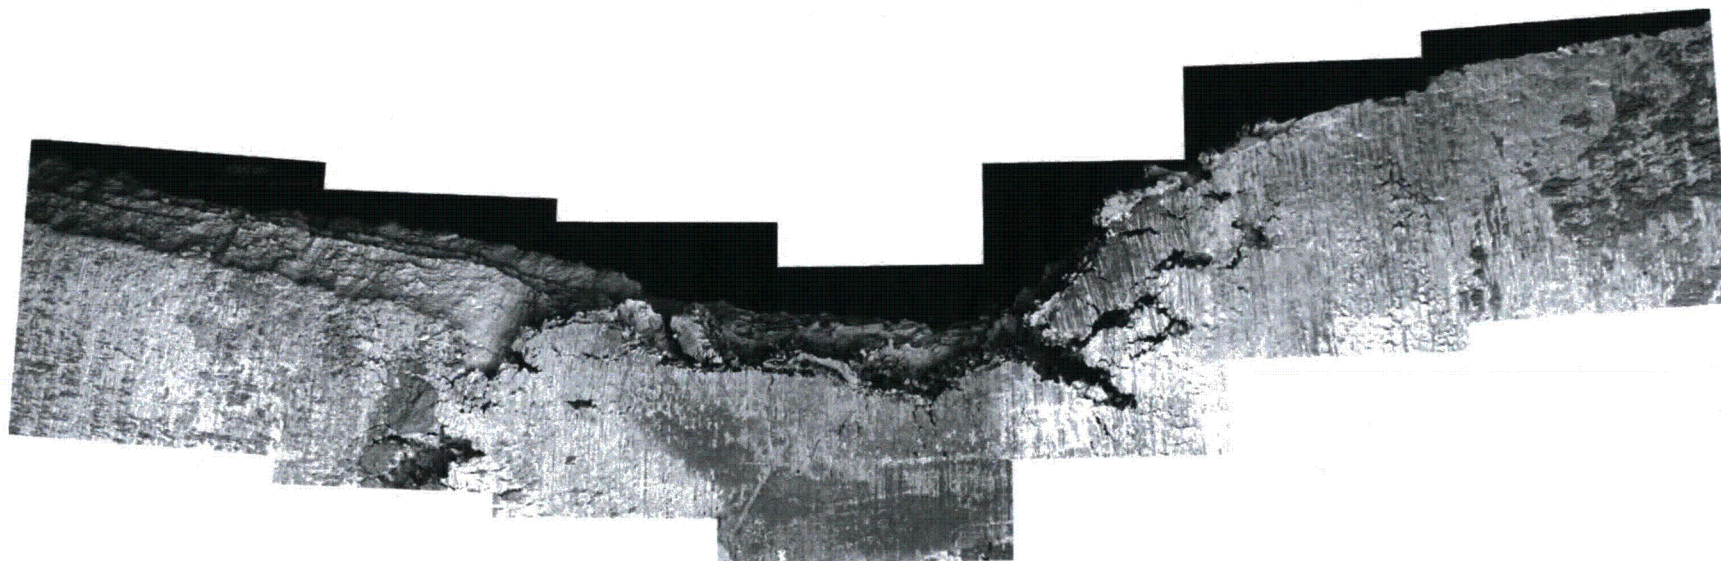
Figure 7-9: OD Surface of R24C41 04H, Adjacent to Burst Opening (Axial Direction is Horizontal)

Figure 7-9 shows the OD surface of R24C41 04H near the burst opening. In this view, the axial direction is horizontal. This fractographic montage shows several secondary axial cracks and some patches of shallow intergranular attack (IGA). This surface is typical of axial ODSCC.

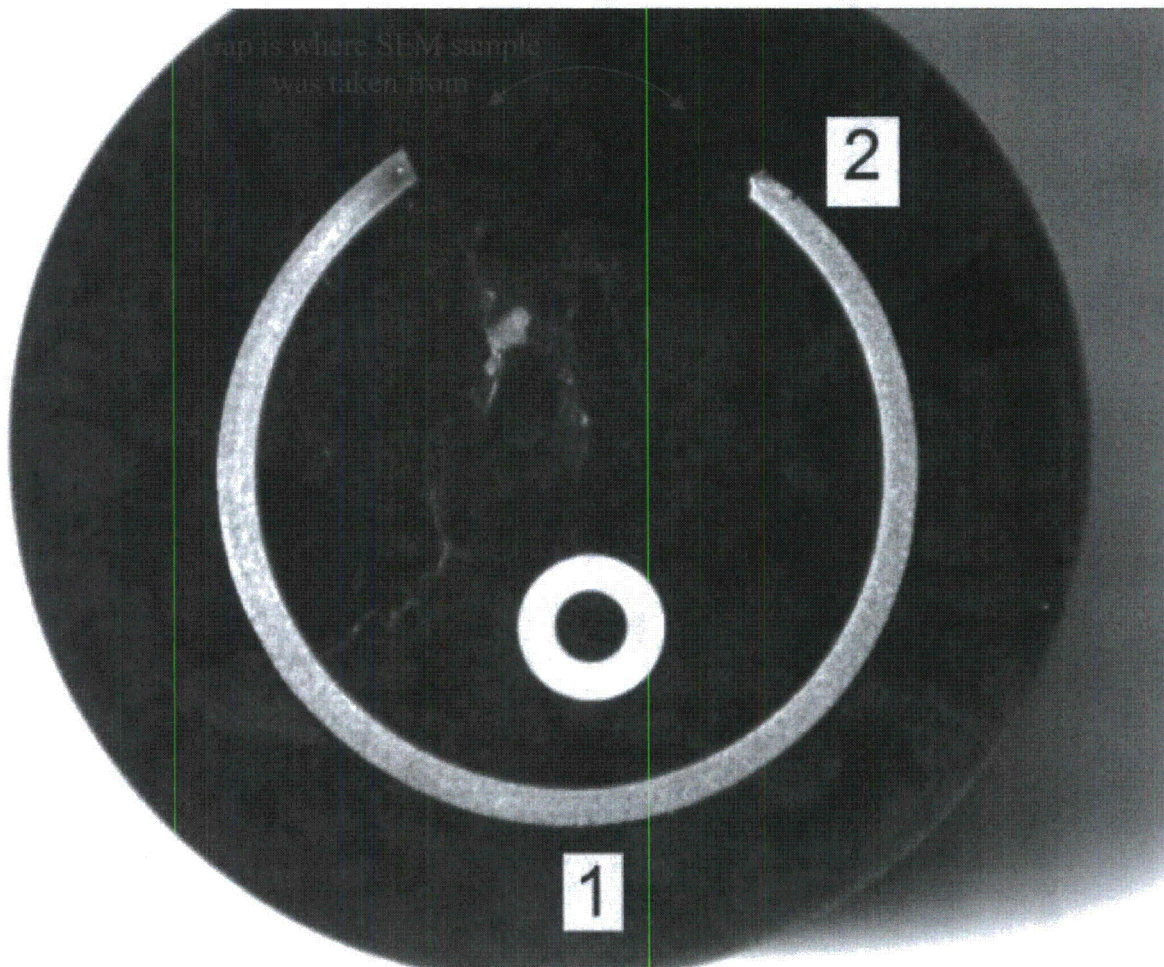
Figure 8-1: R19C38 02H - Overall View of Transverse Section

At this elevation of the TSP, there were only two areas, other than the burst opening that showed any sign of corrosion; these are indicated by the number markers in Figure 8-1. The '1' marker is where the cracks at the 200° azimuthal location were identified (see Figure 5-14 and Figure 5-17). The number '2' marker is associated with the cracks near the 340° location (see Figure 5-14). Cracks near the 0° location are on the SEM sample and the cracks near the 280° location were very short and were not captured in this cross section.

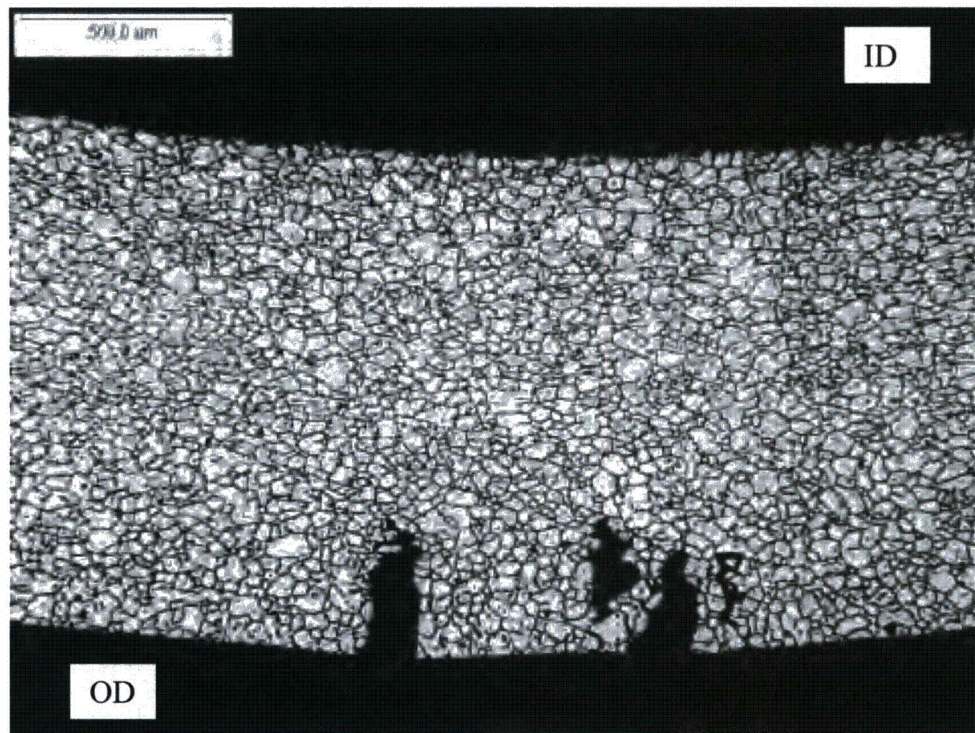
Figure 8-2: R19C38 02H, Transverse Section: Cracks at 200°

Figure 8-2 shows a closer view of the cracks at the 200° location. The cracks have been widened by the swelling of the tube during the burst test. Cracking is intergranular without signs of IGA and are thus intergranular stress corrosion cracks (IGSCC). As these initiate from the outer surface, they are also ODSCC. The figure shows several cracks, two of which break the OD surface at this elevation and two cracks which break the OD surface at another elevation that is not shown in this view. The deepest of these (the middle crack) is 25.7%TW.

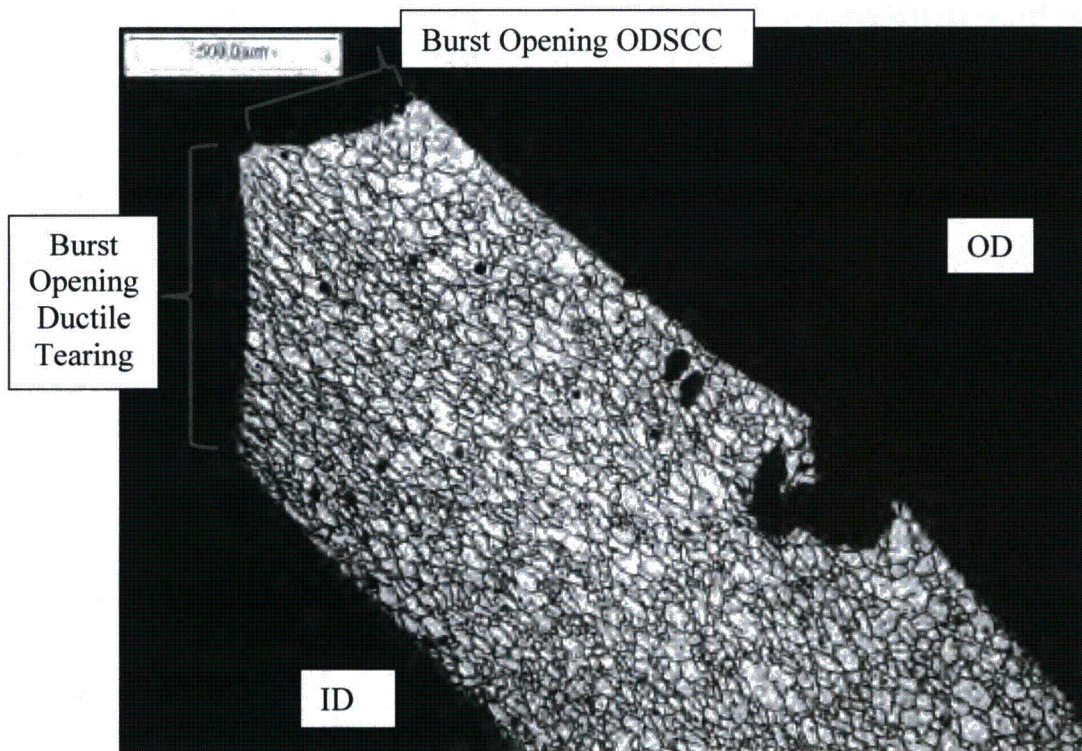
Figure 8-3: R19C38 02H, Transverse Section: Crack at 340°

Figure 8-3 shows a crack at the 340° location, as well as the left side of the burst opening. The 340° crack is 22.9%TW and the crack depth of the burst opening is approximately 27%TW at this elevation. The figure also shows two other cracks which break the OD surface at another elevation that is not shown in this view.

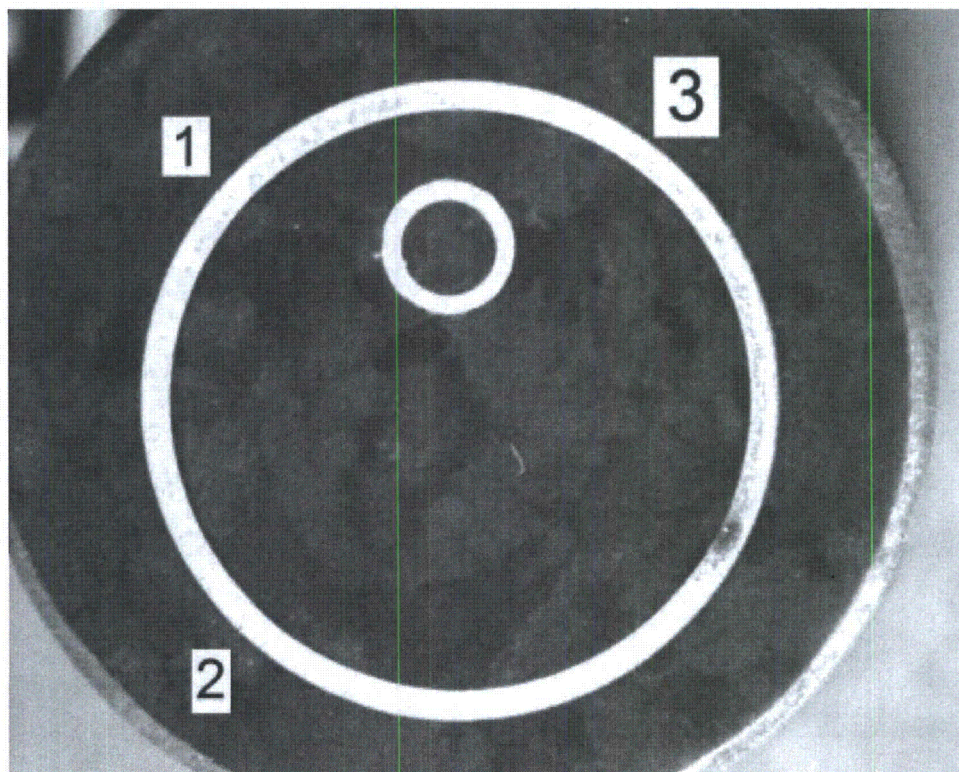
Figure 8-4: R24C41 02H - Overall View of Transverse Section

Figure 8-4 shows a view of a transverse cross-sectional sample (3B2) taken from the 02H TSP of R24C41. As the burst occurred outside of the TSP region, the entire circumference is shown. The white circular marker “O” that is mounted inside the tube corresponds with the 0° location (since the view is in the down direction, azimuthal locations proceed in the counter-clockwise direction). This elevation was chosen to show the cracks at about the 170° location and the patch of shallow corrosion on both sides of 0° (see Figure 6-15 and Figure 5-18). The ‘1’ marker is located at about 20°, the ‘2’ marker is at about 160° and ‘3’ marker is located at about the 340° location.

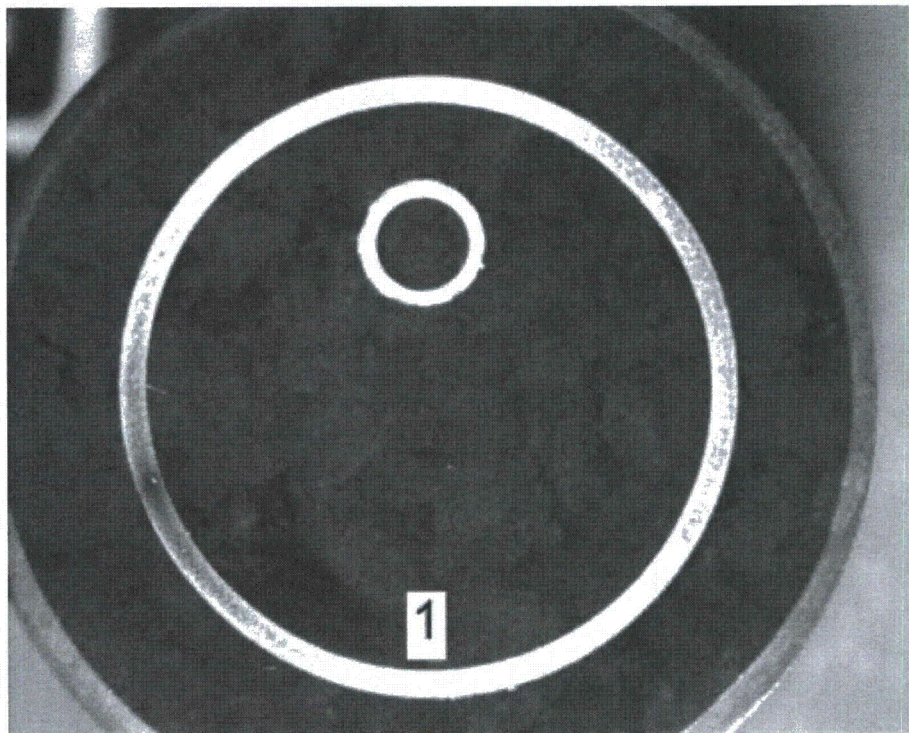
Figure 8-8: R24C41 03H - Overall View of Transverse Section

Figure 8-8 shows a view of a transverse cross-sectional sample (5B2) taken from the 03H TSP of R24C41. As the burst occurred outside of the TSP region, the entire circumference is shown. The “O” that is inside the tube corresponds with the 0° location (since the view is in the down direction, azimuthal locations proceed in the counter-clockwise direction). This elevation was chosen to show the cracks at the 180° location and the patch of shallow corrosion (see Figure 6-19 and Figure 5-20). The ‘1’ marker is located at about 180°.

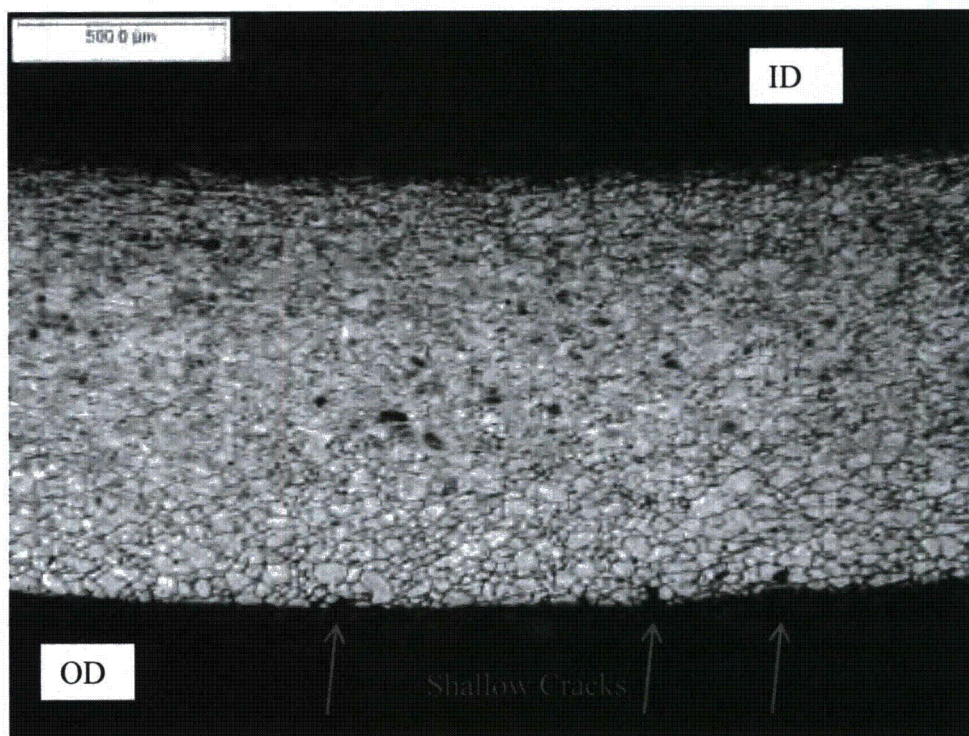
Figure 8-9: R24C41 03H, Transverse Section: Cracks at 180°

Figure 8-9 shows the cracks at the 180° location. The cracks are intergranular, but are shallow. These are only 2-4 grains deep. The deepest crack in this view is 4.4%TW.

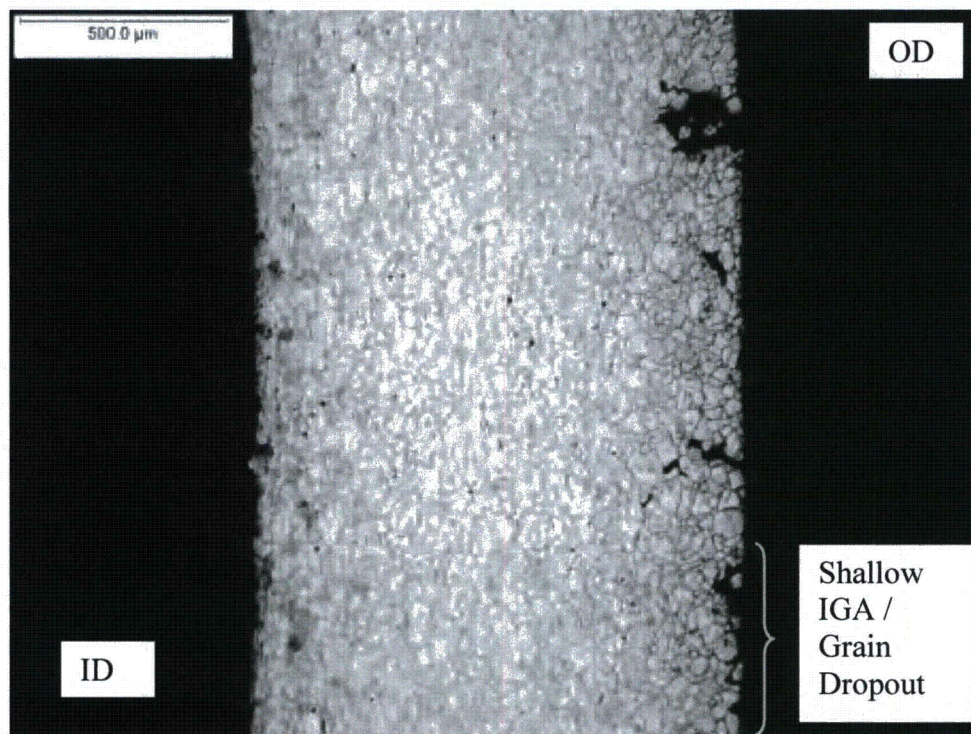
Figure 8-11: R24C41 04H, Transverse Section: Cracks at 80°

Figure 8-11 shows the 80° location of Marker ‘1’. It shows several axial ODSCC cracks with a patch of shallow (<2 grains deep) IGA. The maximum crack depth shown is 16.4%TW.
