PG&E Letter DCL-15-054

Docket No. 50-323, OL-DPR-82
Diablo Canyon Unit 2
One Hundred Eighty-Day Steam Generator Report for Diablo Canyon Power Plant
Unit 2 Eighteenth Refueling Outage

**ONE HUNDRED EIGHTY-DAY STEAM GENERATOR REPORT FOR
DIABLO CANYON POWER PLANT UNIT 2 EIGHTEENTH REFUELING OUTAGE**

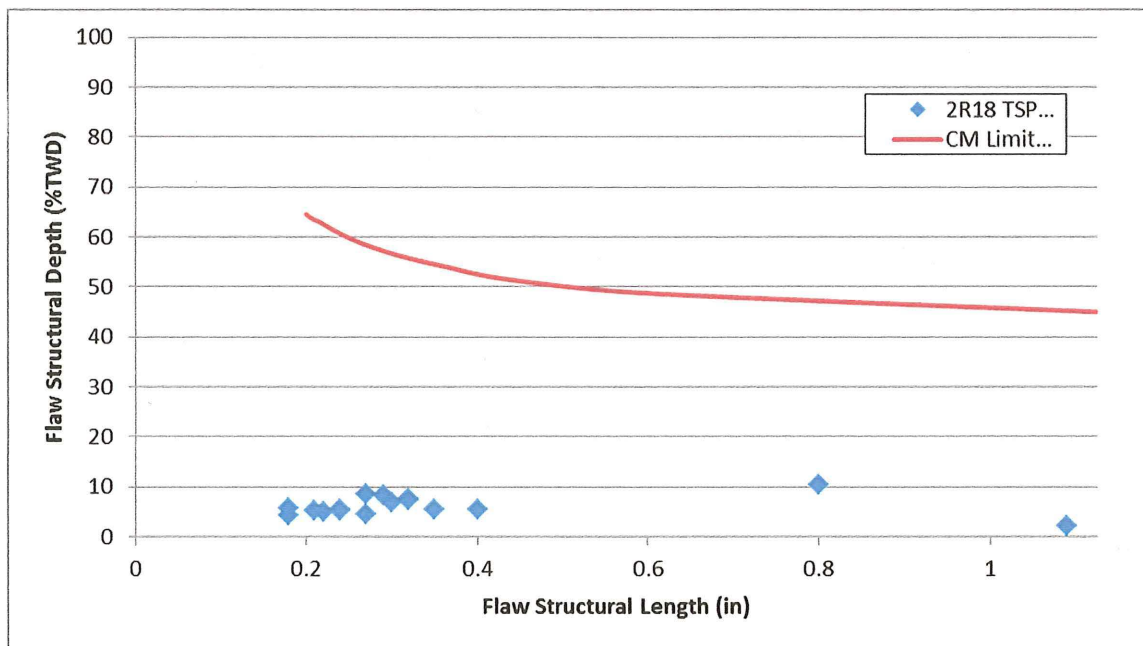
Figure 3
Comparison of 2R18 TSP Wear Indications to the CM Limit

The indications were very shallow, with maximum depths ranging from 3 percent TW to 12 percent TW. The total length of all the indications, with the exception of SG 24 R4C68, did not extend the full width of the TSP.

The most structurally significant wear indication is SG 24 R4C68 6C. There are two indications at this location, located on two separate TSP contact lands of the tre-foil broach. Indication number 1 has a maximum depth of 12 percent TW with a length of 1.22 inch. The length spans the full width of the 1.125 inch TSP, and is slightly longer than the TSP width due to the look ahead of the +Point probe. The wear depth is fairly constant over the TSP length. The structural length and depth that contributes to burst is 0.8 inch and 10.4 percent TW. Indication number 2 is very shallow (3 percent TW maximum depth) and does not reduce the burst strength of the tubing because the indications are at different TSP lands and thus are not interacting.

The 95/50 CM limit for a 1.125 inch long TSP wear scar is 44.6 percent TW. For a quick screening, the TSP maximum wear depth (12 percent TW) is well below the CM limit (44.6 percent TW), thereby demonstrating significant margin to the SIPC. Using the profiling information, the structural length and depth of this bounding indication is 0.8 inch and 10.4 percent TW, demonstrating even more margin the SIPC. All wear indications are plotted on Figure 3 showing their structural length and depth, and margin to the CM limit.
