April 14, 2015

**Re: 7-Day Notification of Spill – 11060 (Report 21)**  
**Lost Creek ISR Project Permit #788**

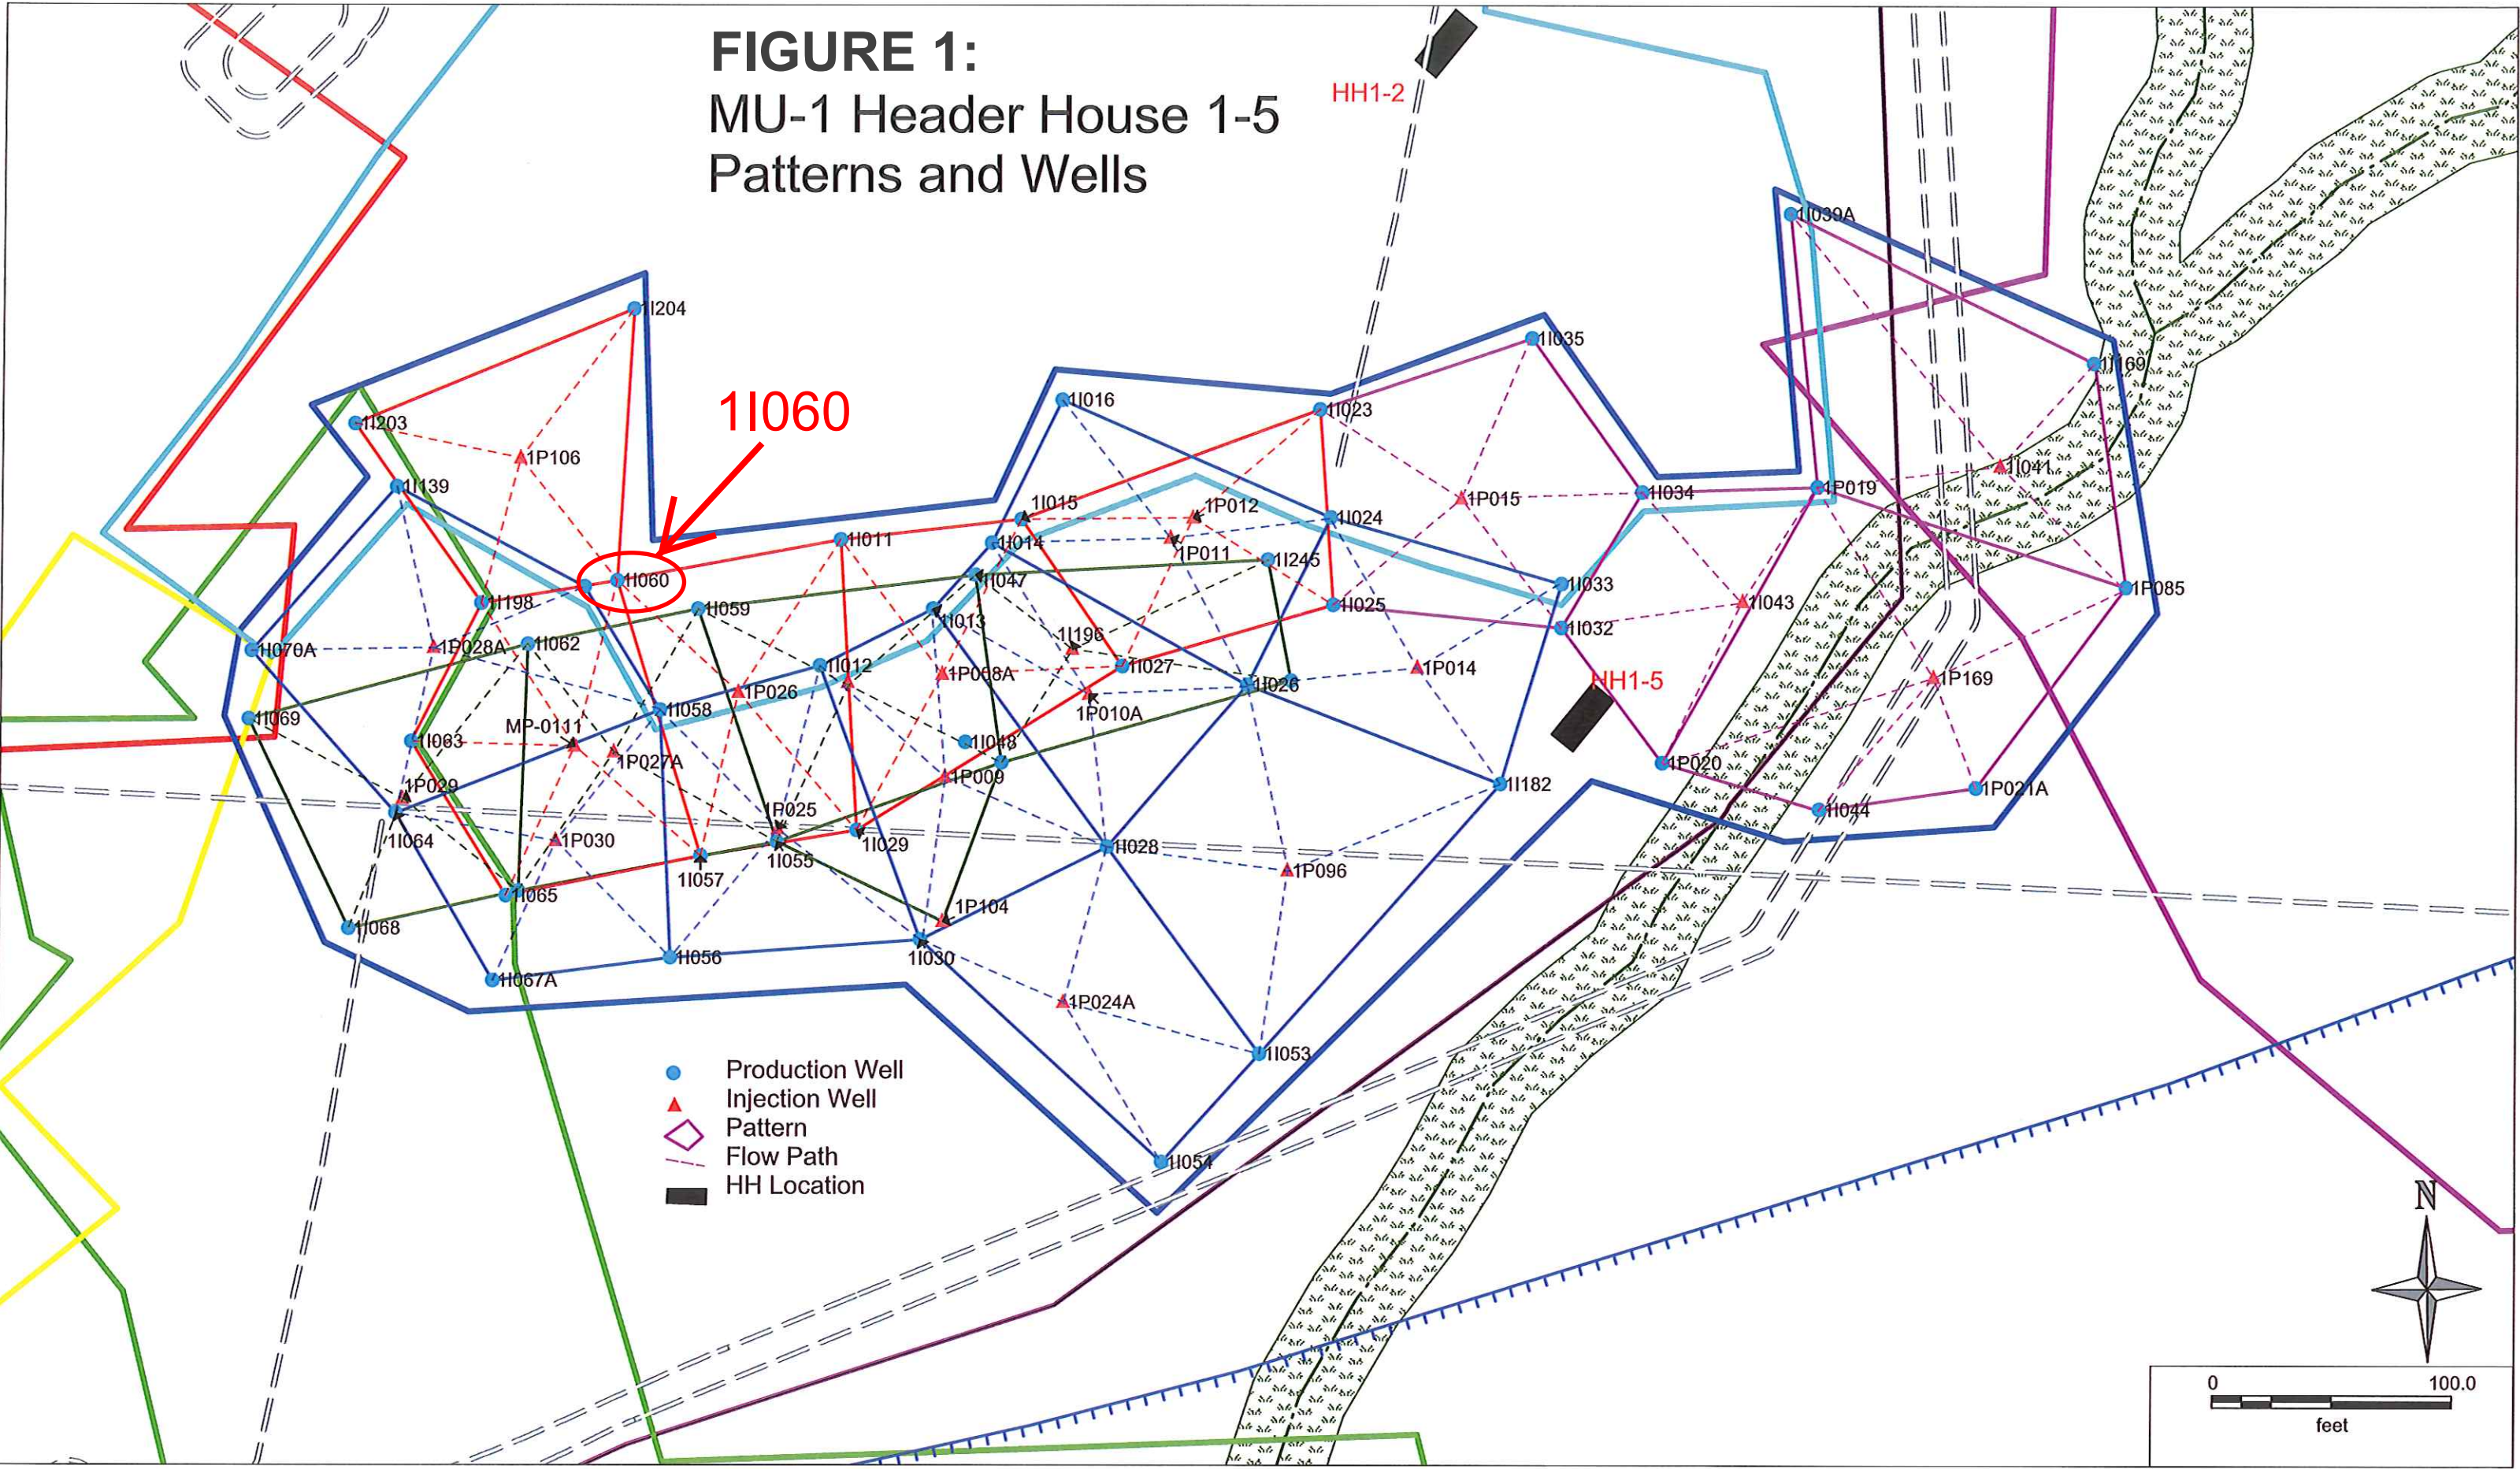
**FIGURE 1:**  
MU-1 Header House 1-5  
Patterns and Wells

Pursuant to Wyoming Department of Environmental Quality (WDEQ) regulation, Lost Creek ISR, LLC ("LCI") hereby provides a written report detailing a release of injection fluid that was reportable to WDEQ. Using the spill report webpage, LCI notified WDEQ of the spill on April 8, 2015 (Incident ID 150408-1357). Additionally, LCI notified WDEQ-LQD (Brian Wood) and NRC (John Saxton and Linda Gersey) of the release via email on the same day it was reported to the WDEQ. Spill volume was grossly estimated to be approximately 960 gallons. The release was located west of HH1-5 in T25N R92W Section 19, NW qtr-qtr of NE qtr and the location of well 11060 is shown on **Figure 1** attached. The release area survey data is not available at this time.
