2.5 Central Processing Facility (License Renewal Environmental Assessment in Progress)

Since mining activities in the CBR current license area have been ongoing since the NRC issued the original license (ca. 1990) and are nearly complete in terms of additional wells to be drilled, the team conducted a limited site visit the morning of October 24, 2012, followed by a meeting in the project offices. The field visit focused on some archaeological sites that had been previously recorded and evaluated as potentially eligible for listing on the NRHP, particularly on the CBR protective management practices for such sites during operations.

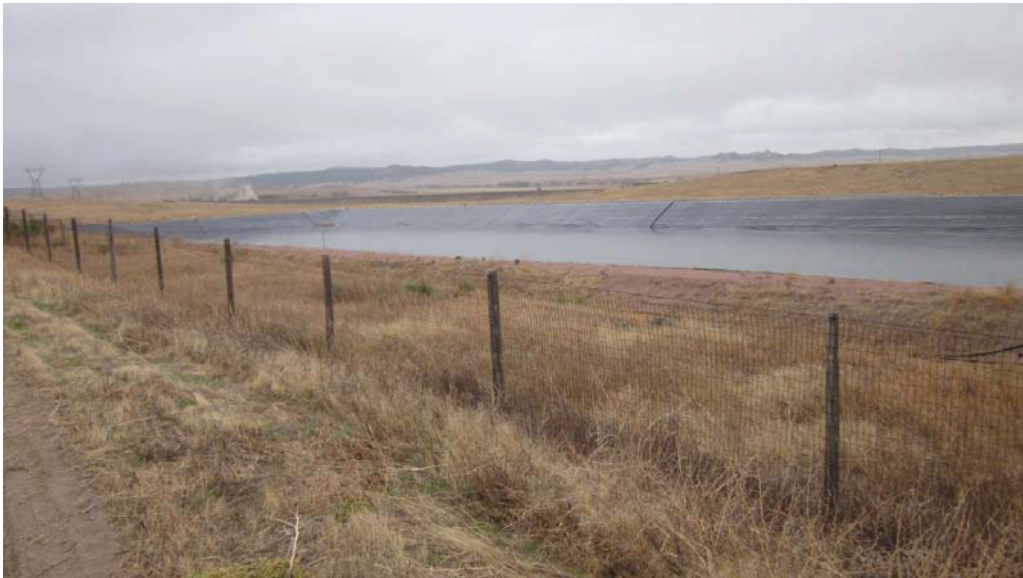
The tour of the CPF began with the lined surface lagoons where water may be temporarily discharged before being injected into one of the two deep disposal wells (**Figure 13**).

Figure 13. Lined lagoon on the CPF. (Photo: DB, October 24, 2012)

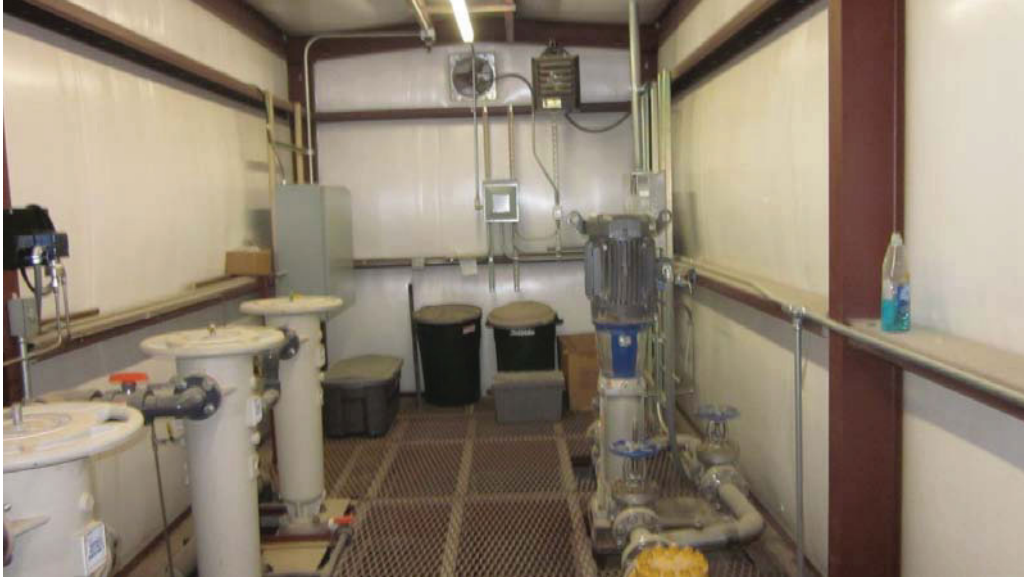
Figure 14. The well house protecting deep injection well #1. (Photo: DB, October 24, 2012)

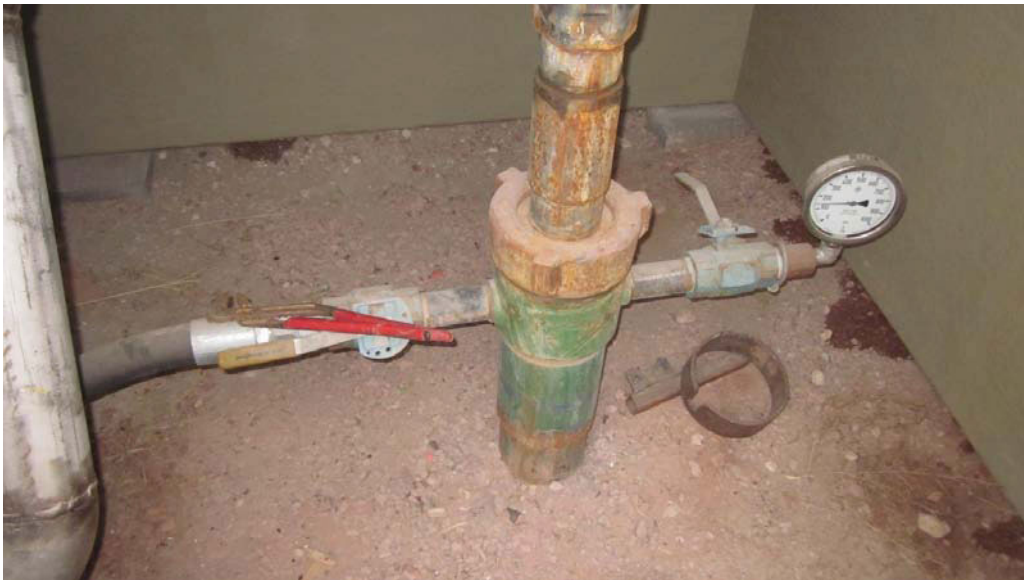
Figure 15. The well head of deep injection well #1. (Photo: DB, October 24, 2012)

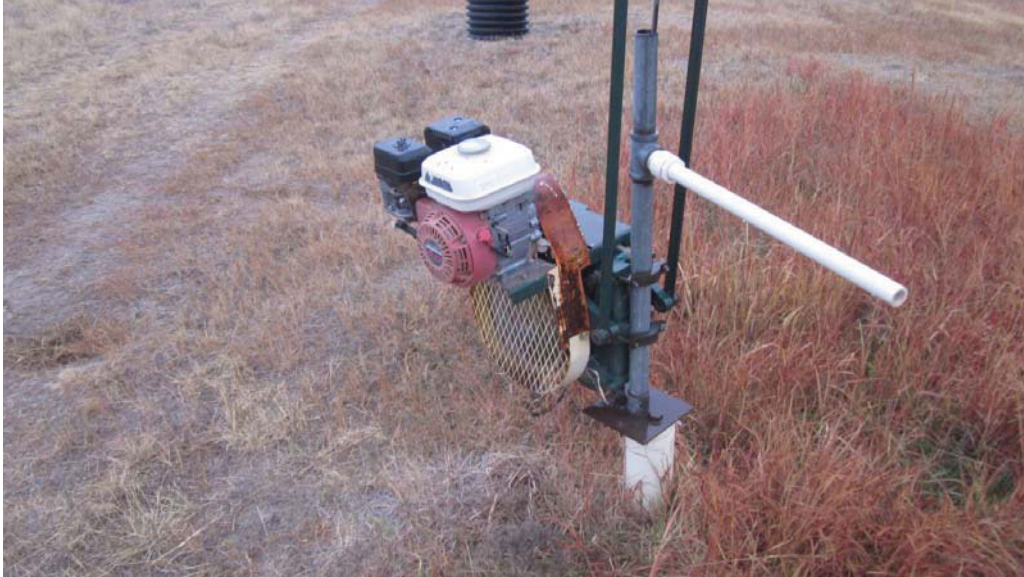
Figure 16. Sentry well equipped with dedicated generator for sampling. (Photo: DB, October 24, 2012)

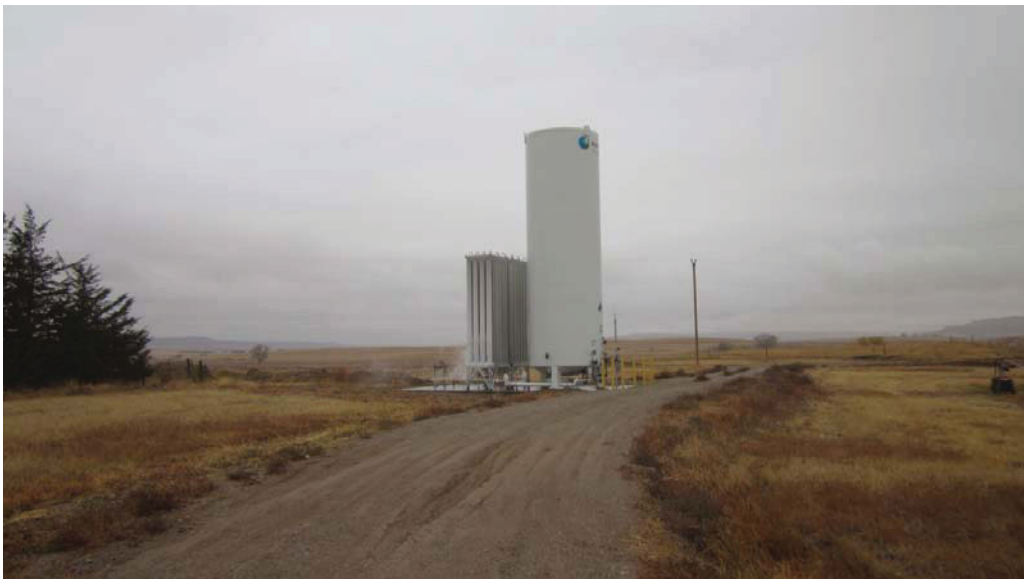
Figure 17. Storage tank holding oxidant on the CPF. (Photo: DB, October 24, 2012)

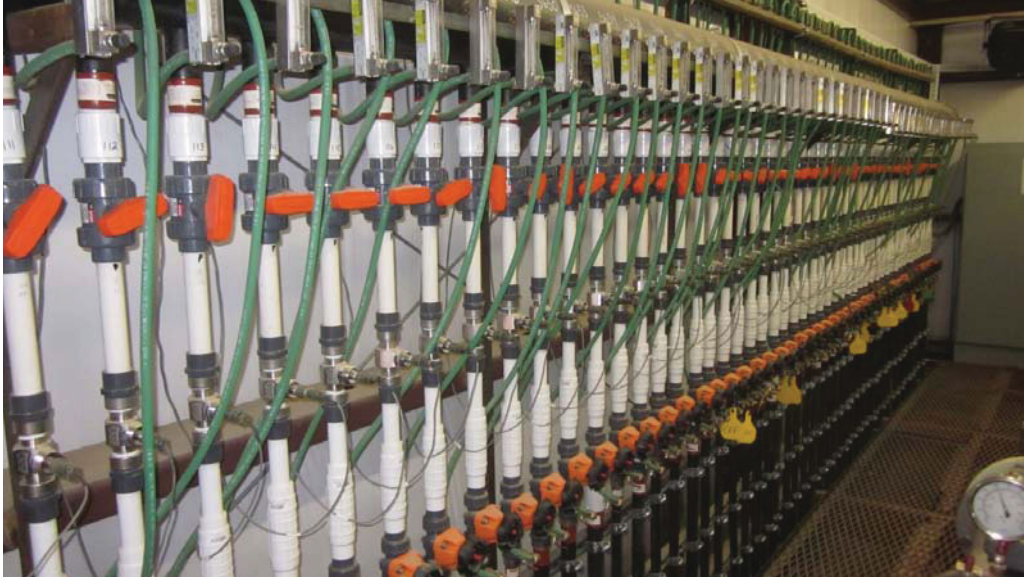
Figure 18. Flow values and ball gauges for injection and extraction wells. (Photo: DB, October 24, 2012)

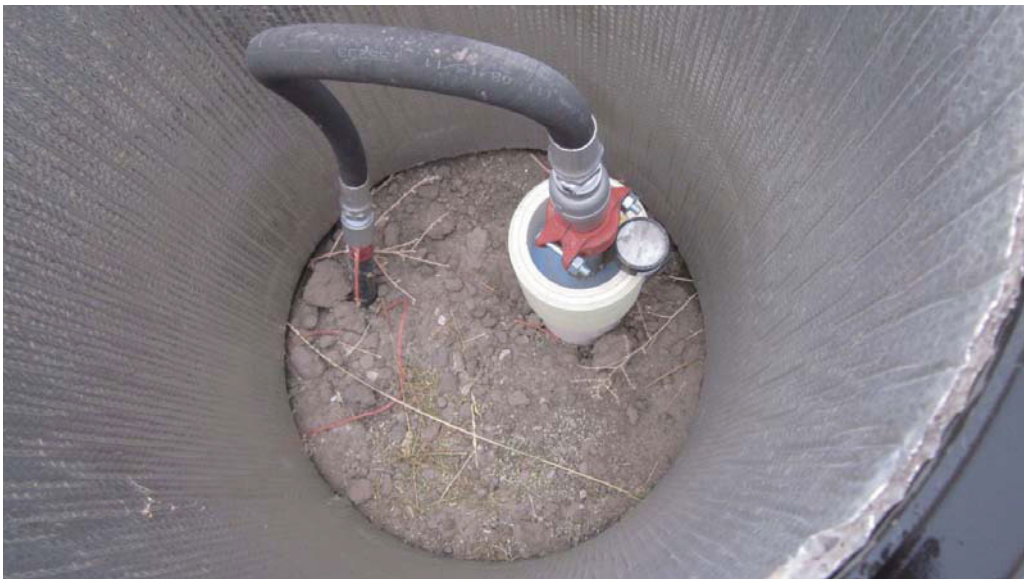
Figure 19. The well head of an injection well. (Photo: DB, October 24, 2012)

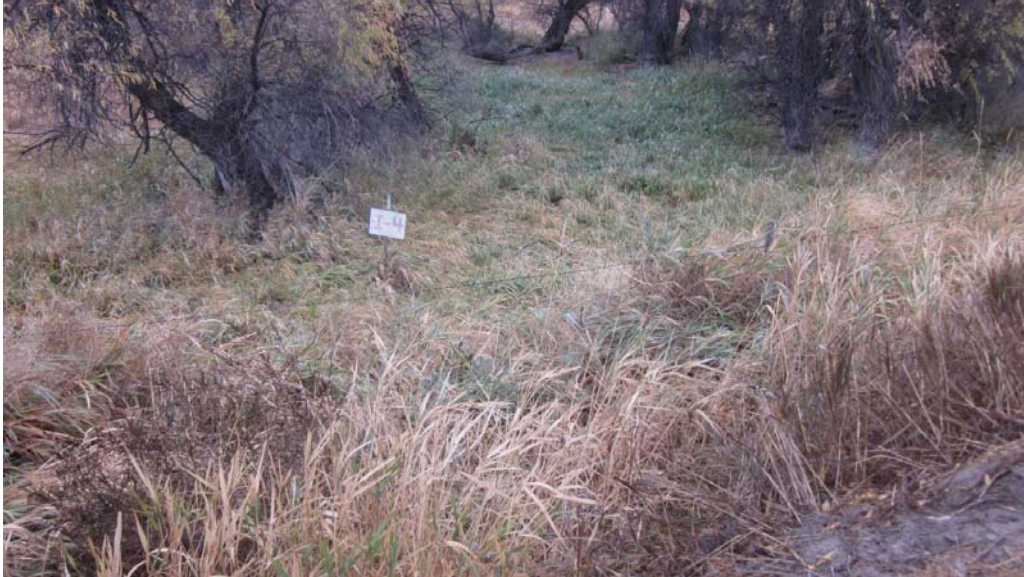
Figure 20. Surface water and sediment sampling location on English Creek. (Photo: DB, October 24, 2012)

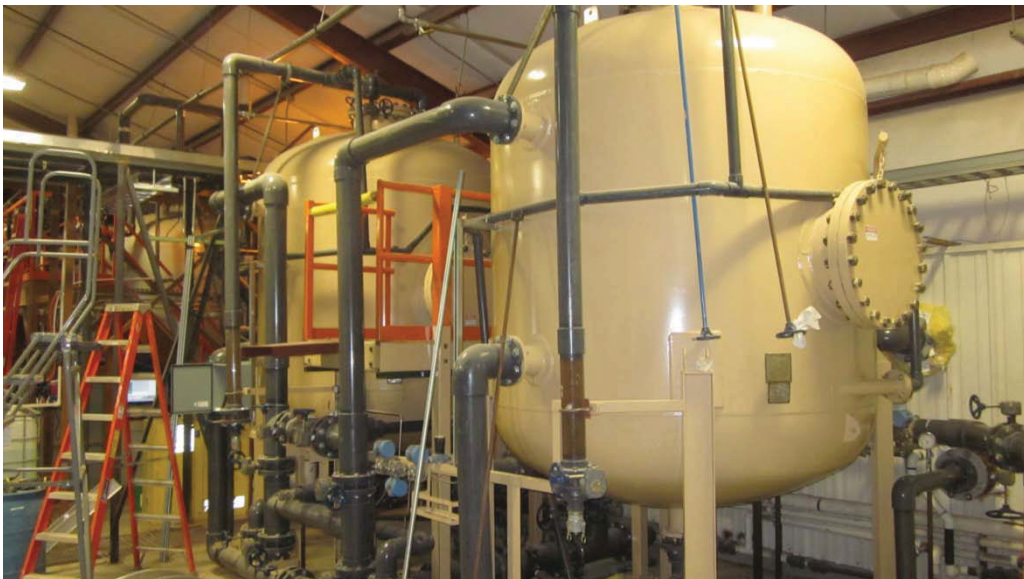
Figure 23. IX column located in an auxiliary building on the CPF. (Photo: DB, October 24, 2012)
