**UNITED STATES
NUCLEAR REGULATORY COMMISSION**

May 14, 2015

EA-14-228

**SUBJECT: WATERFORD STEAM ELECTRIC STATION, UNIT 3 – NRC INTEGRATED
INSPECTION REPORT 05000382/2015001 AND FINAL SIGNIFICANCE
DETERMINATION OF GREEN FINDING NRC INSPECTION
REPORT 05000382/2015009**

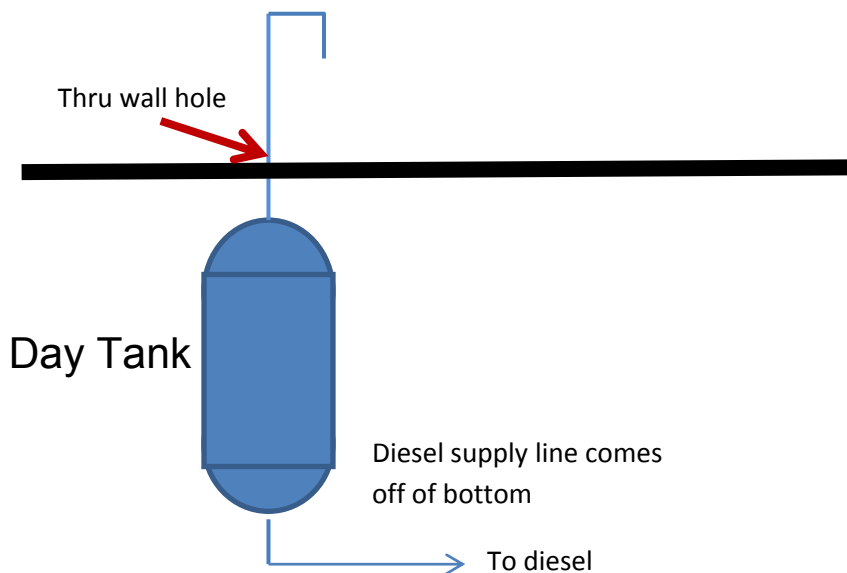
- The analyst used the Waterford-3 at-power Standardized Plant Analysis Risk (SPAR) model, Revision 8.16 for this analysis. In addition, Saphire Revision 8.1.2 was utilized. The analyst used a truncation limit of 10^{-11} . Only the LOOP events were affected. Therefore, the analyst only solved the LOOP sequences.
- The simplified drawing below was typical of both day tank configurations. The vents protruded through the diesel generator building roof and into the same drainage area.

- The equipment that could have been lost included the train A and B emergency diesel generators.
- The risk important events included the failure of both emergency diesel generators. The risk associated with the failure of only one diesel was small compared to the common cause failure of both diesel generators.
- The A vent hole was at a slightly higher elevation. Consequently, the B diesel generator would fail first. The failure of the A diesel was, therefore, the risk driver.
- The National Oceanic and Atmospheric Administration (NOAA) provided site specific tables for rain events (inches/hour) and the expected return period (years). For the Hahnville, Louisiana area, a 6 inch per hour rain event had a 200 year return period.
