Fort Calhoun Station, Unit No. 1
Renewed Facility Operating License No. DPR-40
NRC Docket No. 50-285

Subject: Omaha Public Power District (OPPD) Response to NRC Request for
Additional Information Regarding Relief Request RR-14

REQUEST FOR ADDITIONAL INFORMATION
RELIEF REQUEST NUMBER RR-14
ALTERNATIVE INSPECTION OF REACTOR VESSEL
CLOSURE HEAD WITH RESPECT TO ASME
CODE CASE N-729-1 AS CONDITIONED BY 10CFR50.55A
OMAHA PUBLIC POWER DISTRICT
DOCKET NUMBER 50-285

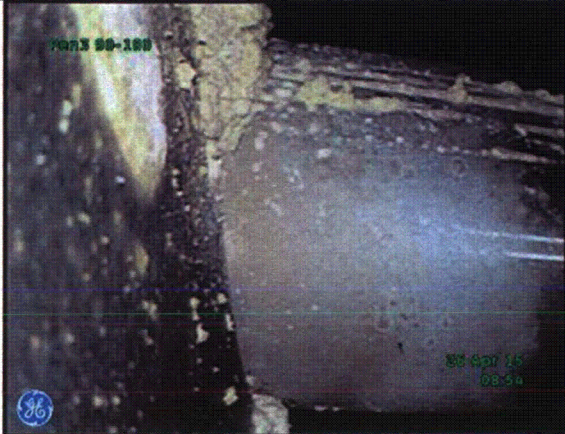
CEDM Nozzle 3	As-Found	As-Left
<p>Question 1 (a) Buildup of discolored deposits around and on nozzle (b) Relevant</p> <p>Question 2 (b) Deposits show flow conditions from above with visible leakage indications from insulation. Deposits have yellowish tint to them. Known CCW leak from flex hose near CEDM 3 and 8 in upper seal housing flowing down CEDM 3 and 8 and pooling on insulation and further leakage on reactor vessel head near surrounding penetrations. See plan view of page one of Attachment 2. Post vacuuming VE showed no sign of degradation/nozzle leakage. (c) Sample not performed.</p> <p>Question 3 N/A - Relevant</p> <p>Question 4 N/A – Relevant with an evaluation per - 3142.1(b)(1) of CC N-729-1 *Leak Source determined CCW Flex Hose leak near CEDM 3/8 (WR #224908)*</p>

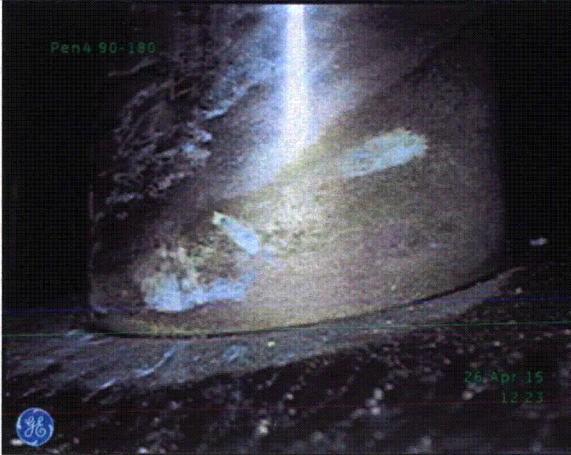
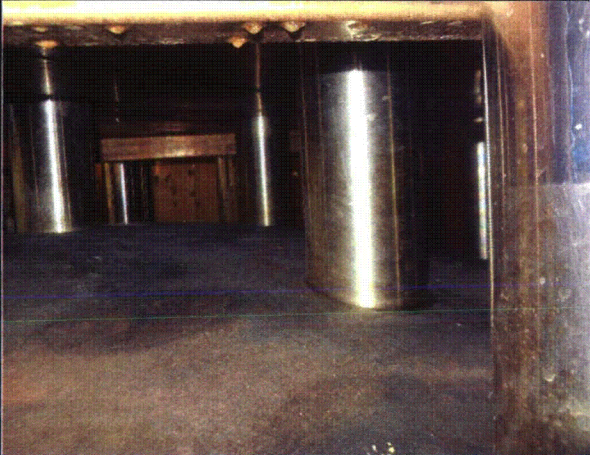
CEDM Nozzle 4	As-Found	As-Left
<p>Question 1 (a) Boric Acid dust accumulation around annulus and discoloration on Nozzle (b) Initial Evaluation as Not Relevant later re-evaluated as Relevant</p> <p>Question 2 (b) See Answer 3 (c) Sample not performed.</p> <p>Question 3 The photos from the initial bare metal inspection on all four sides show a small amount of light BA dust residue collected around the penetration annulus, more concentrated in the downslope side in the of the penetration nozzle. There is light discoloration of the nozzle itself on the 90-180 view, but neither the residue or discoloration are indicative of leak sources, nor are the large deposits or other visible deficiencies. The granule paths in the dust show that drifting has occurred downslope on the RVH, as one would expect from blown dust on a sloped surface.</p> <p>Question 4 See Answer 3 for basis of not evaluating per -3142.1(b)(1) of CC N-729-1 *Leak Source determined RC-100 packing leak (WO #551054)* *Post Cleaning VE determined acceptable*</p>

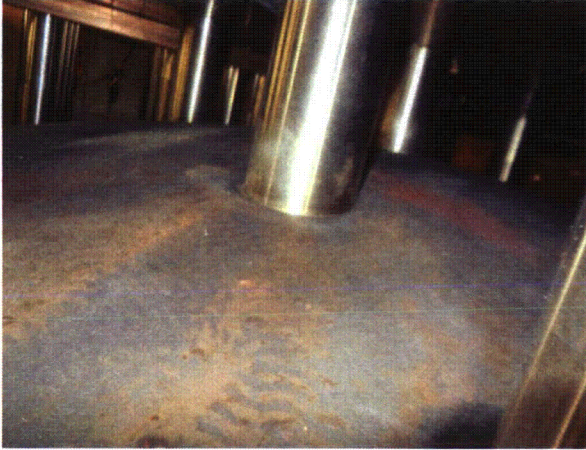
CEDM Nozzle 5	As-Found	As-Left
<p>Question 1 (a) Light Boric Acid dust accumulation around annulus (b) Initial Evaluation as Not Relevant later re-evaluated as Relevant</p> <p>Question 2 (b) See Answer 3 (c) Sample not performed.</p> <p>Question 3 The photos from the initial bare metal inspection on all four sides show a small amount of light dust residue collected around the penetration annulus, more concentrated in the downslope side in the protective leeward side of the penetration nozzle. There is light discoloration of the nozzle itself on the 90-180 view. The granule paths in the dust show that drifting has occurred downslope on the RVH, as one would expect from blown dust on a sloped surface.</p> <p>Question 4 See Answer 3 for basis of not evaluating per -3142.1(b)(1) of CC N-729-1 *Leak Source determined RC-100 packing leak (WO #551054)*</p>

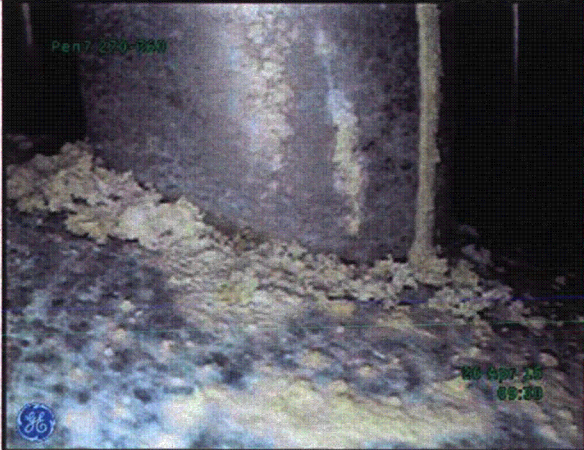
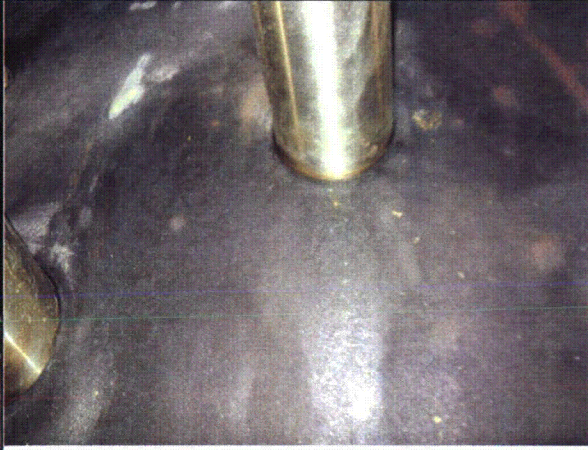
CEDM Nozzle 8	As-Found	As-Left
<p>Question 1 (a) Buildup of discolored deposits around and on nozzle (b) Relevant</p> <p>Question 2 (b) Deposits show flow conditions from above with visible leakage indications from insulation. Deposits have yellowish tint to them. Known CCW leak from flex hose near CEDM 3 and 8 in upper seal housing flowing down CEDM 3 and 8 and pooling on insulation and further leakage on reactor vessel head near surrounding penetrations. See plan view of page one of Attachment 2. (c) See chemistry description at end of report.</p> <p>Question 3 N/A - Relevant</p> <p>Question 4 N/A – Relevant with an evaluation per - 3142.1(b)(1) of CC N-729-1 *Leak Source determined CCW Flex Hose leak near CEDM 3/8 (WR #224908)*</p>

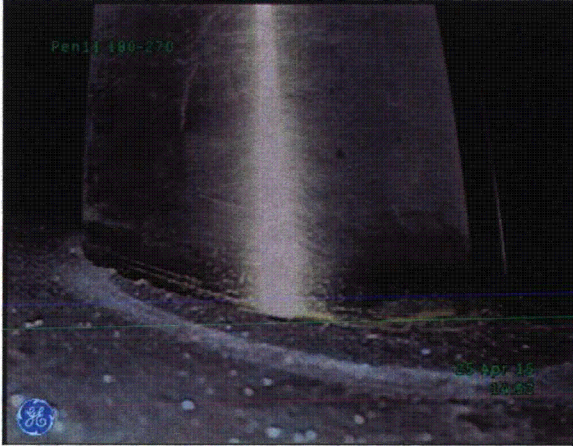
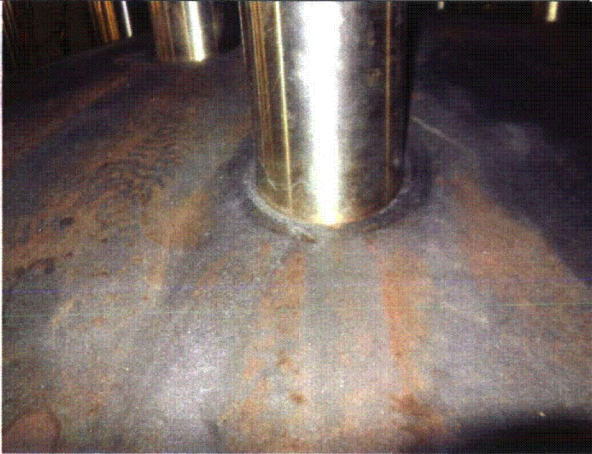
CEDM Nozzle 11	As-Found	As-Left
<p>Question 1 (a) Indication of small amounts of dust deposits on side and base of penetration (b) Initial Evaluation as Not Relevant later re-evaluated as Relevant</p> <p>Question 2 (b) See Answer 3 (c) Sample not performed.</p> <p>Question 3 The initial bare metal inspection on all four sides show a small amount of light dust residue collected around the penetration annulus. This is shown well in the 180-270 view, where a clear oval shaped deposit has settled on the downslope side of the nozzle. The residue is clearly a dust or a stain settled in the leeward side of a protective block from air currents, much like residue particles settled in the annulus region itself as shown in the 270-360 view on the upslope and downslope side where they could not be blown away. Neither the deposit ring or the light staining on the 270° side of the penetration nozzle are indicative of a leak source. The particles and the dust in the annulus also do not provide enough cover to potentially mask any other flaw.</p> <p>Question 4 See Answer 3 for basis of not evaluating per -3142.1(b)(1) of CC N-729-1 *Leak Source determined CCW Flex Hose leak near CEDM 3/8 (WR #224908)* *Post Cleaning VE determined acceptable*</p>

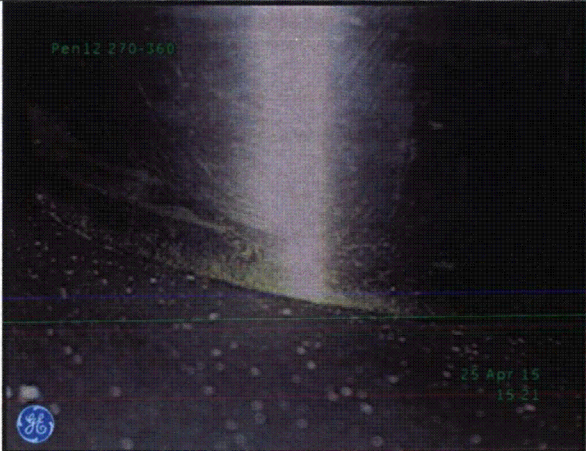
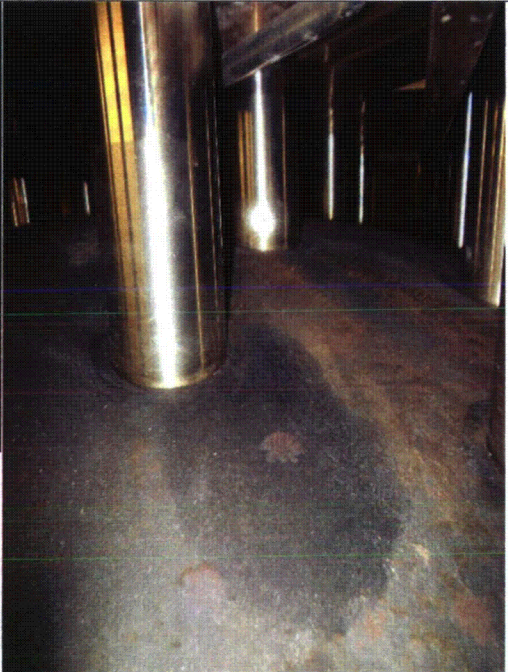
CEDM Nozzle 12	As-Found	As-Left
<p>Question 1 (a) Small amounts of dust deposits on side and base of penetration. No corrosion. Yellow film is indicative of CCW. (b) Initial Evaluation as Not Relevant later re-evaluated as Relevant</p> <p>Question 2 (b) See Answer 3 (c) Sample not performed.</p> <p>Question 3 The initial bare metal inspection on all four sides show a small amount of light BA dust residue collected around the penetration annulus, more concentrated in the downslope side in the protective leeward side of the penetration nozzle. There is light discoloration of the nozzle itself on the 270-360 view, but neither the residue or discoloration are indicative of leak sources, nor are the large deposits or other visible deficiencies. The granule paths in the dust show that drifting has occurred downslope on the RVH, as one would expect from blown dust on a sloped surface.</p> <p>Question 4 See Answer 3 for basis of not evaluating per -3142.1(b)(1) of CC N-729-1 *Leak Source determined CCW Flex Hose leak near CEDM 3/8 (WR #224908)* *Post Cleaning VE determined acceptable*</p>

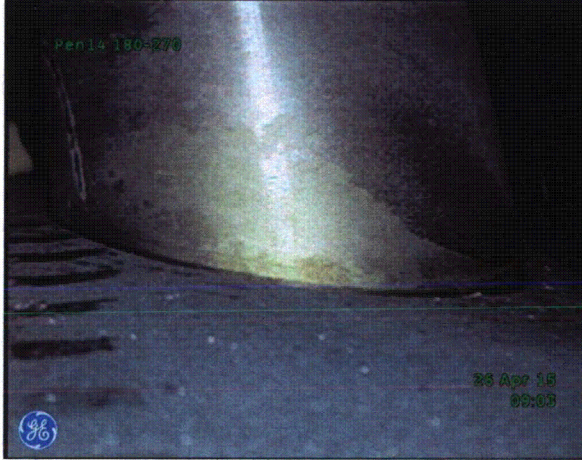
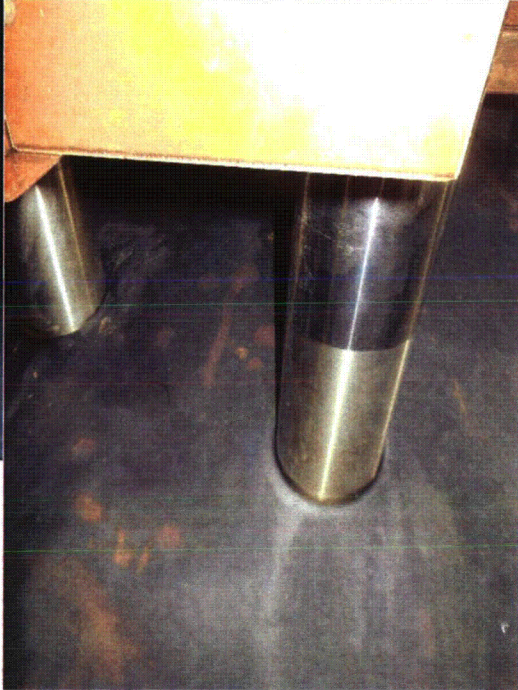
CEDM Nozzle 14	As-Found	As-Left
<p>Question 1 (a) Indication of small amounts of dust deposits on side and base of penetration. No corrosion. Yellow film is indicative of CCW. (b) Initial Evaluation as Not Relevant later re-evaluated as Relevant</p> <p>Question 2 (b) See Answer 3 (c) Sample not performed.</p> <p>Question 3 The initial bare metal inspection show a light dust residue on all four sides of the penetration nozzle. The residue is clearly very light and has settled there from circulation within the shroud, as evidenced by the robot crawler tracks in the 180-270 view that wipe away the residue to show the darker RVH metal beneath. There are no deposits or tracks of leakage; and only a very light droplet staining on the 270-360 view of the nozzle. The residue and staining cannot be hiding a leak source or deficiency, as the dust is so light it would show any indications underneath.</p> <p>Question 4 See Answer 3 for basis of not evaluating per -3142.1(b)(1) of CC N-729-1 *Leak Source determined CCW Flex Hose leak near CEDM 3/8 (WR #224908)* *Post Cleaning VE determined acceptable*</p>

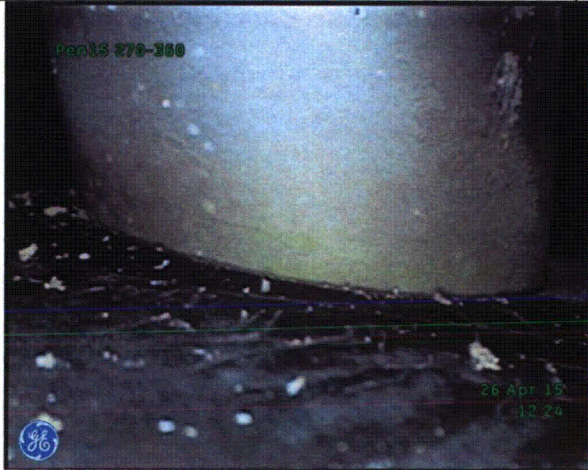
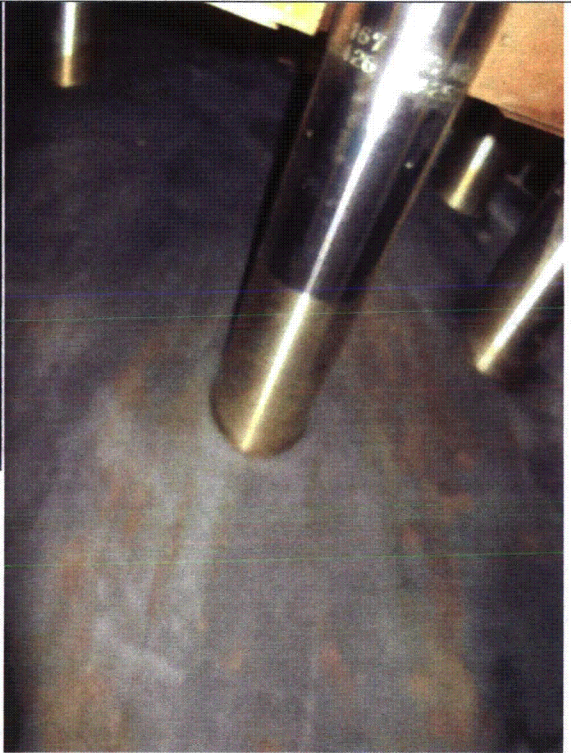
CEDM Nozzle 15	As-Found	As-Left
<p>Question 1 (a) Indication of small amounts of dust deposits on side and base of penetration. No corrosion. Yellow film is indicative of CCW. (b) Initial Evaluation as Not Relevant later re-evaluated as Relevant</p> <p>Question 2 (b) See Answer 3 (c) Sample not performed.</p> <p>Question 3 The initial bare metal inspection photos show no dust residue on the upslope side of the penetration, although dust has settled in the annulus itself and drifted downslope in the leeward side of the penetration. The residue is the same light dust which appears at other penetrations, and no deposits or staining tracks are present. A few small granules of residue appear in the 270-360 view to the side of the penetration nozzle. All have clearly settled or drifted there from circulation within the shroud or drifting down the head; there is no presence of leaks above them like in other areas.</p> <p>Question 4 See Answer 3 for basis of not evaluating per -3142.1(b)(1) of CC N-729-1 *Leak Source determined CCW Flex Hose leak near CEDM 3/8 (WR #224908)* *Post Cleaning VE determined acceptable*</p>

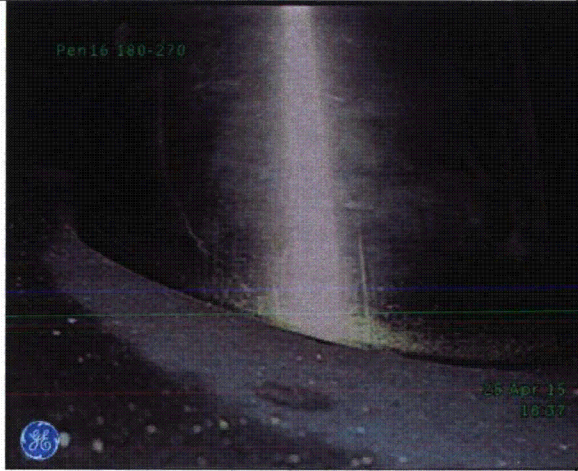
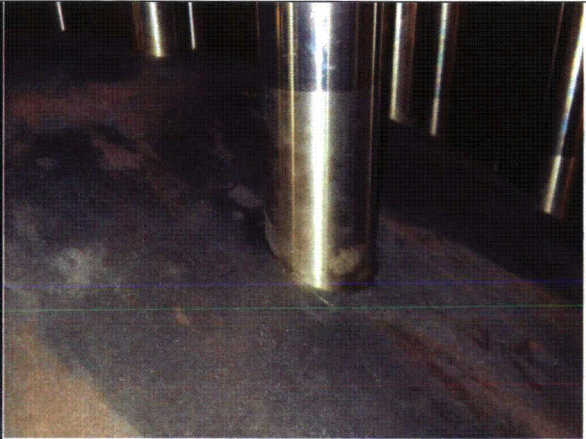
CEDM Nozzle 16	As-Found	As-Left
<p>Question 1 (a) Indication of small amounts of dust deposits on side and base of penetration. No corrosion. Yellow film is indicative of CCW. (b) Initial Evaluation as Not Relevant later re-evaluated as Relevant</p> <p>Question 2 (b) See Answer 3 (c) Sample not performed.</p> <p>Question 3 The initial bare metal inspection photos show what is either a light dust of residue or light staining in the 180-270 view. It is not thick enough to mask any deficiencies or damage. Like many of the other penetrations; there are no actual material deposits, just a general dusting of light residue that has circulated within the RVH shroud and collected in a relatively protected area. This is shown well in the 270-360 view, where the darker color of the bare RVH shows through the dust.</p> <p>Question 4 See Answer 3 for basis of not evaluating per -3142.1(b)(1) of CC N-729-1 *Leak Source determined CCW Flex Hose leak near CEDM 3/8 (WR #224908)* *Post Cleaning VE determined acceptable*</p>

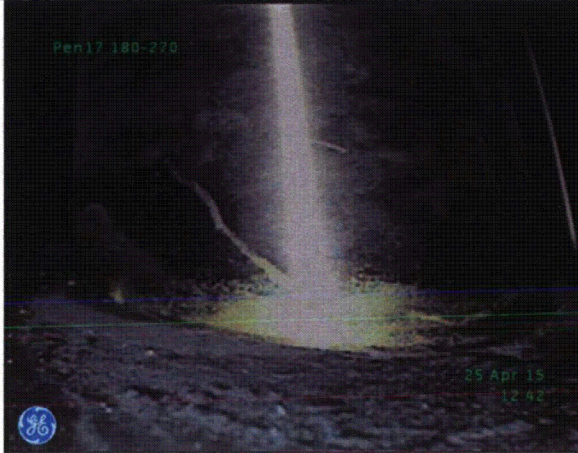
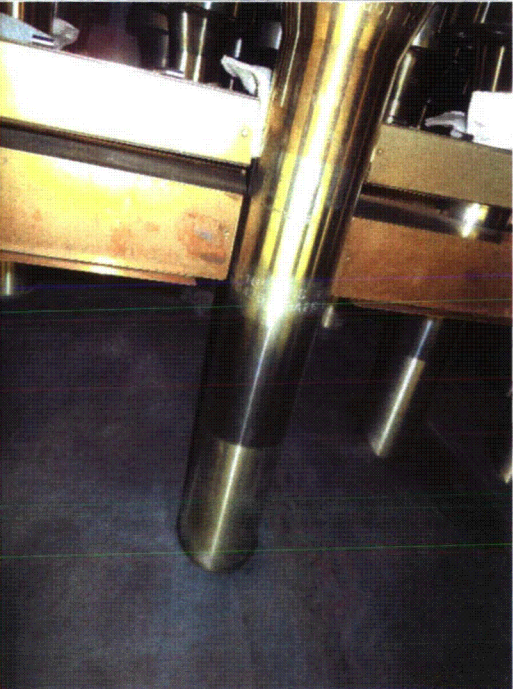
CEDM Nozzle 17	As-Found	As-Left
<p>Question 1 (a) Indication of small amounts of dust deposits on side and base of penetration. No corrosion. Yellow film is indicative of CCW. (b) Initial Evaluation as Not Relevant later re-evaluated as Relevant</p> <p>Question 2 (b) See Answer 3 (c) Sample not performed.</p> <p>Question 3 The initial bare metal inspection photos document no large accumulations or deposits of residue, nor are the penetration located in an area immediately adjacent to one which does. Only a light dust is shown collected directly in the annulus region. There is some light staining and discoloration of the penetration nozzle itself, although some of that is due to the camera lighting. A few small granules are shown near the annulus. None of these are indicative of damage and none can mask any deficiency.</p> <p>Question 4 See Answer 3 for basis of not evaluating per -3142.1(b)(1) of CC N-729-1 *Leak Source determined CCW Flex Hose leak near CEDM 3/8 (WR #224908)* *Post Cleaning VE determined acceptable*</p>

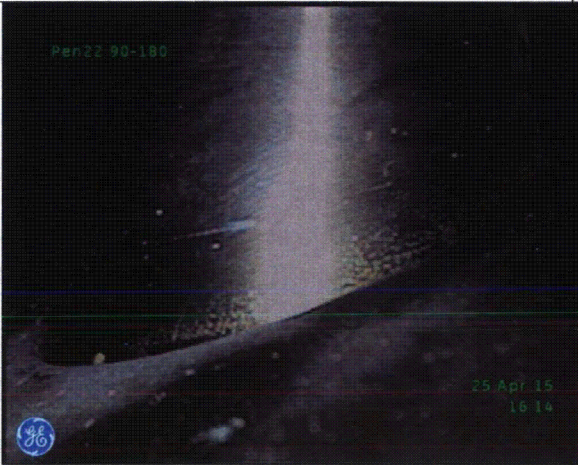
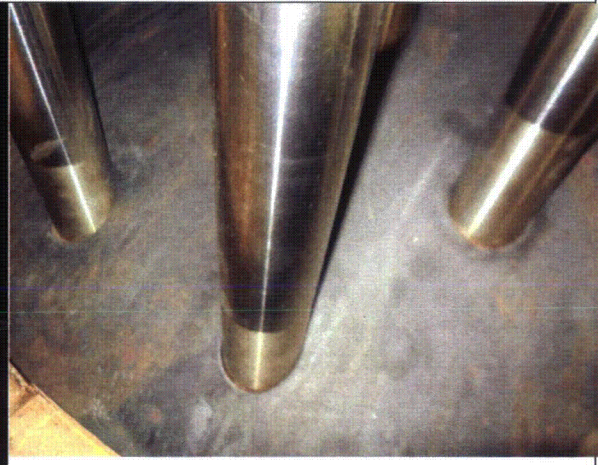
CEDM Nozzle 23	As-Found	As-Left
<p>Question 1 (a). Indication of possible Boric Acid deposits on base of penetration (b) Relevant</p> <p>Question 2 (b) Deposits indicate leakage flow down the head, past the penetration. The leak path is up the curvature of the head from the penetration. The leak source appears to be the known CCW leak from the flex hose near CEDM 3 and 8 in upper seal housing which is then flowing down the curvature of the head to Nozzle 23. See plan view for location (c) See chemistry description at end of report.</p> <p>Question 3 N/A - Relevant</p> <p>Question 4 N/A – Relevant with an evaluation per - 3142.1(b)(1) of CC N-729-1 *Leak Source determined CCW Flex Hose leak near CEDM 3/8 (WR #224908)*</p>

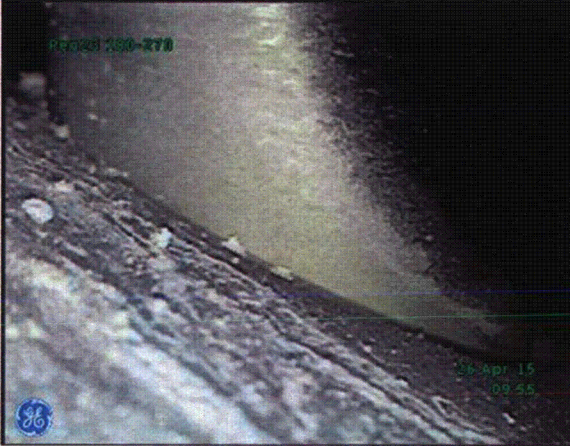
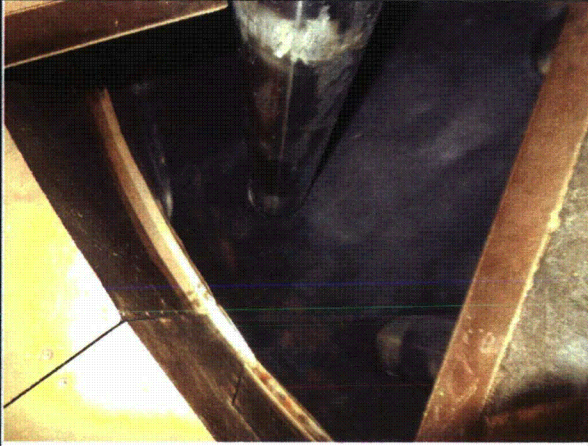
CEDM Nozzle 24	As-Found	As-Left
<p>Question 1 (a) Indication of possible Boric Acid deposits on base of penetration (b) Relevant Question 2 (b) Deposits indicate leakage flow down the head past the penetration. The leak path appears to be up the curvature of the head from the penetration. The leak source appears to be the known CCW leak from the flex hose near CEDM 3 and 8 in upper seal housing. This appears to be flowing down CEDM 3 and 8, which is pooling on insulation. (c) Sample not performed. Question 3 N/A - Relevant Question 4 N/A – Relevant with an evaluation per - 3142.1(b)(1) of CC N-729-1 *Leak Source determined CCW Flex Hose leak near CEDM 3/8 (WR #224908)*</p>

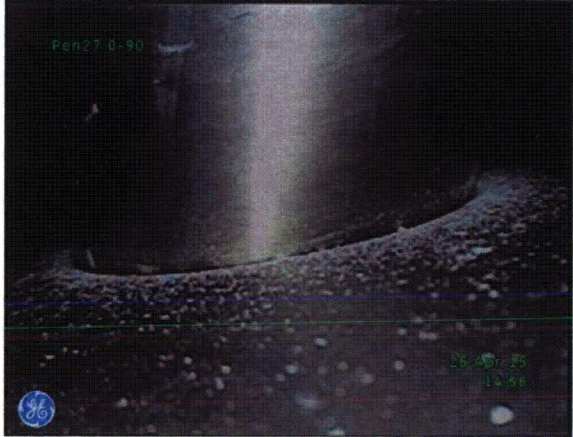
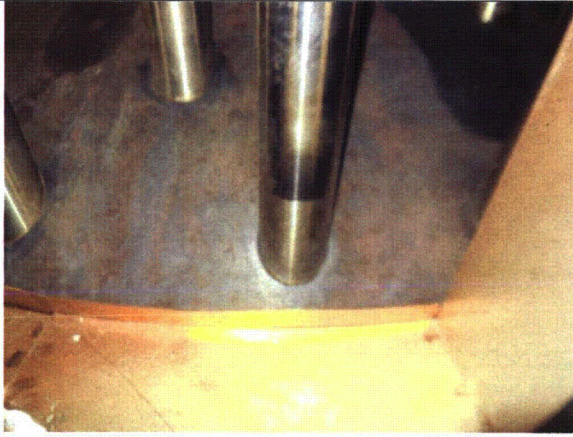
CEDM Nozzle 28	As-Found	As-Left
<p>Question 1 (a). Indication of possible Boric Acid deposits on base of penetration (b). Relevant</p> <p>Question 2 (b). Deposits are of light dusting showing indication of being blown around penetration and collecting around the penetration. Known RCS leak from RC-100 packing near 270-360 degree direction. Dusting due to blown leakage from RC-100. (c) Sample not performed.</p> <p>Question 3 N/A - Relevant</p> <p>Question 4 N/A – Relevant with an evaluation per - 3142.1(b)(1) of CC N-729-1 *Leak Source determined RC-100 packing leak (WO #551054)*</p>

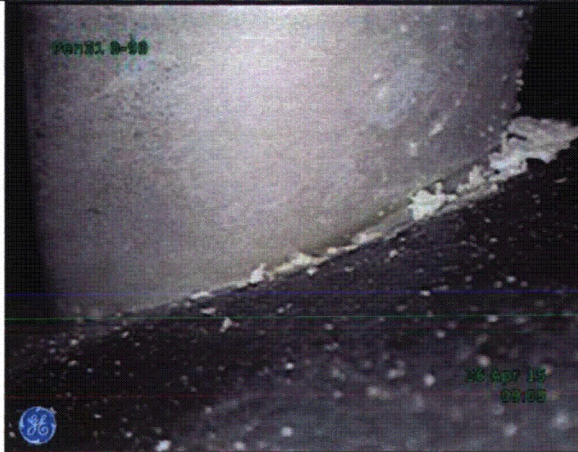
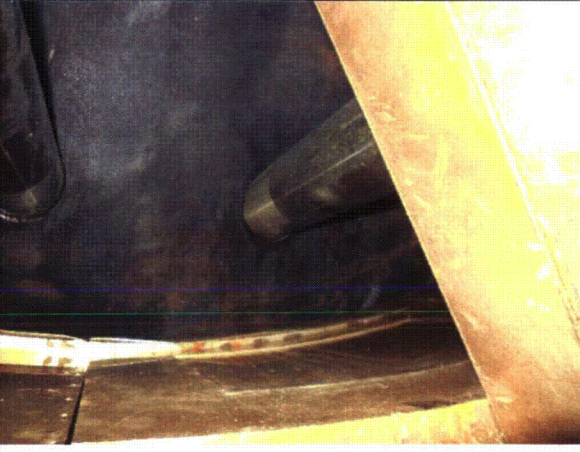
CEDM Nozzle 32	As-Found	As-Left
<p>Question 1 (a). Indication of possible Boric Acid deposits on base of penetration (b). Relevant</p> <p>Question 2 (b). Deposits indicate leakage flow down the head past penetration. The leak path is up the curvature of the head from the penetration. The leak source appears to be the known CCW leak from the flex hose near CEDM 3 and 8 in upper seal housing which is then flowing down the curvature of the head to Nozzle 32. See plan view for location (c) See chemistry report at end of report</p> <p>Question 3 N/A - Relevant</p> <p>Question 4 N/A – Relevant with an evaluation per - 3142.1(b)(1) of CC N-729-1 *Leak Source determined CCW Flex Hose leak near CEDM 3/8 (WR #224908)*</p>

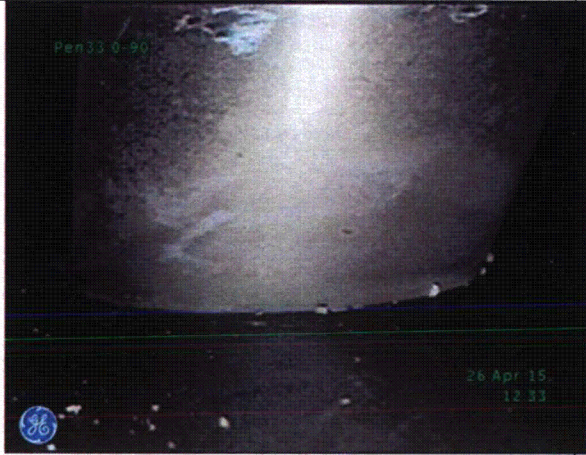
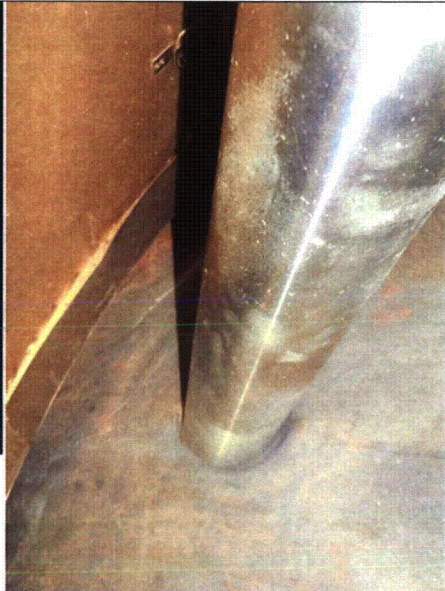
CEDM Nozzle 34	As-Found	As-Left
<p>Question 1 (a). Indication of possible Boric Acid deposits on base of penetration (b). Relevant</p> <p>Question 2 (b). Deposits indicate leakage flow down the head past penetration. Known CCW leak from flex hose near CEDM 3 and 8 in upper seal housing flowing down CEDM 3 and 8 and pooling on insulation and further leakage on reactor vessel head near surrounding penetrations. Flow from CCW flex hose leakage through penetrations above penetration #34 as source (c) Sample not performed.</p> <p>Question 3 N/A - Relevant</p> <p>Question 4 N/A – Relevant with an evaluation per - 3142.1(b)(1) of CC N-729-1 *Leak Source determined CCW Flex Hose leak near CEDM 3/8 (WR #224908)*</p>

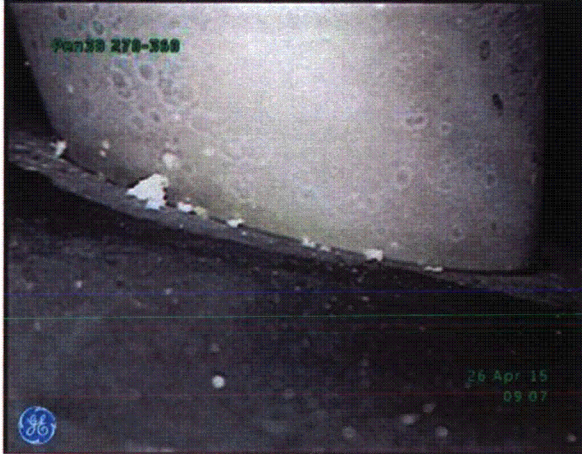
CEDM Nozzle 39	As-Found	As-Left
<p>Question 1 (a). Indication of possible Boric Acid deposits on base of penetration (b). Relevant</p> <p>Question 2 (b). Deposits indicate leakage flow down the head past penetration. Leak path identified as up the curvature of the head from the penetration. Known CCW leak from flex hose near CEDM 3 and 8 in upper seal housing flowing down CEDM 3 and 8 and pooling on insulation and further leakage on reactor vessel head near surrounding penetrations. Flow from CCW flex hose leakage through penetrations above penetration #39 as source (c) Sample not performed.</p> <p>Question 3 N/A - Relevant</p> <p>Question 4 N/A – Relevant with an evaluation per - 3142.1(b)(1) of CC N-729-1 *Leak Source determined CCW Flex Hose leak near CEDM 3/8 (WR #224908)*</p>

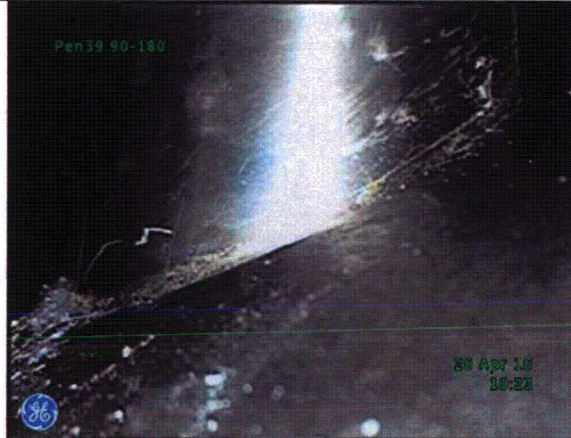
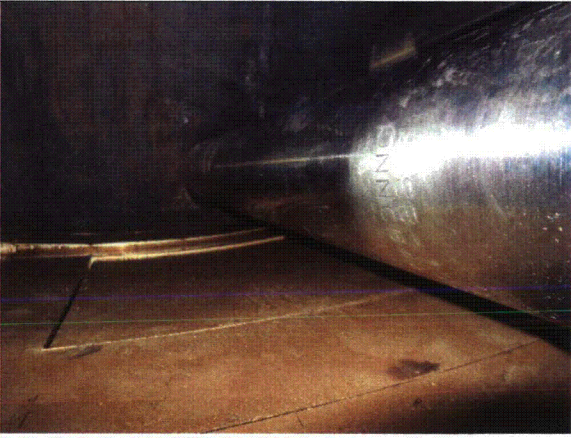
CEDM Nozzle 40	As-Found	As-Left
<p>Question 1 (a). Indication of possible Boric Acid deposits on base of penetration (b). Relevant</p> <p>Question 2 (b). Deposits indicate light dusting in a blowing fashion in the direction of 180-270 degree. Known RCS leak from RC-100 packing near CEDM #40 in the 270-360 degree direction. Dusting due to blown leakage from RC-100. (c) Sample not performed.</p> <p>Question 3 N/A - Relevant</p> <p>Question 4 N/A – Relevant with an evaluation per - 3142.1(b)(1) of CC N-729-1 *Leak Source determined RC-100 packing leak (WO #551054)*</p>

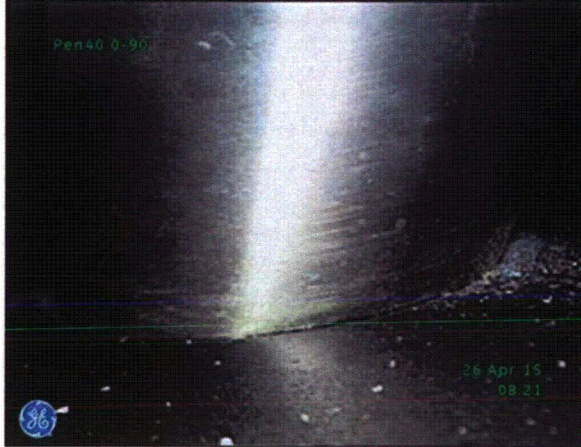
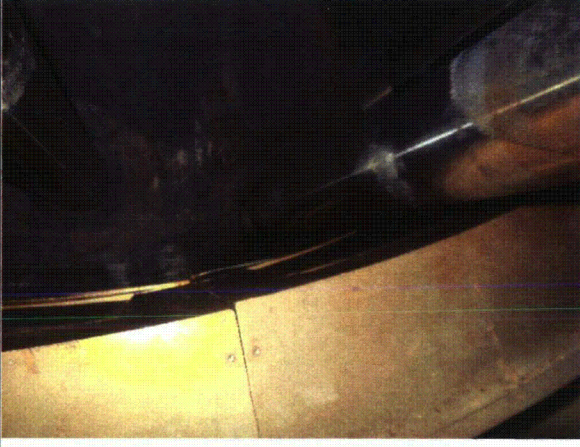
CEDM Nozzle 41	As-Found	As-Left
<p>Question 1 (a). Indication of possible Boric Acid deposits on base of penetration (b). Relevant</p> <p>Question 2 (b). Deposits indicate light dusting in a blowing fashion in the direction of 090-180 degree. Known RCS leak from RC-100 packing near CEDM #41 in the 270-360 degree direction. Dusting due to blown leakage from RC-100. (c) Sample not performed.</p> <p>Question 3 N/A - Relevant</p> <p>Question 4 N/A – Relevant with an evaluation per - 3142.1(b)(1) of CC N-729-1 *Leak Source determined RC-100 packing leak (WO #551054)*</p>

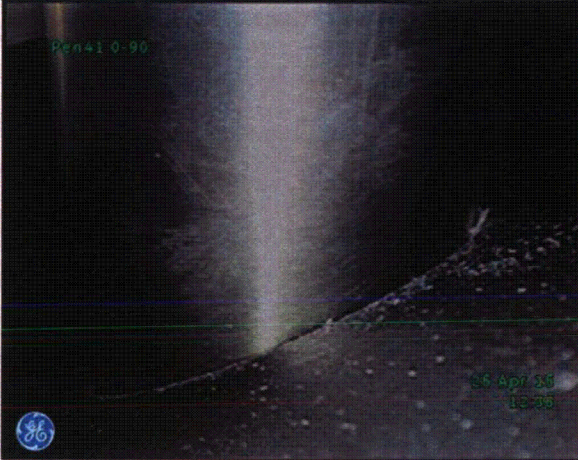
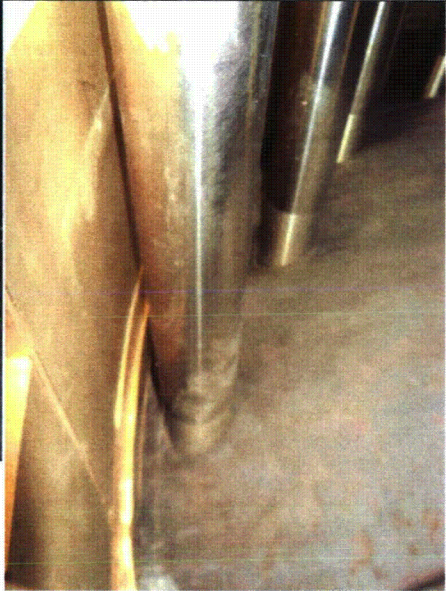
ICI Nozzle 42	As-Found	As-Left
<p>Question 1 (a). Indication of possible light amount of Boric Acid deposits around base of penetration (b). Initial Evaluation as Not Relevant later re-evaluated as Relevant</p> <p>Question 2 (b). See Answer 3 (c). Sample not performed.</p> <p>Question 3 The angle of the slope around penetration 42 is very steep which would allow deposits from above to easily collect around it. The deposits found were light and the deposits near the annulus were from the high point of the RVCH sloop around nozzle 42.</p> <p>Question 4 See Answer 3 for basis of not evaluating per -3142.1(b)(1) of CC N-729-1 *Leak Source determined RC-100 packing leak (WO #551054)* *Post Cleaning VE determined acceptable*</p>

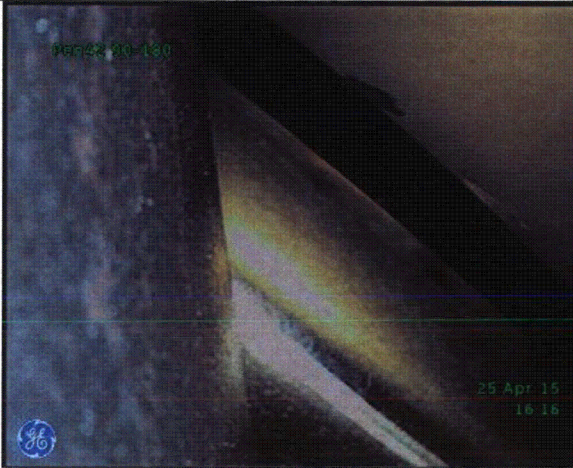
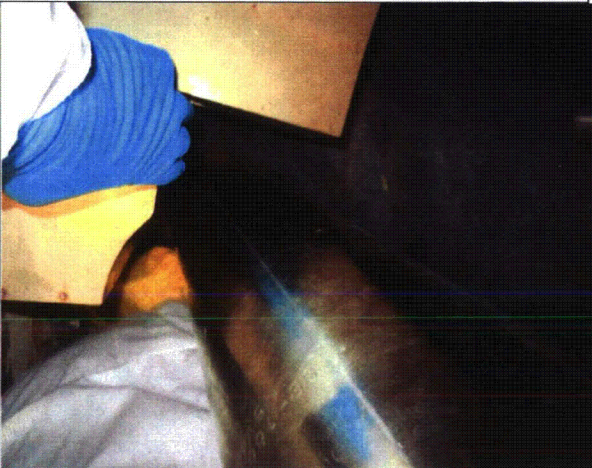
ICI Nozzle 43	As-Found	As-Left
<p>Question 1 (a). Indication of possible medium amount of Boric Acid deposits on base of penetration (b). Initial Evaluation as Not Relevant later re-evaluated as Relevant</p> <p>Question 2 (b). See Answer 3 (c). Sample not performed.</p> <p>Question 3 The angle of the slope around penetration 43 is quite steep which would allow deposits from above to easily collect around it. The deposits found were medium amount and the deposits near the annulus were from the high point of the RVCH sloop around nozzle 43. This would be expected for the amount of deposits above penetration around Nozzle 3 and 8.</p> <p>Question 4 See Answer 3 for basis of not evaluating per -3142.1(b)(1) of CC N-729-1 *Leak Source determined CCW Flex Hose leak near CEDM 3/8 (WR #224908)* *Post Cleaning VE determined acceptable*</p>

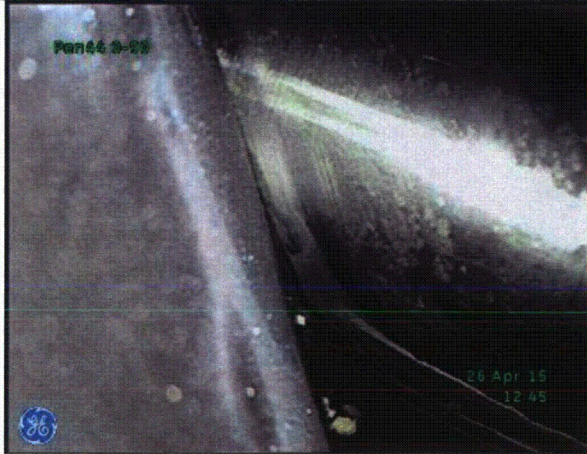
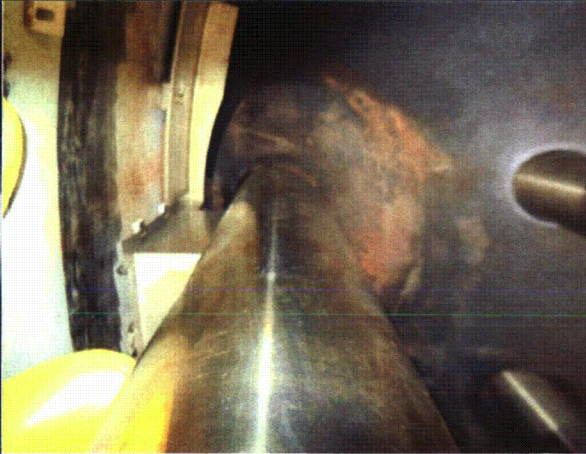
ICI Nozzle 45	As-Found	As-Left
<p>Question 1 (a). Indication of possible light amount of Boric Acid deposits on base of penetration (b). Initial Evaluation as Not Relevant later re-evaluated as Relevant</p> <p>Question 2 (b). See Answer 3 (c). Sample not performed.</p> <p>Question 3 The angle of the slope around penetration 45 is quite steep which would allow deposits from above to easily collect around it. The deposits found were a very light amount and the deposits near the annulus were from the high point of the RVCH sloop around nozzle 45.</p> <p>Question 4 See Answer 3 for basis of not evaluating per -3142.1(b)(1) of CC N-729-1 *Leak Source determined RC-100 packing leak (WO #551054)* *Post Cleaning VE determined acceptable*</p>

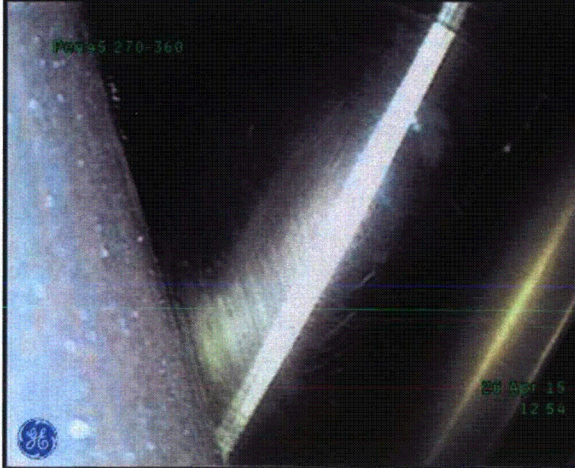
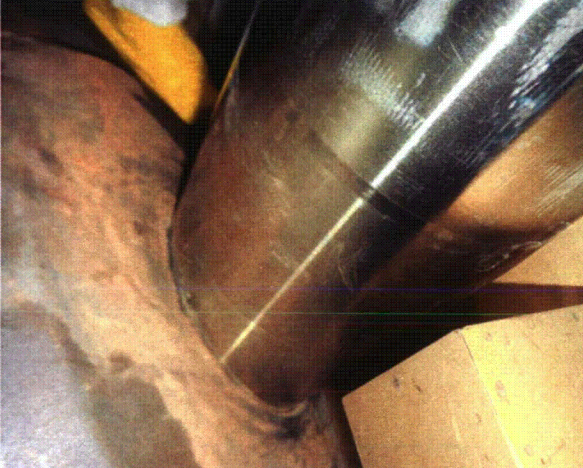
ICI Nozzle 46	As-Found	As-Left
<p>Question 1 (a). Indication of possible light Boric Acid deposits on base of penetration (b). Initial Evaluation as Not Relevant later re-evaluated as Relevant</p> <p>Question 2 (b). See Answer 3 (c). Sample not performed.</p> <p>Question 3 The angle of the slope around penetration 46 is quite steep which would allow deposits from above to easily collect around it. The deposits found were of light amount and the deposits near the annulus were from the high point of the RVCH sloop around nozzle 46. This would be expected for the accumulation of loose deposits above nozzle at Nozzle 21</p> <p>Question 4 See Answer 3 for basis of not evaluating per -3142.1(b)(1) of CC N-729-1 *Leak Source determined RC-100 packing leak (WO #551054)* *Post Cleaning VE determined acceptable*</p>

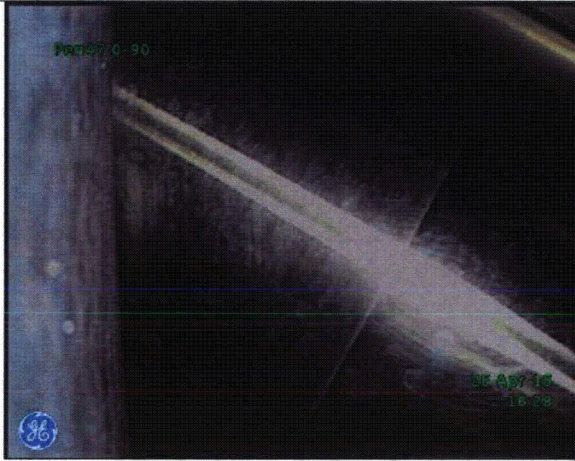
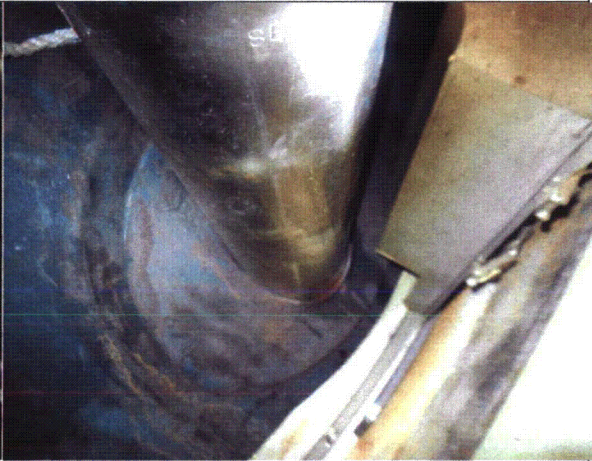
Vent Penetration	As-Found	As-Left
<p>Question 1 (a). Indication of possible heavy Boric Acid deposits on base of penetration (b). Initial Evaluation as Not Relevant later re-evaluated as Relevant</p> <p>Question 2 (b). See Answer 3 (c) Sample not performed.</p> <p>Question 3 Deposits on the side and base of RC-100 penetration. Visual leak path could be traced to above annulus towards the insulation where CCW was pooled from flex hose leak around CEDM 3 and 8.</p> <p>Question 4 See Answer 3 for basis of not evaluating per -3142.1(b)(1) of CC N-729-1 *Leak Source determined CCW Flex Hose leak near CEDM 3/8 (WR #224908)* *Post Cleaning VE determined acceptable*</p>

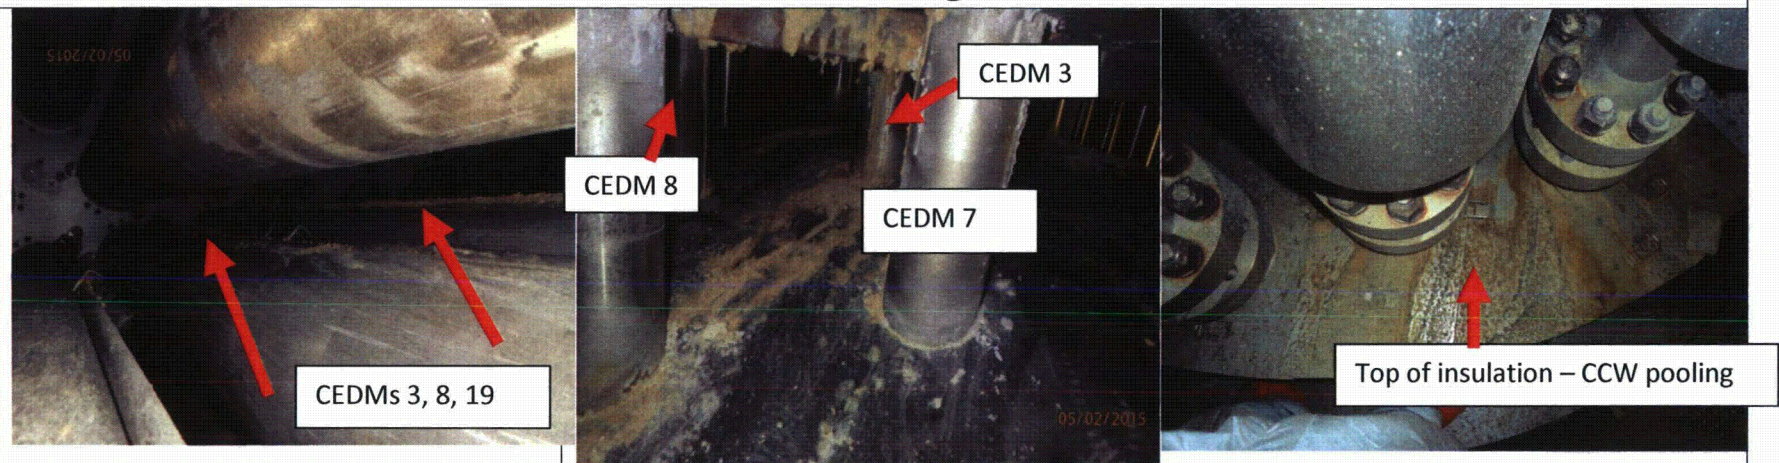
CCW Flex Hose Leakage down CEDM

Component Cooling Water is supplied and returned by a ring header as part of the reactor vessel head work platform. The subject hoses supply and return CCW flow between the CEDM seal assemblies and the ring headers for CEDM cooling. One of the CCW hoses running between CEDMs 3, 7, 8, and 19 developed a leak during the operating cycle. Due to the hose being located above the reactor vessel closure head, the leakage was able to flow onto the surface below the CEDM Drive Assemblies and down the CEDM housings. Evidence of pooling on the top of insulation surface was identified. From this surface, the fluid was able to run down the CEDM housings through insulation and onto head.

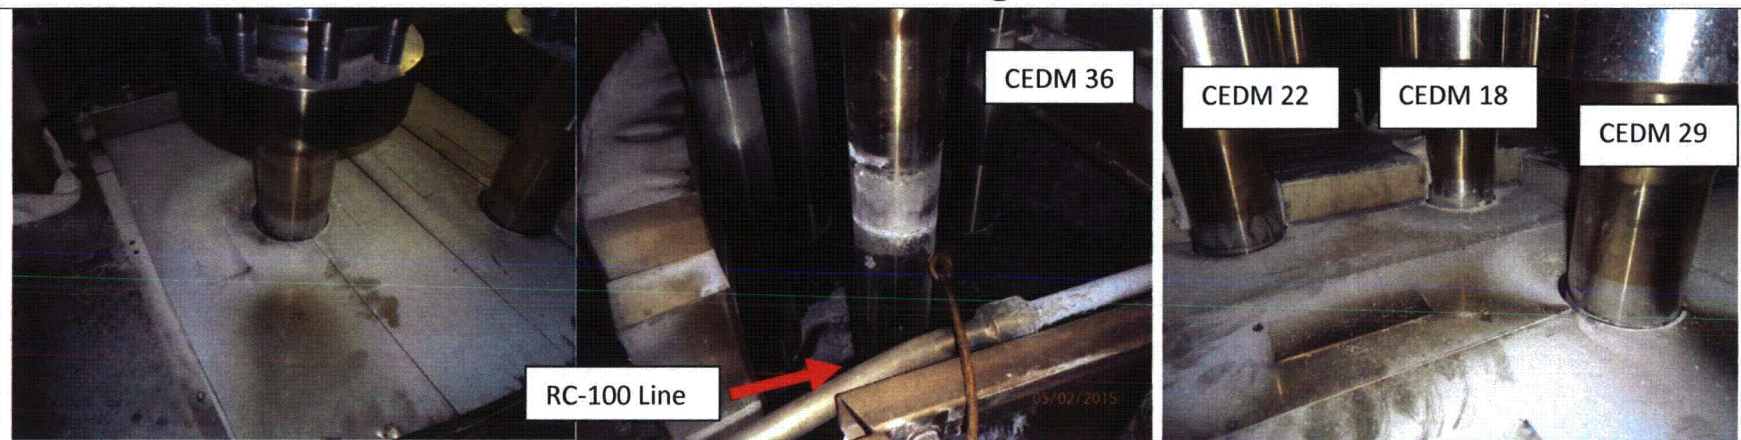
RC-100 Leakage

A packing leak was identified on RC-100 "REACTOR VESSEL RC-1 HEAD VENT TO RCGVS ISOLATION VALVE". Leakage from the packing of this valve results in RCS leakage and subsequent boric acid deposits around the area of the valve. Deposits from the valve packing, combined with other sources, contribute to the overall dust deposits located on the insulation layers and vent piping. Air circulation within the RVH shroud allows for redistribution of light deposit debris.
