LR-N15-0118

Salem Nuclear Generating Station Unit 2
Renewed Facility Operating License No. DPR-75
NRC Docket No. 50-311

SUBJECT: Response to Salem Nuclear Generating Station, Unit 2, Request for Additional Information Re: Spring 2014 Steam Generator Tube Inspections (TAC No. MF5117)

Response to Salem Nuclear Generating Station, Unit 2, Request for Additional
Information Re: Spring 2014 Steam Generator Tube Inspections (TAC No. MF5117)

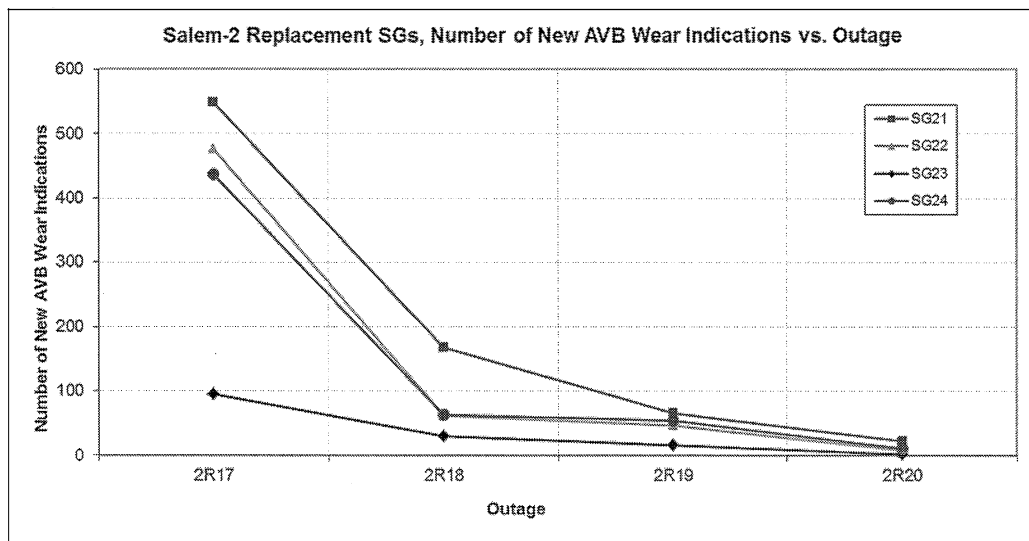
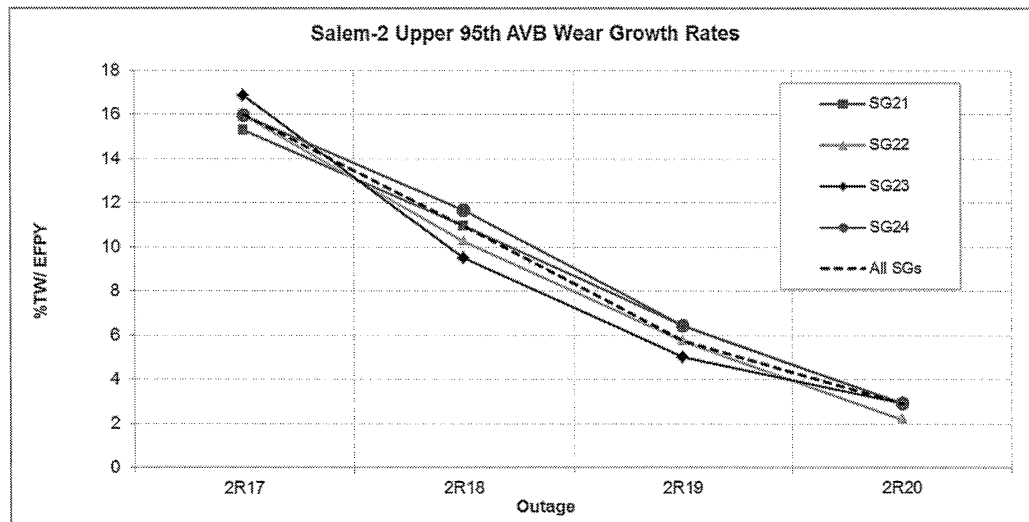
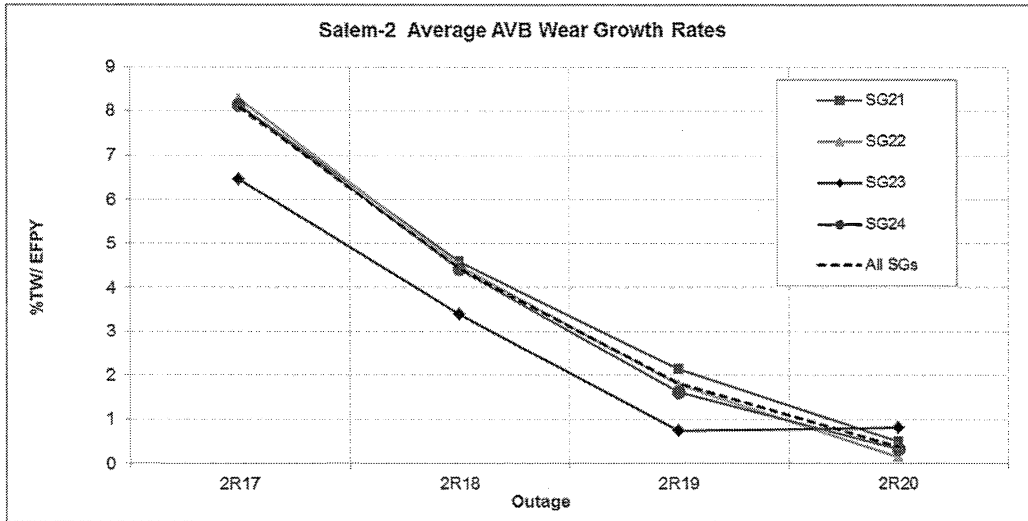
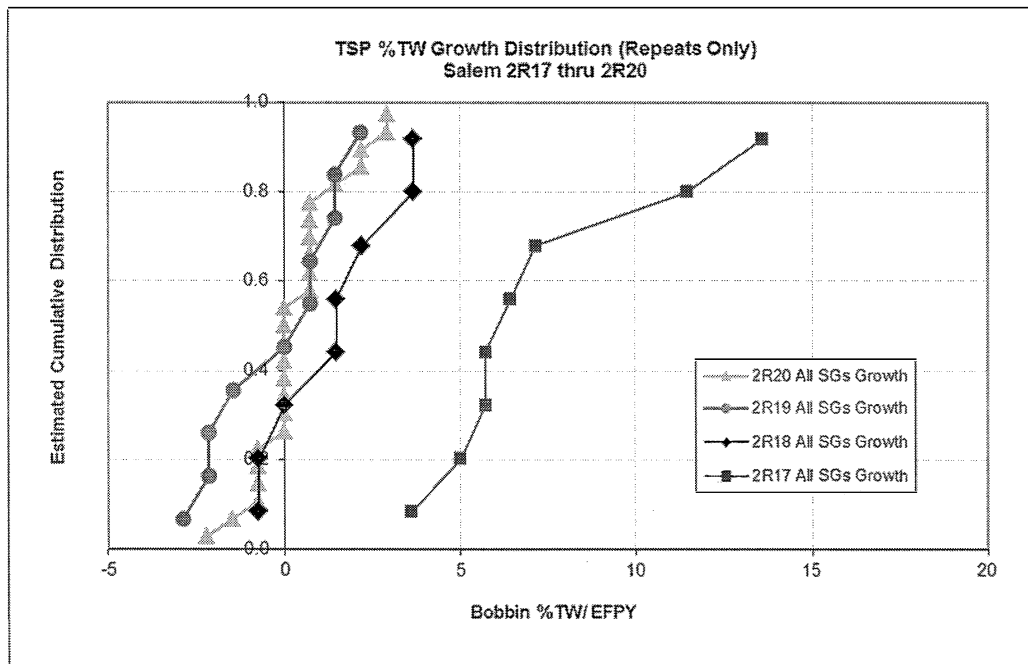
Below is a table summarizing the bobbin eddy current inspection results for the number of indications and tubes with wear at the anti-vibration bars (AVB) and tube support plates (TSP), and four graphs representing the trends for the number of new anti-vibration bar wear indications, AVB wear growth rates, and TSP wear growth rates. The growth rate graphs provide the trends with the upper 95th percentile growth rate and the average growth rate for AVB wear indications with history (with exception of 2R17, since all indications in 2R17 are new). As shown in these graphs, the trends for the number of new anti-vibration bar wear indications, AVB wear growth rates, and TSP wear growth rates at each inspection outage have continued to decline with each inspection outage; or have essentially no change (i.e. – stabilized). The number of TSP wear indications returned to service following outage 2R19 was 24 (Attachment 2 of LR-N14-0009, ML14010A428). During outage 2R20, 35 bobbin TSP wear indications were reported (one additional bobbin indication was reported as a Distorted Support Indication (DSI) bringing the bobbin indication total to 36). The overall population of TSP wear indications is limited and relatively small, with a change of 12 new TSP wear indications detected by eddy current bobbin inspection during outage 2R20. Subsequent to outage 2R20 tube plugging, 24 bobbin TSP wear indications were returned to service.
