Subject: Potential 10CFR Part 21 Notification on Struthers Dunn Relays

Investigation for Potential Part 21 for Struthers Dunn Relays

To: **Bryan Ohmert, (856) 339-2949, PSEG-Nuclear**
From: **Lance Walls, 610-380-2309 lance.walls@exelonpowerlabs.com**
Project: **PSE-72352**
Subject: **Failure Analysis of a Relay**
Manufacturer: Struthers Dunn
Stock Code/Cat ID: X400405
Quantity Received: 1
Model: 219BBX200
Purchase Order No.: 4500850488-0
Qualtech Tag#: CJ358602-05
Date: **19 March 2015**

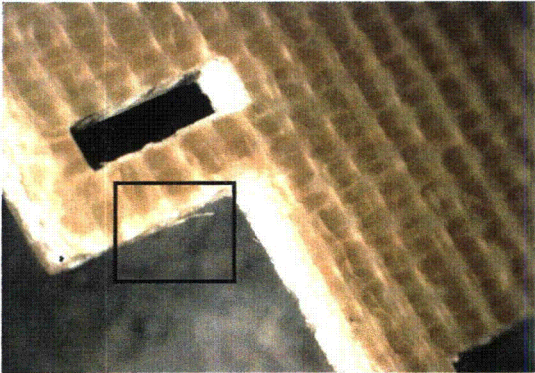
Fiberglass Fiber shown in the box

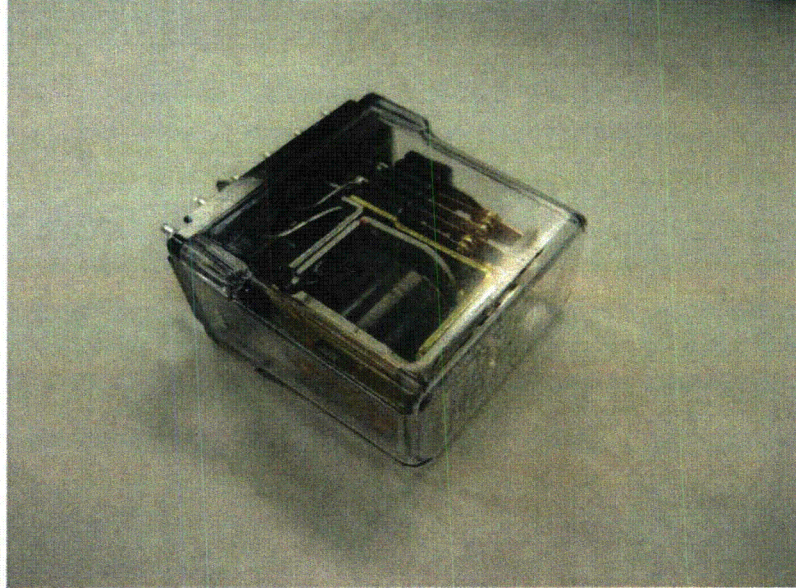
Photograph 3: As Received Condition

- There was no outward indication of any thermal, mechanical, or electrical damage.
- All soldered connections on the pins and contact block were microscopically examined and were verified as being acceptable.
- There was no indication of any arcing on any of the pins. There were only expected wear marks present that were associated with routine insertion / desertion operations.
- Manual manipulation of the assembly yielded no indication of the presence of free-moving or loose internal components or foreign material.
- There was no indication of coil outgassing on the internal surface of the case.
- There were no findings or observations that prohibit energized testing.

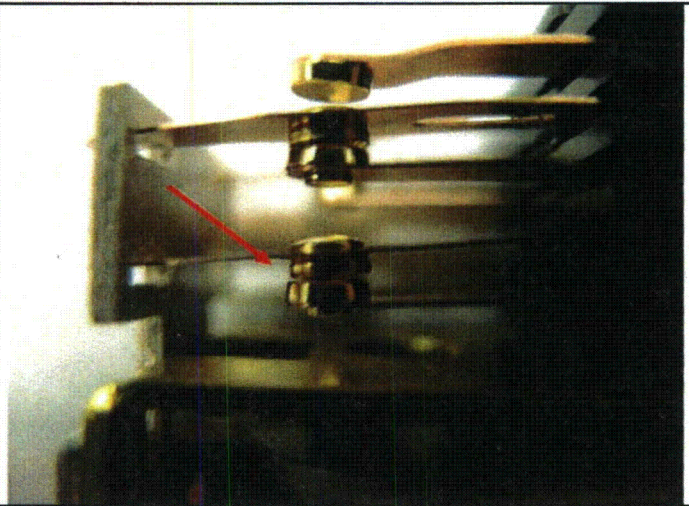
Photograph 4: 8-9 Contact Connection

The arrow in this photograph points to the closed 9-9 contact set. They were viewed via stereomicroscope and there was clear surface – surface engagement in the approximate center areas, with no air gapping observed.

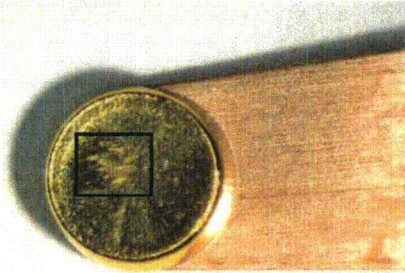
Photograph 5: Contact 8 I

The surface of the 8 contact exhibited pronounced striations in the approximate center of the area. They had the appearance of multiple scratch marks in close proximity and in parallel orientation to one another.

The striation / scratch marks observed with both the 8 and 9 contact surfaces are not a normal or expected observation with contacts that have not been mechanically burnished. Mechanically burnishing will produce scratched surface marks due to the inherent cleaning process, however it is not believed that either of these contacts were burnished.

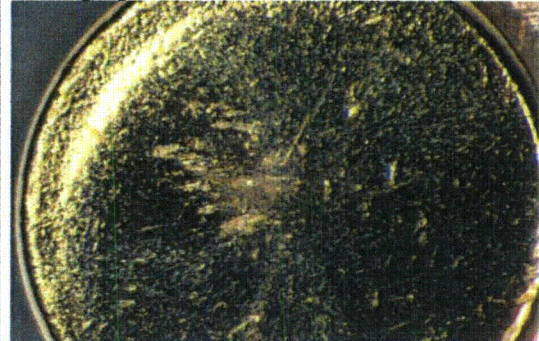
Photograph 6: Contact 8 II

A closer view of the boxed area of photograph 5.

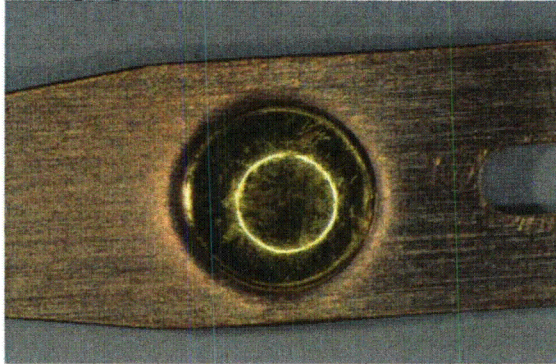
Photograph 7: Contact 9 I

The surface of the 9 contact also had the striation marks that were observed with contact 8, although they were widespread and severe in nature. They appeared to be random and numerous scratch marks.

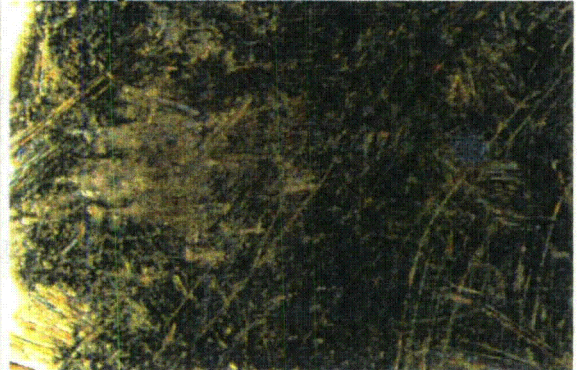
Photograph 8: Contact 9 II

A closer view of the boxed area of photograph 7.

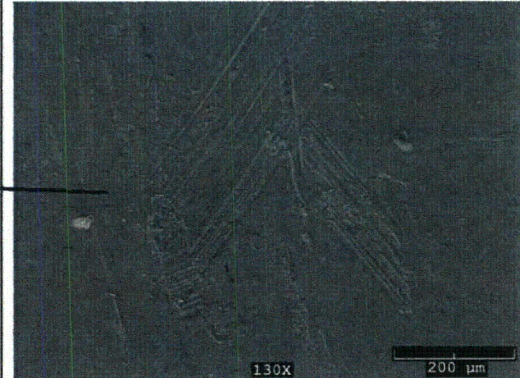
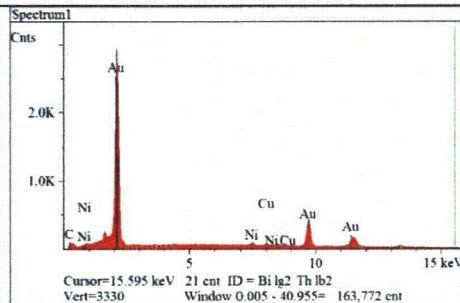
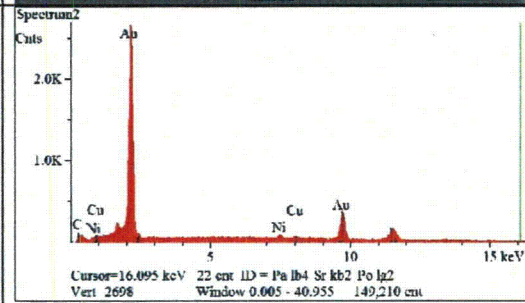
Photograph 10: Contact 8 Surface – Center Area

Photograph 10 exhibits the striation patterns that were present on the contact 8 surface. Again, these patterns are not a typical wear pattern observed relay contact make/break or wipe operations. Gold was primary elemental constituent in both snapshots, with similar concentrations of Nickel and Copper in both.

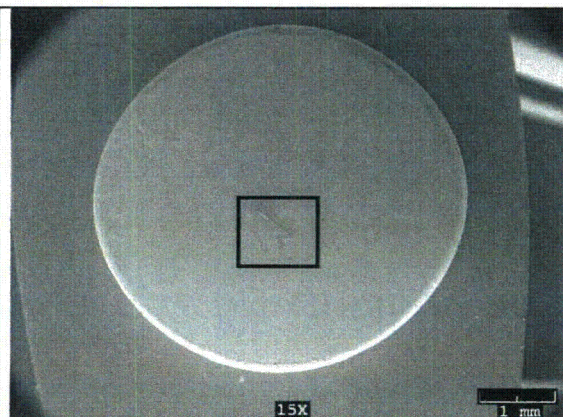
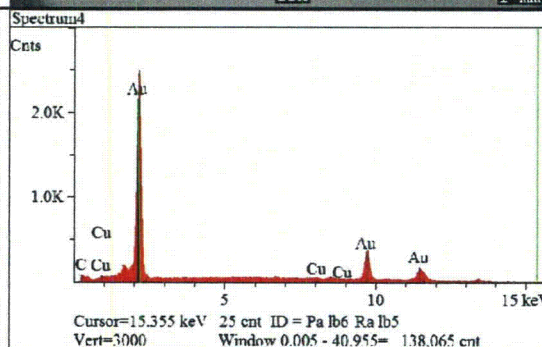
Photograph 11: Contact 9 Surface

The contact 9 surface had the striation patterns present both in the contact center area and away from the center area. Gold was the primary constituent, and the presence of Copper was also detected. No Nickel was detected. The boxed area will be better explained in photographs 12 and 13.

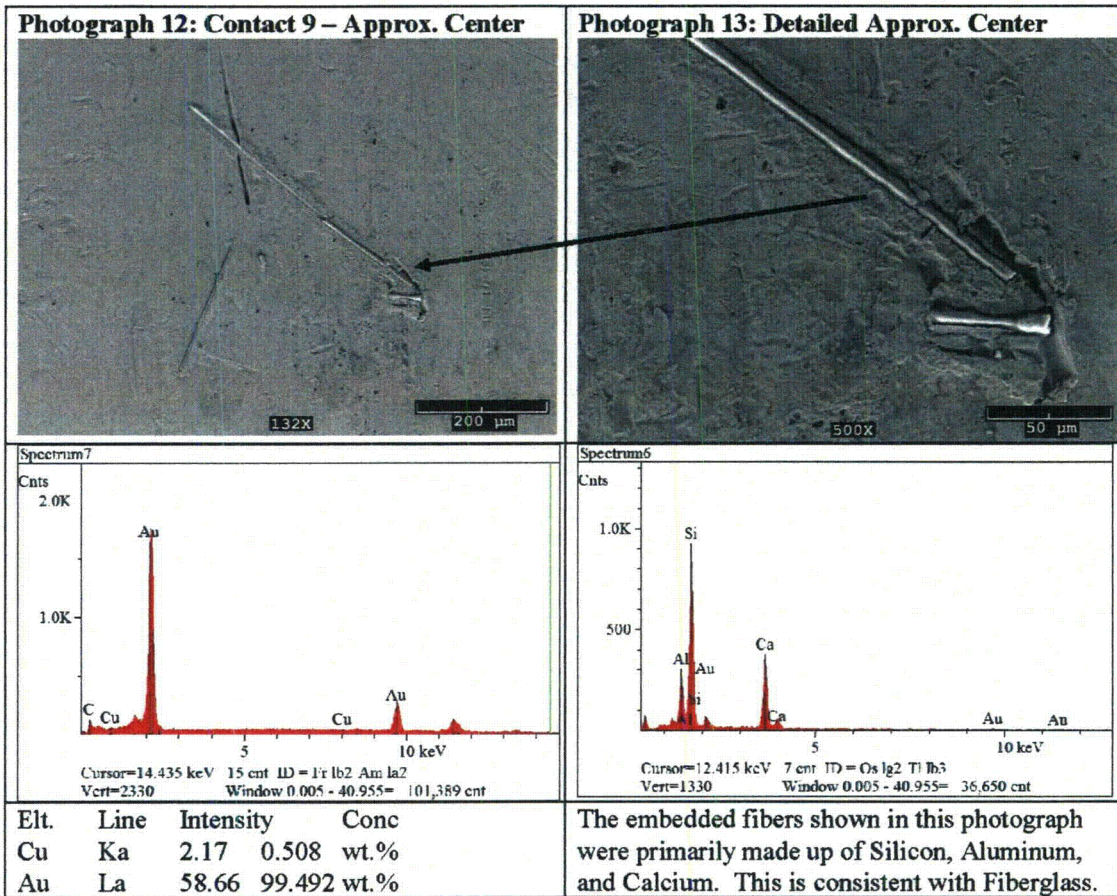
The embedded fibers in the contact surface, which are exhibited in photographs 12 and 13 had an elemental composition consistent with Fiberglass. The fact that they are embedded into the surface of the contact suggests that they were present at the time of manufacture when the surface was coated. The presence of other similar cavities into the contact surface may suggest that there were other fiberglass fibers present at one time, but that they became disassociated due to contact make / break operations. The irregular patterns in the contact surfaces and the presence of the fiberglass fibers in the approximate center of contact 9 are the most likely cause of the excessive resistance.

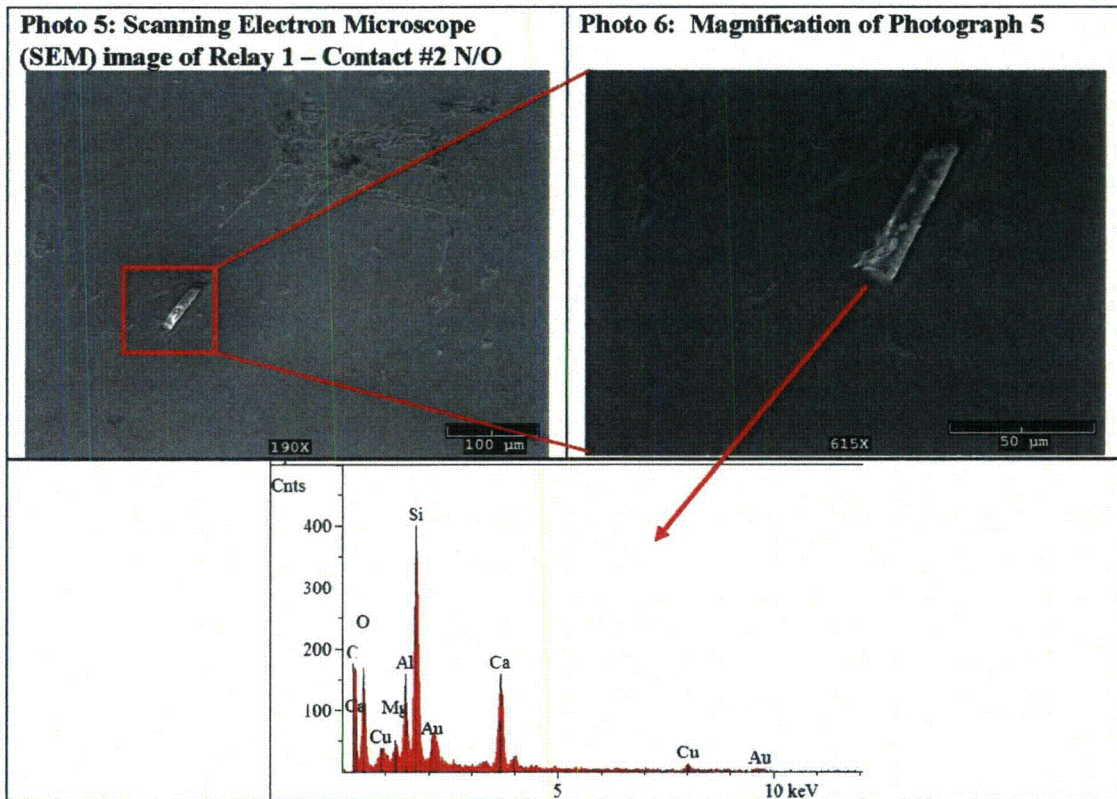
Embedded foreign material was observed on the #2 N/O contact surface. The embedded foreign material in the contact surface had an elemental composition consistent with fiberglass shown in the Energy Dispersive Spectroscopy spectrum shown above (Primary constituents are Si, Ca, Al, O).

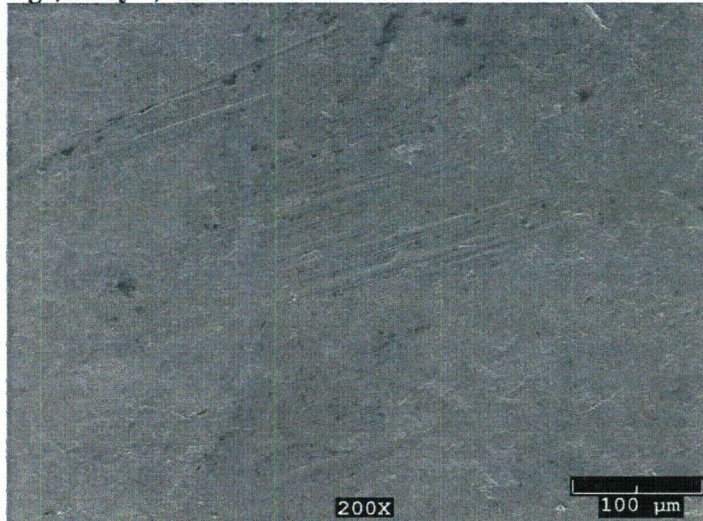
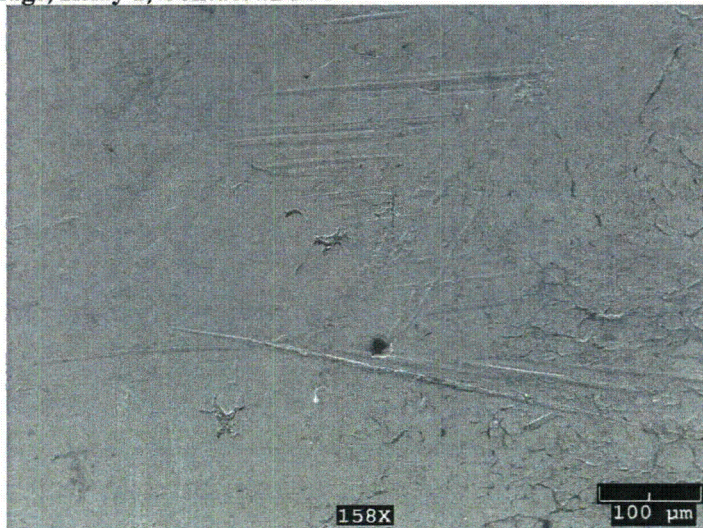
The photographs above are representative of the remaining contact surfaces examined from Relay 1. All the other contact surfaces did not contain any foreign material, but revealed scratches on the contact surface.

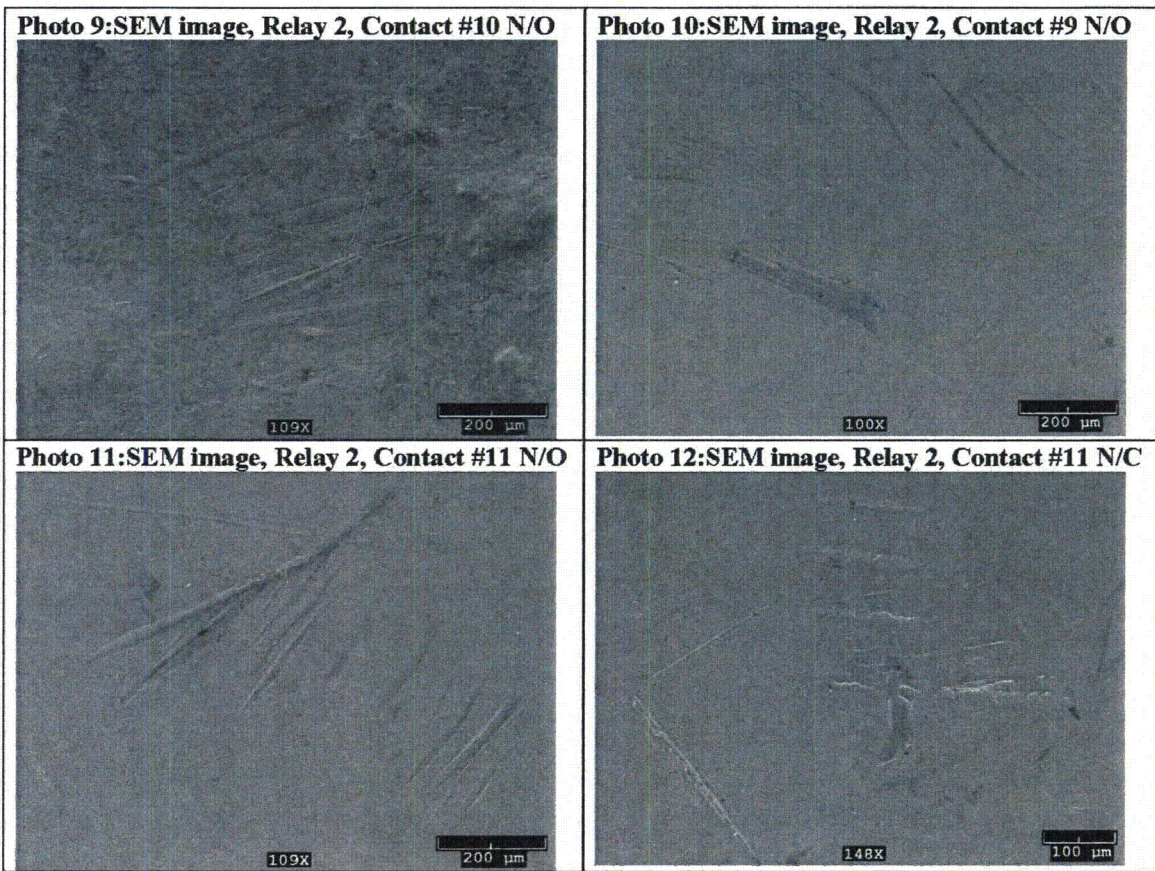
The photographs above are representative of the contact surfaces examined from Relay 2. All of the contact surfaces did not contain foreign material, but revealed scratches on the contact surface.
