**UNITED STATES
NUCLEAR REGULATORY COMMISSION**

May 27, 2015

EA-15-081

**SUBJECT: PILGRIM NUCLEAR POWER STATION – NRC SPECIAL INSPECTION REPORT
05000293/2015007; AND PRELIMINARY WHITE FINDING**

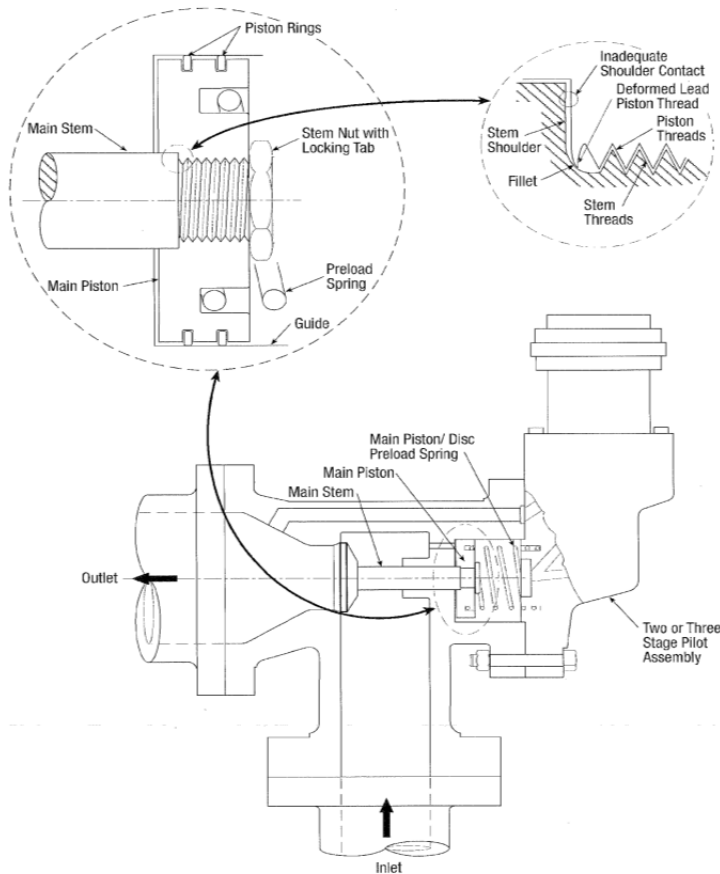
The 'C' SRV was subsequently sent to an offsite testing facility for as-found setpoint verification, low pressure testing, and an inspection of valve internal components. While the 'C' SRV satisfactorily stroked during both the setpoint test and additional low pressure (100 psig) actuation test at the testing facility, the inspection revealed notable damage to some internal valve main stage parts. Specifically, the main valve piston had indications of some scoring and the lower piston ring (two rings in total) was seized within the piston ring. The most noteworthy damage was wear (grooves) in the main operating cylinder liner where the operating piston rings rest while the valve is in its closed position. The cylinder liner wear resulted in resistance to valve operation in the open direction through contact with the operating piston rings. Upon the disassembly, the technicians noted that the piston was not tightly secured and the locking tab was slightly rotated out of its grooved position. In its normal/assembled condition, the main valve stem is threaded into the main piston, torqued, and is secured with a washer and stem nut with locking tab on the opposite side of the piston (See SRV figure below).

Diagram of Target Rock SRV from NRC Information Notice 2003-01, "Failure of Boiling Water Reactor Target Rock Main Steam Safety/Relief Valve," dated January 15, 2003

The assembly of the valve is such that the main stem is torqued to the piston (100 ft-lbs) and the stem nut is torqued to the threaded end of the main stem (50 ft-lbs). However, there has been prior operating experience, including an instance at PNPS in 2013, where the stem nut was found loose. Based on prior operating experience, there have been separate issues that may have contributed to torque relaxation or looseness at the stem/piston or stem nut interface. These included 1) inadequate stem shoulder contact at the main stem/piston interface, 2) inefficient test gag device that potentially allowed substantial internal valve impact during full pressure setpoint testing, and 3) a stem nut torque value that was less than optimal. It was not apparent that a single item alone was the cause for the identified issues. Further, based on historical operating and internal inspection data, internal wear problems were not assured even when the old style test gag device and lower stem nut torque existed (i.e., human performance/installation and specific in-service vibration levels may also have had negative impacts). The testing facility currently uses a re-designed test gag device to prevent a large impact force during the full pressure bench testing, and the vendor recommended an increased stem nut torque value (100 ft-lbs) in December 2013.

verification, and the 100 psig SRV lift were completed satisfactorily at the testing facility. However, disassembly and inspection of the valve's internal parts yielded similar results (e.g., operating cylinder liner wear) to that of the 'C' SRV. As a result of the as-found inspection results of the 'A' and 'C' SRVs, Curtiss-Wright Flow Control Company, Target Rock Division, issued Interim 10 CFR Part 21 Interim Report (EN 50900) on March 17, 2015, due to the potential to induce a defect during the testing of the relief valve model (three stage Target Rock Model 0867F).

During the shutdown following the January 27, 2015, reactor scram, Entergy replaced both the 'A' and 'C' SRVs with refurbished and certified replacement SRVs. Both were tested with the new test gag design. The 'A' SRV was refurbished prior to the stem nut torque value change so it was torqued to 50 ft-lbs, and the stem nut for the 'C' SRV, refurbished later, was torqued in accordance with revised instructions and was torqued to 100 ft-lbs. With respect to the 'B' and 'D' SRVs, which operated satisfactorily during the transient, they had both previously been tested prior to their May 2013 installation and both had a 50 ft-lb torque applied to the stem nut.
