**SUBJECT: DAVIS-BESSE NUCLEAR POWER STATION - INSPECTION OF APPARENT  
CAUSE EVALUATION EFFORTS FOR PROPAGATION OF LAMINAR CRACKING  
IN REINFORCED CONCRETE SHIELD BUILDING AND CLOSURE OF  
UNRESOLVED ITEM INVOLVING SHIELD BUILDING LAMINAR CRACKING  
LICENSING BASIS - INSPECTION REPORT 05000346/2014008**

Inspection Report 05000346/2014008; 11/03/2014 – 04/15/2015, Davis-Besse Nuclear Power Station; Inspection of Apparent Cause Evaluation Efforts for Propagation of Laminar Cracking in Reinforced Concrete Shield Building; Closure of Unresolved Item Regarding Whether the Licensee's Acceptance of Laminar Cracking in the Shield Building Required NRC Review and Approval.

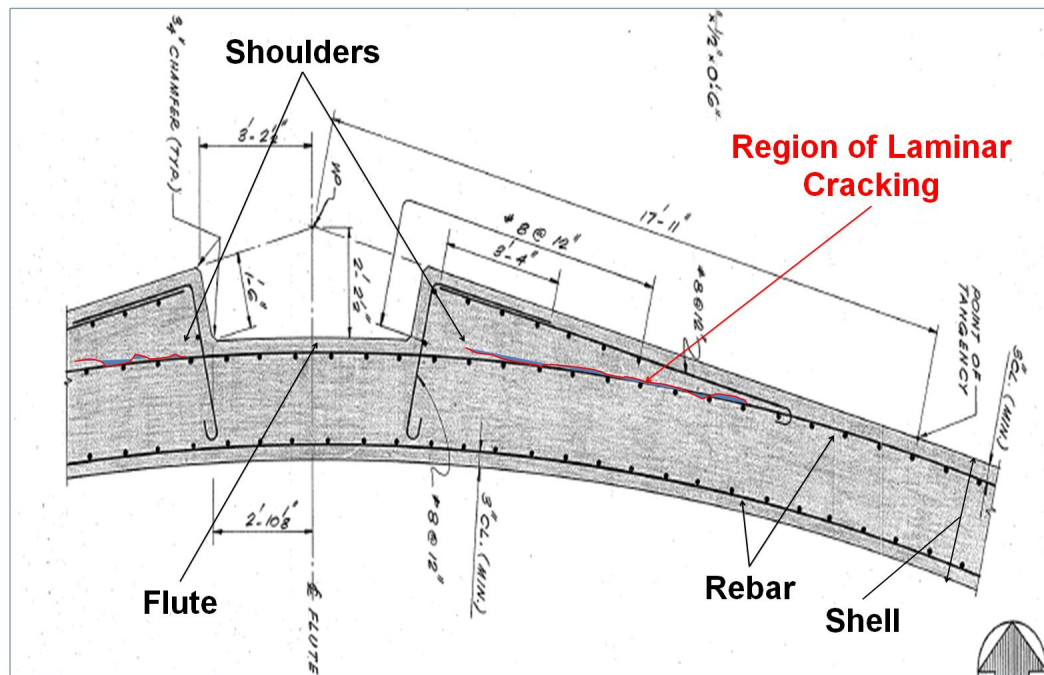
**Figure 3: Flute and Shoulder Cross-Section**

During construction of the SB access opening to replace the reactor pressure vessel head in late 2011, the licensee discovered laminar subsurface cracking in the SB (Figure 3). Through Impulse Response testing and confirmatory core borings, the licensee bounded the extent of cracking as along the outer rebar mat in the SB flute shoulders, at the top of the SB near the junction with the roof, and at the SB main steam line penetrations. The licensee was able to demonstrate via rigorous and conservative structural calculations that the SB remained structurally adequate for the controlling load cases, and remained capable of performing its design safety functions. The licensee's analysis and associated NRC review regarding operability of the SB are discussed in NRC Inspection Report (IR) 05000346/2012007 (ADAMS Accession No. ML12128A443).
